Evaluation of a Timber Bridge for the Secondary Road System Using FRP Reinforced Glued-Laminated Girders

Delaware County, Iowa is taking a step in that direction through the construction of a 64 ft. long bridge comprised of fiber-reinforced polymer (FRP) reinforced glued-laminated timber girders and a transverse glued-laminated timber deck. The bridge was designed by Matt Smith of Laminated Concepts, Inc. of New York state with technical guidance provided in the design and fabrication of the FRP reinforced girders by the University of Maine. The bridge was fabricated by Alamco Wood Products, Inc. of Albert Lea, MN. Prior funding for the design, construction (including materials), and monitoring/evaluation of this project has been obtained through the IBRC program with the assistance of Curtis Monk, Division Bridge Engineer with the Iowa Division of the FHWA.

This report summarizes the monitoring and evaluation of the structure conducted immediately following the construction of the bridge and throughout the first couple years after construction.

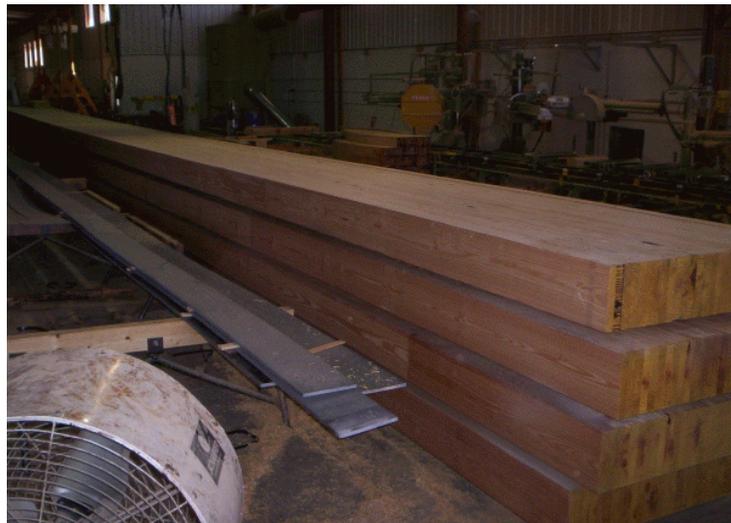
The initial inspection, conducted at the Alamco Wood Products, Inc. plant in Albert Lea, MN, found the glued-laminated girders were in excellent condition upon removal from the clamps. The girders were then planed, drilled, routed, and prepared for FRP installation.

Figure 7. Glued-laminated girders prior to FRP installation

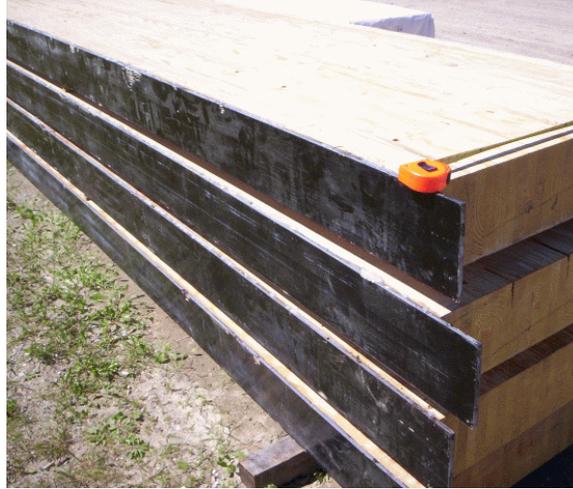
Immediately following the fabrication of the girders, representatives from Iowa State University and Delaware County traveled to the plant site to witness the FRP installation. Mark Nahra, the Delaware County Engineer, was onsite to observe the installation of the FRP plate on the eight girders, which was performed by Justin Crouse, a research associate for the University of Maine. Installation of the 0.50 in. FRP plate transpired with no complications.

Figure 8. Glued-laminated girders after FRP installation

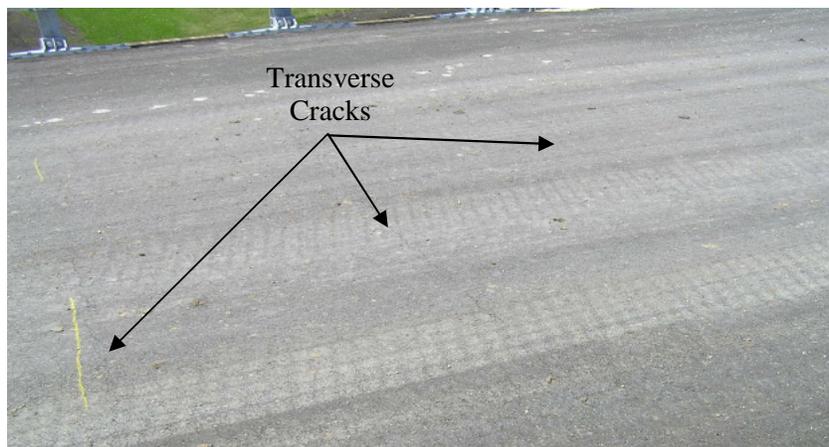
First, there appeared to be no moisture-blocking membrane placed between the glued-laminated deck and the wearing surface to prevent moisture from coming in contact with the deck and underlying girders should there be a break in the wearing surface. Second, the wearing surface did not cover the entire deck surface but, instead, terminated just inside the metal base plates used to attach the guardrail posts to the deck, leaving approximately 1 ft. of the deck surface exposed. Third, the wearing surface was measured as approximately 3 in. in depth at centerline and tapered to approximately 1 in. in depth at the guardrail. Lastly, evident at each panel joint and at both abutments were small, noticeable, transverse cracks in the asphalt wearing surface. Figure 9 attempts to illustrate these cracks, although they are difficult to identify. As alluded to previously, these cracks will allow for infiltration of moisture to both the deck panels and girders, which may lead to further problems in the future.

Figure 9. Transverse cracks at panel joints on Delaware County Bridge

Inspection prior to testing revealed transverse cracks in the asphalt wearing surface only weeks after placement of the wearing surface. The presence of these cracks along with small differential panel deflections indicates that there may be other factors affecting the condition of the asphalt-wearing surface on the bridge.

- The relative deflection performance of the deck panels with the longitudinal stiffener beams was well within specified limits; however, transverse cracking of the wearing surface above the deck panel joints appears to be occurring and is the result of unidentified factors.

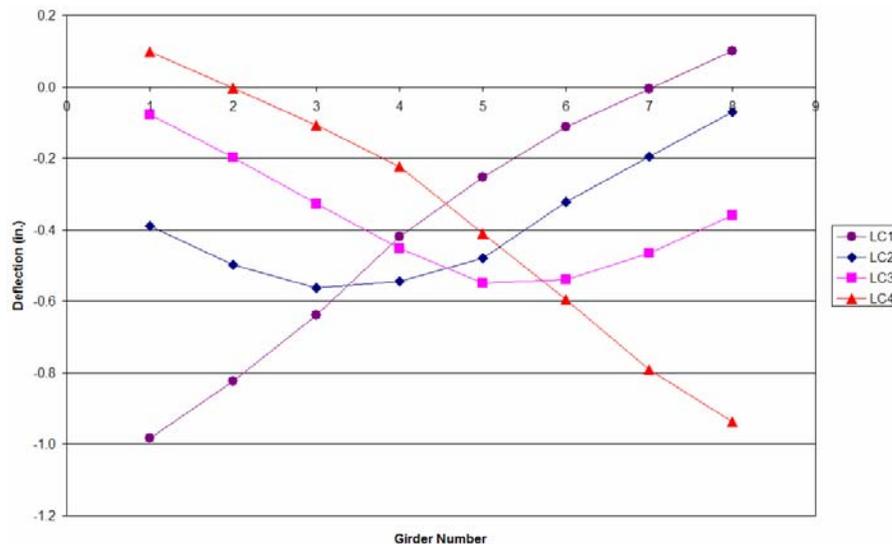
Illustrated in Figure 10 is the transverse global deflection of the bridge for all four load cases when the load truck is positioned longitudinally near mid-span. The maximum deflections were approximately -0.90 in. to -1.00 in. for load cases 1 and 4 at the exterior girders. When the load truck was positioned near the longitudinal centerline of the bridge; as in load cases 2 and 3, the maximum deflections were approximately -0.55 in. The decrease in the maximum deflection from load case 1 and 4 to load case 2 and 3 is likely the result of transverse load distribution characteristics associated with load position.

Current design specifications call for deflection checks of the form L/n , L being the clear span of the bridge. For this bridge, the American Association for State Highway Transportation Officials (AASHTO) Standard Specification (1996) specifies that global deflection of timber bridges be limited to 1.51 in.; the AASHTO LRFD (1998) specification limits the same deflection to 1.77 in.; the timber design manual, *Timber Bridges: Design, Construction, Inspection and Maintenance* (Ritter 1990), published by the Forest Service, limits this deflection to 2.09 in. The maximum deflections for the Delaware Co. Bridge for each load case are 0.72 in., 0.68 in., 0.41 in. and 0.40 in. after normalization to the standard HS-20 load truck for comparative purposes. This indicates that the deflection performance of the bridge is within the limits of the current design specifications and manual.

Figure 10. Girder deflection for load cases 1-4, load truck near mid-span

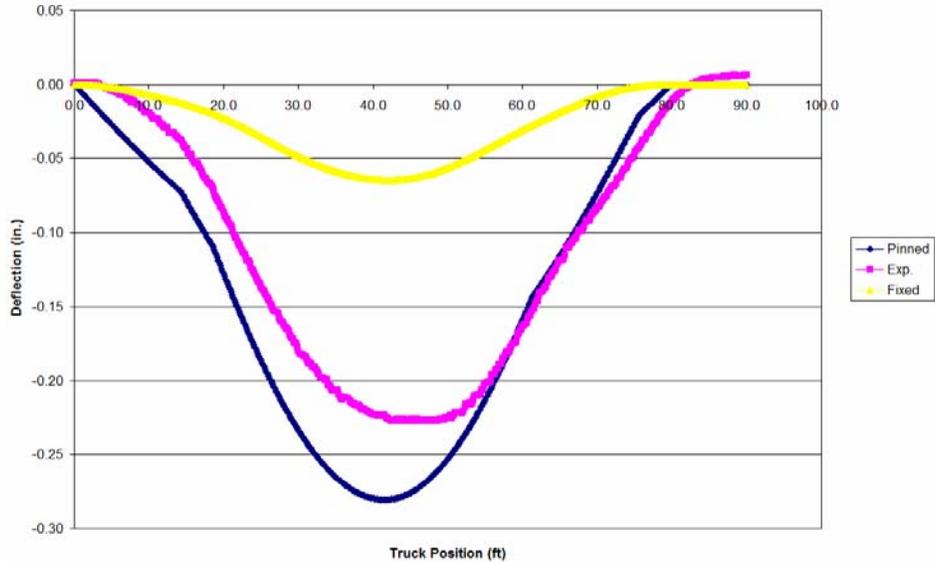
To investigate the level of girder end restraint, deflections were approximated from equations based on standard beam theory for a pinned-pinned condition and a fixed-fixed condition. These deflections were then compared with the measured deflections. Illustrated in Figure 11 are the calculated and measured deflections for one girder, which is representative of all girders for all four load cases. Since the experimental data trend line is closer to the fixed-fixed trend line than the pinned-pinned trend line, there is apparently some level of rotational restraint at the girder ends of the Delaware Co. Bridge.

Figure 11. Calculated and experimental deflections for Delaware County Bridge

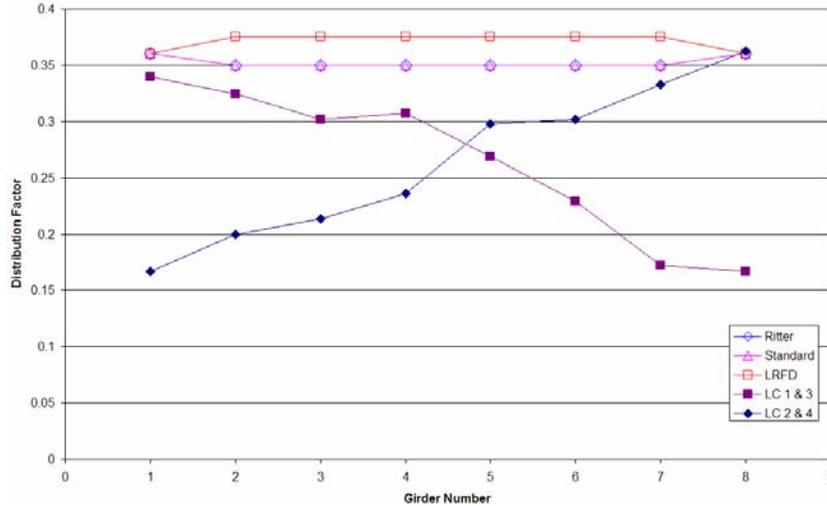
Illustrated in Figure 12 are the codified and experimental distribution factors for the Delaware County Bridge. From Figure 12 it is clear that the equations in [1], [2], and [3] used to calculate distribution factors are conservative.

Figure 12. Experimental and codified distribution factors
