Road Safety Audit for the US 61/ Harrison Street and West Locust Street Intersection in Davenport- Scott County, Iowa

Final Report
October 2008

Sponsored by
the Iowa Department of Transportation

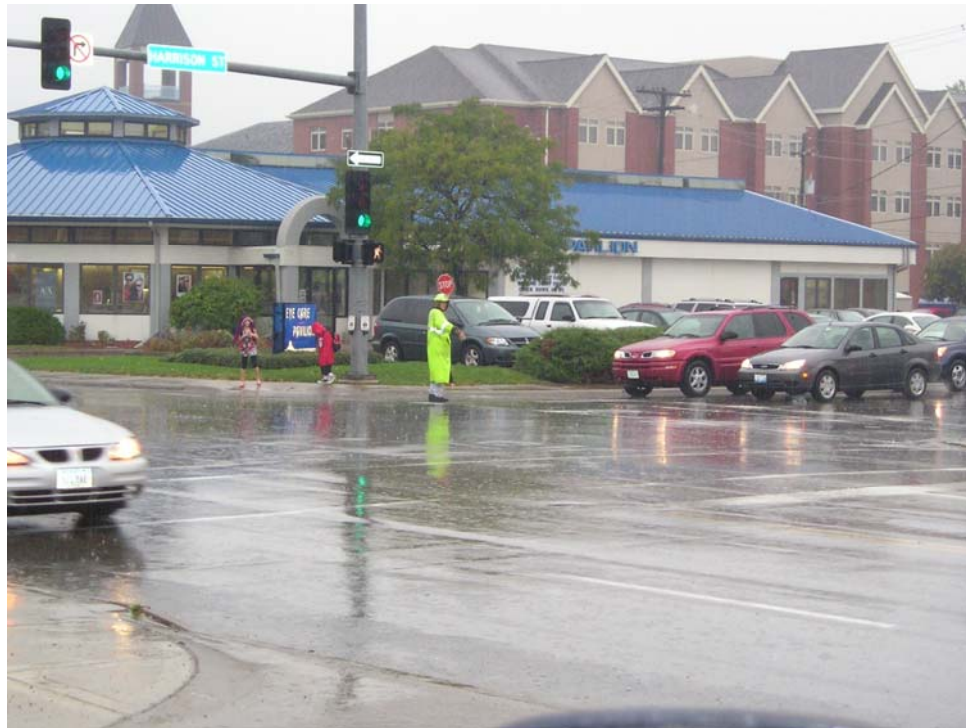
The Davenport Police Department has established a crossing guard training program for school pedestrian crossings. One of these crossings is located at the audit intersection. Shirley Hicks and Robin Nelson, who work in that department, described the details of the program. Crossing guards are trained and compensated by the police department and are made up mostly of retired persons. According to Hicks and Nelson, these guards are very conscientious and do a good job protecting the children. They are furnished with highly visible apparel for various weather conditions and are compensated for their work. A crossing guard committee has been formed that meets about five times annually to discuss the problems and concerns of the guards. Some of the recent comments include concerns for sidewalk conditions approaching this intersection and the need for right turn on red restrictions during school children commute times at one corner of the intersection. A need to repaint the crossing's pavement markings was also noted. These issues will be examined in this report during the field reviews later.

Figure A.1. Crossing guard with school children

At the next scheduled crossing guard meeting, consider discussing MUTCD Part 7 guidance and recommendations, especially regarding STOP paddle requirements and apparel, and consider discussing the crossing habits of junior high students.

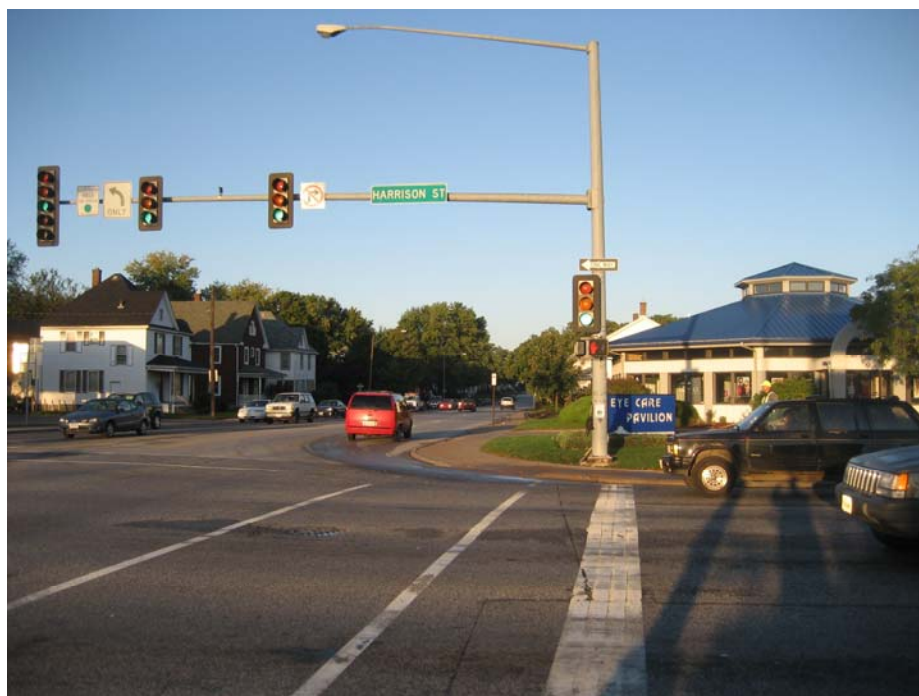
Figure A.2. Pedestrian crossing pavement markings

Replace existing pedestrian crossing markings, using milled-in installation to prolong service life. Additionally, install a “No Right Turn When Pedestrians Are Present” sign or similar restrictive signing for southbound Harrison Street to westbound Locust Street traffic. Consider installing count-down signals for pedestrian use.

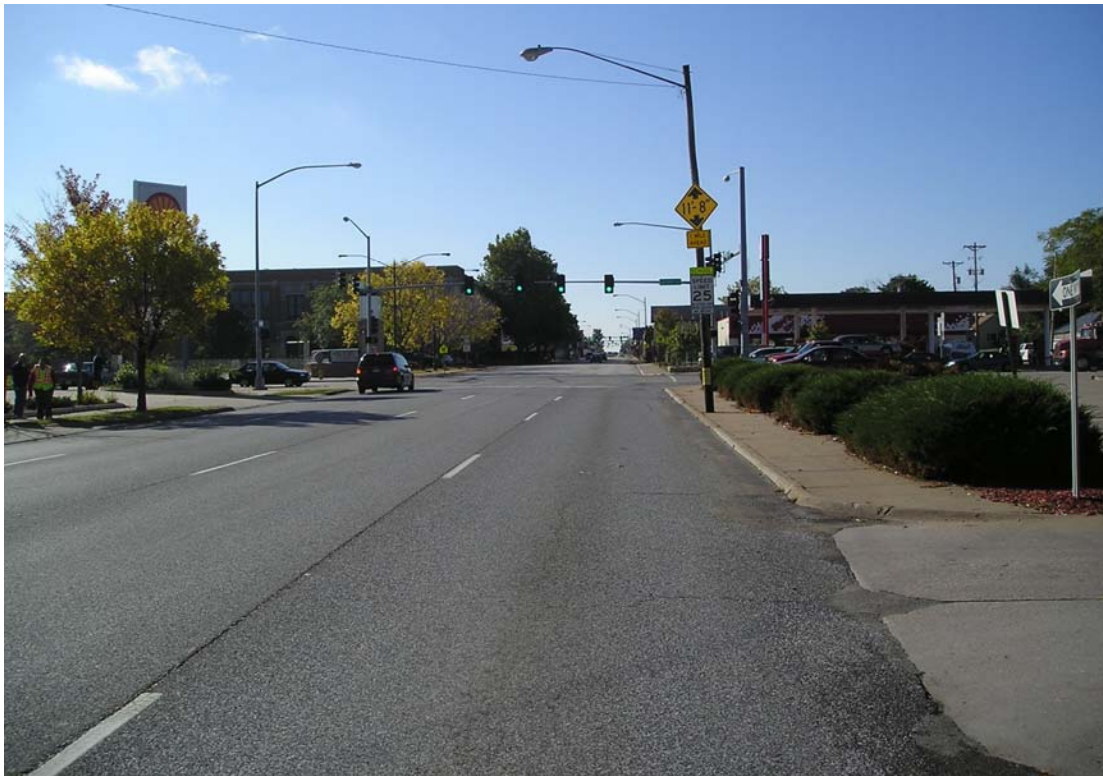
Figure A.6. Southbound Harrison Street

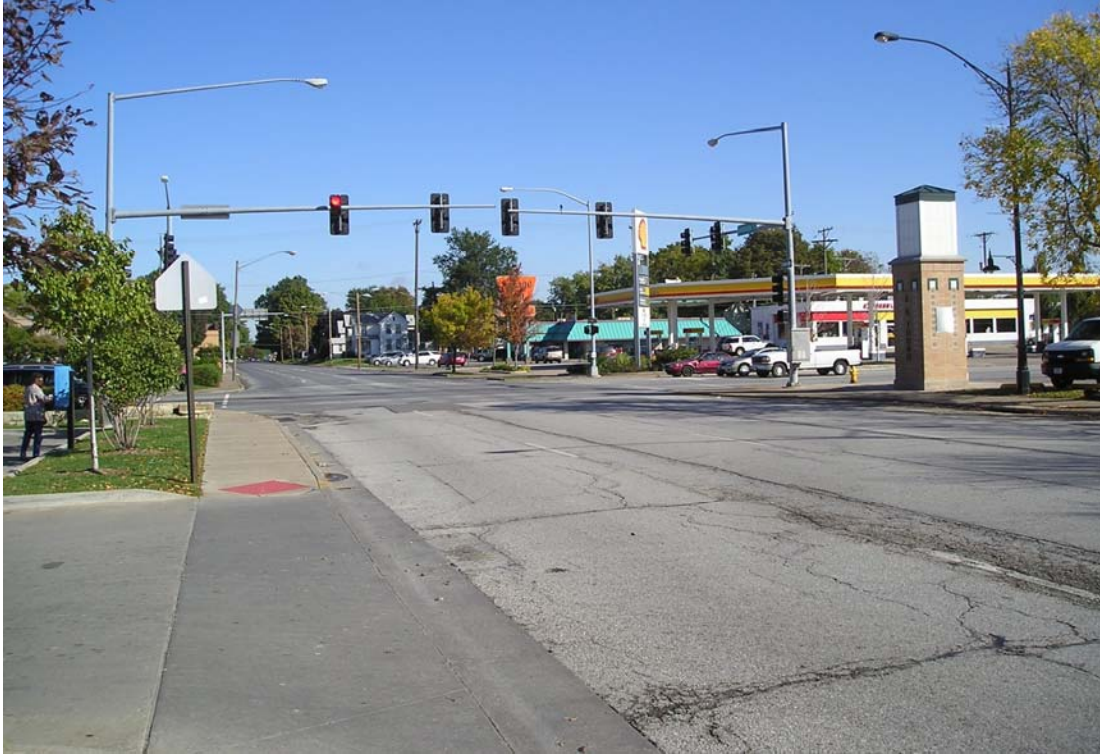
The southbound traffic signal assembly features a “tattle-tail signal” facing south to advise law enforcement officers if a signal violation has occurred. This can be effective, but it is less efficient than automated enforcement because it requires the presence of an officer to observe violations and issue citations.

Figure A.7. Tattle-tail signal for southbound Harrison Street traffic

When the city's automated enforcement program is recommenced, consider relocating cameras to this intersection to address red light running. Meanwhile, continue using the "tattle-tail" signal on southbound Harrison Street to mitigate signal violations for that movement.

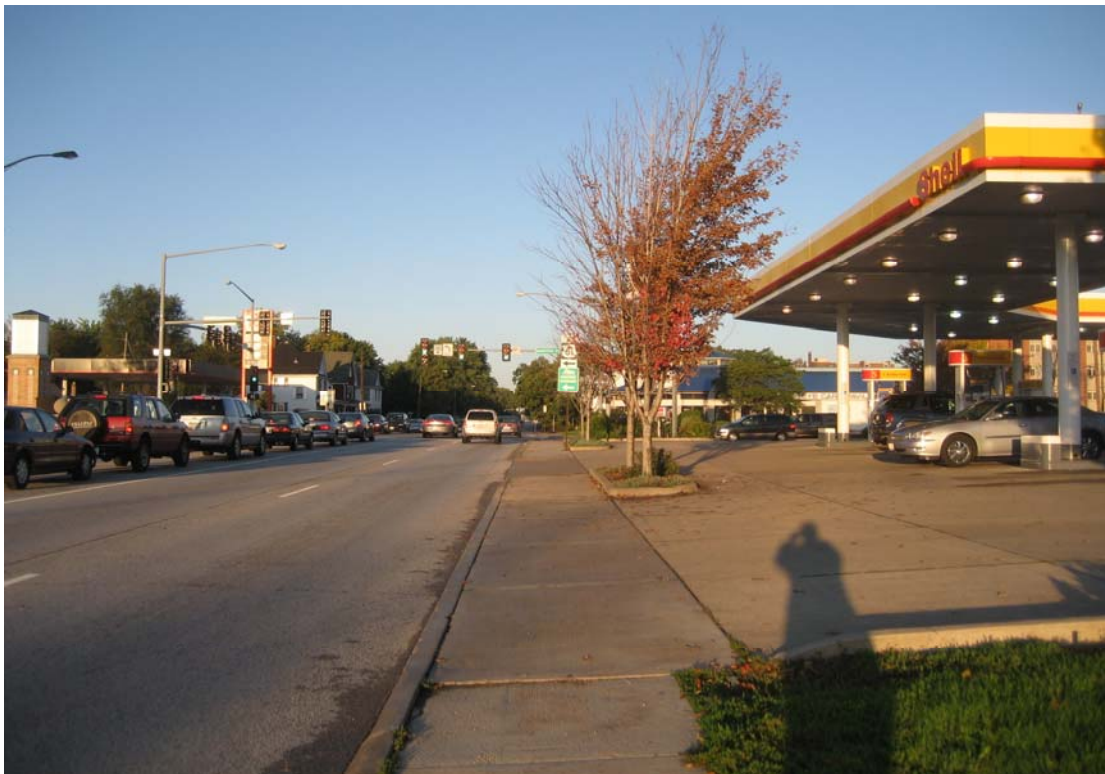
Some visibility restrictions from parked vehicles, vegetation, and a business sign were noted in the northwest corner of the intersection, but all sight restrictions were off the public right-of-way. In addition, it was noted that the visibility of the right-hand signs and signals was hampered by trees and other vegetation along westbound Locust Street approaching the intersection.

Figure A.8. Westbound Locust Street

Consider visiting with service station owners and other advocates about the sight restrictions caused by trees and vegetation along westbound Locust Street approaching the intersection. If possible, negotiate removal and/or trimming to improve sign and signal visibility.

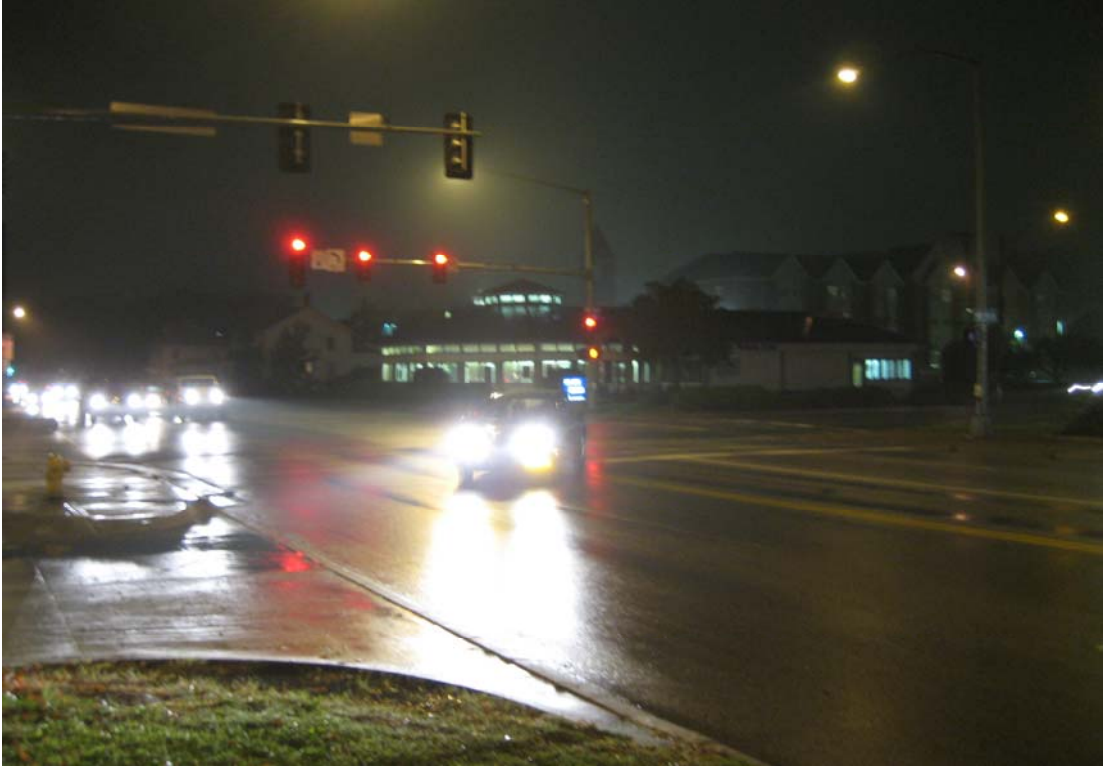
Traffic signal visibility was very good after dark. Street lighting appeared adequate. However, sign visibility was not good, especially for signs mounted on the signal poles and mast arms, because glare from the bright traffic signals hampered legibility of the sign messages. Providing newer sheeting for the street name signs and relocating one-way arrows to the signal pole may improve visibility of these signs. It was also observed that no signal head was mounted on the right-side pole for eastbound Locust Street traffic. This might hamper signal visibility for left-lane vehicles approaching the intersection.

Figure A.9. Nighttime view of traffic signals

Replace street name and one-way signs at the intersection with micro-prismatic sheeting signs. Upper and lower case lettering should be used to comply with recommendations in the *Manual on Uniform Traffic Control Devices* (MUTCD). Also, relocate the mast arm-mounted one-way sign for eastbound Locust Street to the signal pole to avoid nighttime visibility conflicts with the traffic signals.
