Utility Cut Repair Techniques— Investigation of Improved Cut Repair Techniques to Reduce Settlement in Repaired Areas

Final Report
December 2005

Sponsored by
the Iowa Highway Research Board (IHRB Project TR-503)

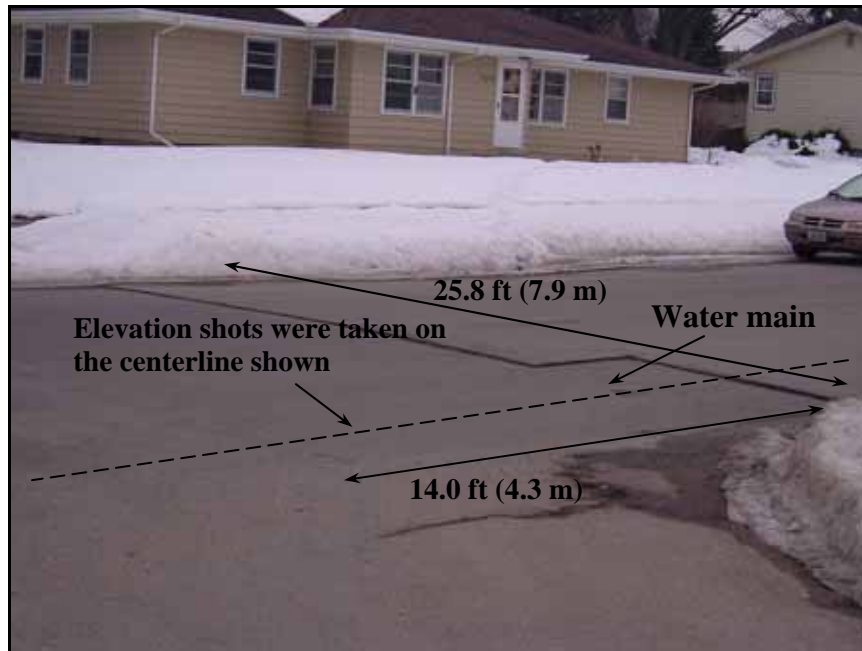
drop between the assumed trenching excavation limits and existing pavement, indicating significant settlement on the patched or reconstructed site.

Figure 1. Poorly performing utility cut in asphalt pavement

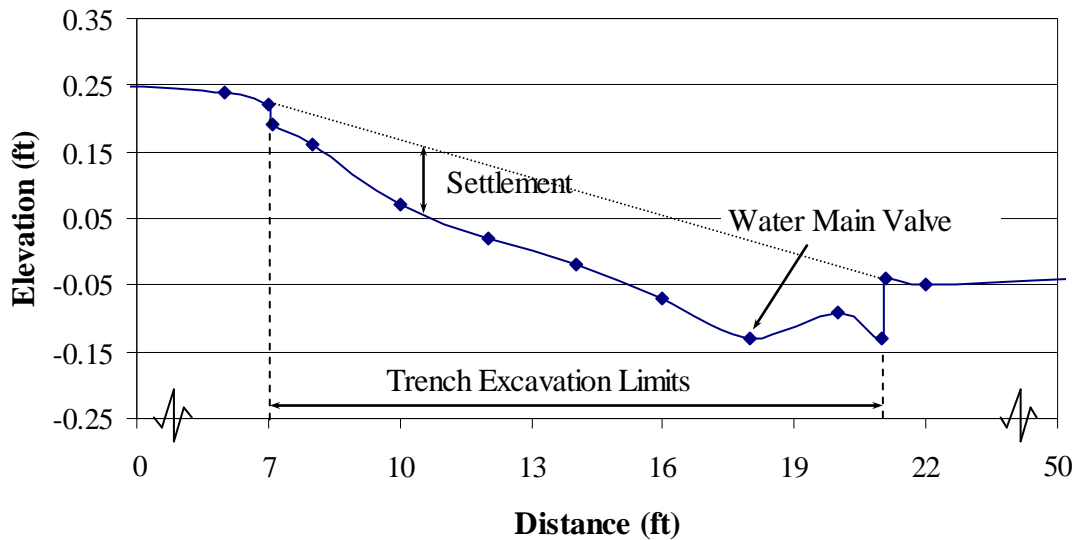
Figure 2. Settlement profile of poorly performing utility cut in asphalt pavement

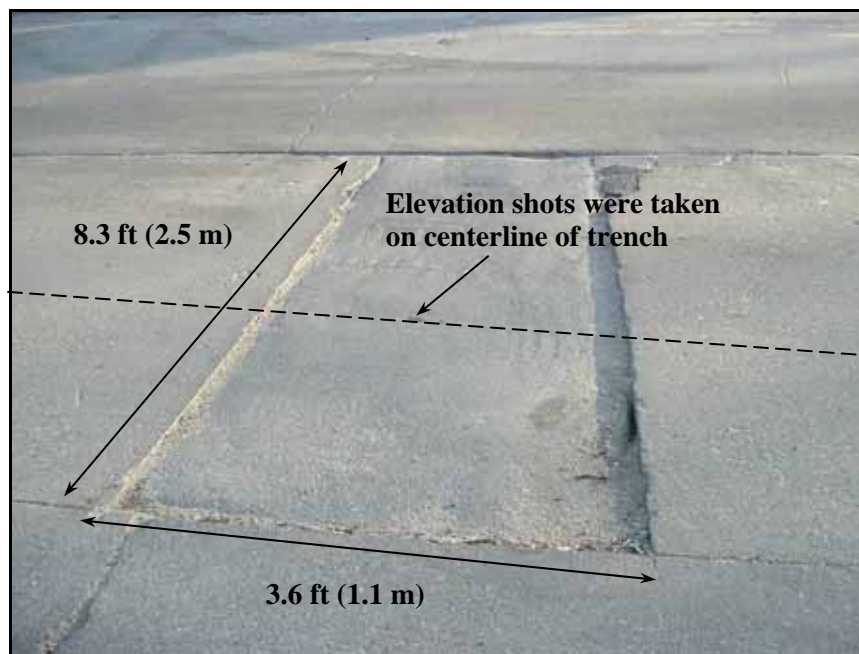
Figure 3. Poorly performing utility cut in concrete pavement

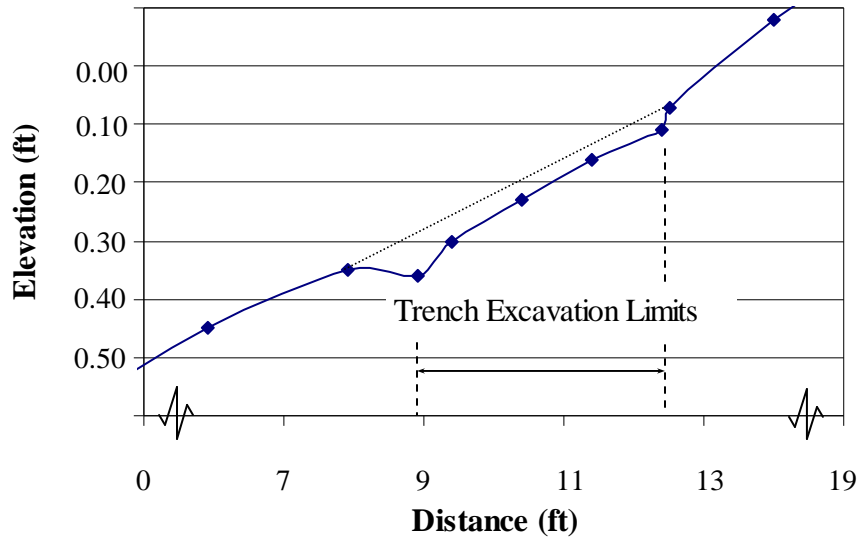
Figure 4. Settlement profile of poorly performing utility cut in concrete pavement

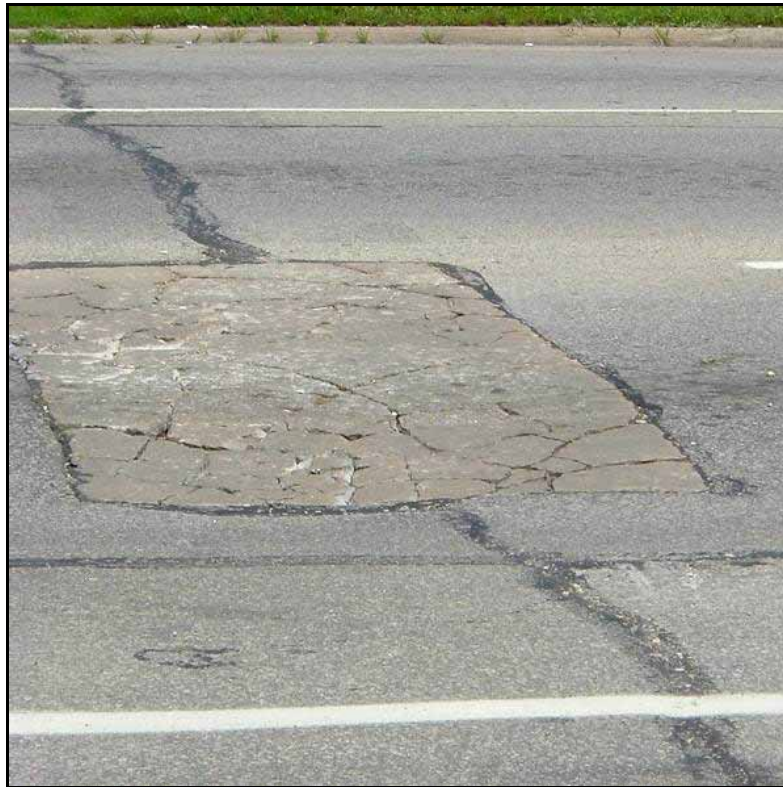
Utility cuts, specifically to repair water main breaks, are made throughout the year. Breaks that occur in the winter months are generally surfaced with a temporary cold patch installed until weather conditions improve for placing of a permanent pavement surface. Figure 5 shows an example of a utility cut constructed by a private contractor in the winter that has yet to receive a permanent asphalt surface. At the time this picture was taken, the patch was said to be three years old. With the deterioration of this temporary patch, visible map cracking can be observed in Figure 5.

Figure 5. Temporary cold patch in Cedar Rapids, with an estimated age of three years

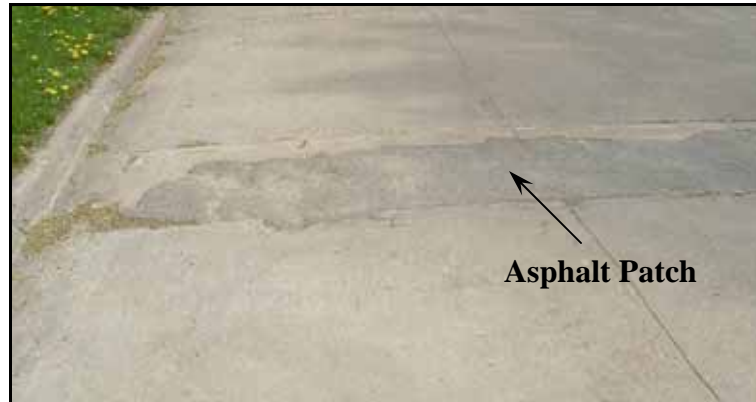
During the site visits, it was observed that in one city, utility cuts were repaired by placing asphalt near the edge of the concrete surfaced cut to compensate for the differential settlement. Applying this technique decreases the settlement impact felt by a driver; however it also decreases the aesthetic appearance of the existing roadway (see Figure 6).

Figure 6. Asphalt patch on top of concrete patch to "repair" the settlement problem

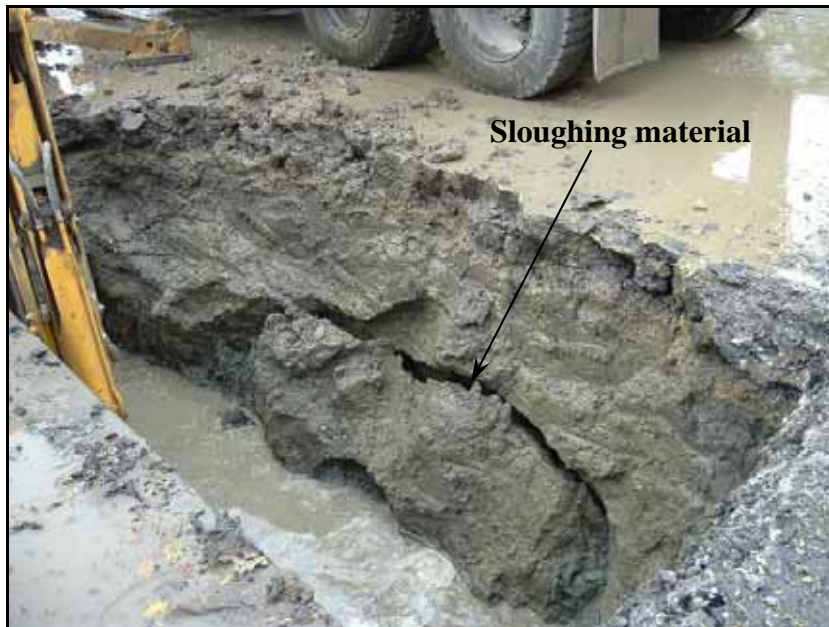
Natural factors play a role in the performance of a utility cut. For example, during an excavation of a water main break, adverse conditions occur such as that shown in Figure 7. As a result of the break, material becomes saturated and weak and begins to slough off. This in turn forms large voids underneath the existing material surrounding the cut, making adequate compaction difficult. Other problems that may arise during the reconstruction of the trench include large lift thicknesses, improper compaction, and lack of moisture control.

Figure 7. Material sloughing off the edges of the trench

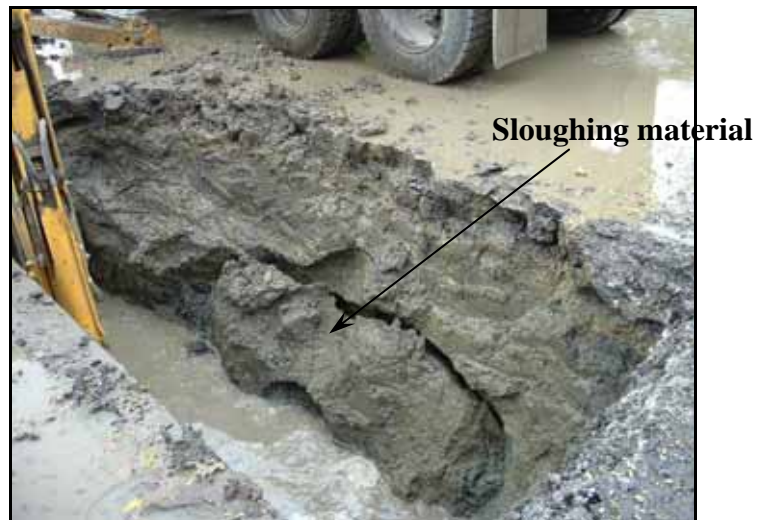
Figure 24. Material sloughing off in Ames site

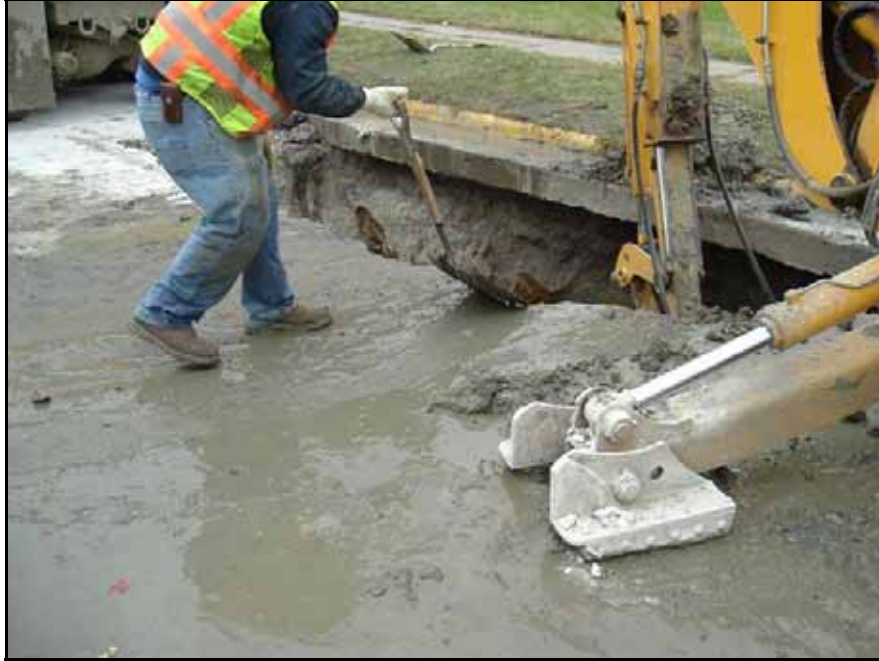
Approximately four feet (1.2 m) of one-inch limestone was placed as a bedding and backfill material up to two feet (0.6 m) above the pipe crown. This bedding material was compacted in two-foot (0.6 m) layers with a vibrating plate. Figure 27 shows the bedding material being dumped into the trench. A material referred to as 3/8 minus was then used as a backfill material extending from the top of the bedding material to the surface of the excavated area. This material was also compacted in about two-foot (0.6 m) layers with a vibrating plate. Figure 28 shows the compaction of the 3/8 minus material using the vibrating plate connected to the end of the backhoe. As a result of the construction, saturated material and debris from the excavation and surrounding area were shoveled into the trench during the backfilling process (see Figure 29).

Figure 29. Saturated material shoveled into the trench

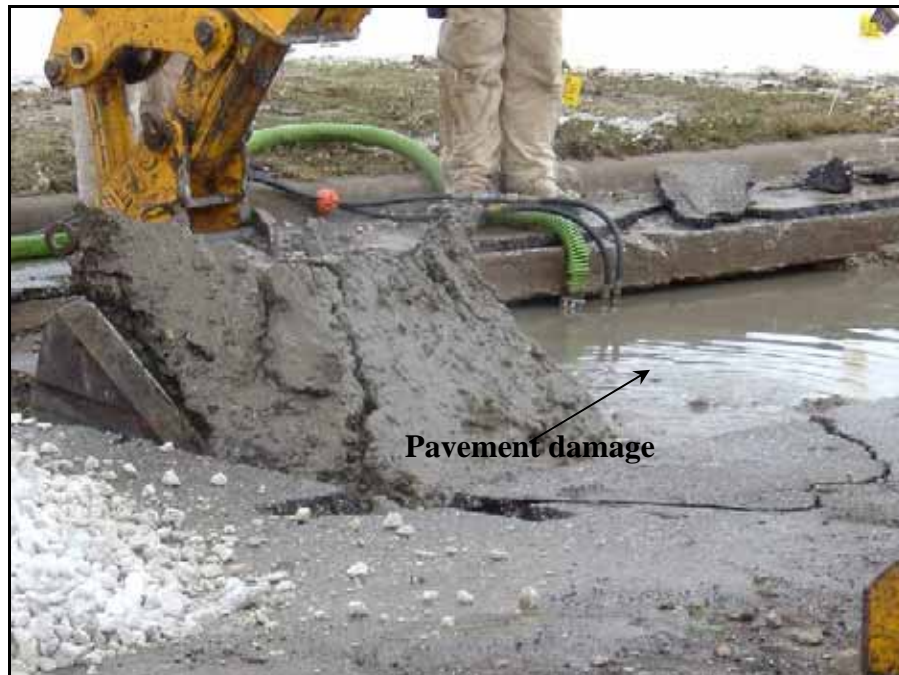
Figure 36. Saturated material being excavated

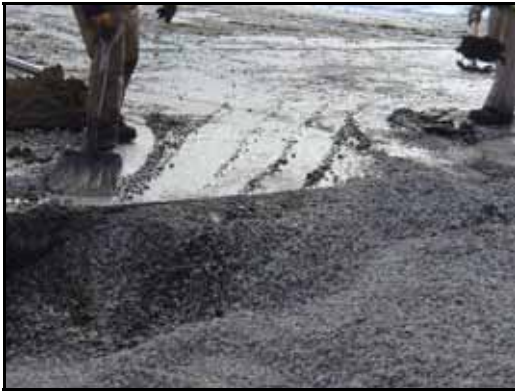
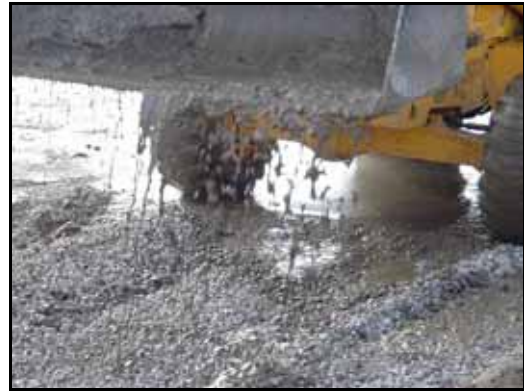
(a) Cleaning excess material into the trench

(b) Saturated backfill material

Figure 38. Incorporating surrounding material into the trench

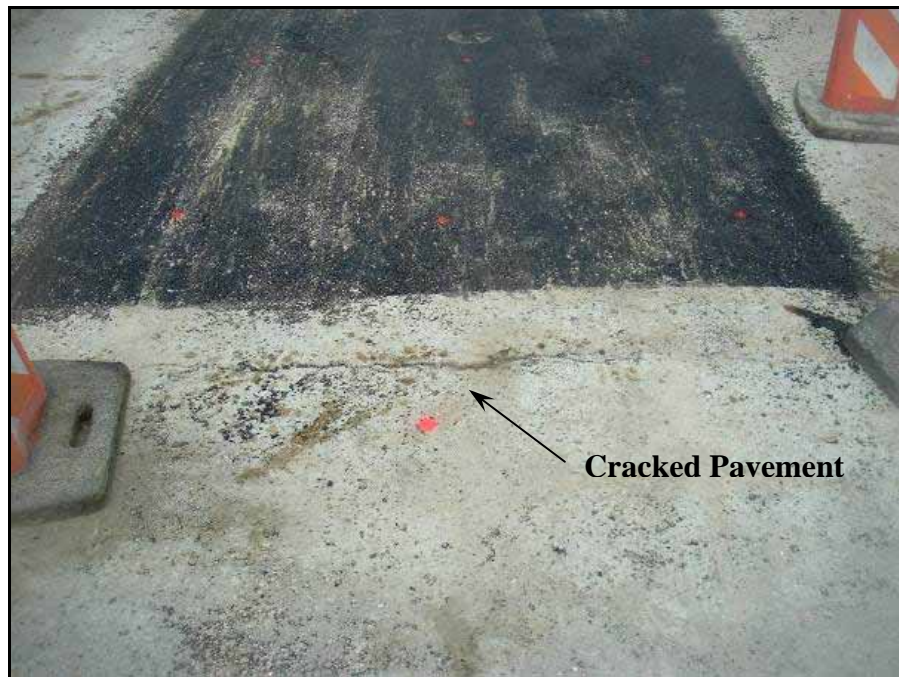
A 1-inch clean material was then used as a bedding material around the pipe, where this material was worked around the pipe and block with a shovel. A recycled crushed concrete backfill material classified with particle sizes 3/4-inch or less was imported from the landfill where it has been reclaimed from previous concrete pavement excavations. This site was backfilled with two lifts of material dumped about three to four feet (0.9 m to 13.1 m) deep each, and was tamped with a vibrating plate for about three to four seconds in no specific compaction pattern. Figure 41 shows a lift of the material being tamped in place. The pavement surface consists of 6 inches of concrete and 2 inches of asphalt overlay. As a result of the backhoe rolling over the edge of the trench during the backfill compaction process, the surrounding composite pavement was damaged (see cracked pavement in Figure 42).

Figure 42. Visible pavement damage on utility edge

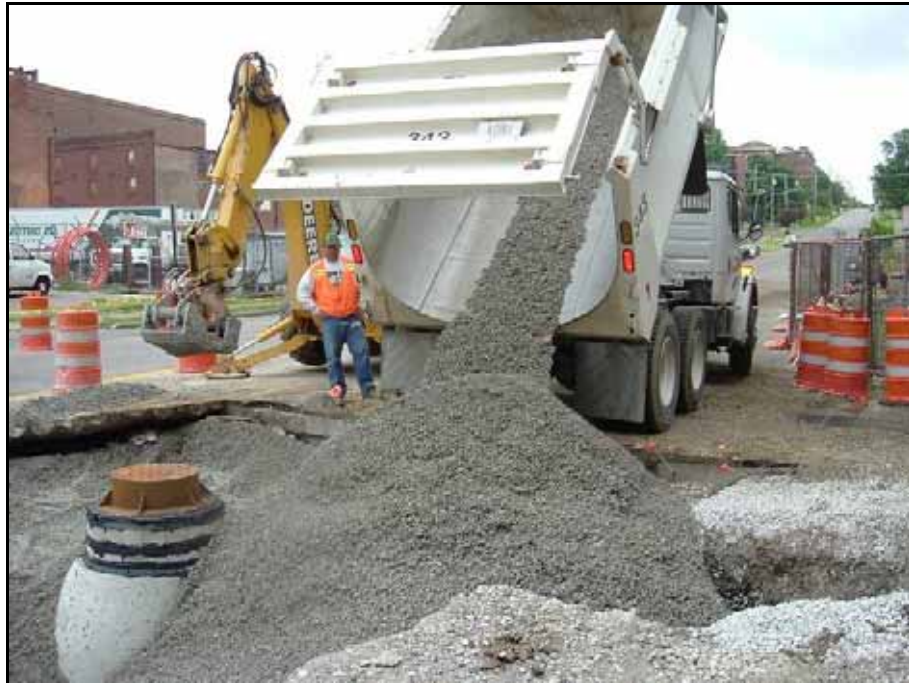
Figure 43. Large backfill lift being placed

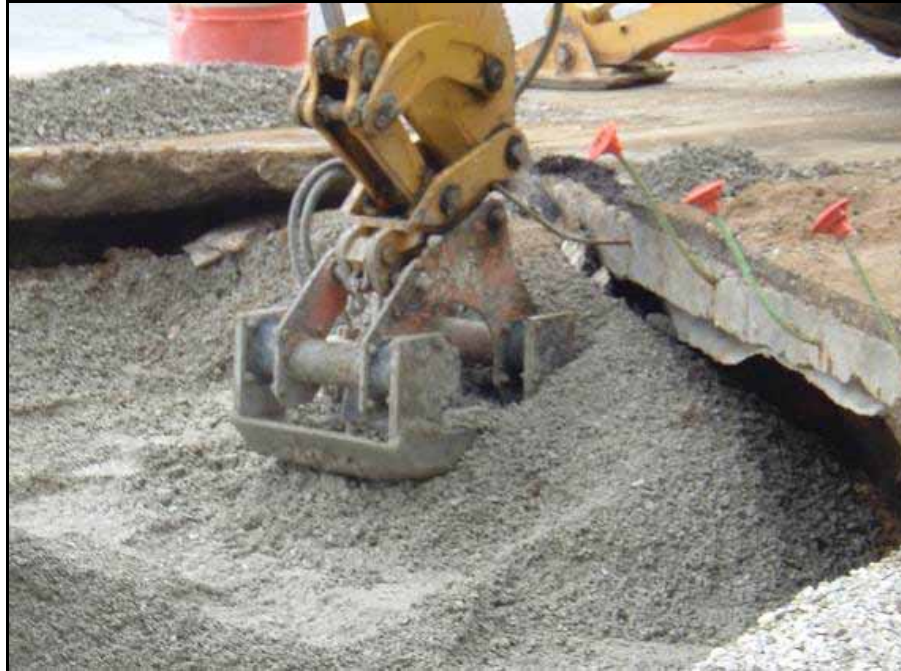
As a result of the cut, large cavities formed beneath the surrounding pavement of the trench. Figure 44 shows the large cavities and the attempt to compact this hard to reach area. These confined cavities underneath the pavement made compaction difficult using the vibrating plate on the end of a backhoe.

Figure 44. Large cavities forming beneath pavement

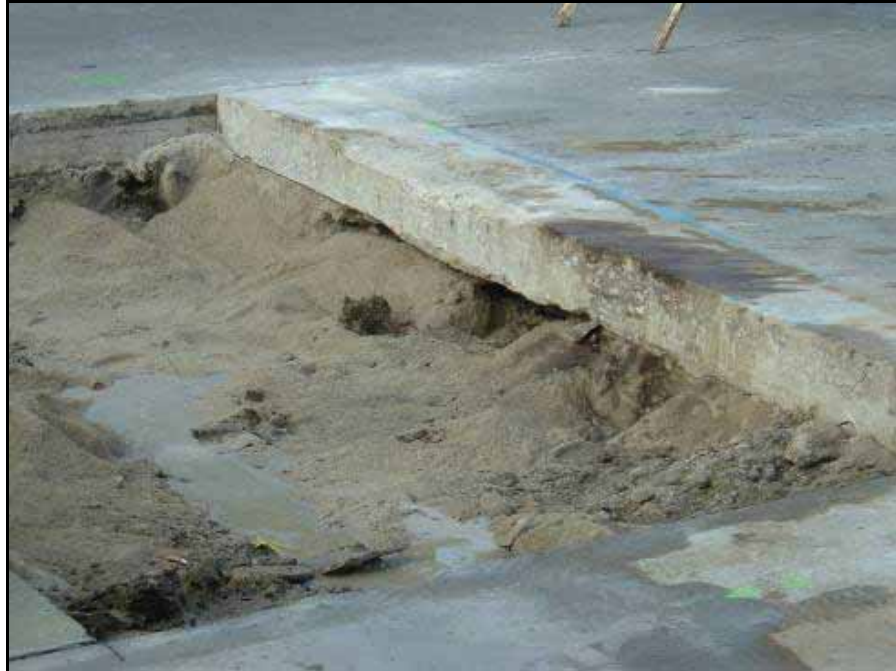
Excavation and construction of the trench began on June 30, 2004. The sewer main break repair was completed by a contractor in Des Moines and is located east of E. 28th Street and Grand Avenue. This site was excavated, filled, and plated the day before the research team arrived, therefore documentation of the construction procedures were not made. The site was covered with a metal plate since surfacing was unable to be placed the following day. When the plate was removed, the manufactured sand (crushed limestone) used as backfill material had begun to settle along the trench edges, likely as a result of traffic vibrations (see Figure 45). Therefore, the concrete pavement was cut back to compensate for these cavities (see Figure 46).

Figure 45. Backfill material caving in on trench edges
