# **ACCELERATED IMPLEMENTATION OF INTELLIGENT COMPACTION TECHNOLOGY FOR EMBANKMENT SUBGRADE SOILS, AGGREGATE BASE, AND ASPHALT PAVEMENT MATERIALS**

Project Report

Route 4, Kandiyohi County, Minnesota  
June 14-17, 2008

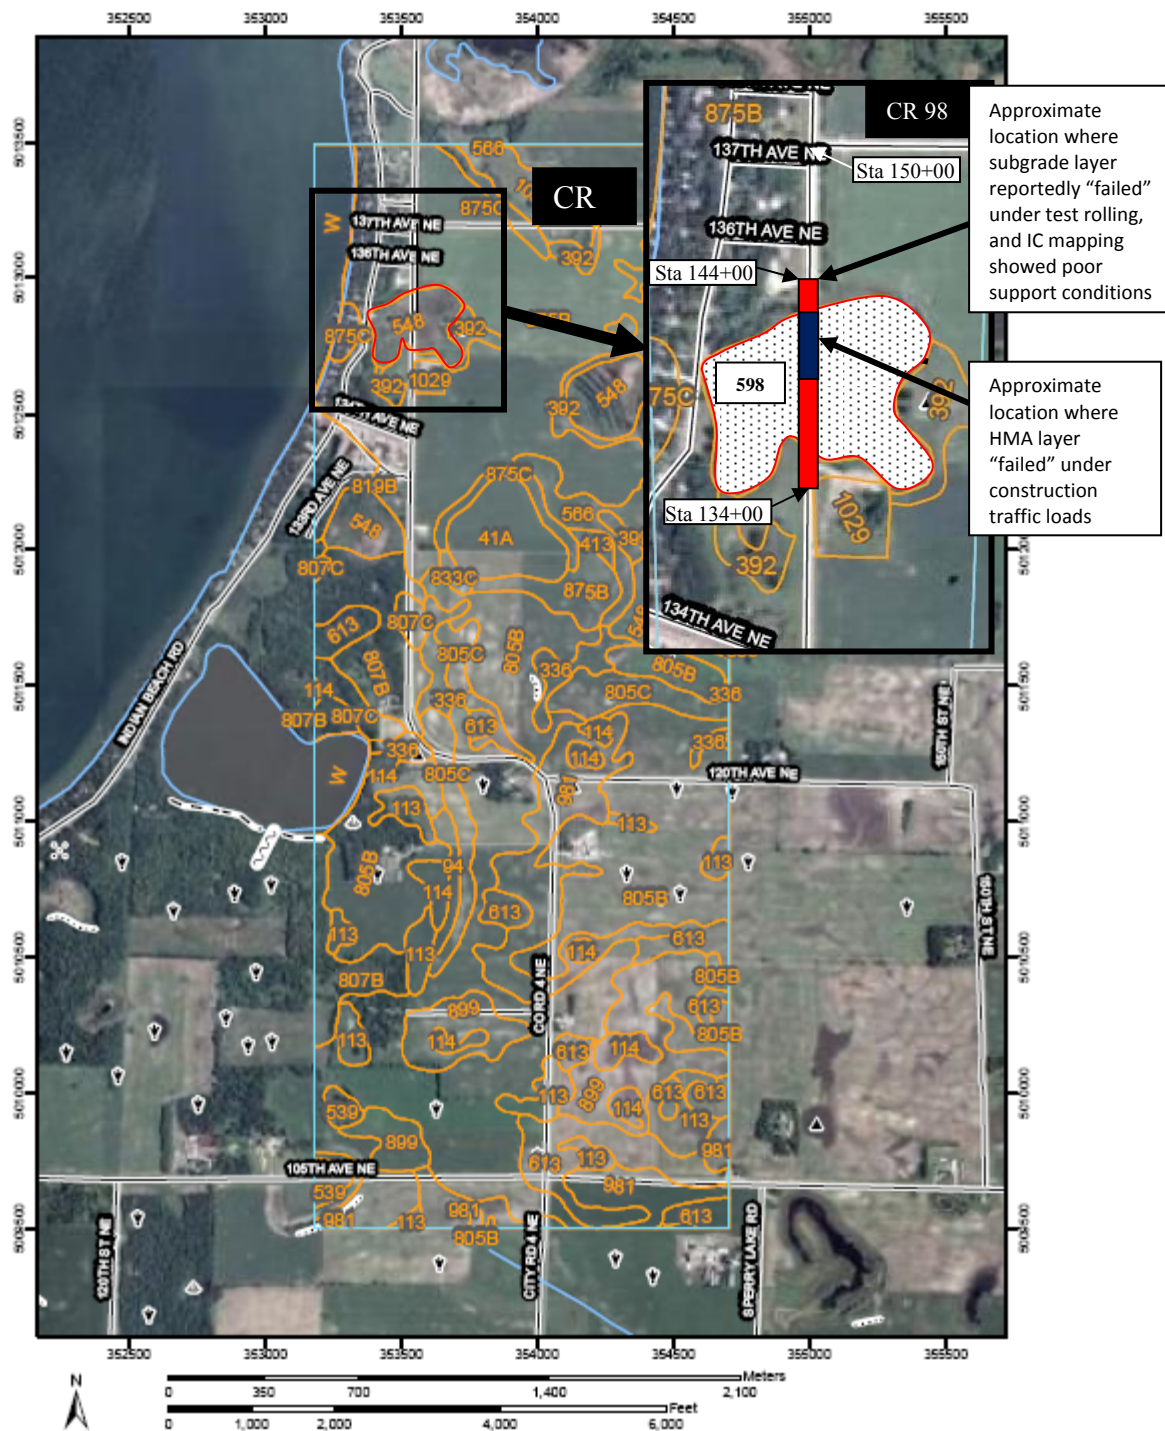
The approximate location of the area that “failed” under test rolling (Sta. 134+00 to 144+00) is highlighted on the soil survey map presented in Figure 4. The natural soils in this area consist of Palms muck soil series with sandy substratum (shown as soil series 548). According to NRCS (2008), these soils contain muck to a depth of about 0.7 m (27 in) underlain by clay loam and sandy soils to a depth of about 1.5 m (60 in), below natural grade. A review of project drawings indicates that approximately 1 m to 2 m (3 ft to 6 ft) of new subgrade fill was placed over the previous grade in this region. No information on treatment of the muck soils present in this region during construction or type of new subgrade fill material used for construction of the new grade is available at this time of the report. Full depth DCP tests up to 2 m would be useful in this area to give a quick indication of the soil profile.

**Figure 4. Aerial image with soil survey information of the project area (NRCS 2008)**

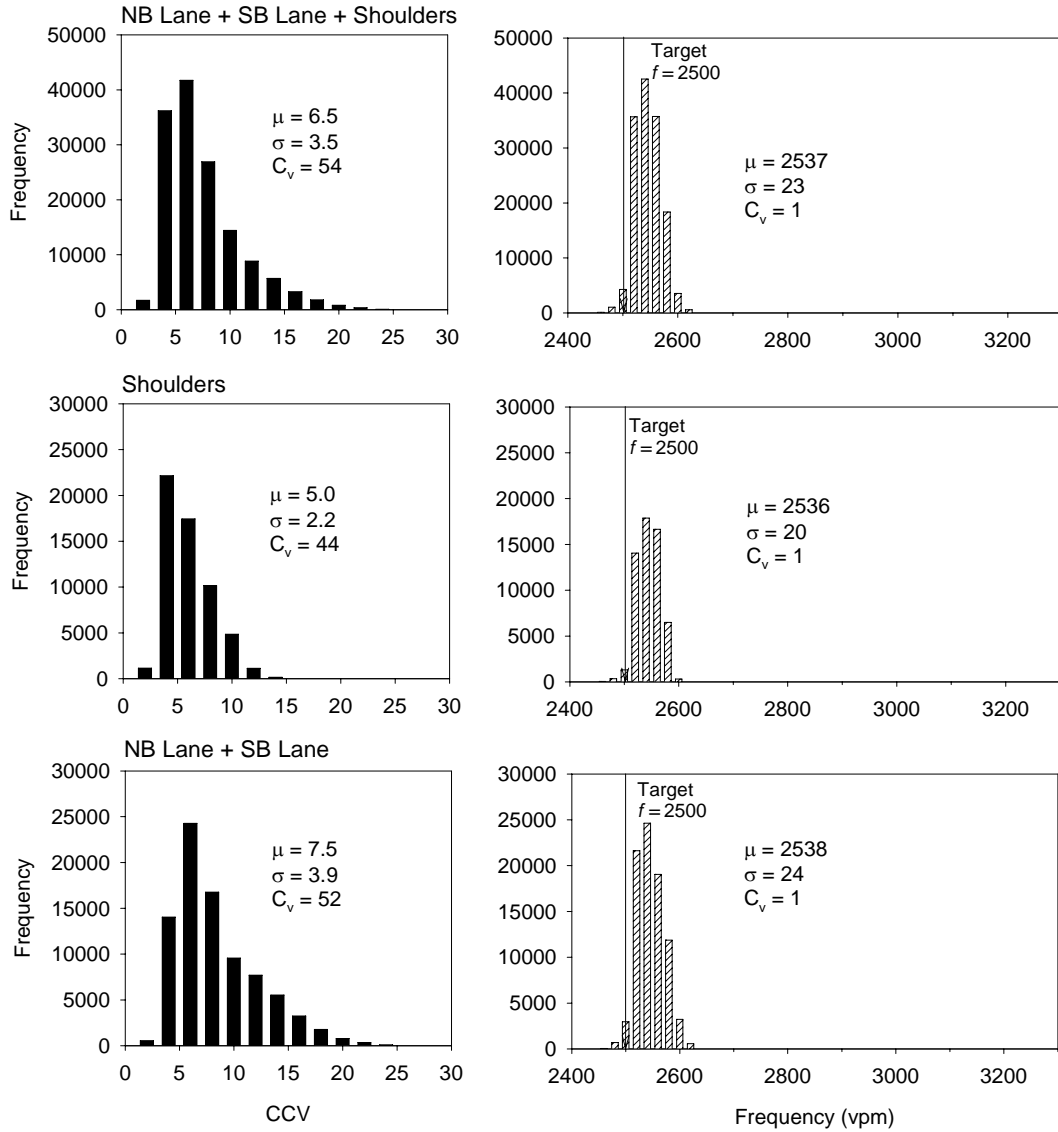
At 0.6 mm amplitude setting (subbase map 1), CCV-values on the shoulder lanes were lower compared to CCV-values on the pavement lanes. Average CCV on the pavement lanes was about 1.5 times greater than average CCV on shoulder lanes (Figure 10). The average measured drum vibration frequency (~ 2540 vpm) was close to the target frequency setting of 2500 vpm. Field observations indicate that the shoulders were not subjected to as much traffic as vehicles were predominantly driven within the pavement lanes.

**Figure 10. CCV and frequency histograms for subbase map 1 ( $a = 0.6$  mm)**

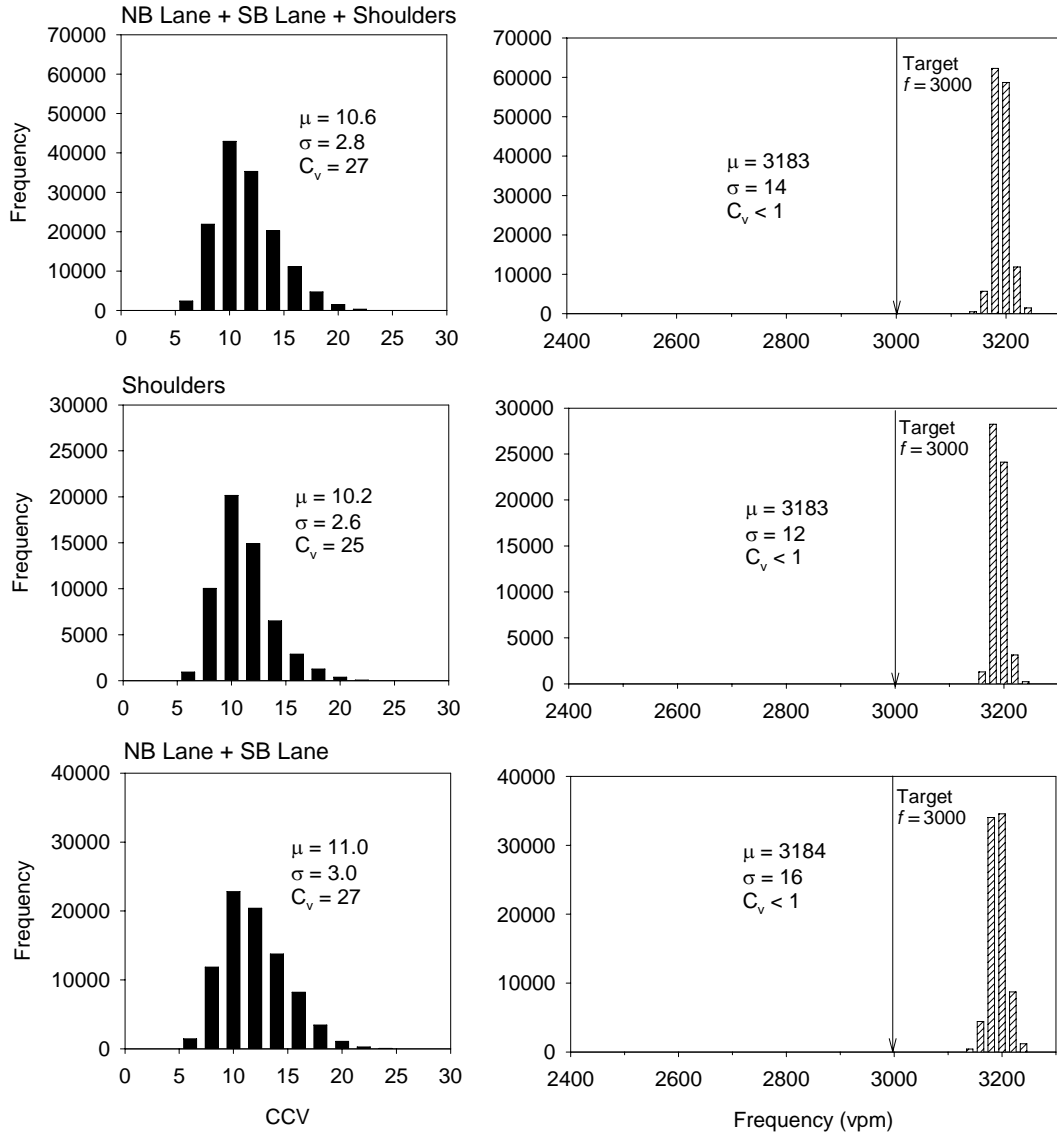
At 0.3 mm amplitude setting (subbase map 2), CCV-values on the shoulder lanes and pavement lanes have similar frequency distributions and average values (Figure 11). The measured drum vibration frequency was about 3180 vpm which was greater than the 3000 vpm target setting. CCV-values at the 0.3 mm amplitude setting were on average about 1.5 times greater (based on values along the pavement lanes – three roller lanes) than CCV-values at the 0.6 mm amplitude setting. Also, CCV-values showed less non-uniformity with  $C_v$  (coefficient of variation) of about 27% ( $a = 0.3$  mm) compared to  $C_v$  of about 52% ( $a = 0.6$  mm).

Figure 11. CCV and frequency histograms for subbase map 2 ( $a = 0.3$  mm)

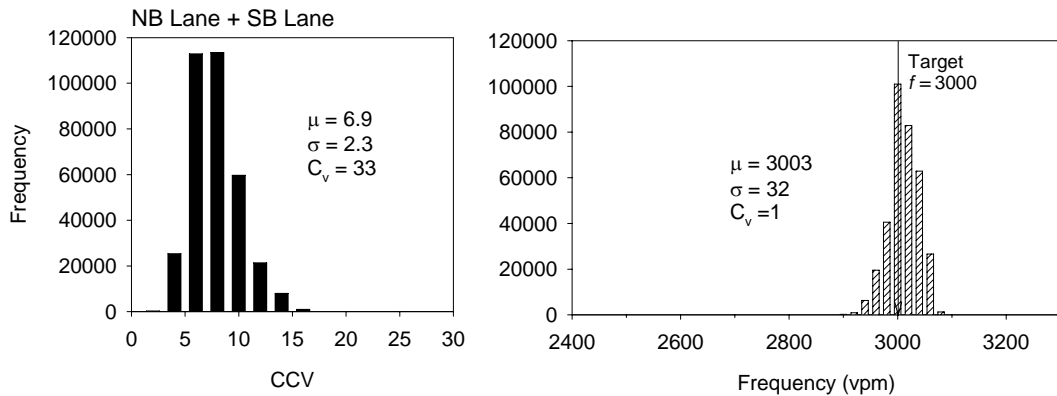
For the HMA non-wearing course layer, average CCV on the pavement lanes was about 6.9 with  $C_v$  of about 33% (Figure 12). The measured drum vibration frequency (~ 3000 vpm) was close to the target frequency setting of 3000 vpm for the HMA wearing course layer.

Figure 12. CCV and frequency histograms for HMA non-wearing course map ( $a = 0.6$  mm)

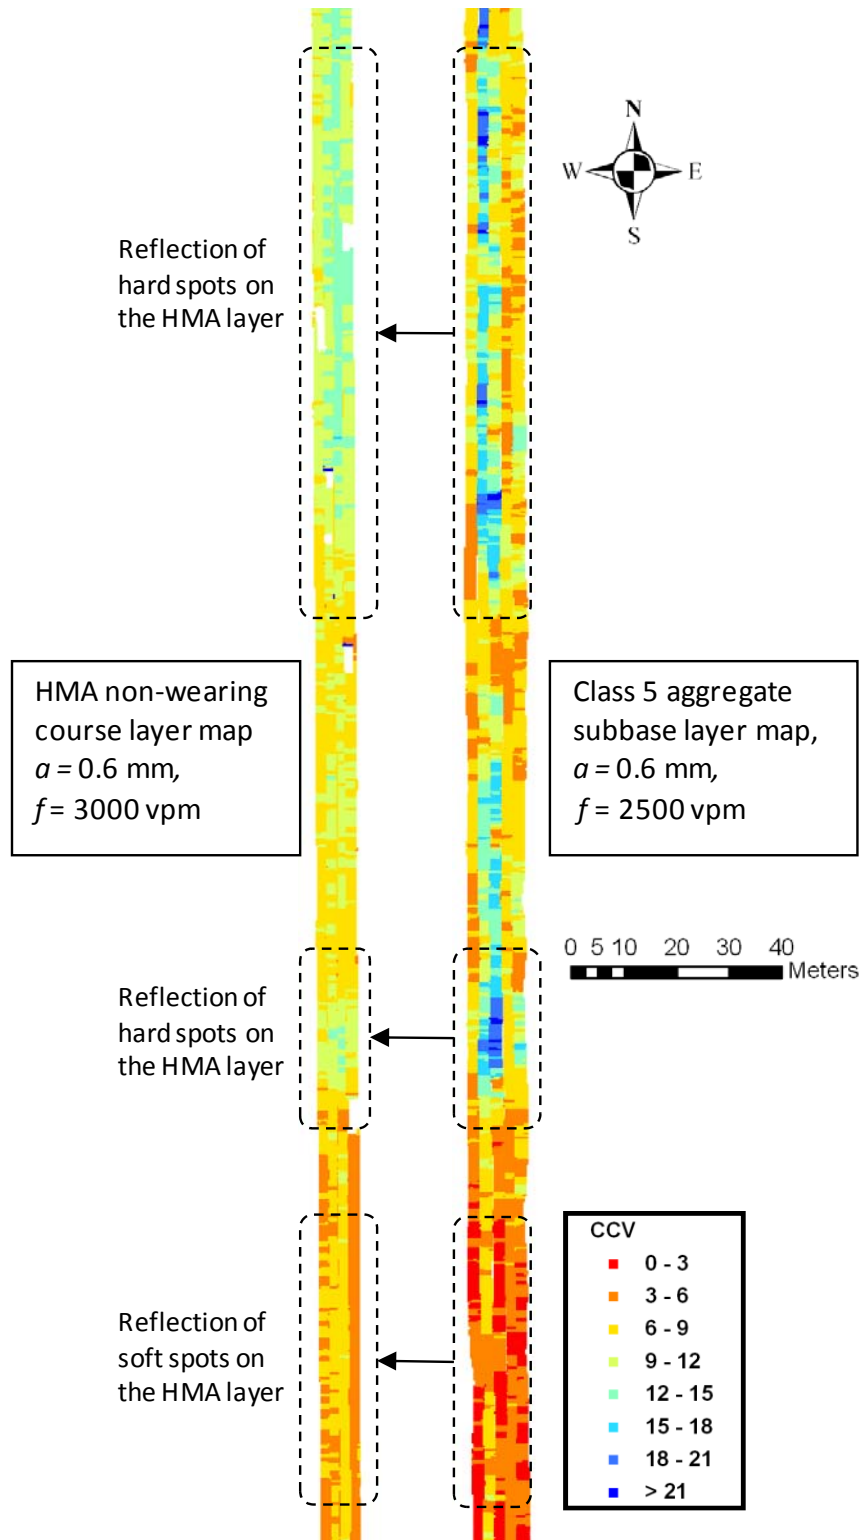
Figure 13 shows CCV maps of the HMA non-wearing course layer and the underlying subbase layer for a 210 m (700 feet) long section with heterogeneous subbase. Figure 14 compares CCV measurements (raw data and 5 m moving average) on HMA non-wearing course and subbase layers over a 1300 m (4000 feet) long section along the SB pavement lane. CCV measurements on subbase layer obtained at  $a = 0.3$  mm and  $a = 0.6$  mm setting are presented in Figure 14 for comparison. Figures 13 and 14 show locations of high CCV and low CCV areas on the subbase layer (measured at  $a = 0.6$  mm) reflecting on CCV measurements on the HMA layer. Measurements obtained at  $a = 0.3$  mm setting did not clearly differentiate soft/hard zones on the subbase layer. Data presented in Figure 14 is further analyzed using regression analysis as presented in Figure 15. Regression relationships in Figure 15 indicate statistically strong relationship between CCV measurements obtained on the HMA non-wearing course layer and subbase layer at  $a = 0.6$  mm setting with  $R^2$ -value of about 0.7. CCV measurements obtained on the subbase layer at  $a = 0.3$  mm show relatively poor correlation to CCV measurements on the HMA layer.

**Figure 13. Comparison of HMA non-wearing course layer and subbase layer map showing the influence of underlying layer heterogeneity**

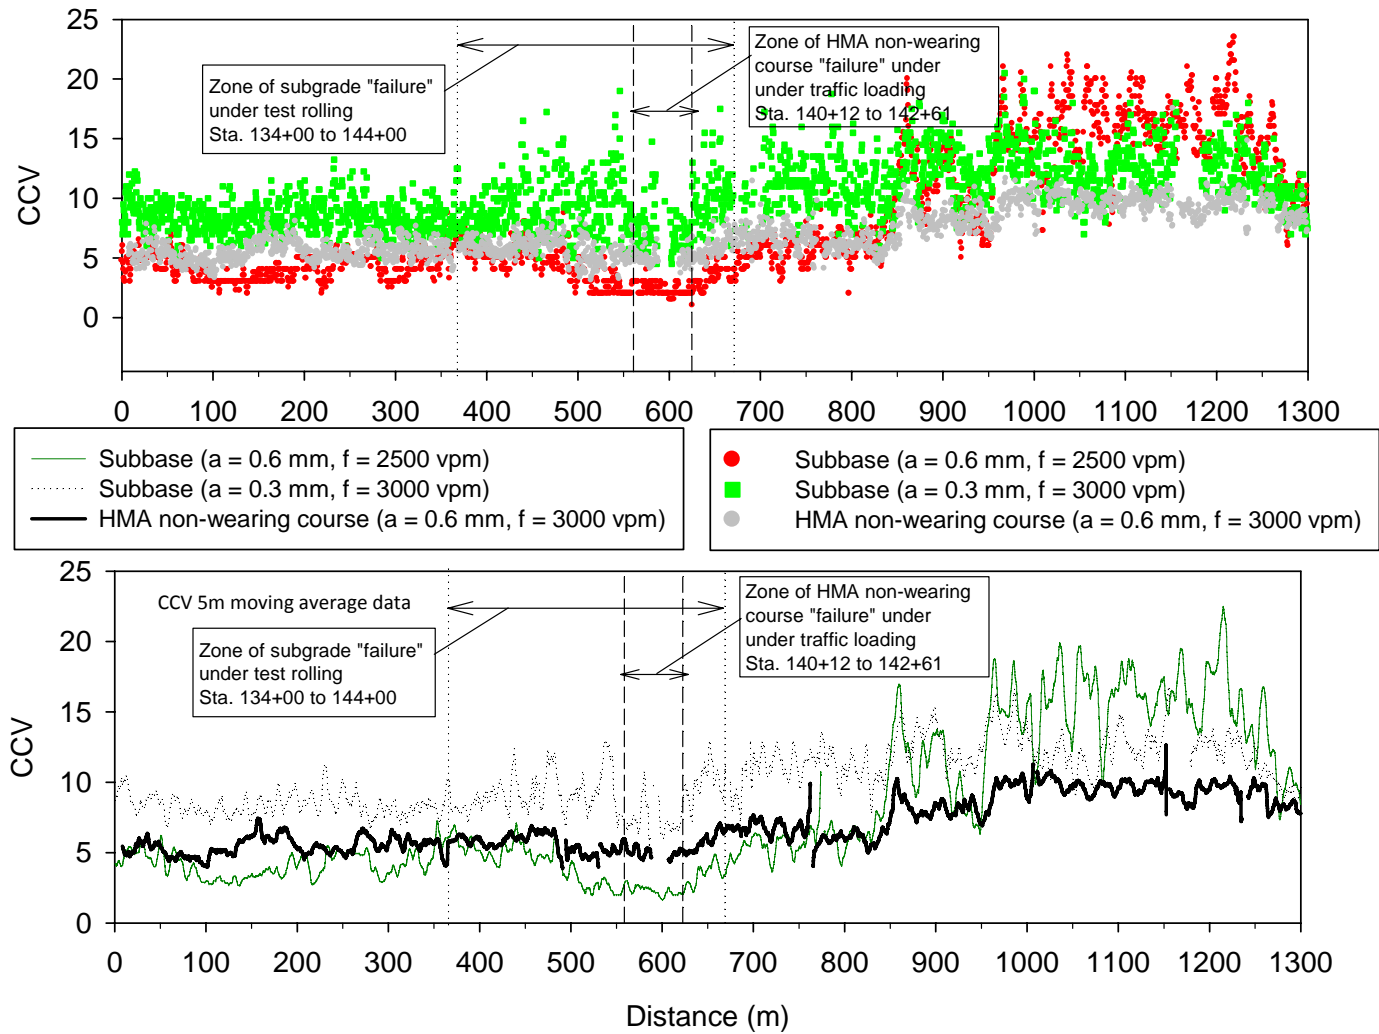
Figure 14. Comparison of CCV measurements on HMA non-wearing course layer and subbase layer

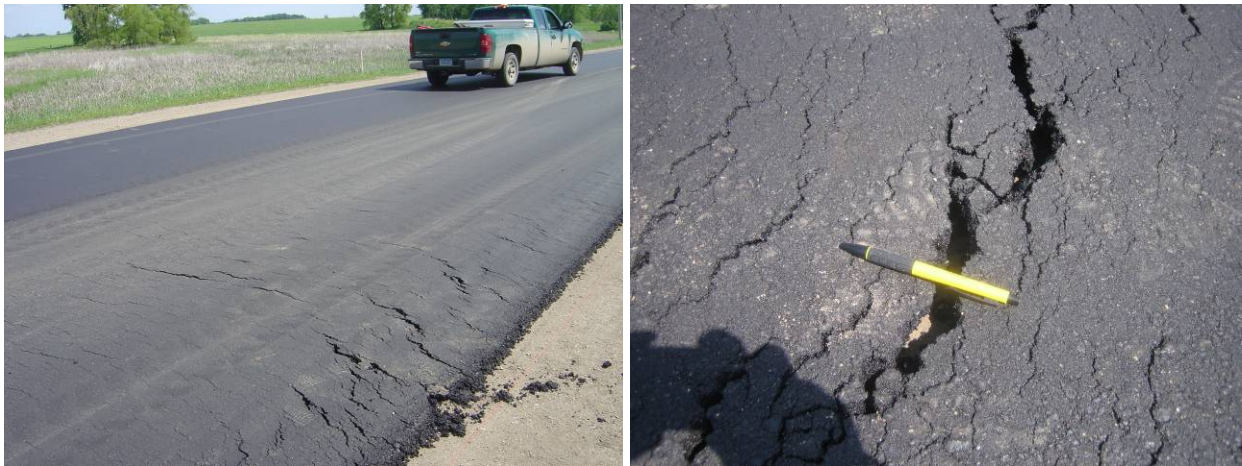
Following compaction operations on the HMA non-wearing course layer on the SB lane, premature “failure” cracks were observed over a 200 feet long section (Sta 140+12 to 142+61) on the HMA layer under construction traffic (Figure 14). To further evaluate the condition, the CCV measurements on the HMA wearing course layer and the subbase layer in this area were compared as shown in Figures 17 and 18. The data shows average CCV = 2.5 for the subbase layer which is considerably lower than the project average CCV = 7.5. Average CCV on the HMA wearing course in the area was about 5.2, which is also lower than the project average of about 6.9. This area is located within the area where the subgrade layer reportedly “failed” under test rolling in Summer 2007 (Sta. 134+00 to 144+00). Again, the underlying natural soils in this section were identified in the soil survey as consisting of peat/muck soil deposits (see Figure 4).

**Figure 16. Premature failure observed in the HMA non-wearing course layer between Sta. 140+12 and Sta. 142+61**

- Following compaction and mapping of the HMA non-wearing course layer on the SB lane, premature “failure” cracks were observed over a 200 feet long section on the HMA layer. Average CCV of the underlying subbase layer in this area = 2.5 which is considerably lower than the project average CCV = 7.5. Average CCV on the HMA non-wearing course in the area = 5.2 which is also lower than the project average = 6.9. This area is located within the area where the subgrade layer reportedly “failed” under test rolling in Summer 2007, and is an area identified on NRCS soil survey maps consisting of peat/muck soils.

- Multiple regression analysis of the CCV measurements on the HMA layers and subbase layers should be conducted with incorporating HMA temperature data into the regression model.
- Performance monitoring inspections, i.e., crack survey inspections on the HMA layer, should be carried out a few times a year to identify performance trends that relate to CCV values.
- 2-m (6 ft) deep DCP tests should be performed immediately in the location of low CCV areas to further investigate the stiffness of the subgrade layers below the granular subbase.

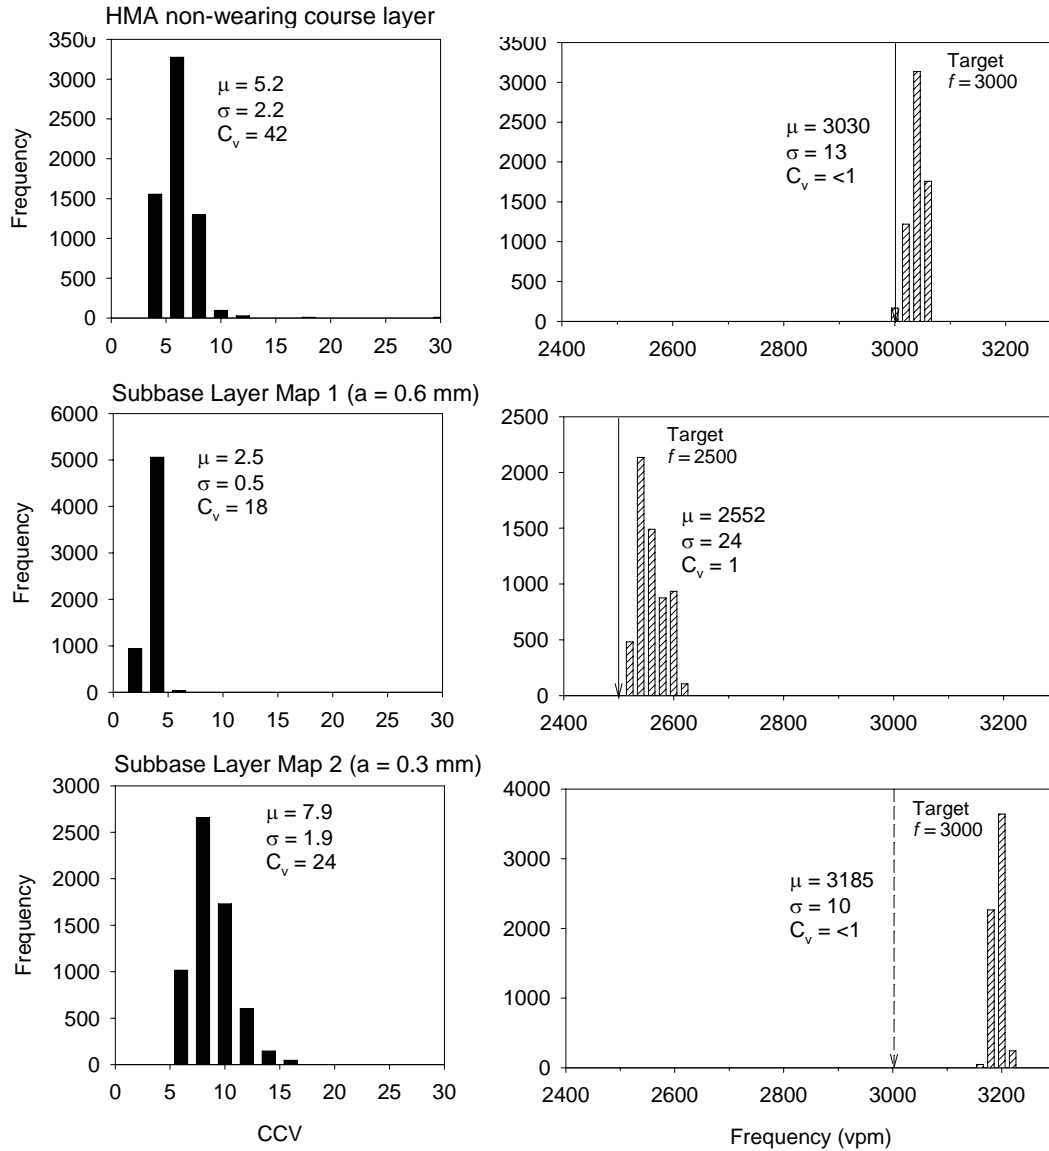
**Figure 18. CCV and operation frequency comparison between HMA non-wearing course layer, subbase layer map 1, and subbase layer map 2 between Sta. 140+12 to 142+61.**
