# The Deleterious Chemical Effects of Concentrated Deicing Solutions on Portland Cement Concrete

Larry Sutter Michigan Tech

# Research Objectives

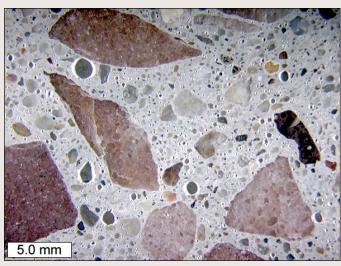
• Stereomicroscope image of polished surface from core SD\_04, magnified here approximately 4x

• Stereomicroscope image of polished surface from core SD\_04, magnified here approximately 22x.

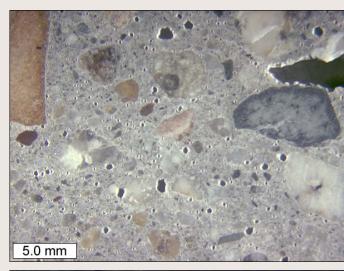
• Stereo microscope images to show air void structure on polished slab from core T-2.

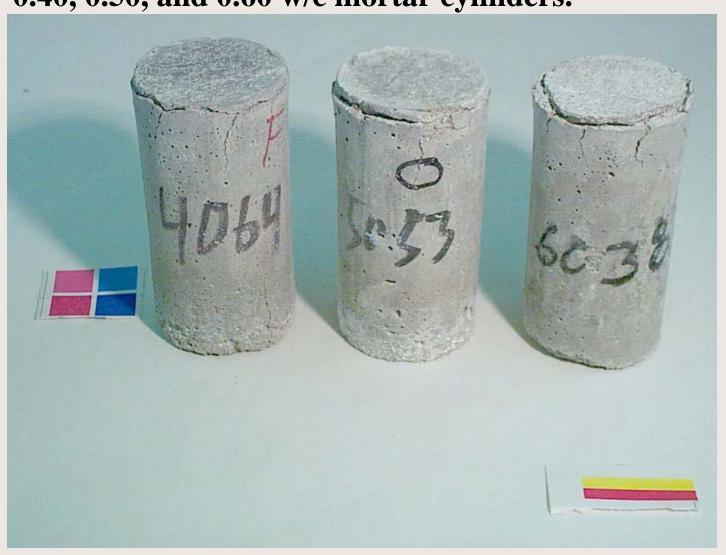
Cylinders exposed to MgCl<sub>2</sub> solution after 84 days of exposure @ 40 °F. From left to right: 0.40, 0.50, and 0.60 w/c mortar cylinders.

- Specimens were held at a constant 40 °F so no freezing occurred that could result in the damage observed
- Expansion was caused by the formation of calcium oxychloride
- Results from the reaction of calcium hydroxide (*present in the hardened cement paste*) with chloride ions (*provided by the deicer*)

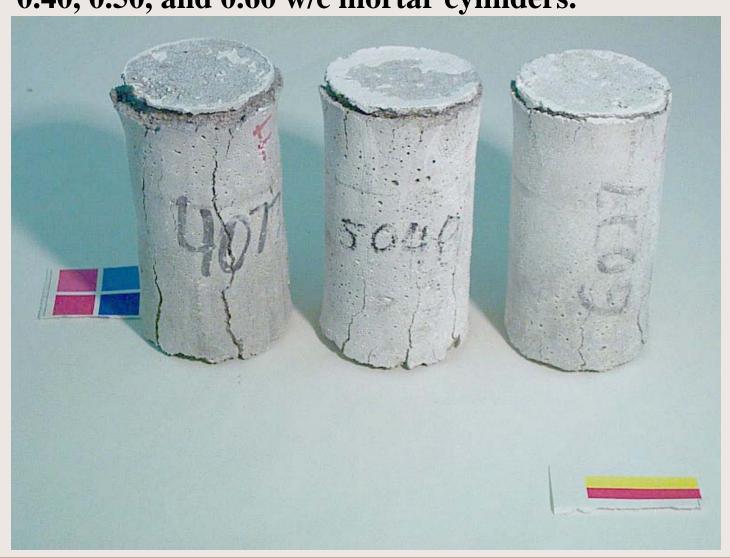
Cylinders exposed to CaCl<sub>2</sub> solution after 84 days of exposure @ 40 °F. From left to right: 0.40, 0.50, and 0.60 w/c mortar cylinders.

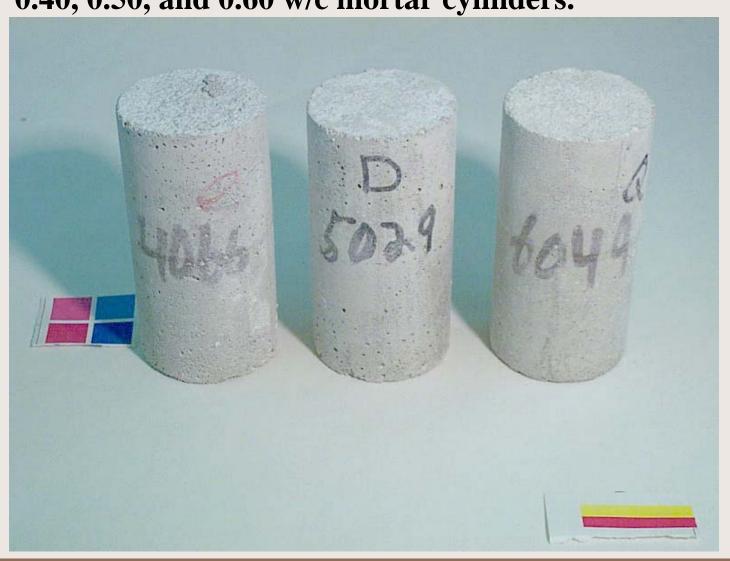
Cylinders exposed to NaCl solution after 84 days of exposure @ 40 °F. From left to right: 0.40, 0.50, and 0.60 w/c mortar cylinders.

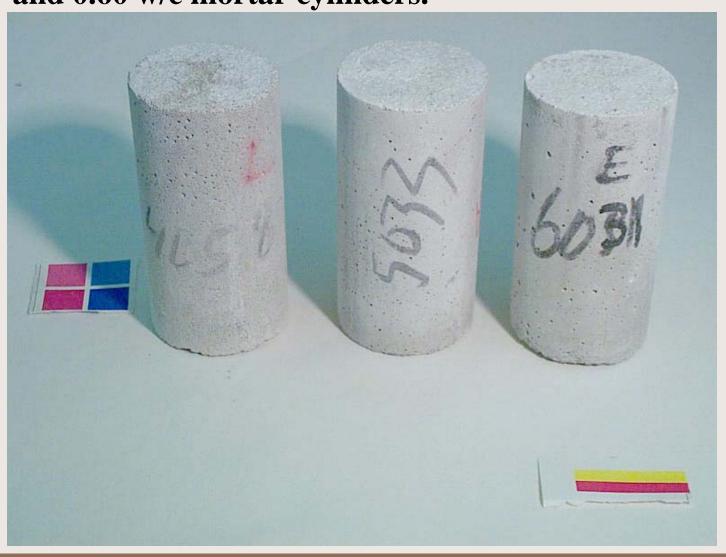
Control cylinders exposed to lime water solution after 84 days of exposure @ 40 °F. From left to right: 0.40, 0.50, and 0.60 w/c mortar cylinders.

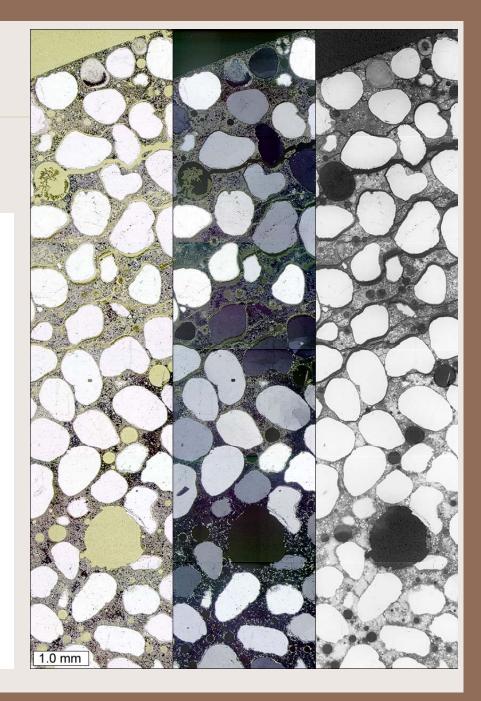
From left to right:
plane polarized light,
cross polarized light, and
epifluorescent mode images of thin
section prepared from cylinder
immersed in MgCl<sub>2</sub> solution.

- Petrographic Analysis
- Thin sections from 0.50 w/c specimens
- MgCl<sub>2</sub> and CaCl<sub>2</sub> show similar alteration
  - Ca(OH)<sub>2</sub> depleted region
  - Cracks in-filled with calcium oxychloride

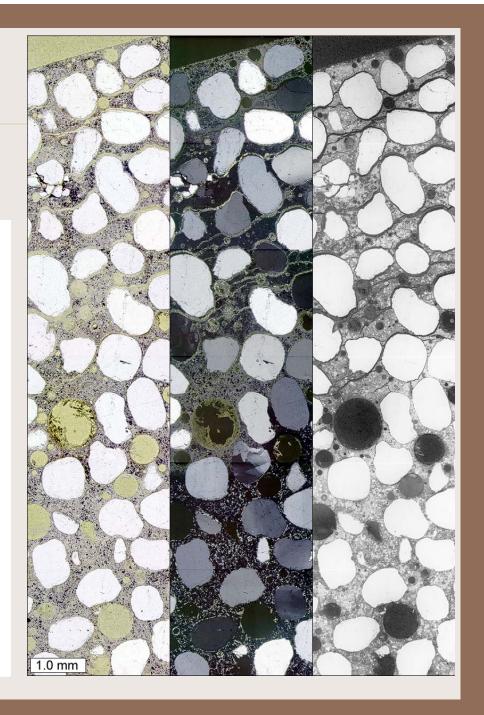
From left to right:
plane polarized light,
cross polarized light, and
epifluorescent mode images of thin
section prepared from cylinder
immersed in CaCl<sub>2</sub> solution.

- Petrographic Analysis
- Thin sections from 0.50 w/c specimens
- MgCl<sub>2</sub> and CaCl<sub>2</sub> show similar alteration
  - Ca(OH)<sub>2</sub> depleted region
  - Cracks in-filled with calcium oxychloride

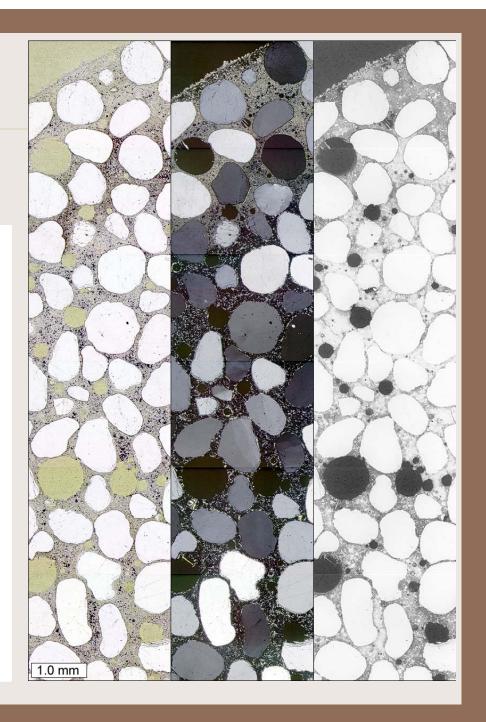
From left to right:
plane polarized light,
cross polarized light, and
epifluorescent mode images of thin
section prepared from cylinder
immersed in NaCl.

- Petrographic Analysis
- Thin sections from 0.50 w/c specimens
- NaCl and lime water controls show no alteration

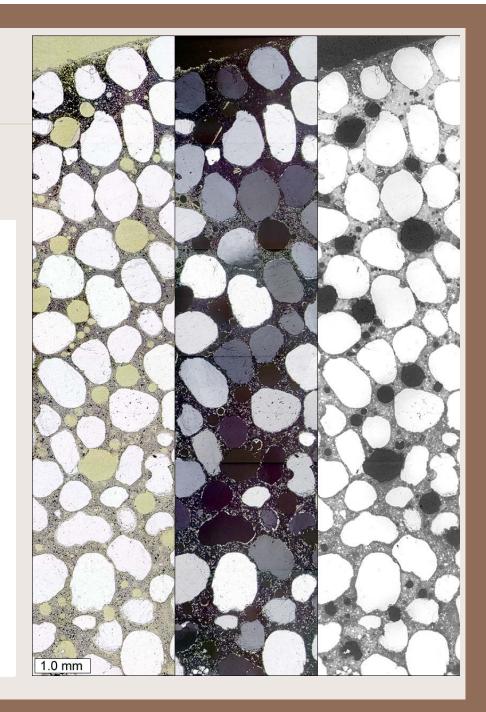
From left to right:
plane polarized light,
cross polarized light, and
epifluorescent mode images of thin
section prepared from cylinder
immersed in lime water.

- Petrographic Analysis
- Thin sections from 0.50 w/c specimens
- NaCl and lime water controls show no alteration

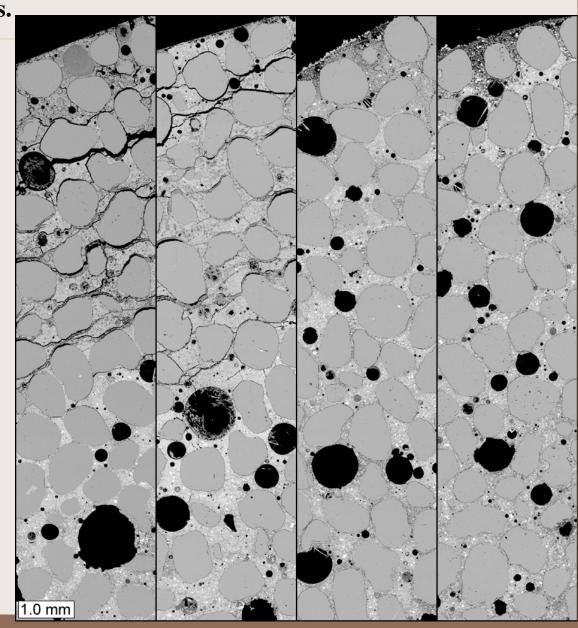
Scanning electron microscope images of thin sections prepared from cylinders immersed in, from left to right, MgCl<sub>2</sub>, CaCl<sub>2</sub>, NaCl, and saturated lime solutions.

- SEM Analysis
- Backscattered electron images
  - Parallel cracks
  - Ca(OH)<sub>2</sub> and oxychloride deposition in the voids of the MgCl<sub>2</sub> and CaCl<sub>2</sub> specimens

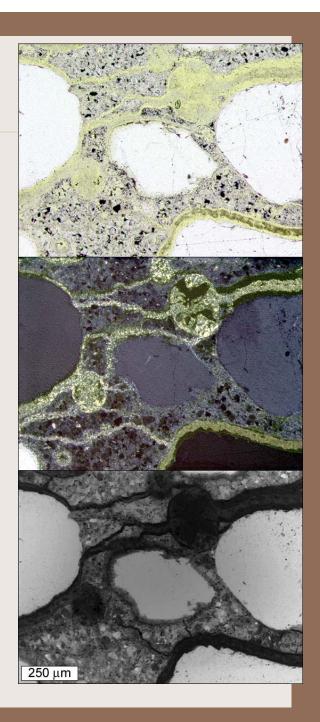
- Petrographic Analysis
  - Cracks and air voids filled with remnant calcium oxychloride crystals in thin section prepared from MgCl<sub>2</sub> solution immersed sample

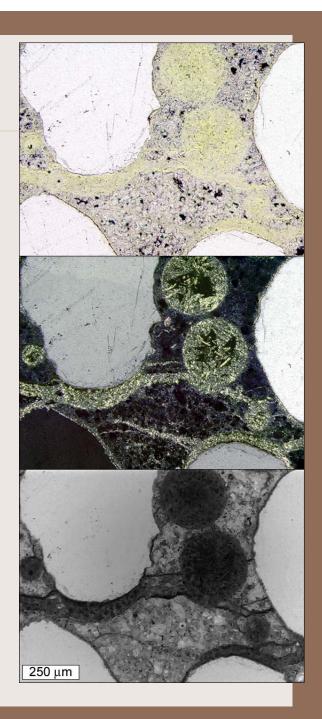
- Petrographic Analysis
  - Cracks and air voids filled with remnant calcium oxychloride crystals in thin section prepared from CaCl<sub>2</sub> solution immersed sample

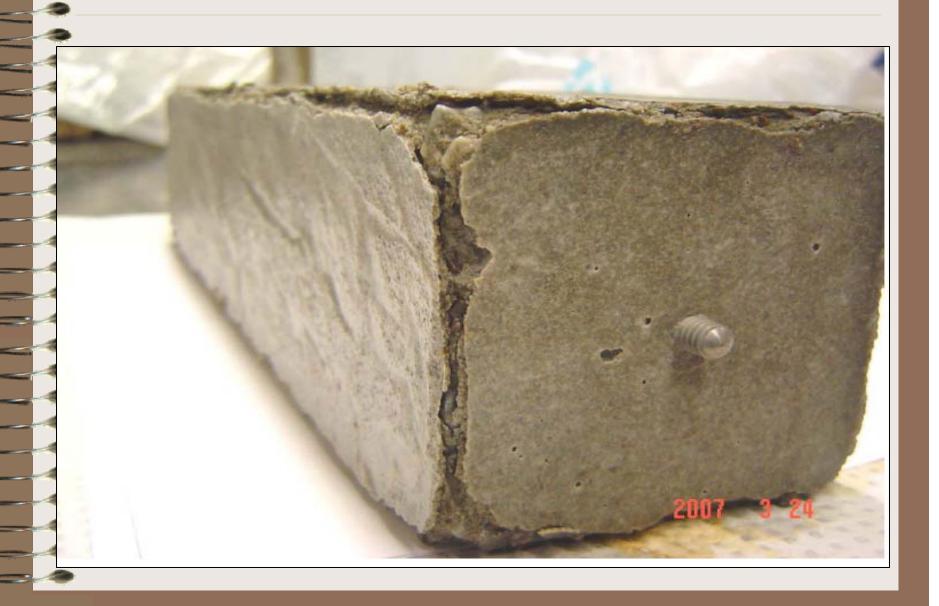
Concrete prisms subjected to 133 cycles of freeze/thaw cycles in 17% CaCl<sub>2</sub>

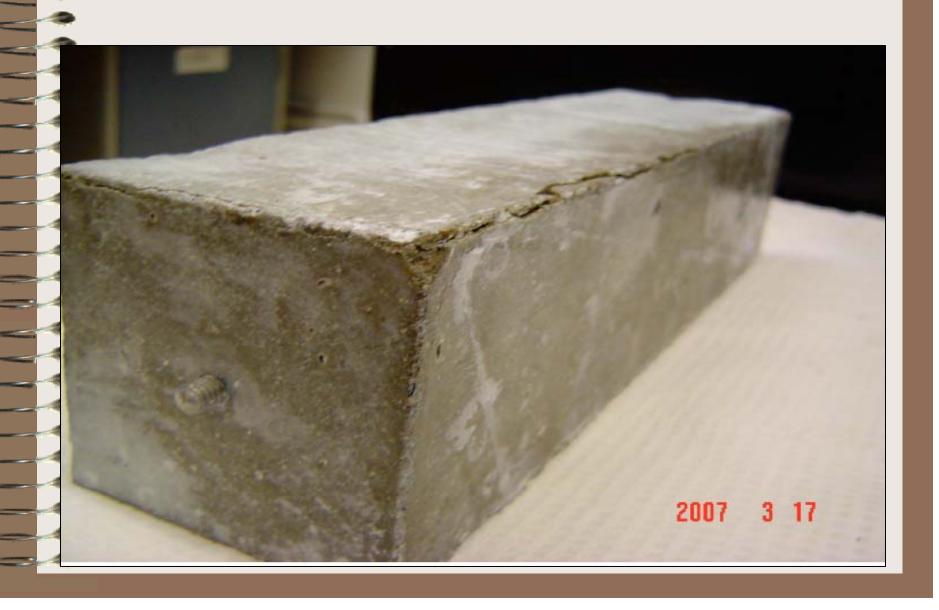
Concrete prisms subjected to 133 cycles of freeze/thaw cycles in 15% MgCl<sub>2</sub>

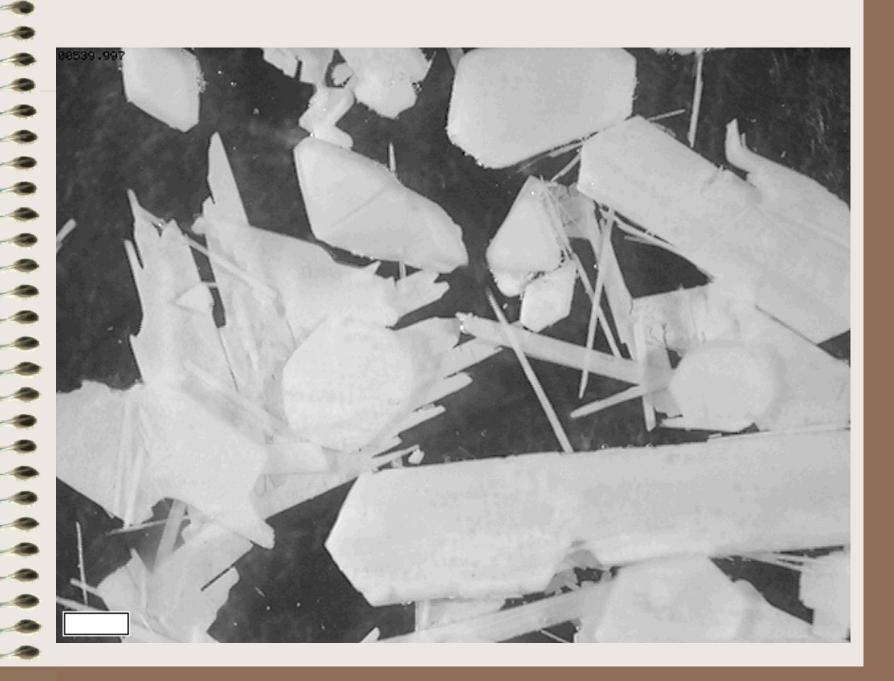
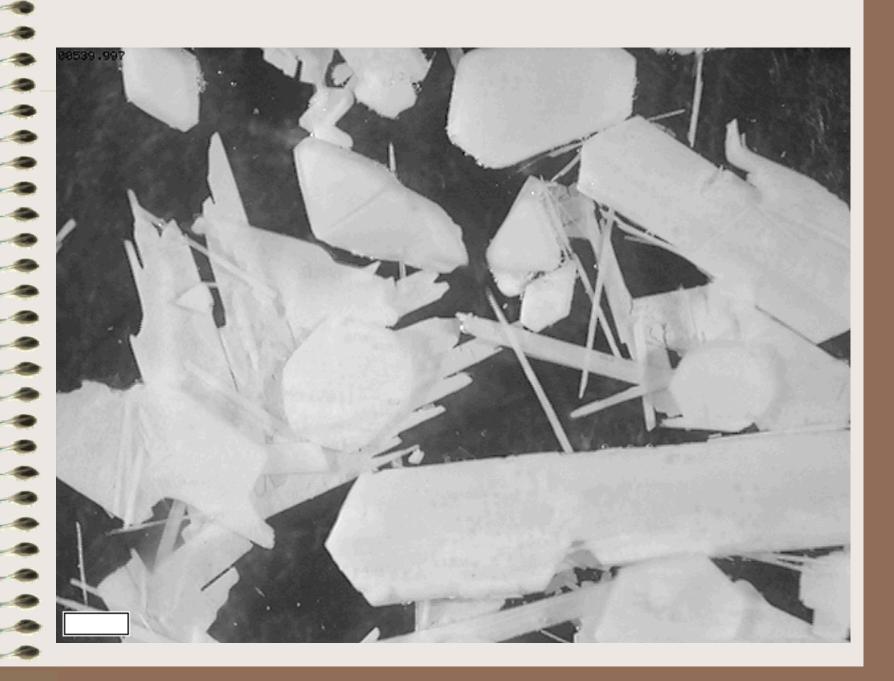
Calcite Deposits

Laboratory tests confirmed that oxychloride phases quickly convert to calcite ( $CaCO_3$ - or calcium carbonate) when exposed to atmosphere in the presence of water
