ROAD MAP TRACK 6
Innovative Concrete Pavement
Joint Design, Materials, and
Construction

Peter C. Taylor
National Concrete Pavement
Technology Center

MAP Brief 6-1:

**Preventing Joint Deterioration in
Concrete Pavements
A Summary of Current Knowledge**

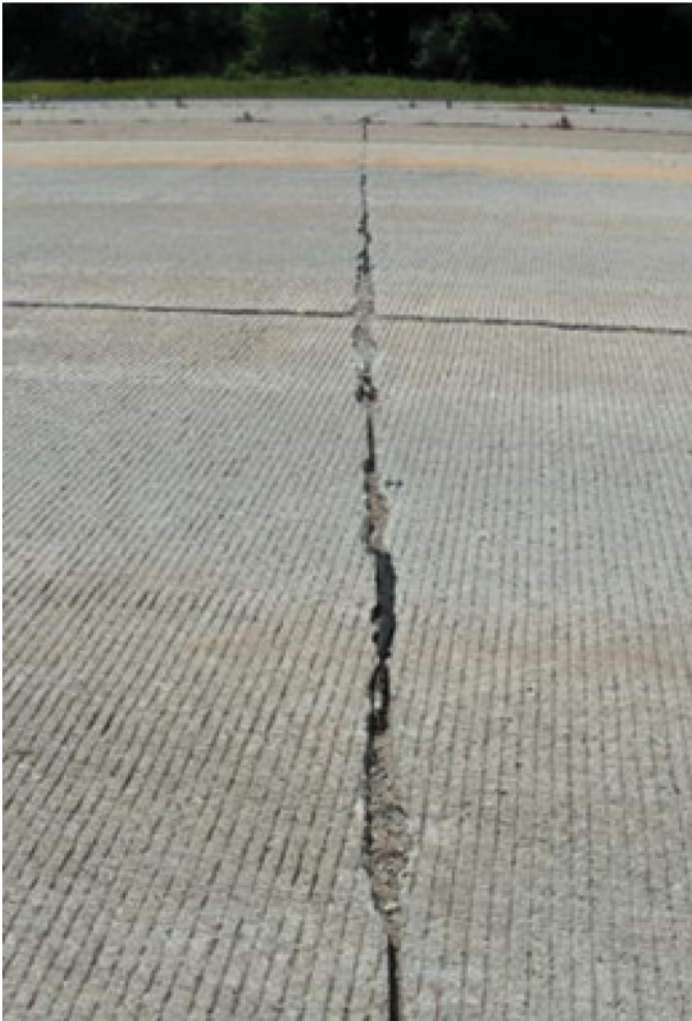
In the second, mechanical, form of deterioration (Figure 4), typical characteristics are as follows:

- Damage is normally narrow and shallow, and may be on only one side of the joint.
- Damage starts near the edge of the slab and propagates along the joint rather than outward.
- The cracks often appear around aggregate particles rather than through them, indicating that the first damage may have occurred in the first few hours after placing.

It is likely that poor maintenance of the sawing equipment and/or inappropriate sawing practices are leading to damage around the saw cut that may not be visible initially, but will be exercised and opened up by weathering. Such damaged areas will also tend to act as water traps, thus leading to accelerated freezing-related distress, as described above.

Figure 4. Typical mechanical distress

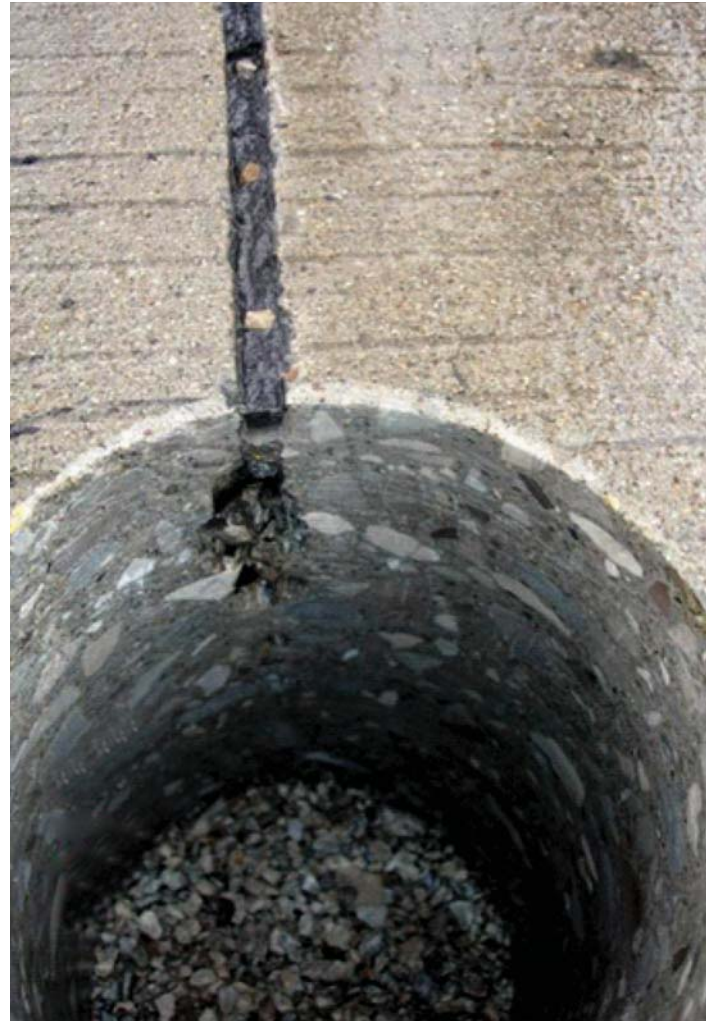
Figure 5. Example of damage occurring in a slab that has not cracked out

- Ensure that the saw cuts initiate a crack so that water can get away (Figure 5), for instance make sure the longitudinal saw cuts are at least T/3 in depth.
- Ensure that the base has some permeability to allow
