Evaluation of Steel Bridges

Evaluation of a Timber Bridge for the Secondary Road System Using FRP-Reinforced, Glued-Laminated Girders

tech transfer summary

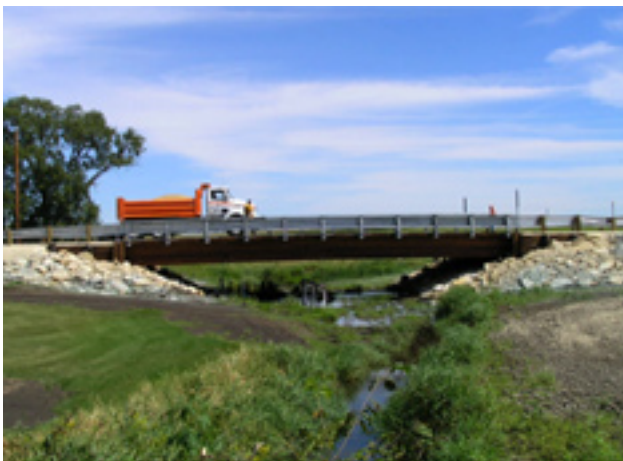
Bridge in Delaware County comprised of fiber-reinforced polymer (FRP), reinforced glued-laminated timber girders, and a transverse glued-laminated timber deck

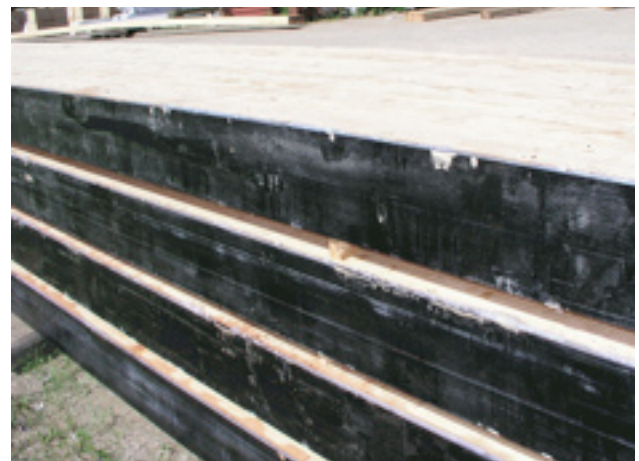
Glued-laminated girders after FRP installation
