# — PERFORMANCE HISTORY OF — CONCRETE OVERLAYS IN THE UNITED STATES

JUNE 2023

National Concrete Pavement  
Technology Center

Gross, J. 2023. *Performance History of Concrete Overlays in the United States*. National Concrete Pavement Technology Center, Iowa State University, Ames, IA.

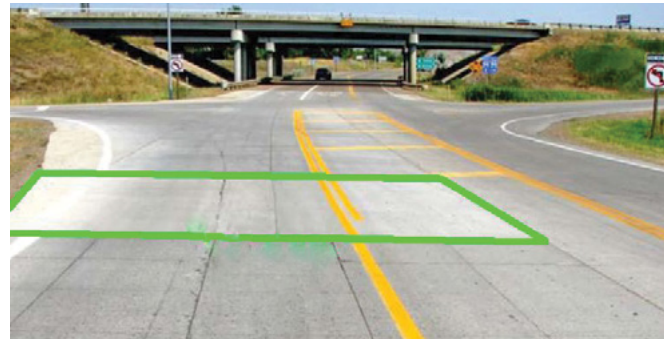
Removal and full-depth repair of 15 panels (0.2%) was performed in 2005. Approximately 30 cracked panels (0.5%) were observed in 2008. Figure 13 and Figure 14 show the condition of the overlay in 2008 and 2020, respectively.

**Figure 13. SR-16 near the I-94 interchange in Dawson County, Montana (June 2008), showing a repaired area (green box)**

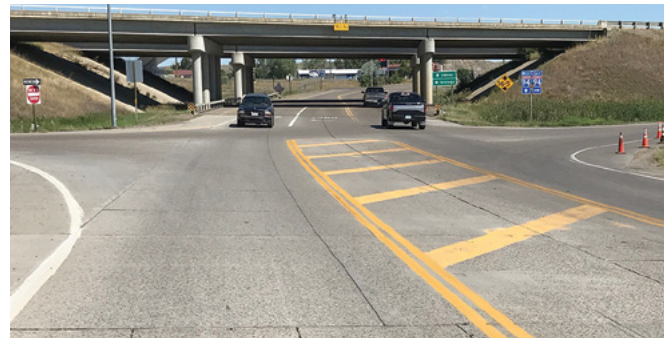
**Figure 14. SR-16 near the I-94 interchange in Dawson County, Montana (June 2020)**

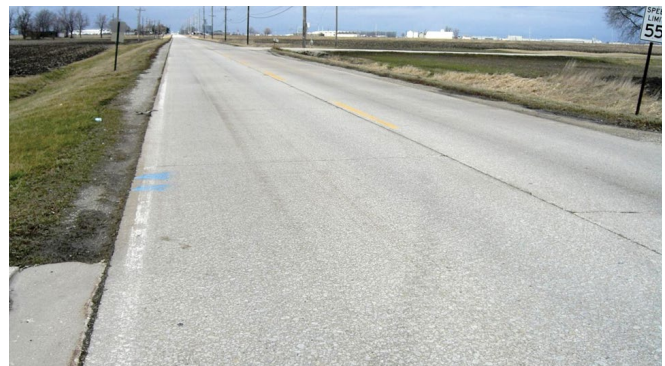
Faulting and minor cracking has been observed. The overlay was diamond ground after 28 years of service, and some patching was performed in the vicinity of a grain elevator. Figure 16 and Figure 17 show the condition of the overlay in 2012 and 2020, respectively.

**Figure 16. CR-56 near Peru, Illinois, after 38 years (2012)**

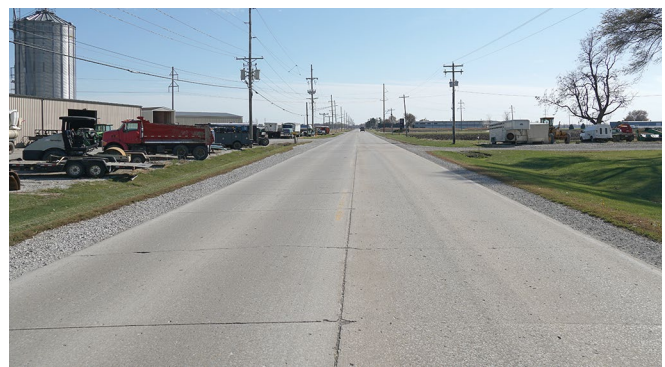
**Figure 17. CR-56 near Peru, Illinois, after 48 years (2020)**

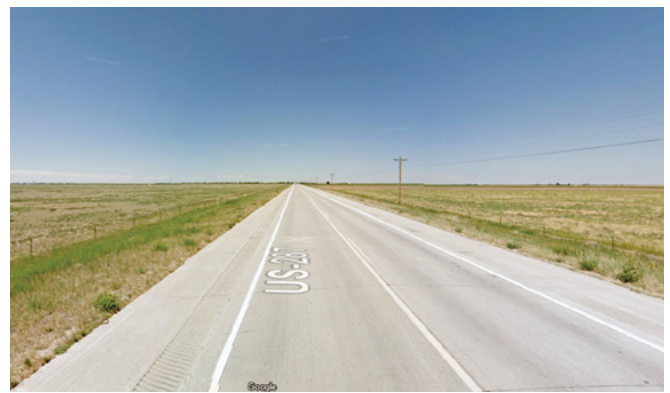
Isolated cracking has been observed in the southbound shoulder at one location based on 2012 imagery. Approximately 30 patches (0.3% of total panels) have been applied. Figure 19 and Figure 20 show the condition of the overlay in 2012 and 2020, respectively.

**Figure 19. US-287 in Kiowa County, Colorado, looking south (2012)**

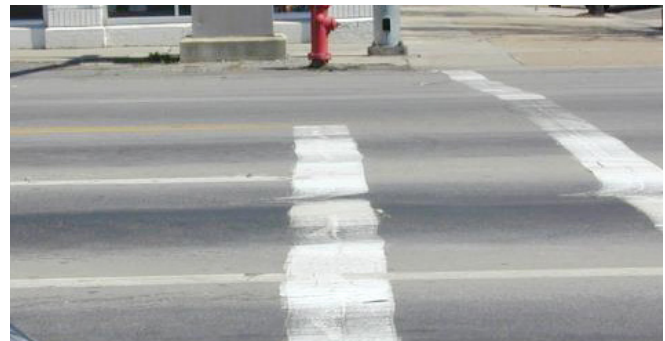
**Figure 22. Rutted asphalt on US-89 in Provo, Utah, prior to concrete overlay (before 2001)**

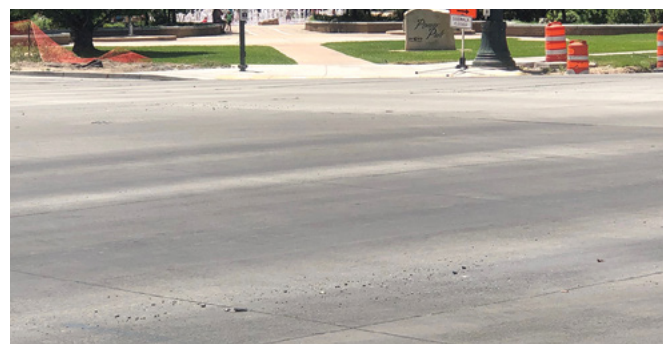
After the 2001 concrete overlay was placed, early cracking around utility structures and ultimately corner and longitudinal cracking caused by repetitive truck loading was observed. A few individual panels around utility structures were replaced early in the life of the project. Originally designed for 10 years, the 2001 concrete overlay was replaced after 11 years by a full-depth concrete section in 2012 to provide for additional capacity. Figure 22 and Figure 23 show the condition of US-89 before the 2001 concrete overlay was placed and in 2020, respectively.

**Figure 23. US-89 in Provo, Utah (2020)**

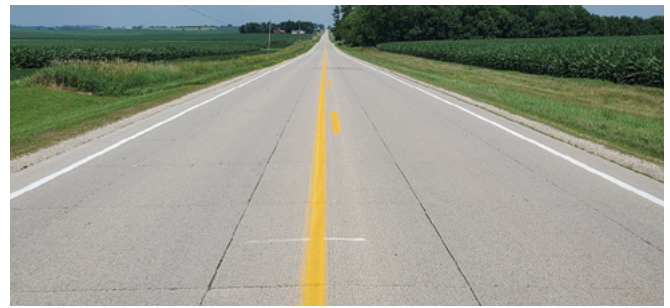
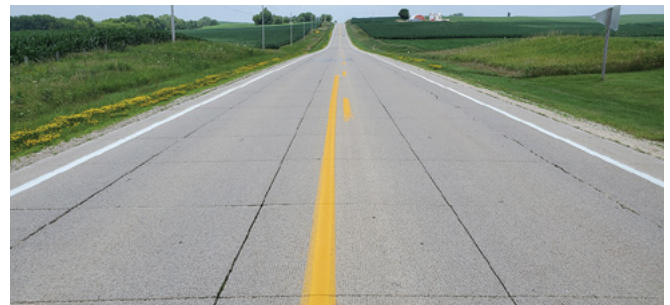
Since the overlay was placed, longitudinal cracking, primarily attributed to tooled joints, has been observed. The International Roughness Index (IRI) value of the overlay surface as of 2018 was 177 inches per mile. Repairs have included panel patching. Figure 25 and Figure 26 show the condition of the overlay in 2014 and 2020, respectively.

**Figure 25. SH-13 bonded overlay north of Manchester, Iowa (2014)**

**Figure 26. SH-13 bonded overlay north of Manchester, Iowa (2020)**

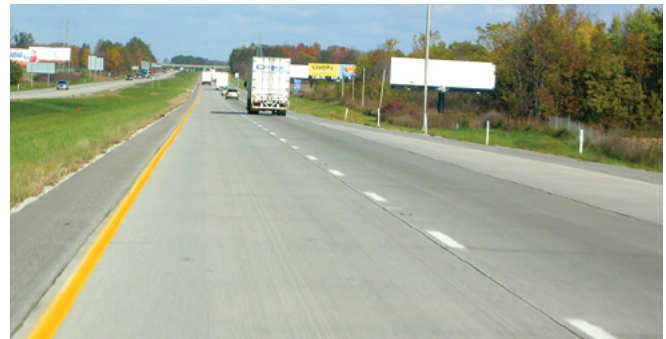
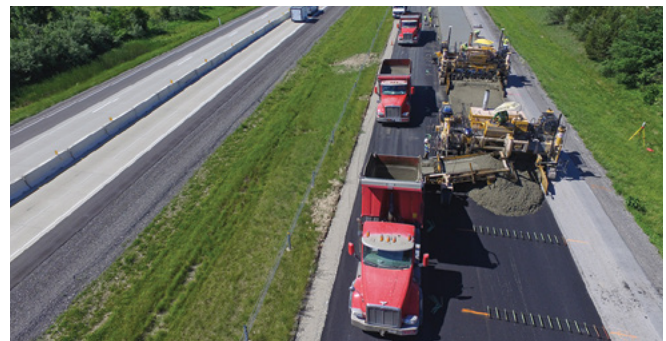
Based on imagery from 2012 and 2013, mid-panel, longitudinal, and/or corner cracking has been observed in approximately 2% of panels. Full-depth patching has been performed on approximately 6% of panels, and diamond grinding was performed in 2005 after 19 years in service. Due to the success of the original overlay, some areas were reconstructed as an overlay in 2019. Figure 28 and Figure 29 show the condition of the overlay in 2005 and 2019, respectively.

**Figure 28. I-69 in Grant County, Indiana, after grinding (2005)**

**Figure 29. I-69 in Grant County, Indiana (2019)**

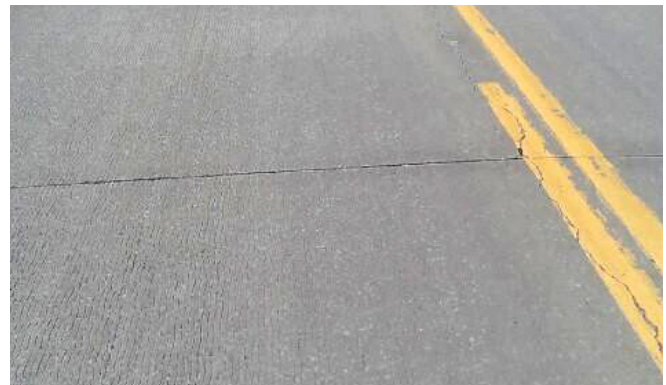
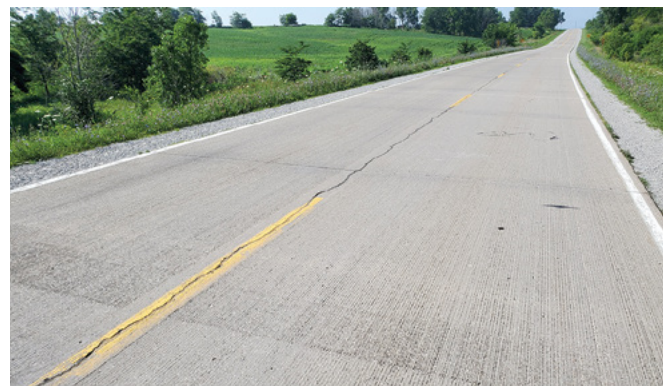
Since the overlay was placed, material-related distress, joint shadowing, and joint distress have been observed. The IRI value of the overlay surface in 2017 was 108 inches per mile. Crack sealing and patching have been performed. Figure 34 and Figure 35 show the condition of the overlay in 2014 and 2020, respectively.

**Figure 34. V-63 in Jefferson County, Iowa (2014)**

**Figure 35. V-63 in Jefferson County, Iowa (2020)**

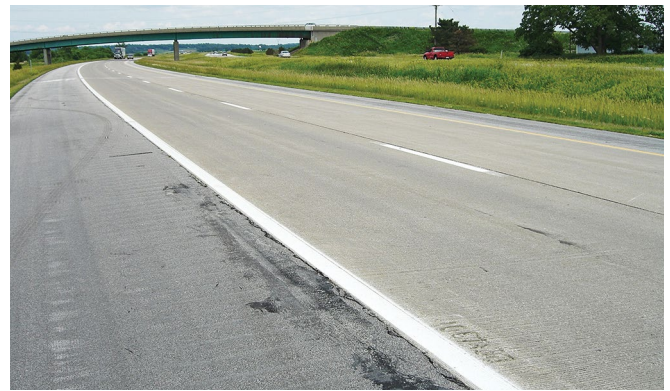
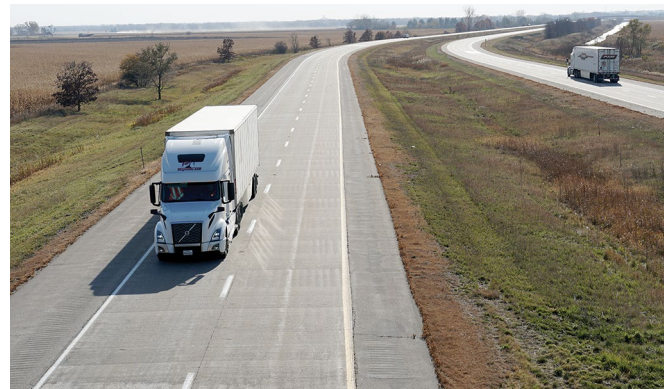
Since the overlay was placed, debonding and subsequent structural failure has been observed at a few isolated locations. Twenty-five full-depth patches (0.5% of total panels) have been applied. Figure 37 and Figure 38 show the condition of the overlay in 2011 and 2020, respectively.

**Figure 37. Eastbound I-88 in Whiteside County, Illinois, looking west (2011)**

**Figure 38. I-88 in Whiteside County, Illinois (2020)**

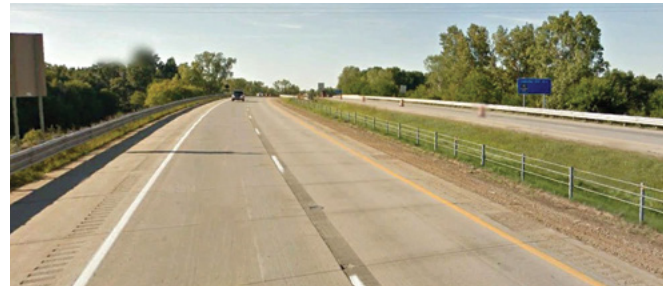
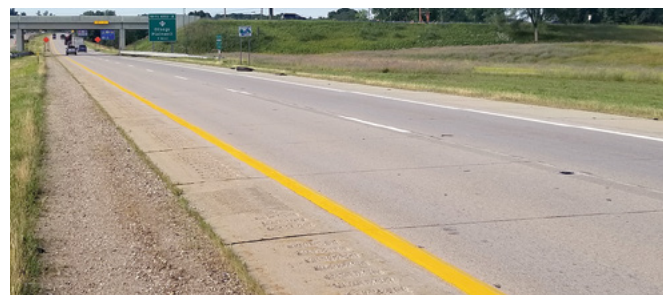
Since the overlay was placed, a 0.8-mile-long section of the northbound inside lane was observed to be experiencing early joint deterioration. Repairs have included 18 patches (0.3% of total panels) and the sealing of 24 cracked slabs (0.4%). Figure 40 and Figure 41 show the condition of the overlay in 2012 and 2020, respectively.

**Figure 40. US-131 in Allegan County, Michigan (2012)**

**Figure 41. US-131 in Allegan County, Michigan (2020)**

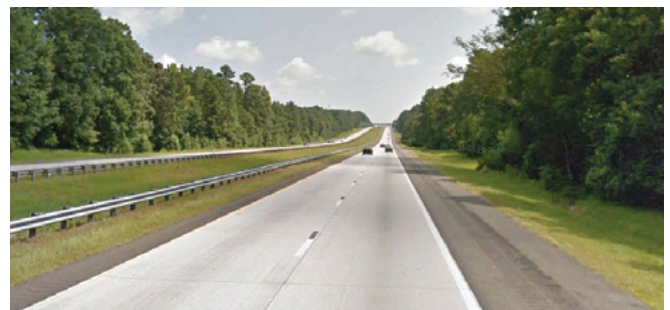
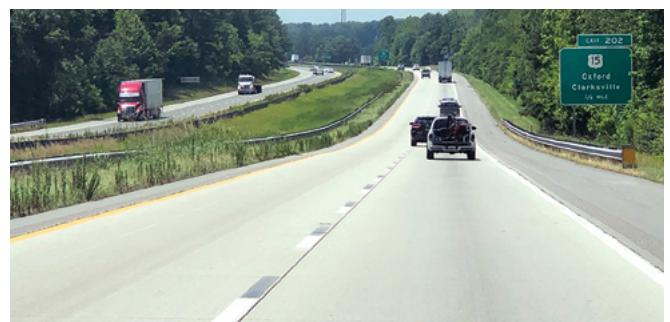
Since the overlay was placed, mid-panel cracking has been observed in 1.5% of slabs, and 98% of those cracked slabs were constructed during the first project in 1997. Repairs have included full-depth patching (on 0.2% of slabs) and crack sealing. Figure 43 and Figure 44 show the condition of the overlay in 2013 and 2020, respectively.

**Figure 43. I-85 in Granville County, North Carolina (2013)**

**Figure 44. I-85 in Granville County, North Carolina (2020)**

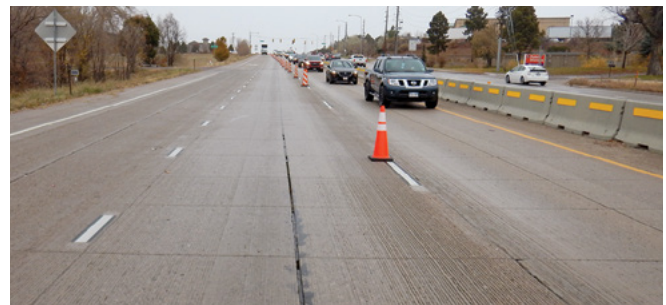
Since the overlay was placed, cracking has been observed in fewer than 1% of slabs, though map cracking is present, and faulting of less than 0.06 inches has been observed. The average IRI value of the overlay surface was 140 inches per mile. Less than 80 square feet of concrete patching has been performed. Figure 46 and Figure 47 show the condition of the overlay in the southbound lanes of SH-83 and an example of minimal spalling, respectively, in 2018.

**Figure 46. Southbound lanes of SH-83 in Arapahoe County, Colorado, looking north (2018)**

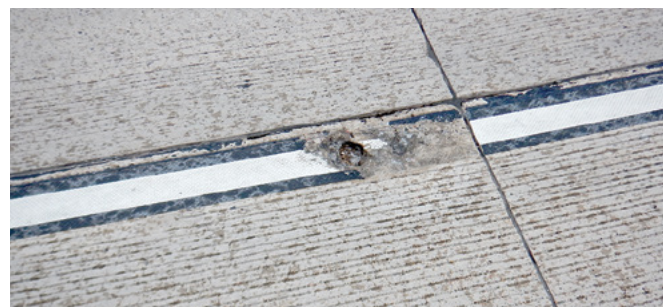
**Figure 47. Minimal spalling at slab corner on SH-83 in Arapahoe County, Colorado (2018)**

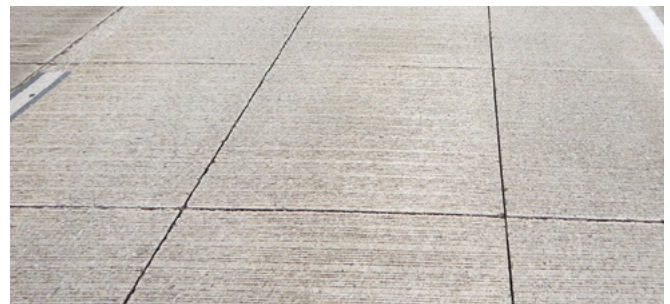
**Figure 50. Typical joint condition on US-425 near Ferriday, Louisiana (2019)**

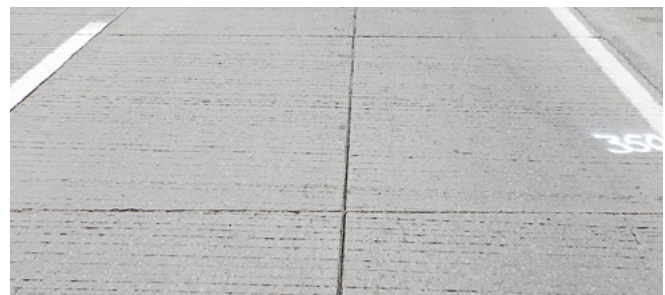
**Figure 53. Typical slab condition on SR-119 near Uniontown, Pennsylvania, looking south (2019)**

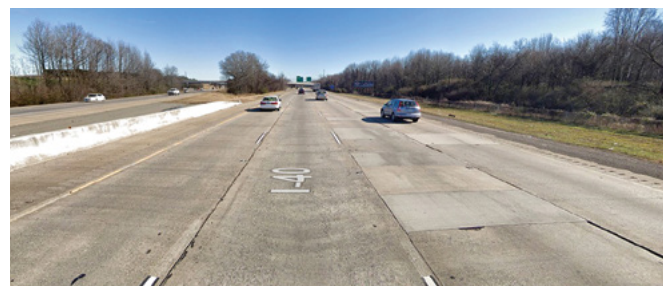
**Figure 59. Full-depth patches on eastbound I-40**
