The Use of Eastern Cottonwood for Stress-Laminated Sawn Lumber Bridges in Iowa

Paula Hilbrich Lee Michael Ritter

This case study presents information pertaining to 3 stress-laminated sawn lumber timber bridges constructed from Eastern Cottonwood in Iowa.

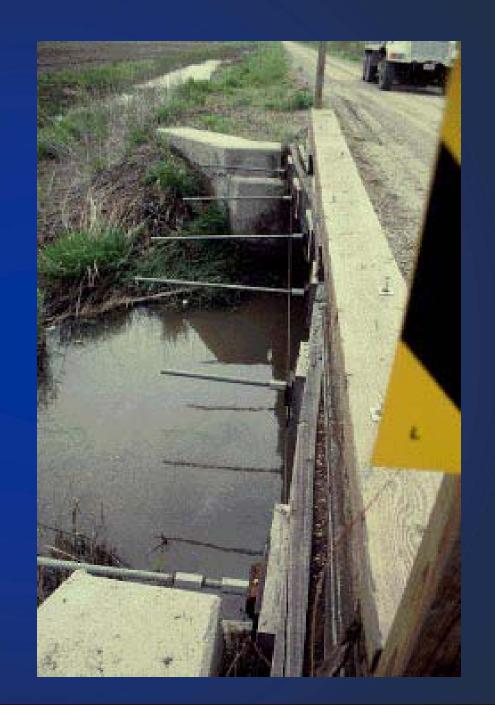
Dean Bridge Geometry

at LT1 8.5 inches narrower at midspan of north edge

Attributed to layout of laminations that varied in width as much as 0.5 inches

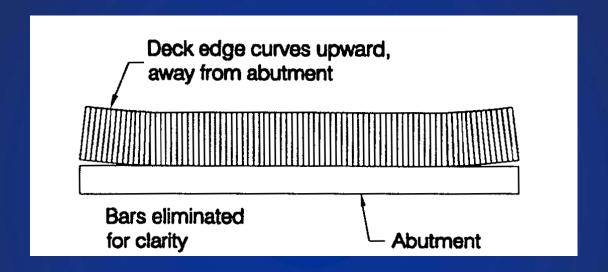
Dean and Decatur Bearing Condition
Unchanged throughout monitoring period.
Likely result of constructing deck
on uneven temp. supports
