Contribution to Structural details on Timber Bridges

Otto Kleppe, Tormod Dyken, Hauke Burkart
Norwegian Public Roads Administration

Overview – Timber bridges in Norway

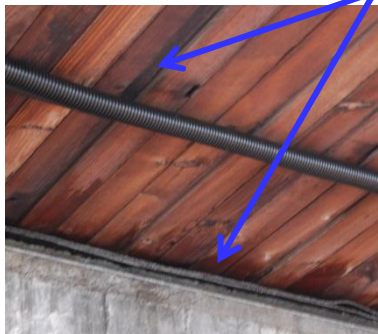
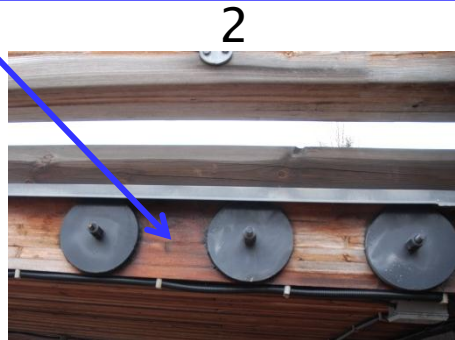
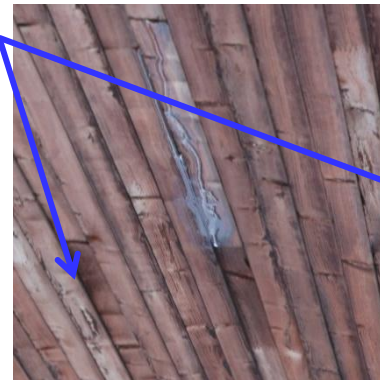
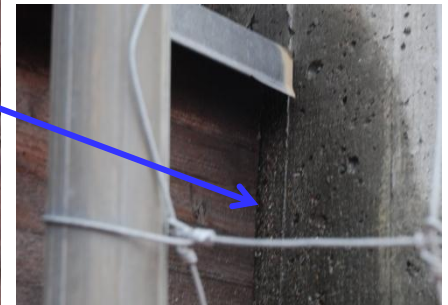
Water at wrong location

- Leaking membrane
- Missing or defective drip moulding (throating). The water overruns the edge of the deck and down the side face
- The water run on the support shelf or beam. Consequently the water will be absorbed by the sill, and also by the slab when the sill is made of timber

- This water at the wrong place is very unfortunate and have to be repaired within a few years.

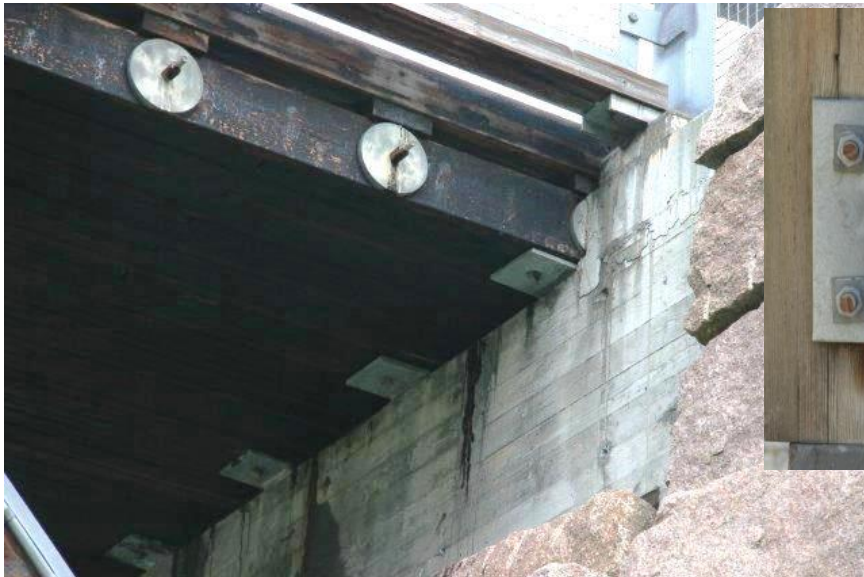
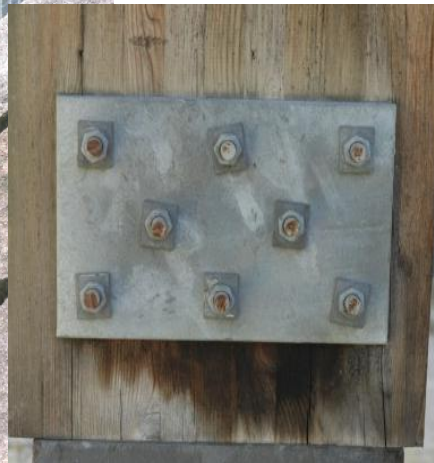
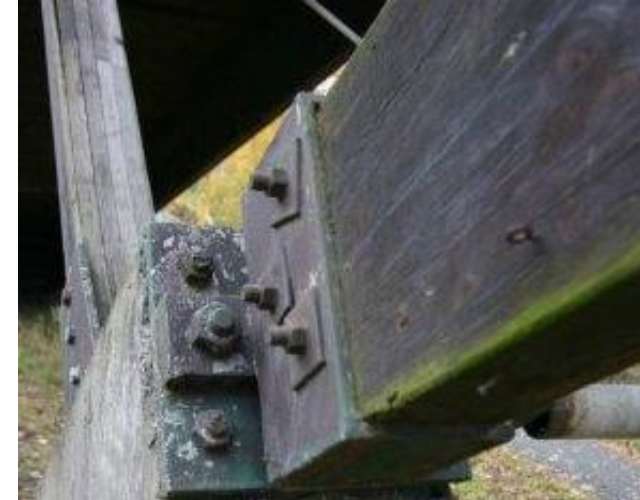
Moisture/water absorbed in the end-grain

- Water/moisture may be accumulated in different ways, enclosed and consequently absorbed in the end-grain.
- Here are three examples

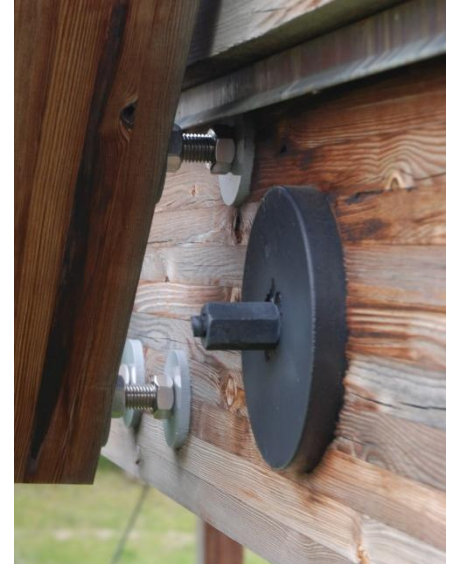
Prestressing bar

- In some very few cases
 - Failure of the prestressing bar – one case
 - The protruding end of the prestressing bar is sometimes far too short to allow re-tensioning of the bar
- All stress laminated decks
 - Important to find the correct point of time for re-tensioning the tendons

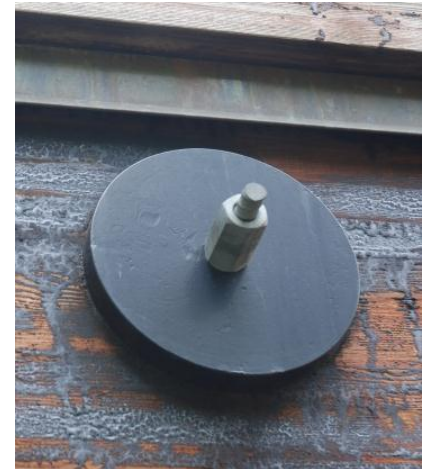
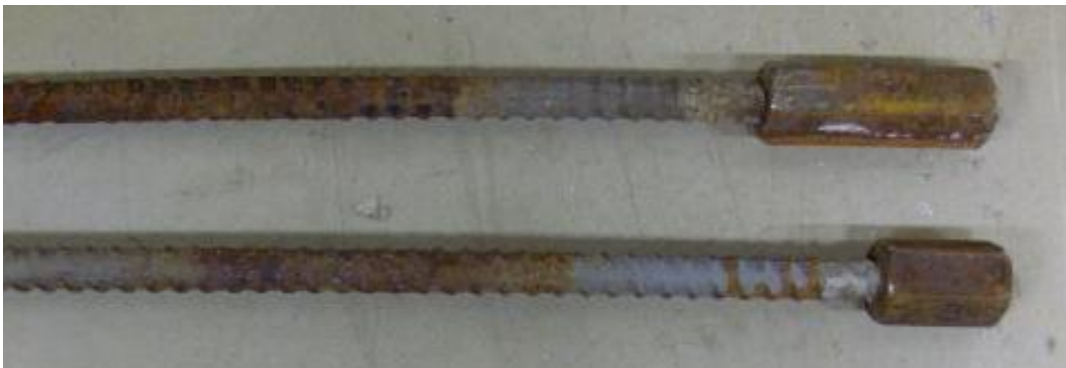
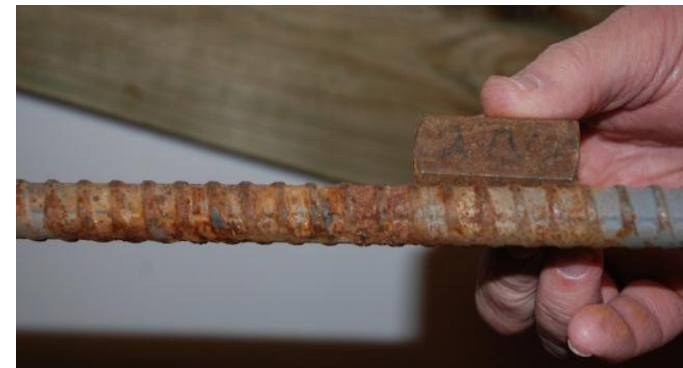
Corrosion on the tendon

All tendons are thermal zinc sprayed

- Corrosion on the prestressing bar – The cause is so far not completely known
- A reason for the corrosion is most likely water penetration into the location of the bar
- The design of the membrane termination at the edge of the deck and the drop moulding should probably be improved

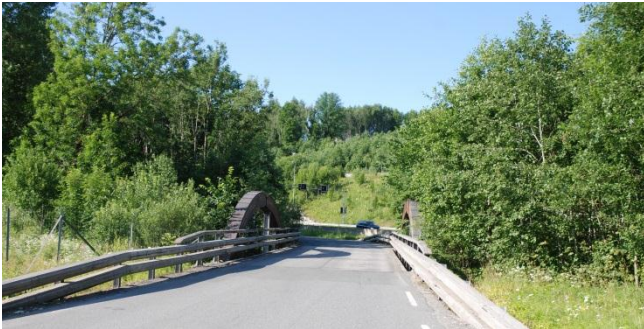
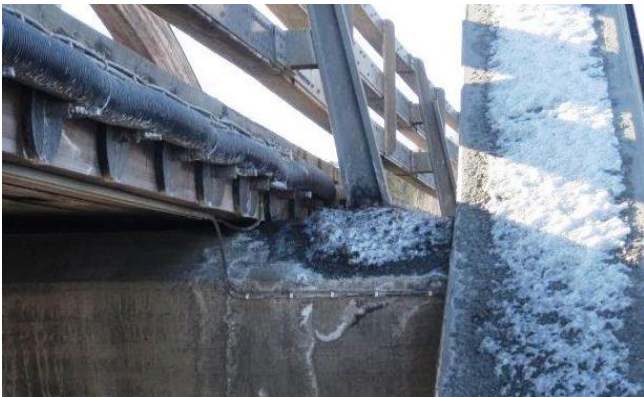
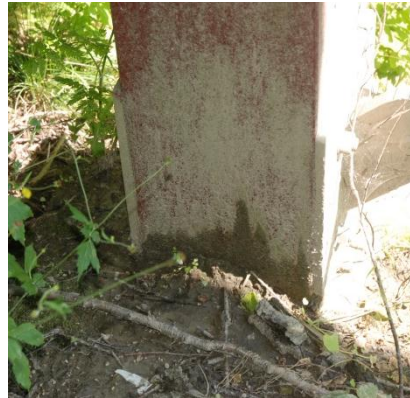
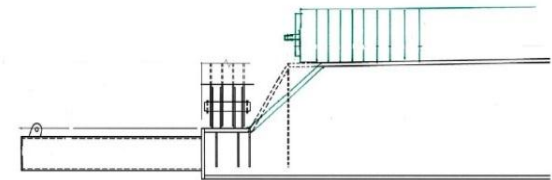
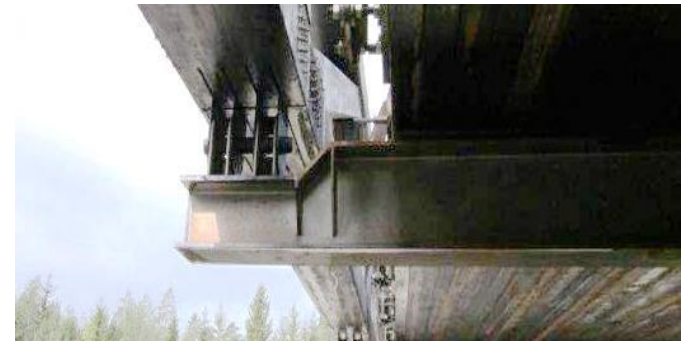
Influence from the vegetation and gravel/debris

- Vegetation close to (touching) the bridge
- Gravel/debris touching or surrounding parts of the timber bridge

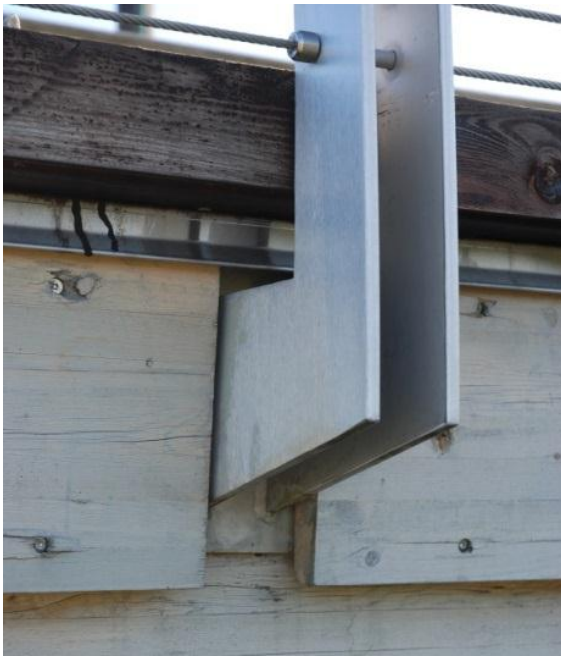
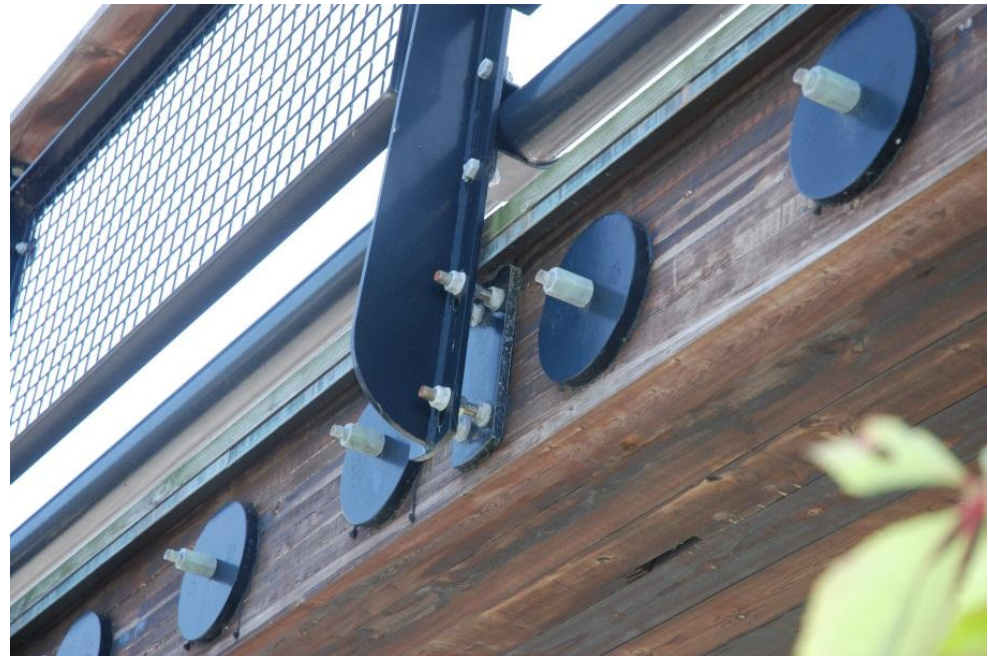
Connecting point for parapet

- Water follows the steel structure and reaches the timber in concentrated amount
- Precipitation running off from one member to the one below

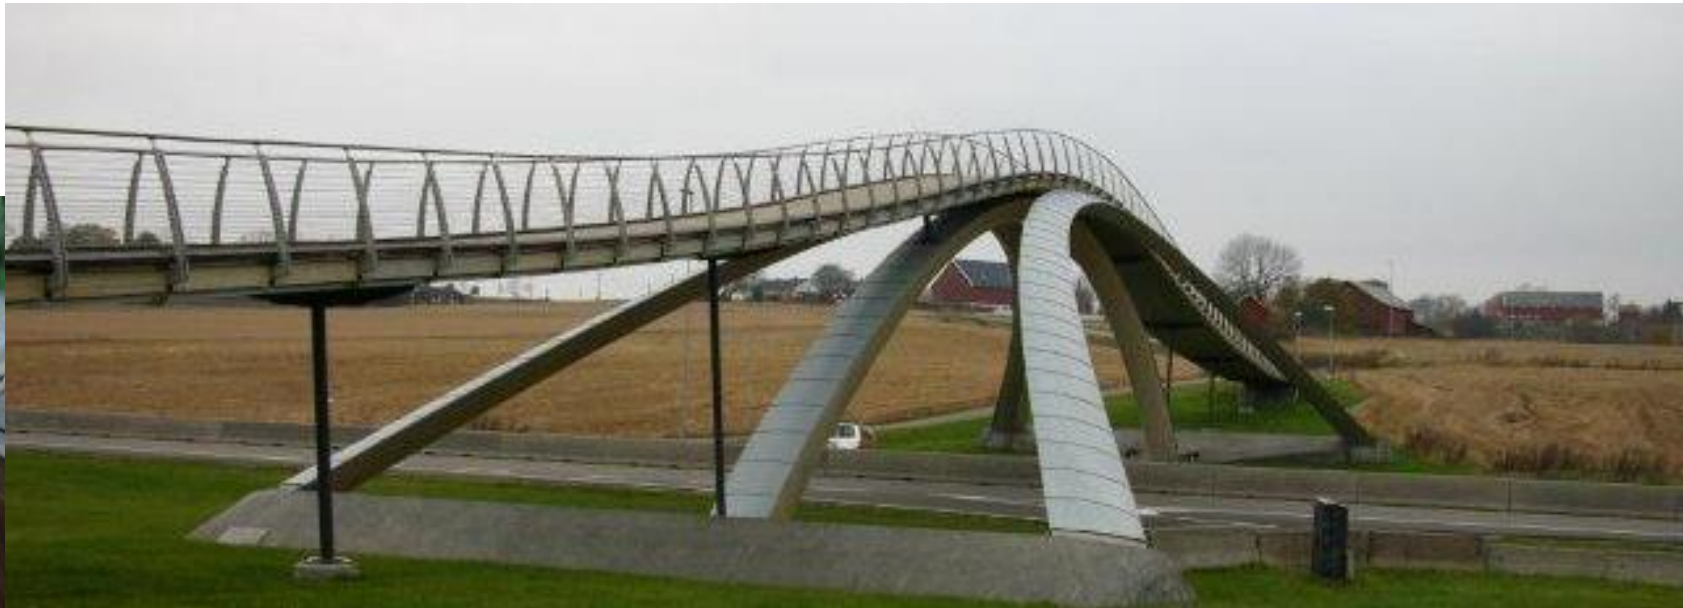
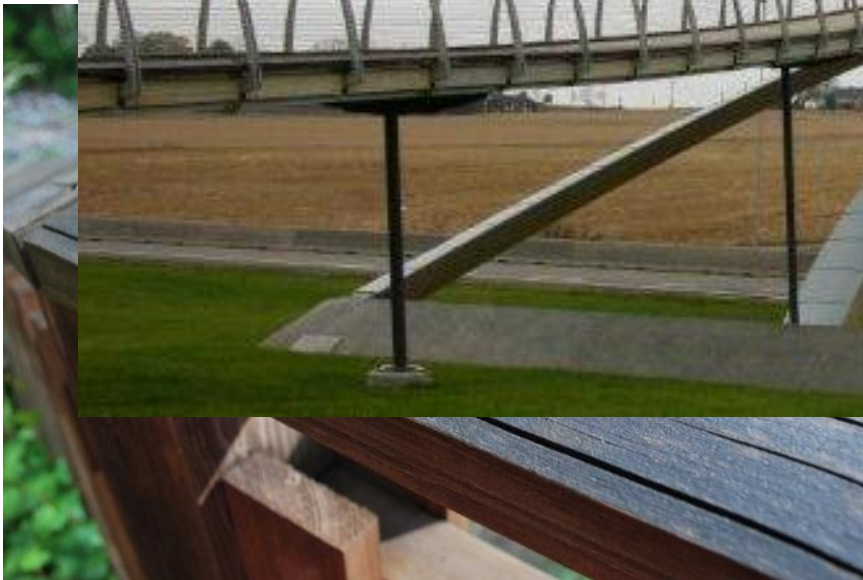
Water penetrating into cracks

- *Gloeophyllum sepiarium* (Rusty gilled polypore) on timber bridges
- Water following the surface without structural protection and penetrating cracks. The water will dry out very slowly and cause wood decay fungus attack

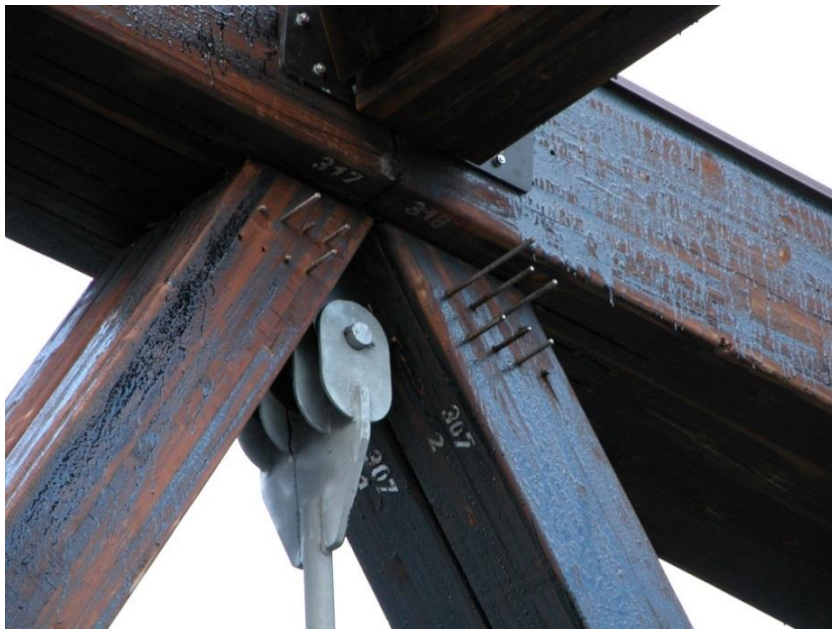
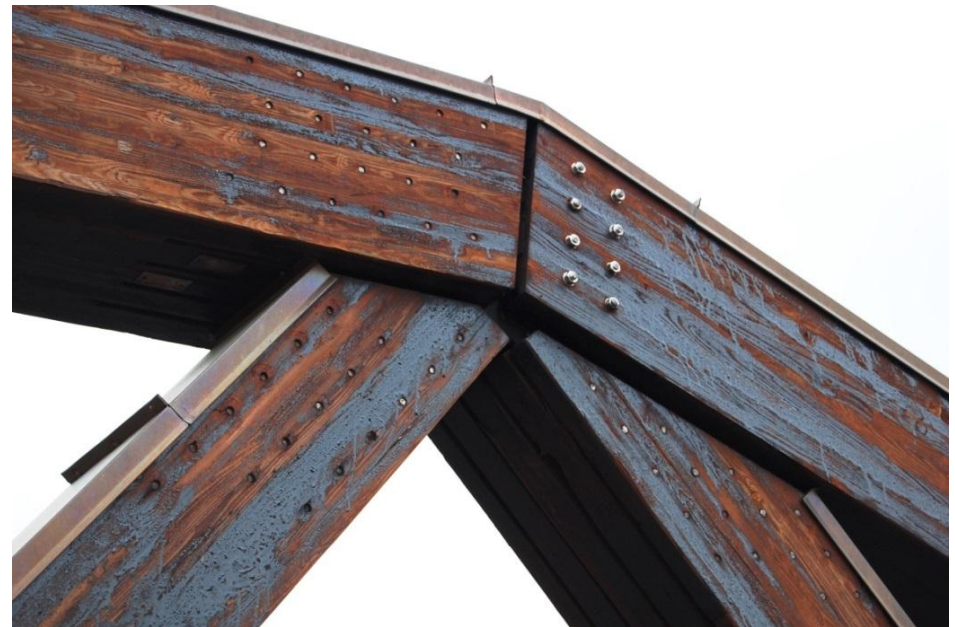
Moving dowels

- Dowels moving out of the timber as a result of traffic loading
- Today we use dowels with thread and nuts where moving could happen
