Glulam beams and columns after 5 years exposure to outdoor climate

**Anna POUSETTE
Karin SANDBERG**

**SP Technical Research Institute of Sweden
Wood Technology
Skellefteå, Sweden**

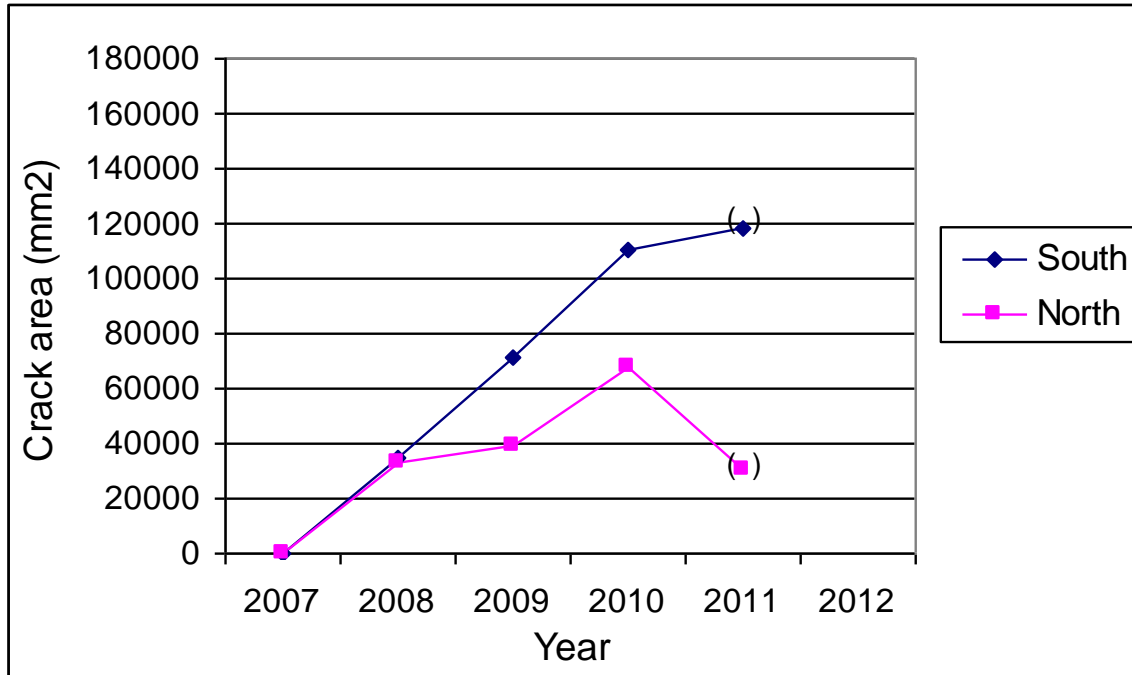
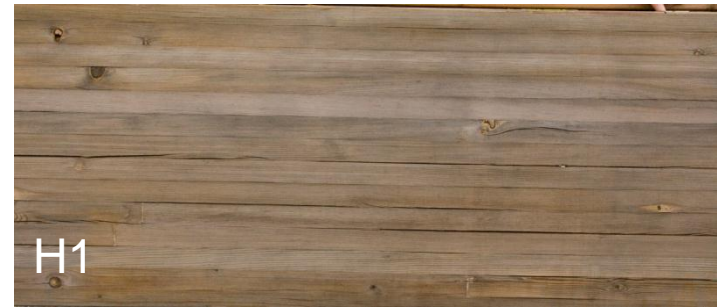
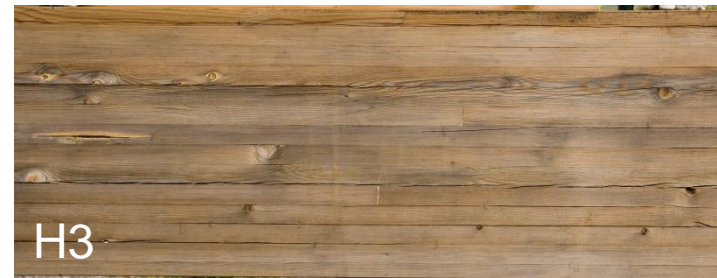
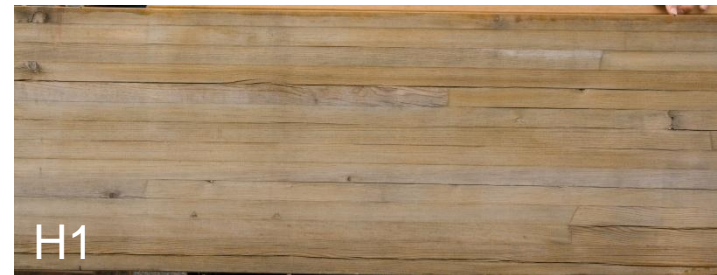
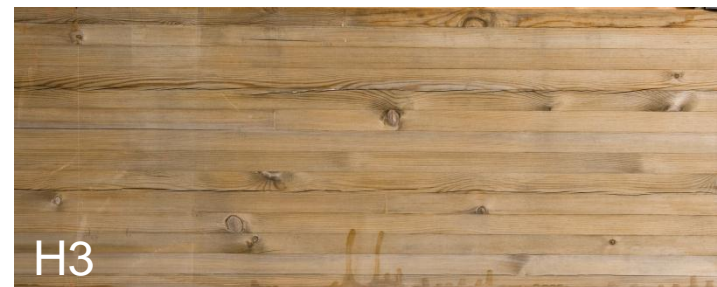
Crack area (mm²) in beam type B1, (wood oil) on south and north side, average of five beams (2011 only one beam)

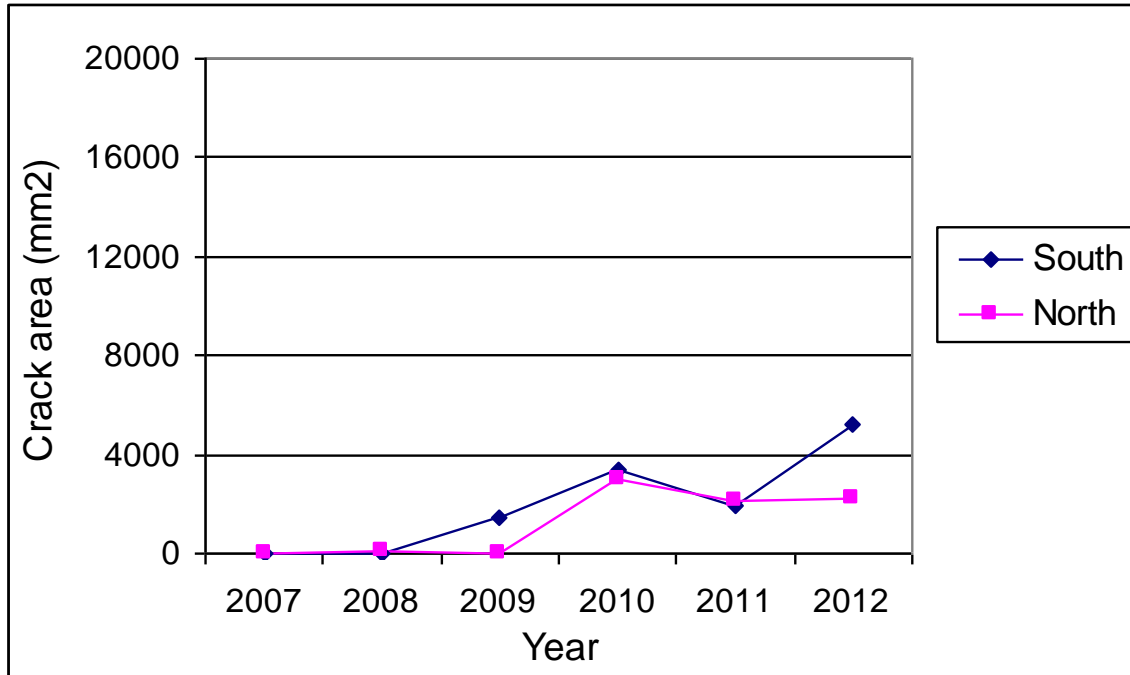
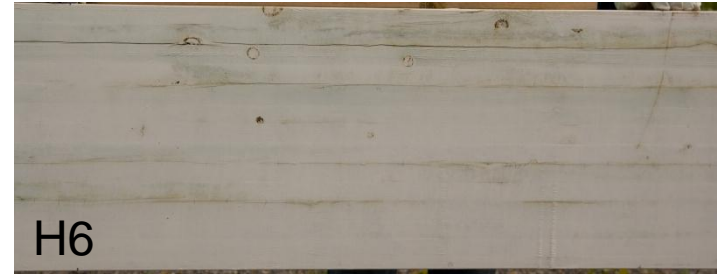
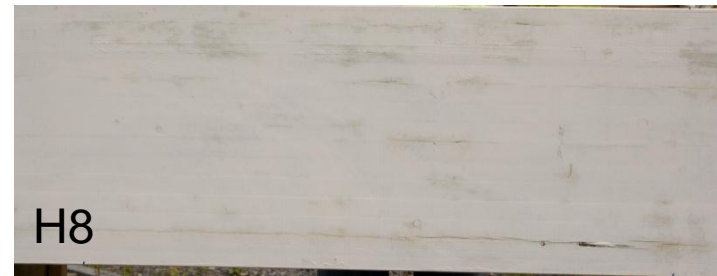
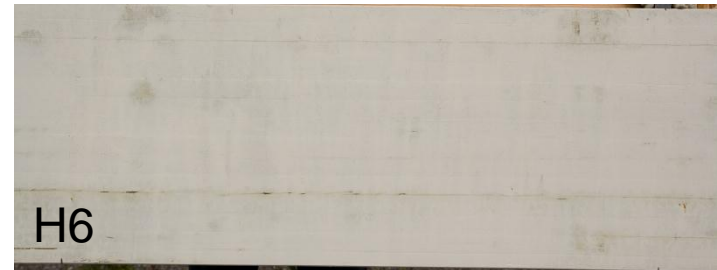
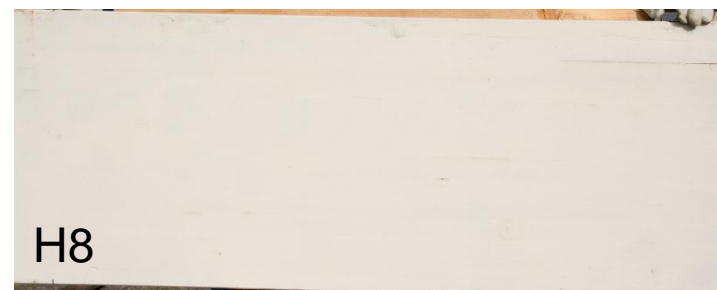
Crack area (mm²) in beam type B2, (white paint)
on south and north side,
average of five beams

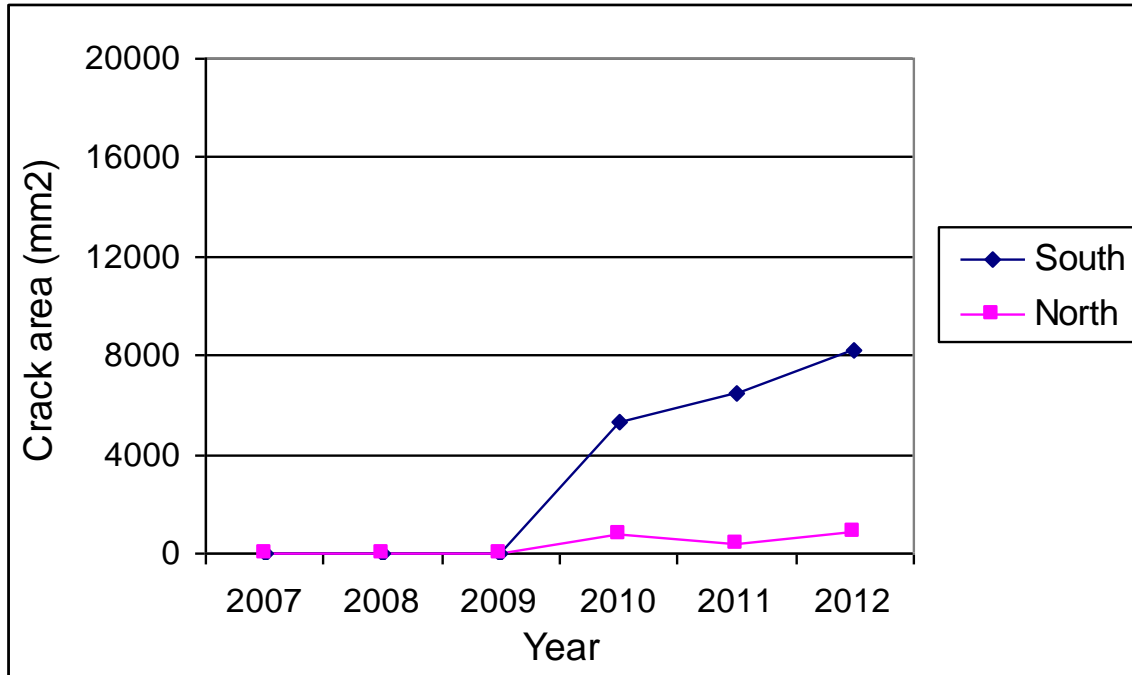
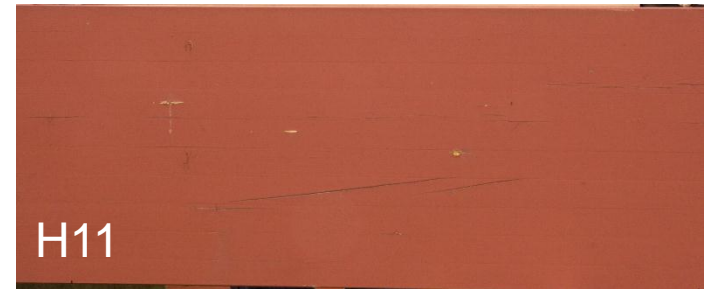
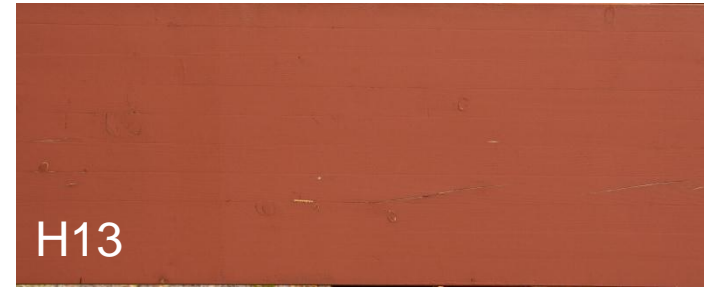
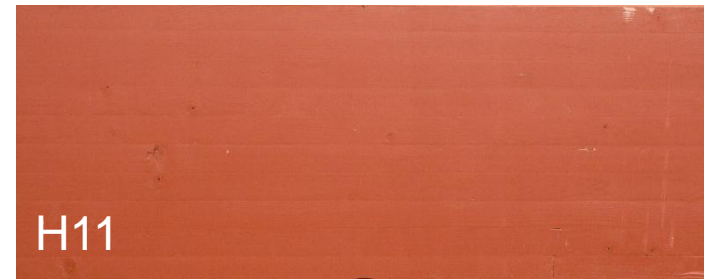
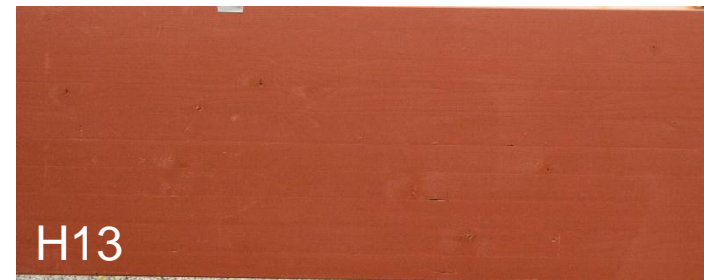
Crack area (mm²) in beam type B3, (red paint)
on south and north side,
average of five beams

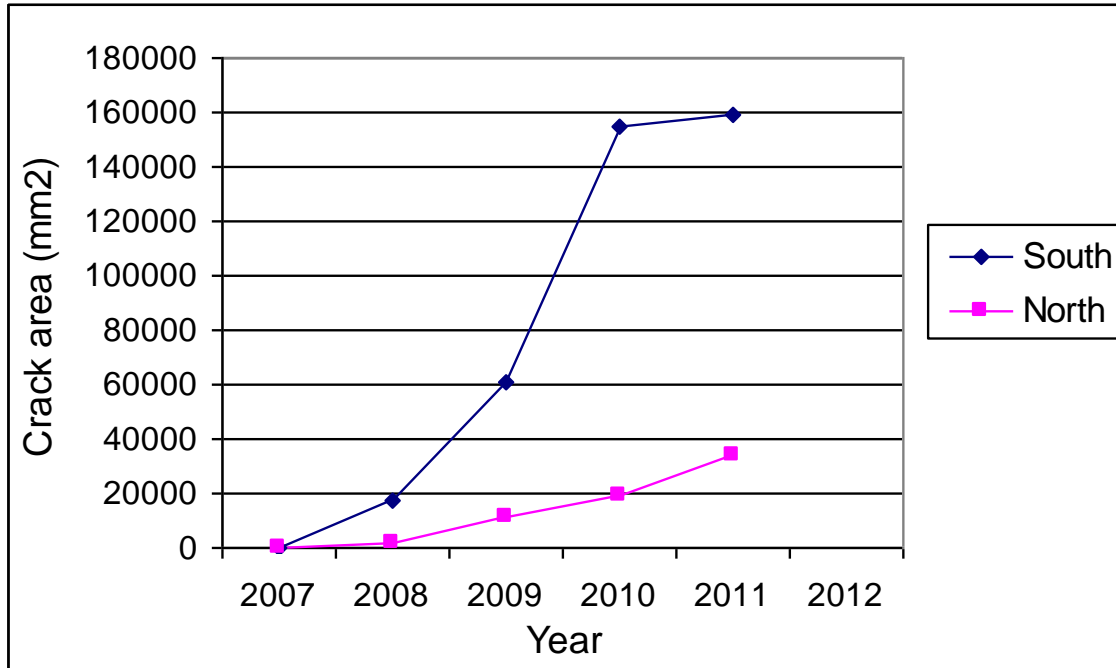
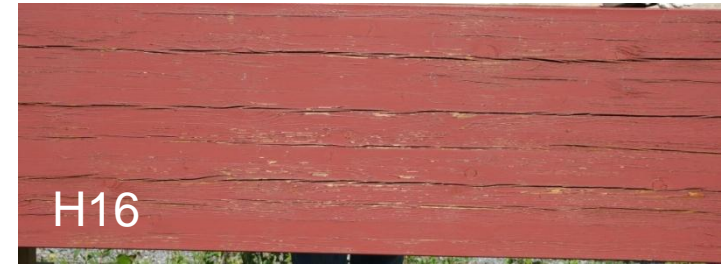
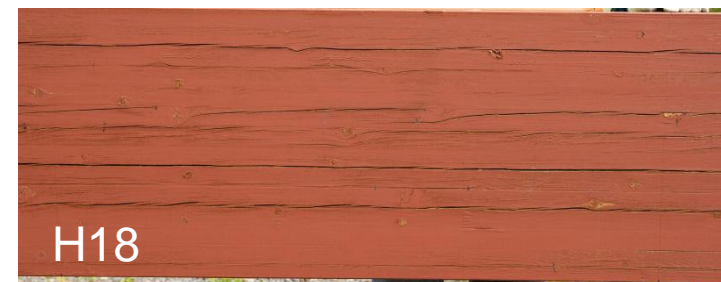
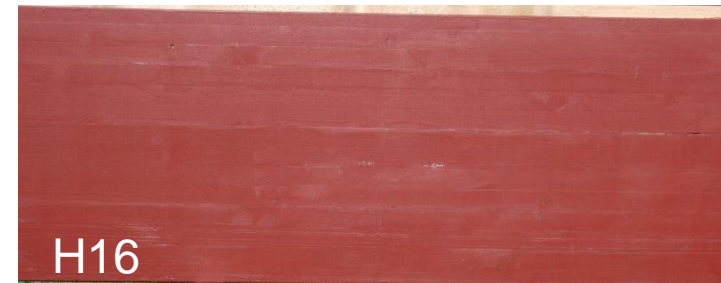
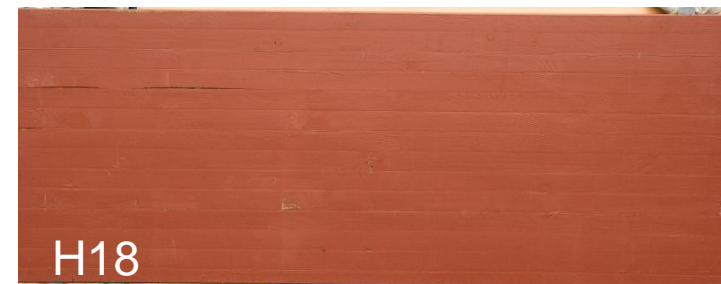
Crack area (mm²) in beam type B4, (red paint)
on south and north side,
average of five beams

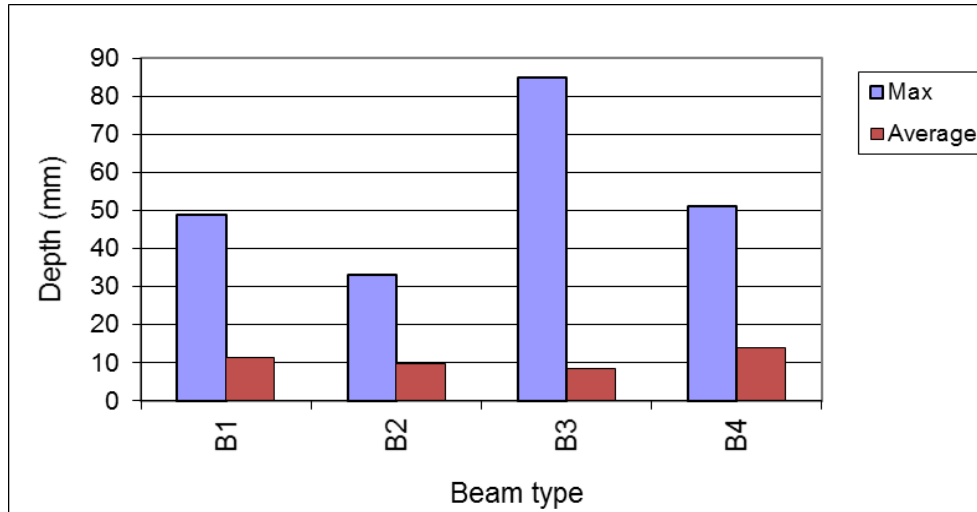
Maximum and average crack depths (mm) in beam types B1-B4

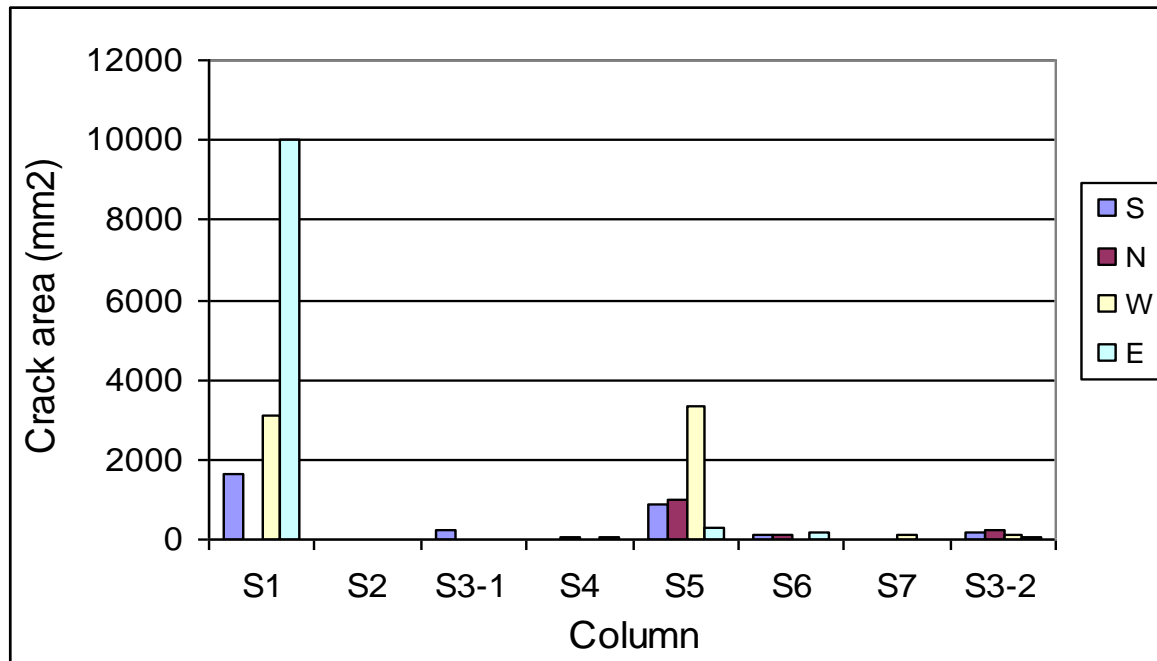
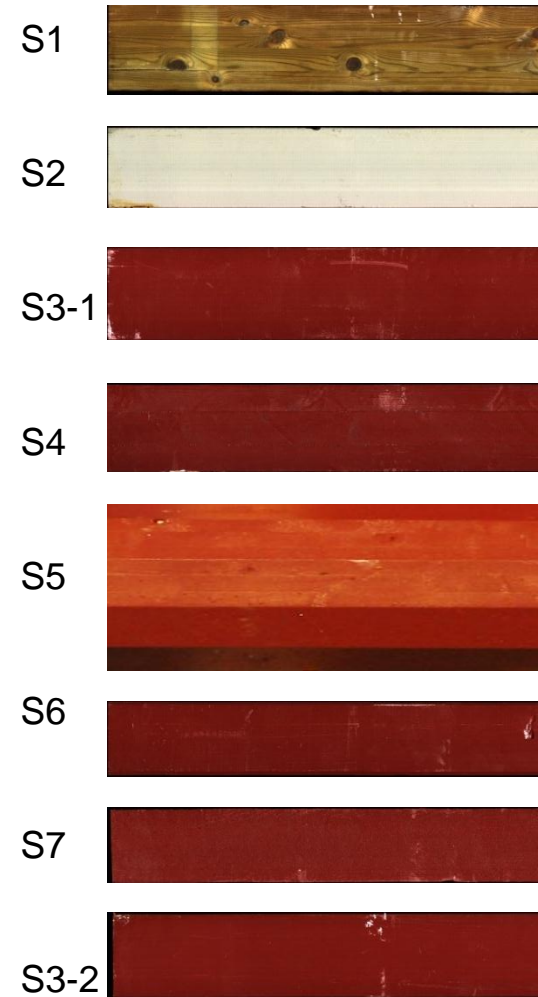
Crack area (mm²) for the different sides of columns south (S), north (N), west (W) and east (E)

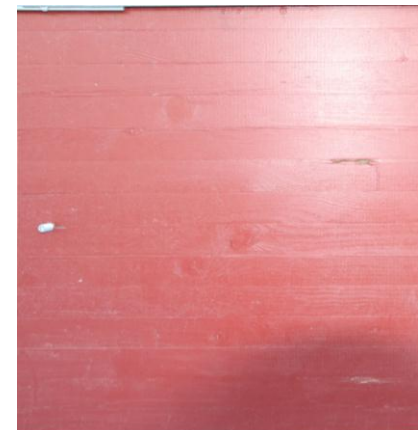
2007

Beam H16, south side
