Field Performance of Timber Bridges: A National Study

2nd International Conference on Timber Bridges
September 30 – October 2, 2013 – Las Vegas, Nevada USA

National Bridge Inspection Study

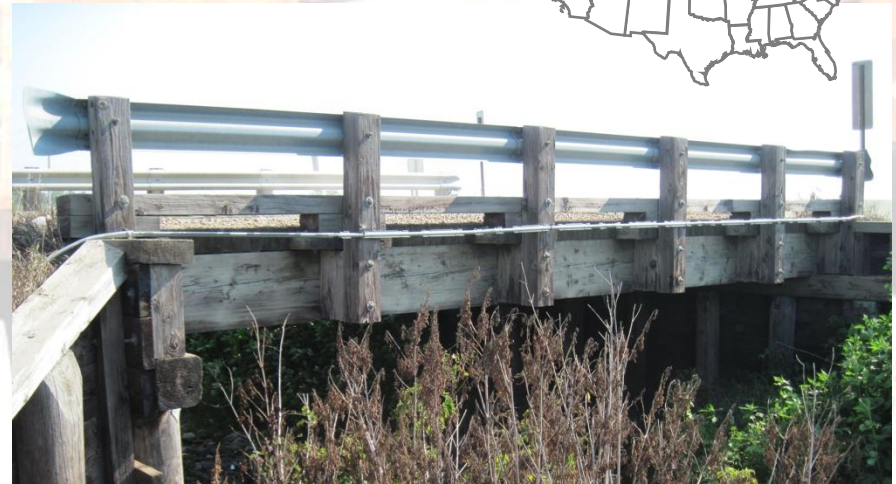
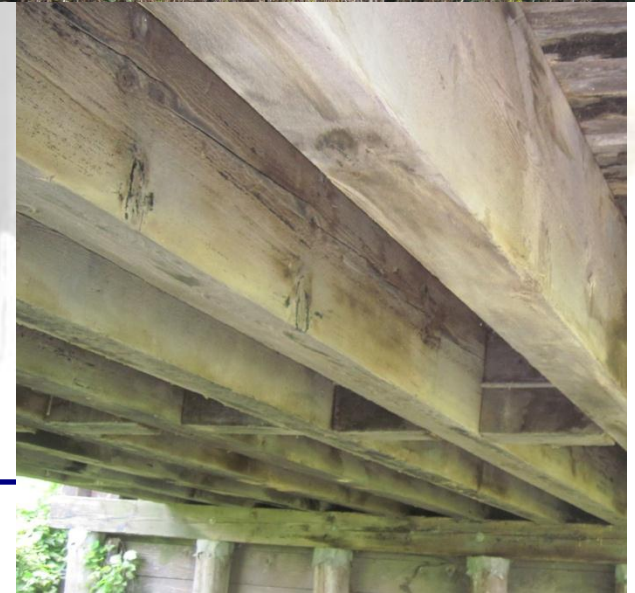
Solid Sawn Stringer/ Timber Deck

- Southern Minnesota
 - County (4)
- Northern Wisconsin
 - Forest Service (4)
 - 1-3 spans
 - 6-10 m, 20-35 ft length
 - 1 and 2 lanes wide
 - Gravel, bituminous, timber plank over timber deck
- Superstructure NBI (5-7)
- Deck NBI (5-7)

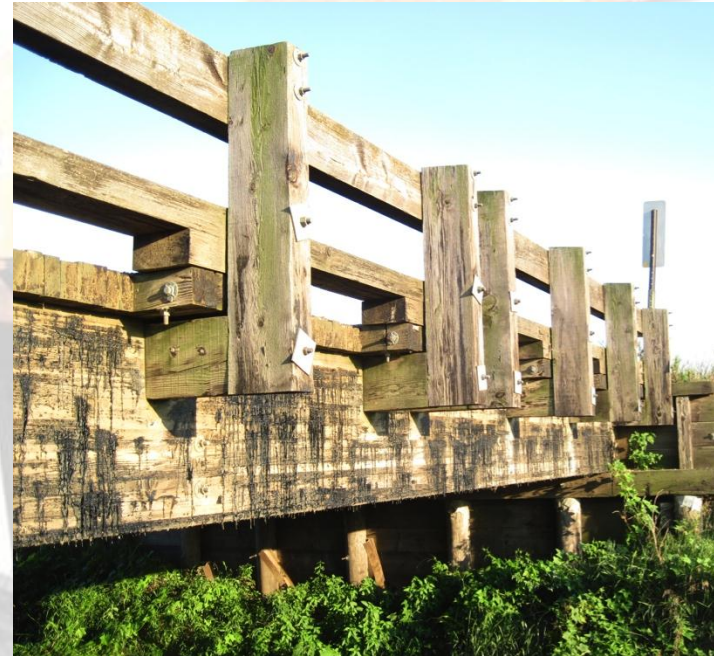
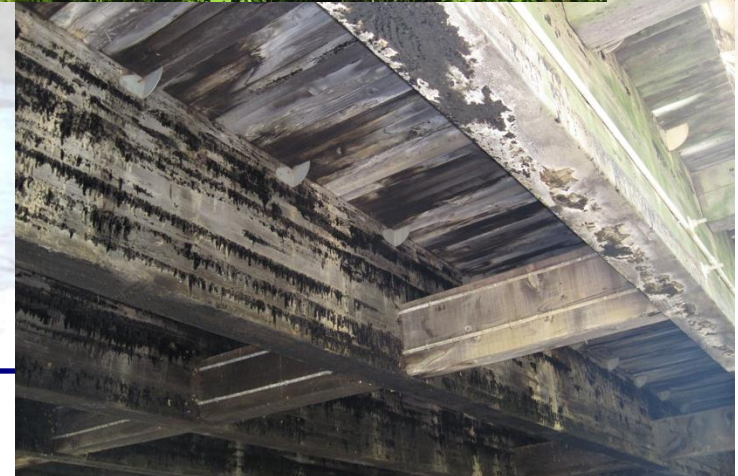
Glulam Stringer / Timber Deck

- Southern Minnesota
 - County (4)
 - 45 years old
 - Single span
 - 10-12 m, 33-40 ft length
 - 2 lanes wide
 - Bituminous and gravel over timber deck
- Superstructure NBI (6-7)
- Deck NBI (6-7)

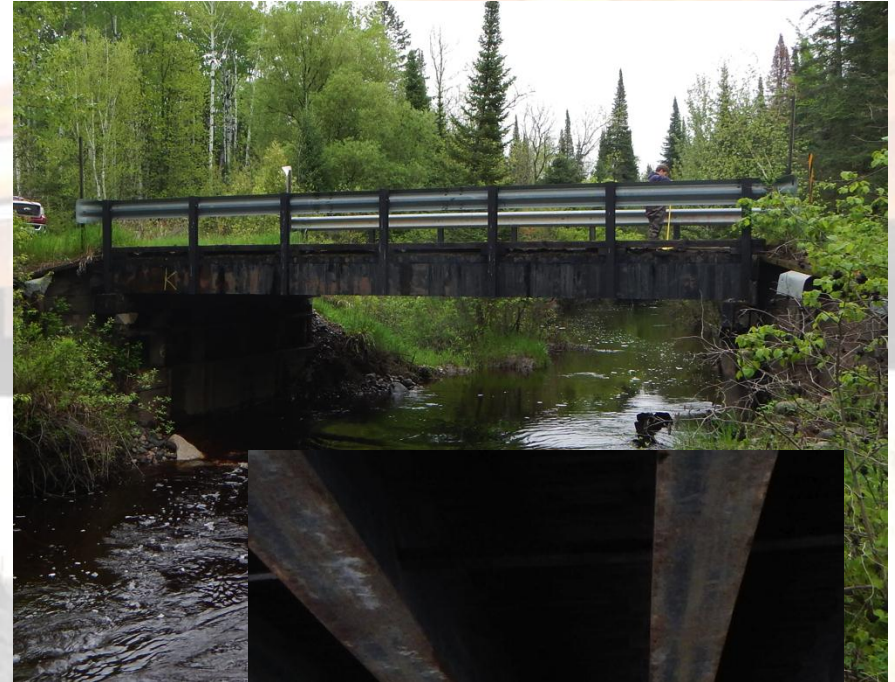
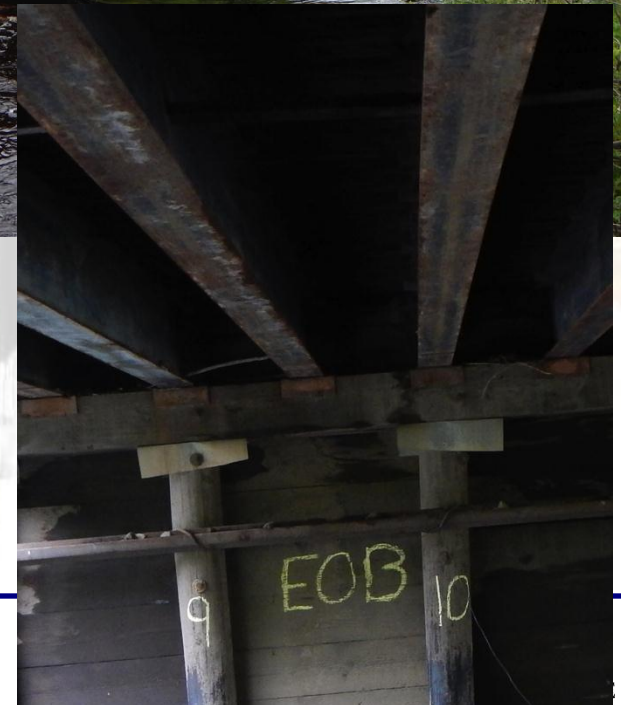
Steel Beam / Timber Deck

- Northern Minnesota
 - County owned (5)
 - 26-42 years old
 - Single span
 - 9-11 m, 28-35 ft length
 - 2 lanes wide
 - Bituminous over timber deck
- Superstructure NBI (6-7)
- Deck NBI (7-8)

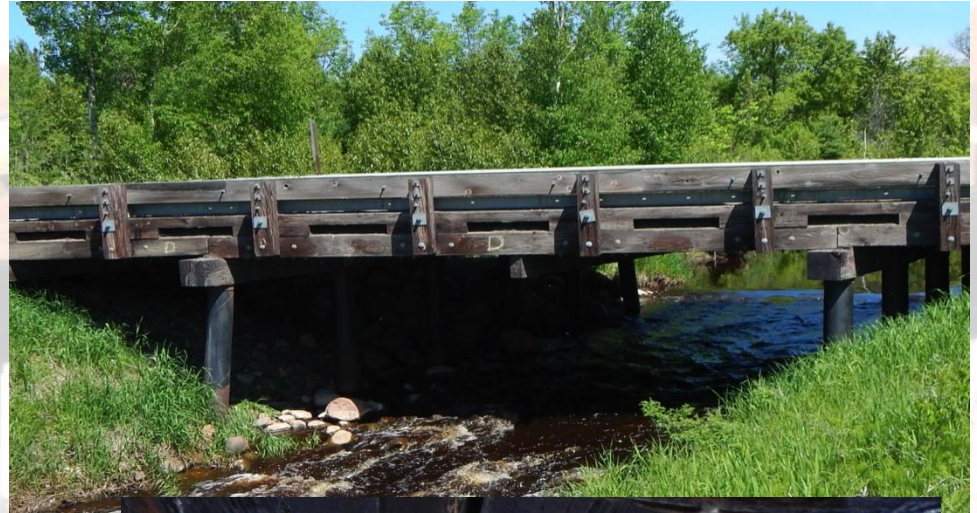
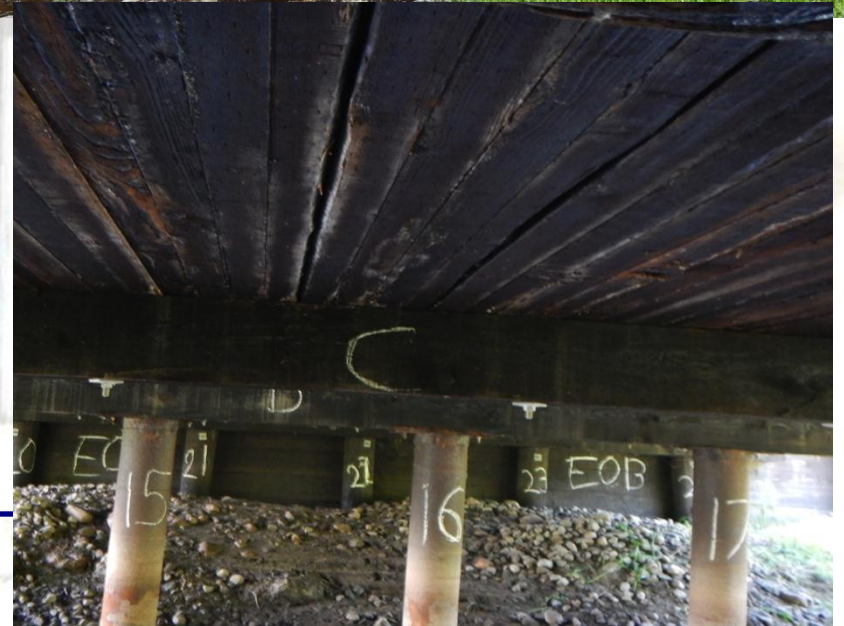
Spike Laminated Slab

- Northern Minnesota
 - County owned (5)
 - 22-32 years old
 - Multiple span
 - 15-18 m, 46-62 ft length
 - 2 lanes wide
 - Bituminous overlay
- Superstructure NBI (5-7)
- Deck NBI (4-5)

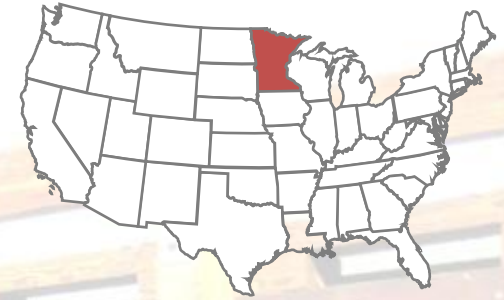
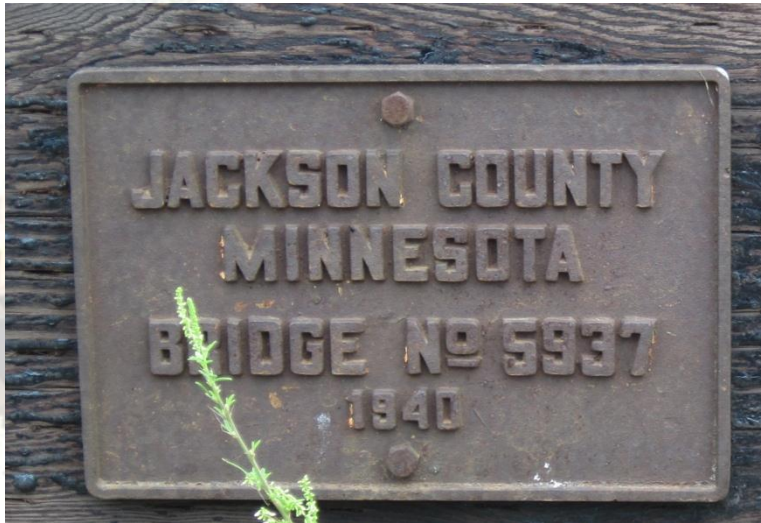
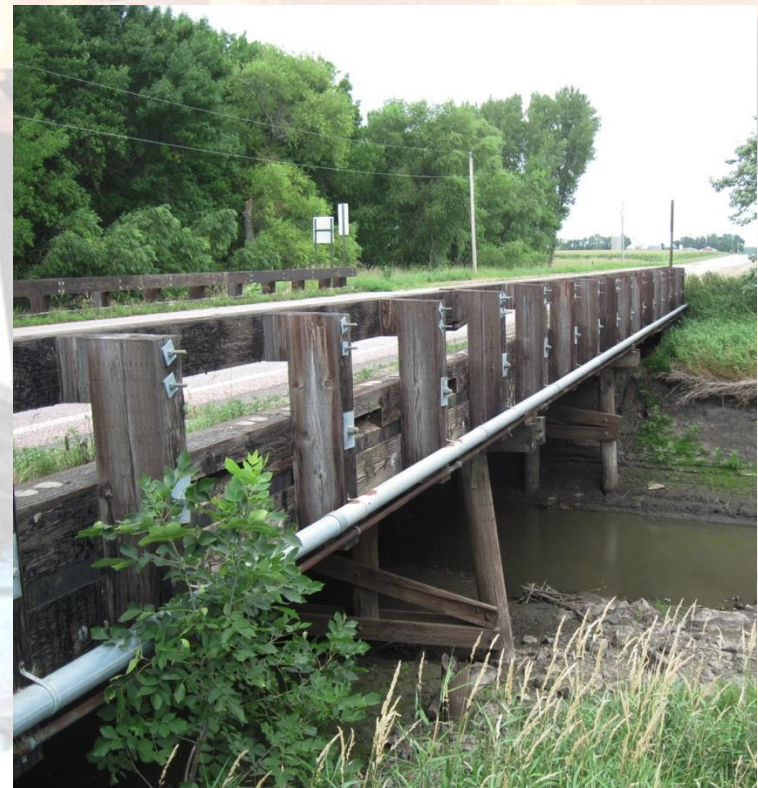
Jackson County, Minnesota

Built in 1940 – 73 years of service

- Average Daily Traffic - 1,050
- **Condition Rating – 7** on a scale of 0 thru 9 (New)
- Deck replaced in 1991.
