Aalto University
School of Engineering

The Durability of Wood-Concrete Composite Bridges

Lauri Salokangas

Aarne Jutila

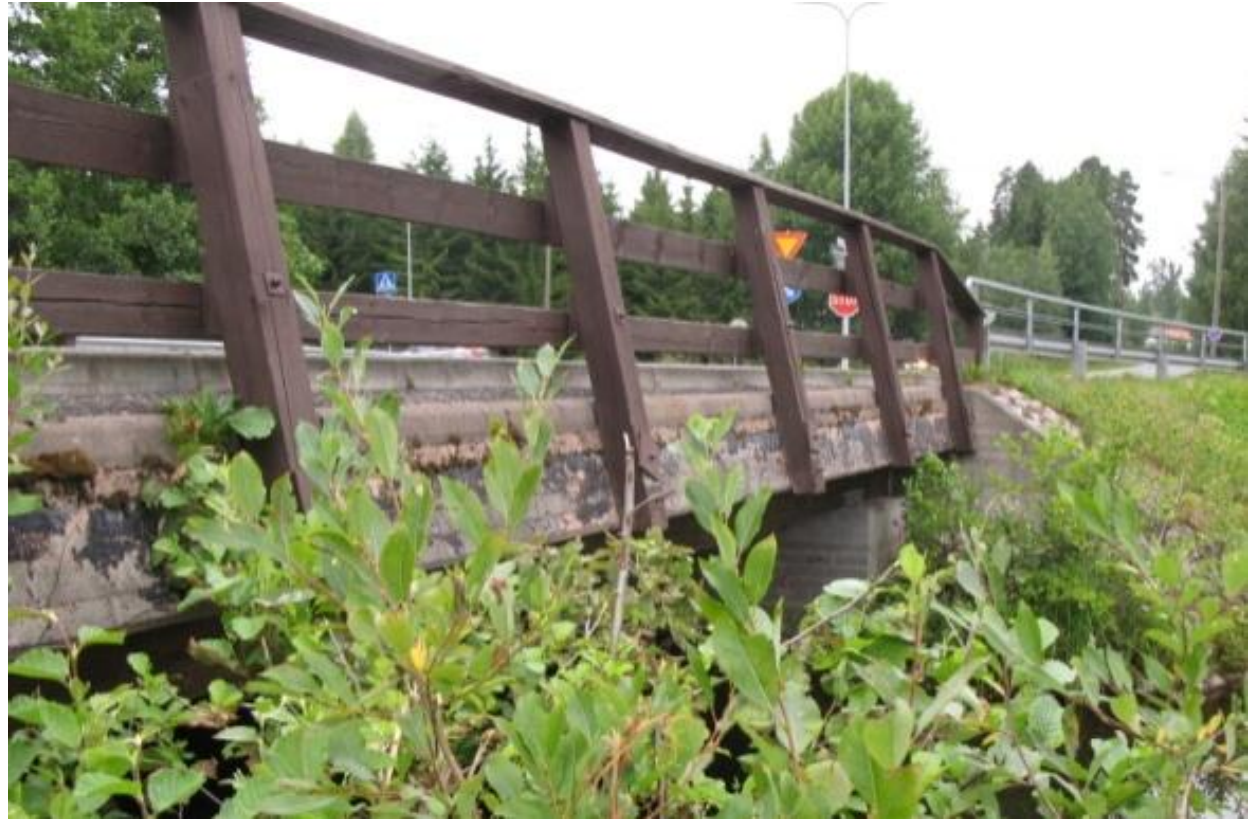
Kruununmylly Bridge, inspection of outlook today

Refurbish is needed in:

- clearance of vegetation
- surfacing the edge beams
- renewing the wooden railings

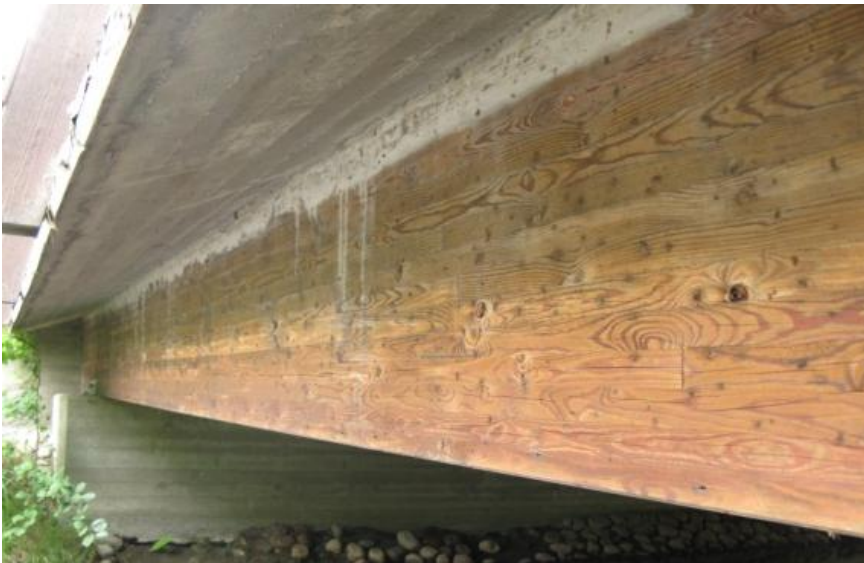
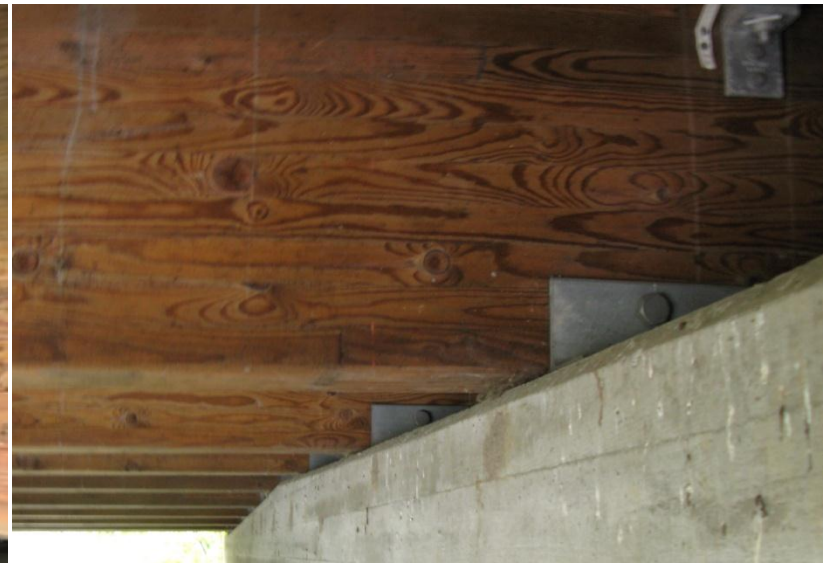
Kruununmylly Bridge, Inspection of timber beams

Beams are perfect under concrete deck after 20 years service life

- No cracks or other damages were found
- Moisture content was measured to be between 14 – 18 %

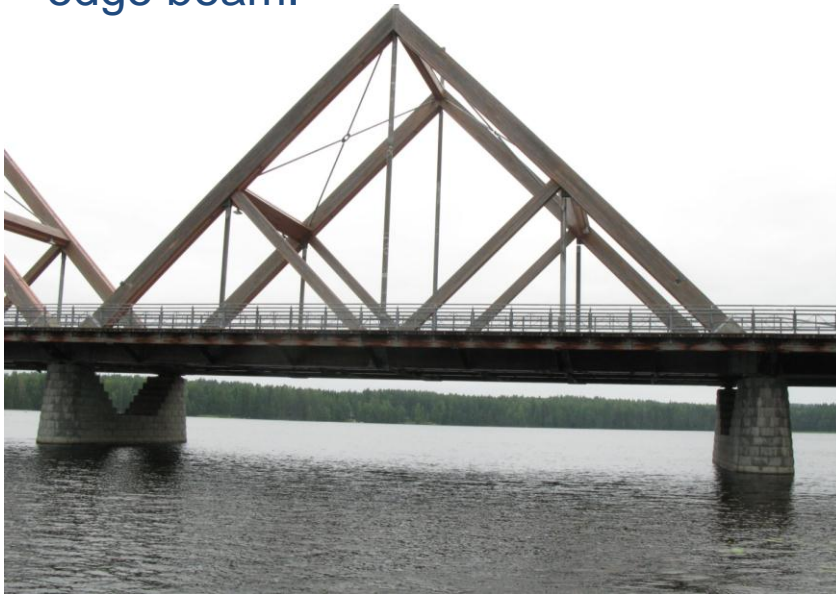
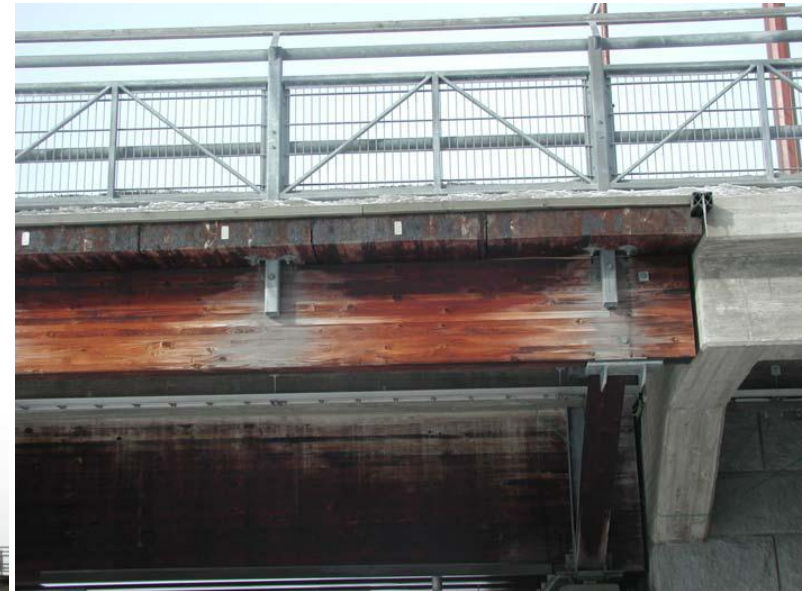
Vihantasalmi Bridge, inspection of the outlook after 14 years service

- Zinc coating of railing poles has caused runs on the surface of the edge beam.

The outer surface of the utmost beam at the end of the bridge is similarly blotchy at railing pole positions

Refurbish is needed to improve the outlook

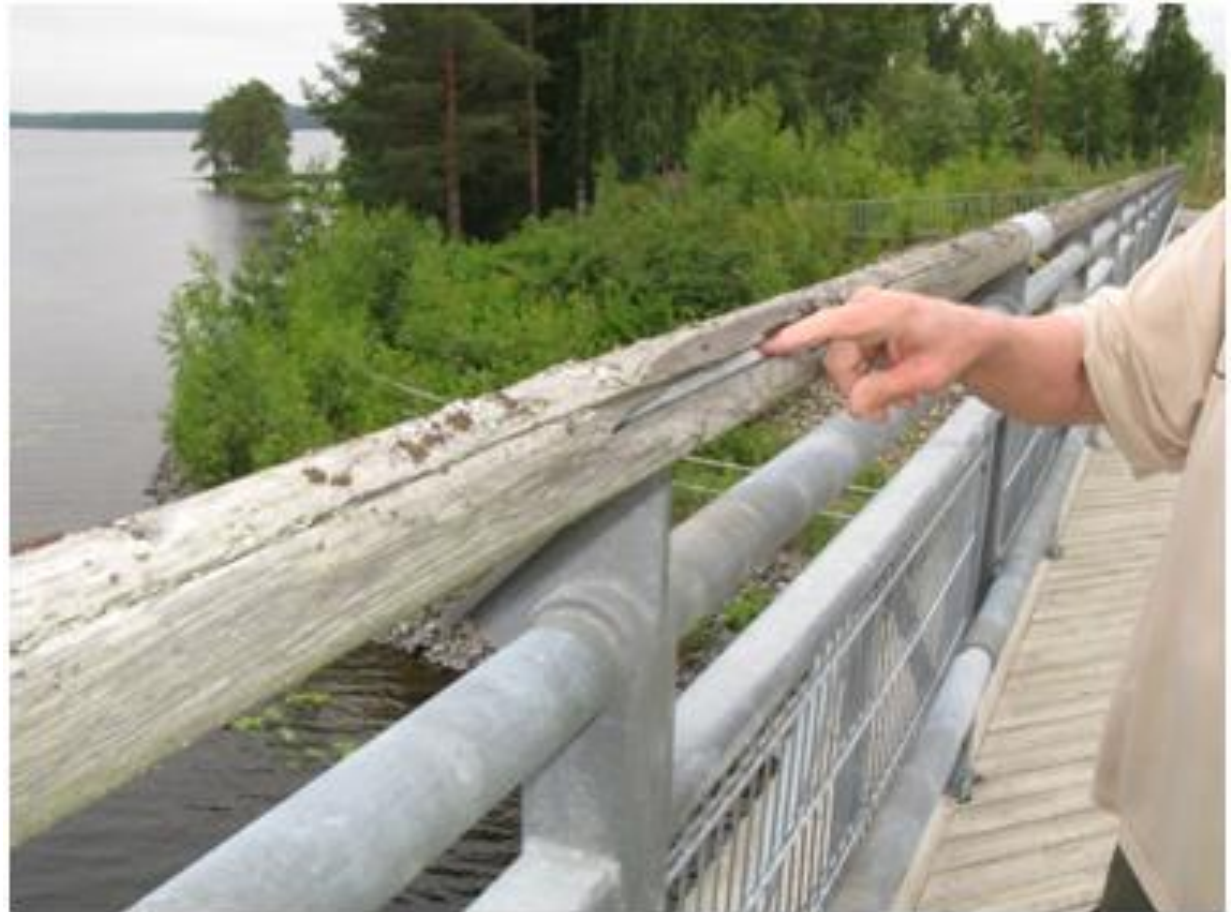
Vihantasalmi Bridge, inspection of outlook and details

- clearance of vegetation
- renewing the wooden hand guide
- many other details

Refurbish is needed in:

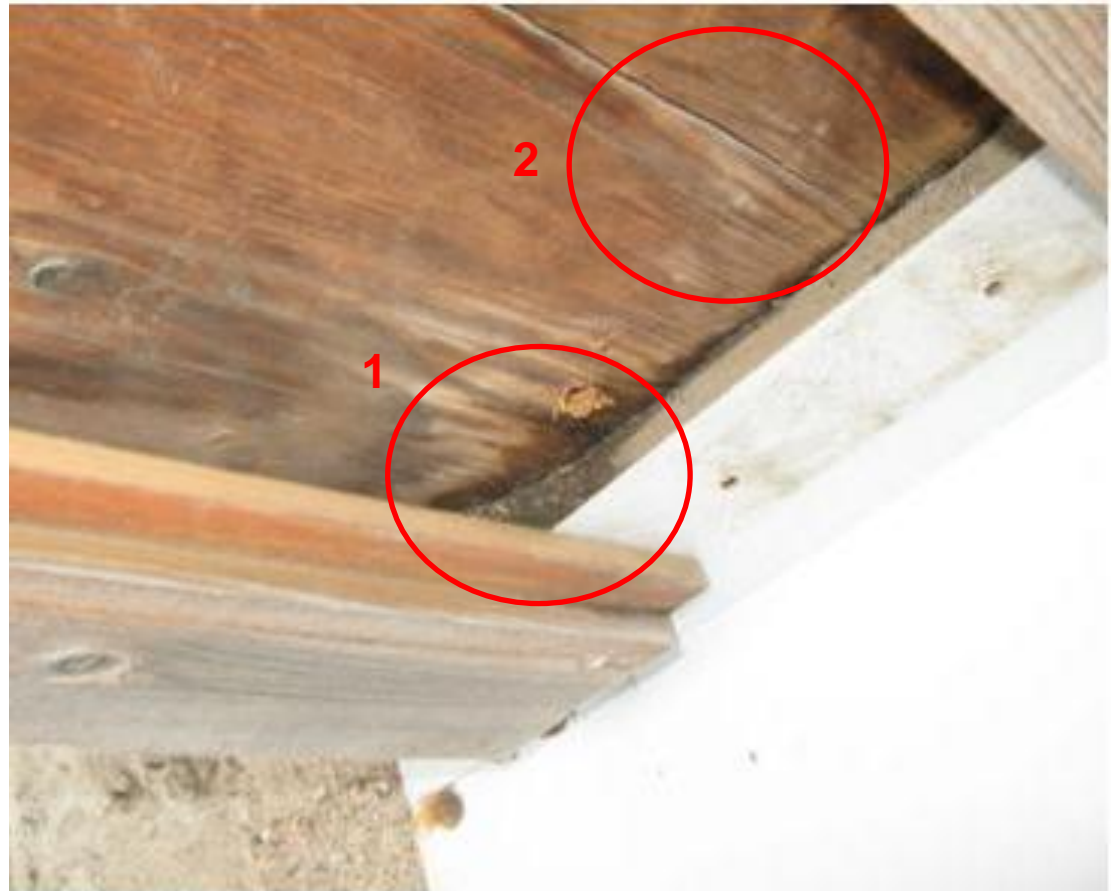
Vihantasalmi Bridge, Inspection of wooden members

- Under protective cover at the ends of inclined members:

1. Water pockets

2. Cracks

- Designed ventilation for timber members is not able to keep the ends of wooden parts dry

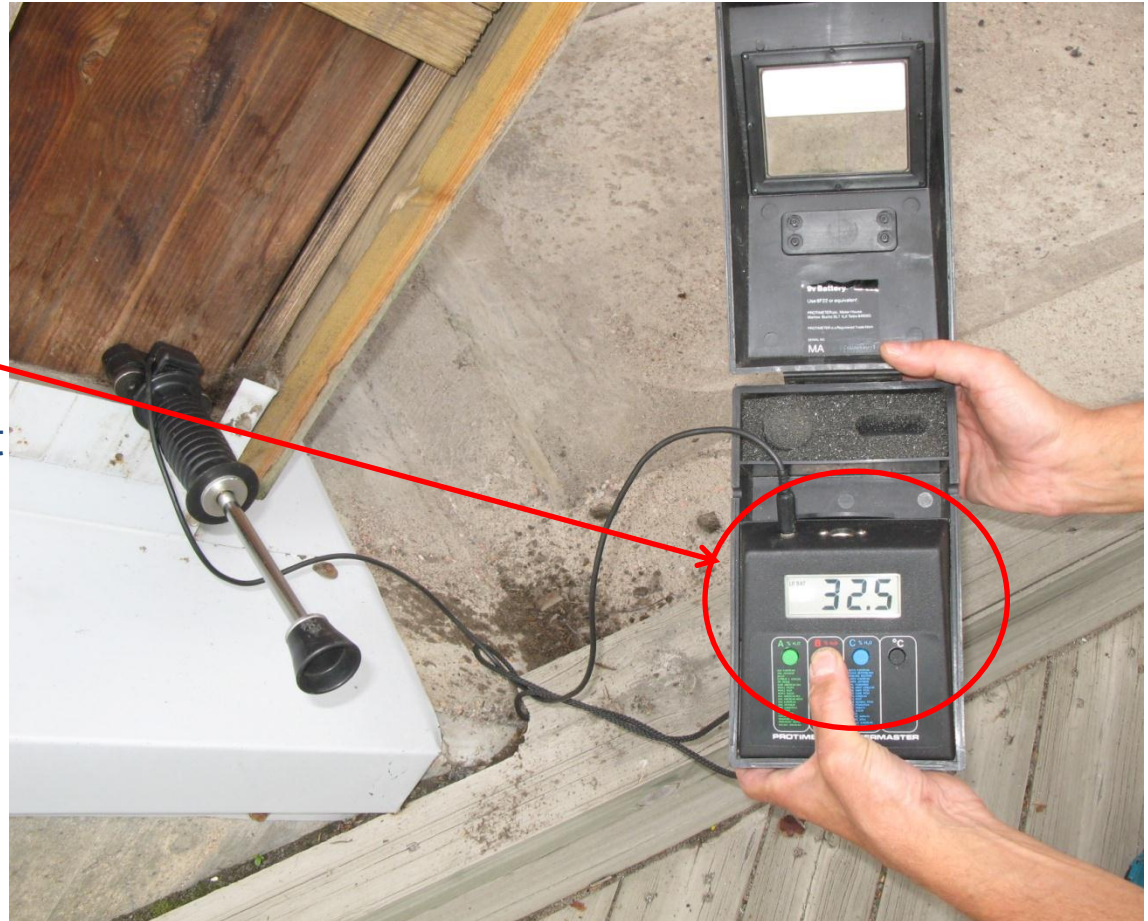
Vihantasalmi Bridge, Inspection of wooden members

- **Some ends of the wooden members are practically in saturated condition**
- High moisture content was before measured at ends of glulam beams of the wood-concrete deck

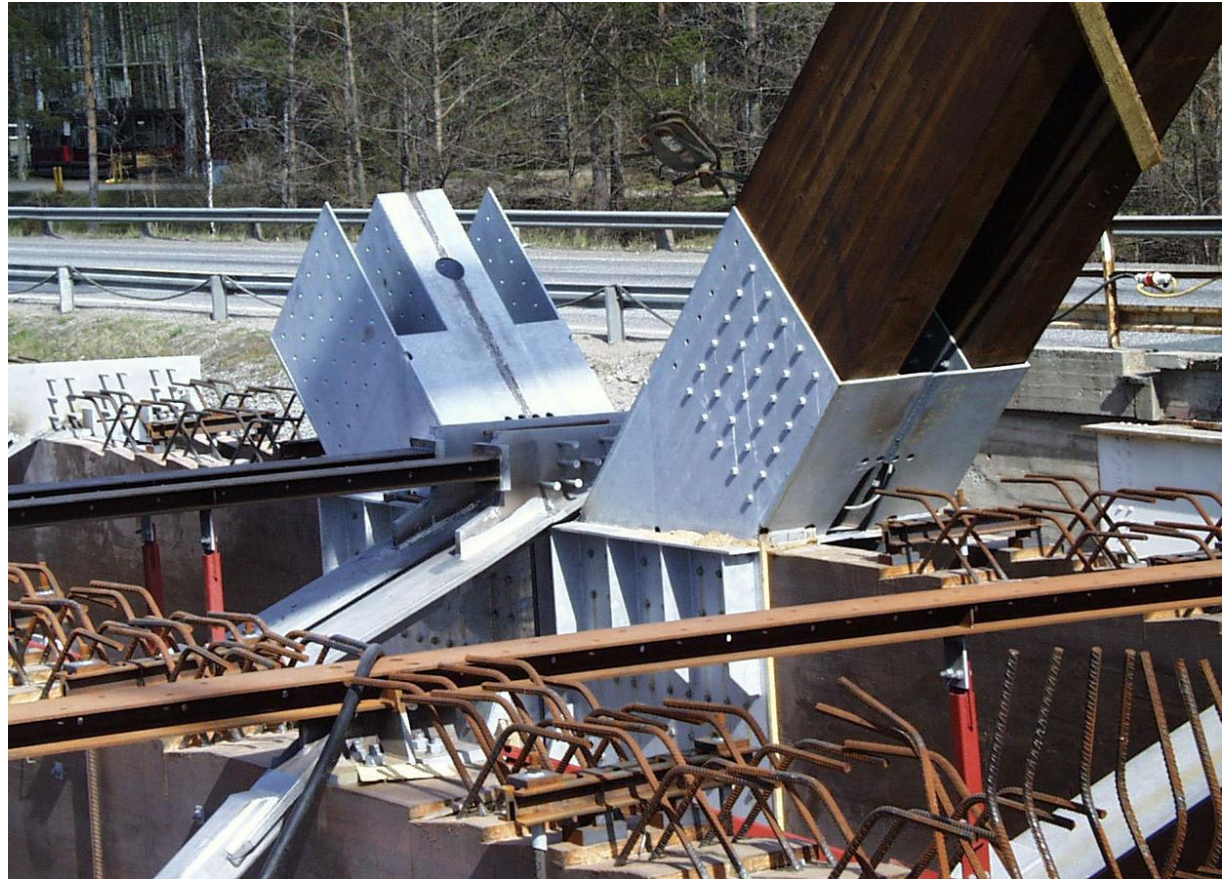
Vihantasalmi Bridge, Inspection of wooden members

Reasons of high moisture content in the joint:

- The ends of the inclined wooden members are overall confined by steel casing
- And then, cast in concrete
- The water cannot evaporate anywhere

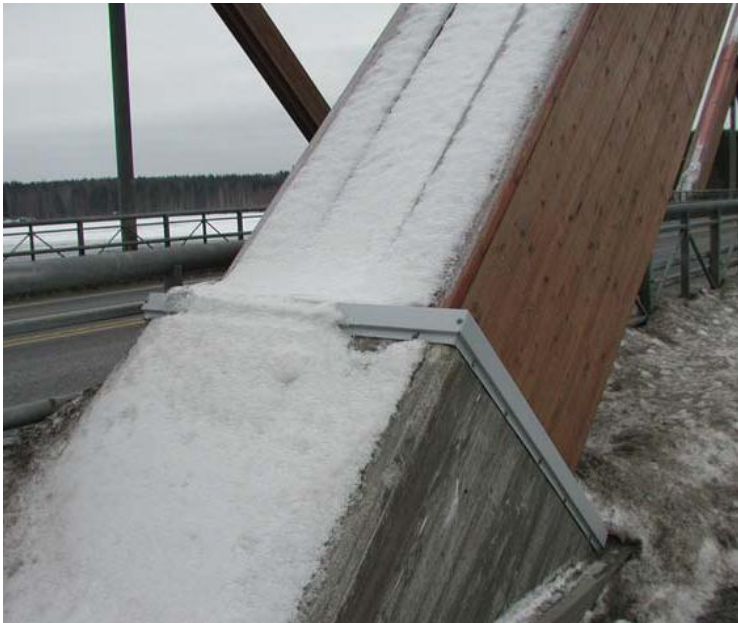
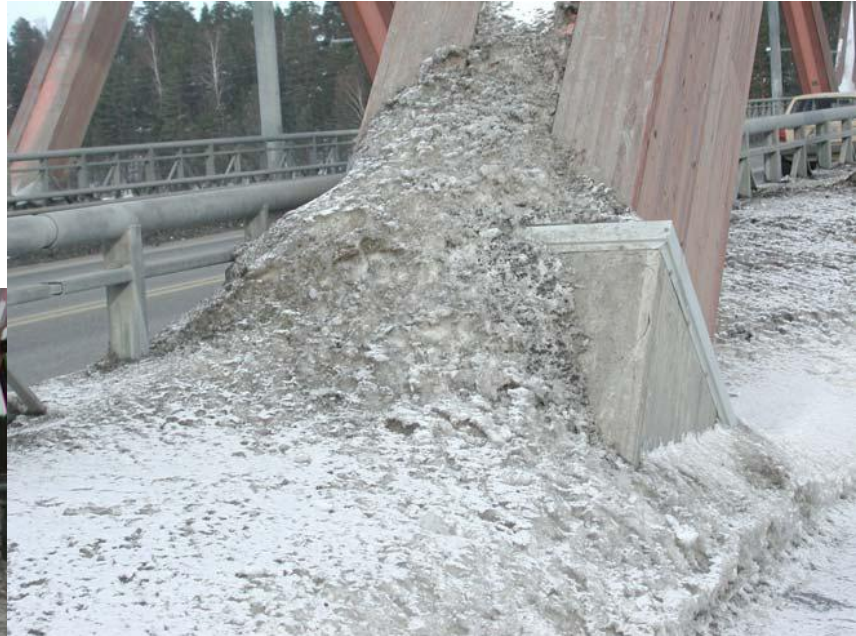
Vihantasalmi Bridge, Inspection of wooden members

- The steel “shoe” together with the ends of wooden members above the deck are cast inside a concrete footing block

- In winter dirty snow is piling at the root of the inclined members

Repair actions are needed !
