GOODPASTURE COVERED BRIDGE REHABILITATION

165-foot-long heavy
timber Howe truss
main span

International Conference on Timber Bridges, 2013

OBEC Consulting Engineers

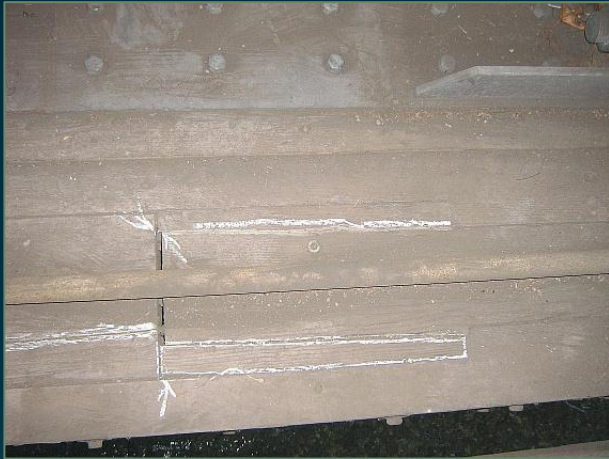
REPAIR ADDED >7 TONS OF DEAD LOAD BUT WAS ONLY MARGINALLY EFFECTIVE

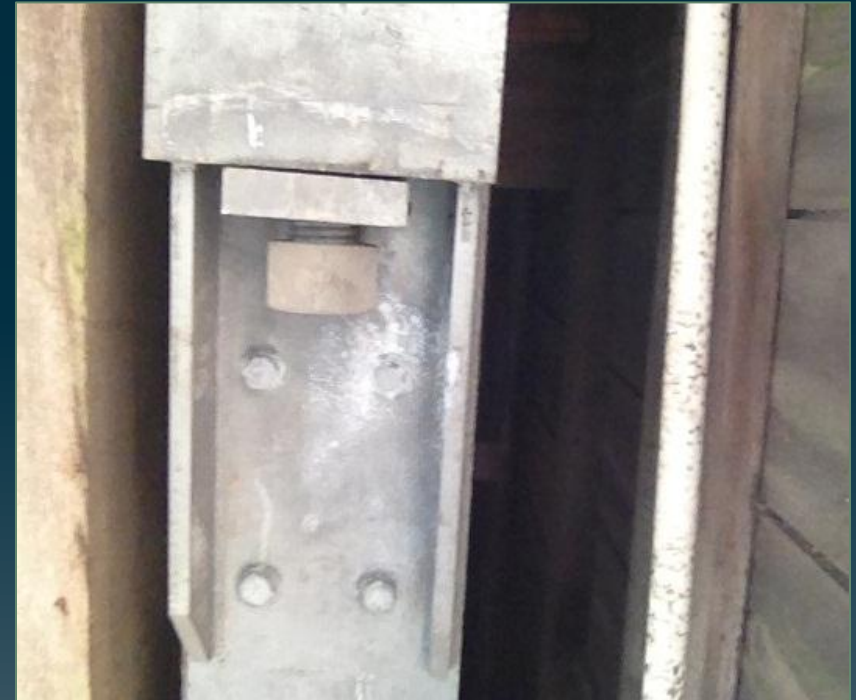
Broken splices leaving gaps to 1/2"

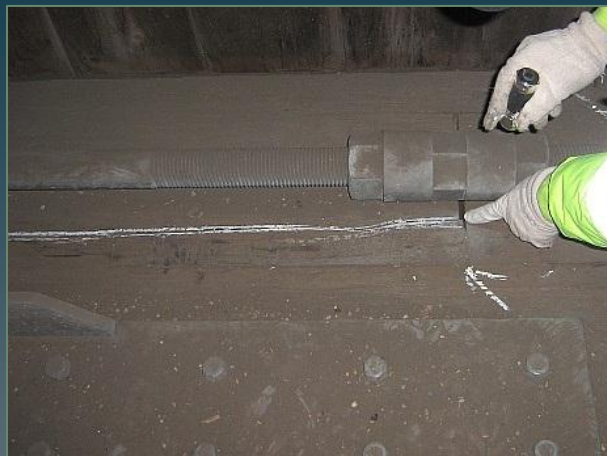
Some rods were never engaged

Gaps not
closed by
tie rods

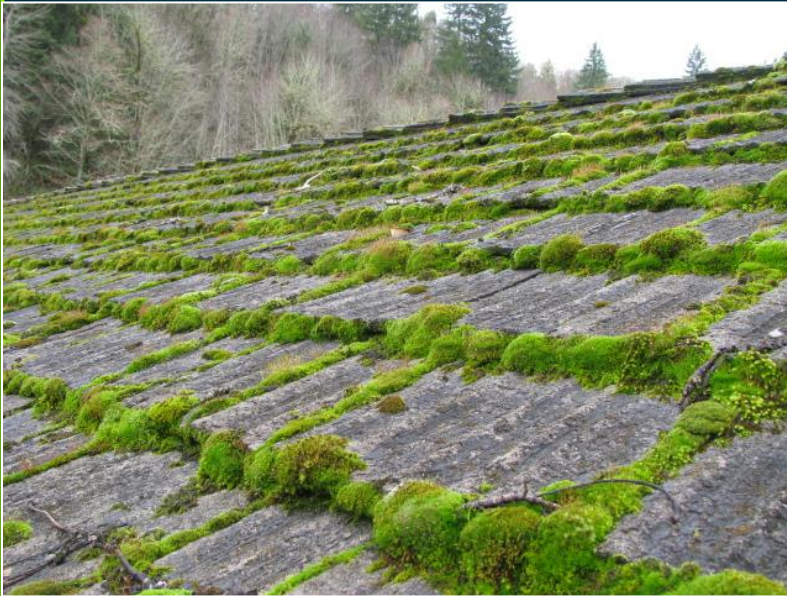
Very heavy cement/wood fiber composite roofing was leaking

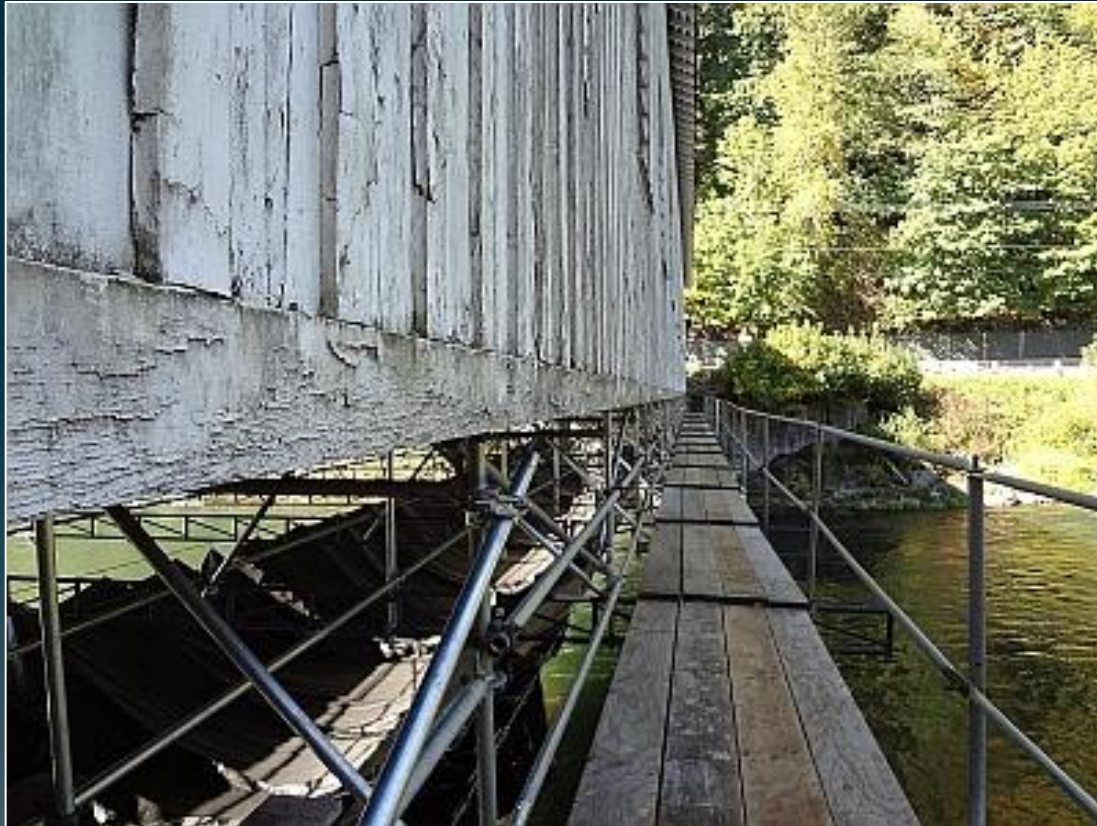
2012 photo

4-INCH SAG AT MID-SPAN EVEN WITH LIGHTER ROOF
