Kings Covered Bridge Rehabilitation

Somerset County, Pennsylvania

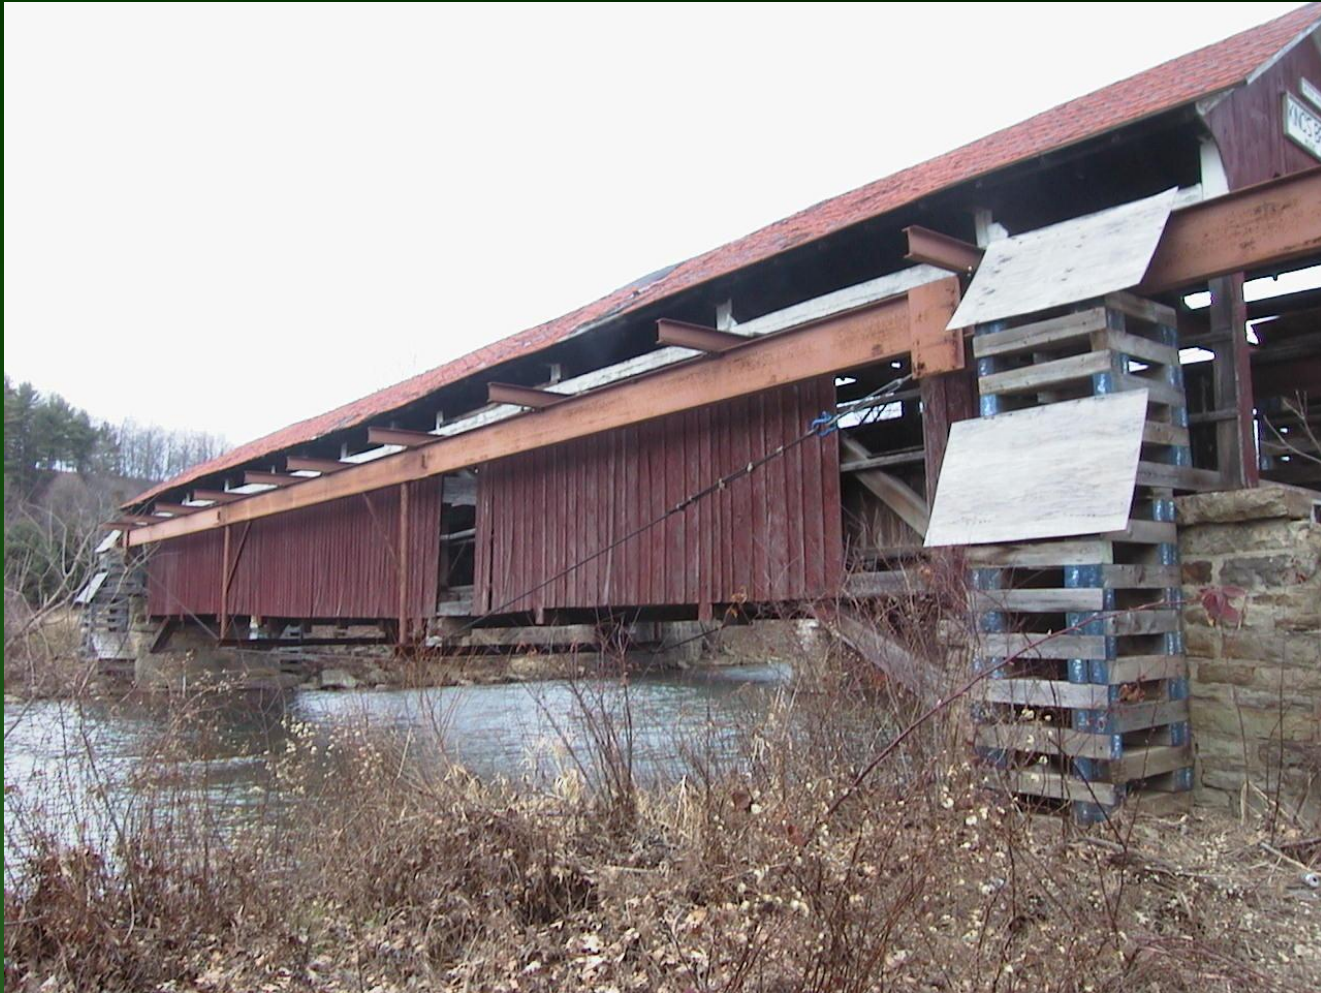
Failures

Both lower chords, several posts and tie beams

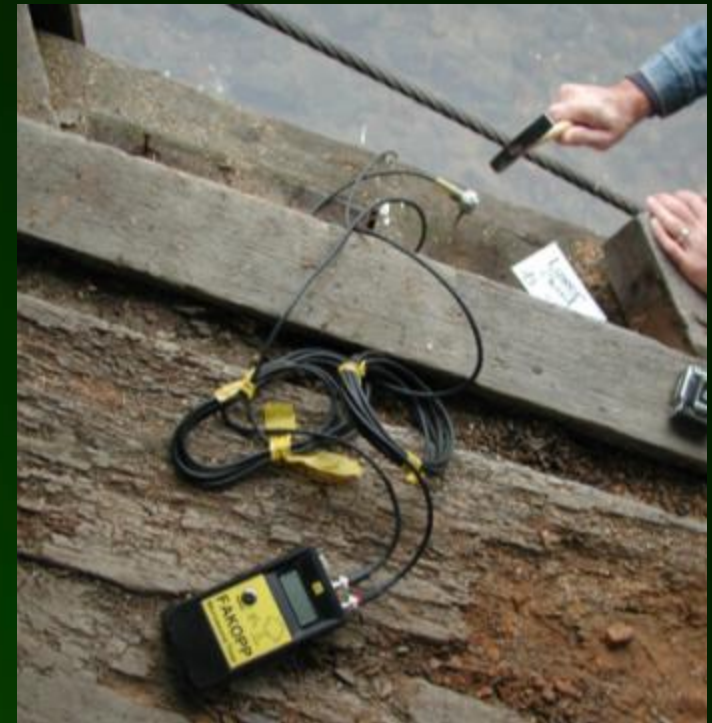
Stress Wave Timer

Both chords had relative drilling resistance below 15%

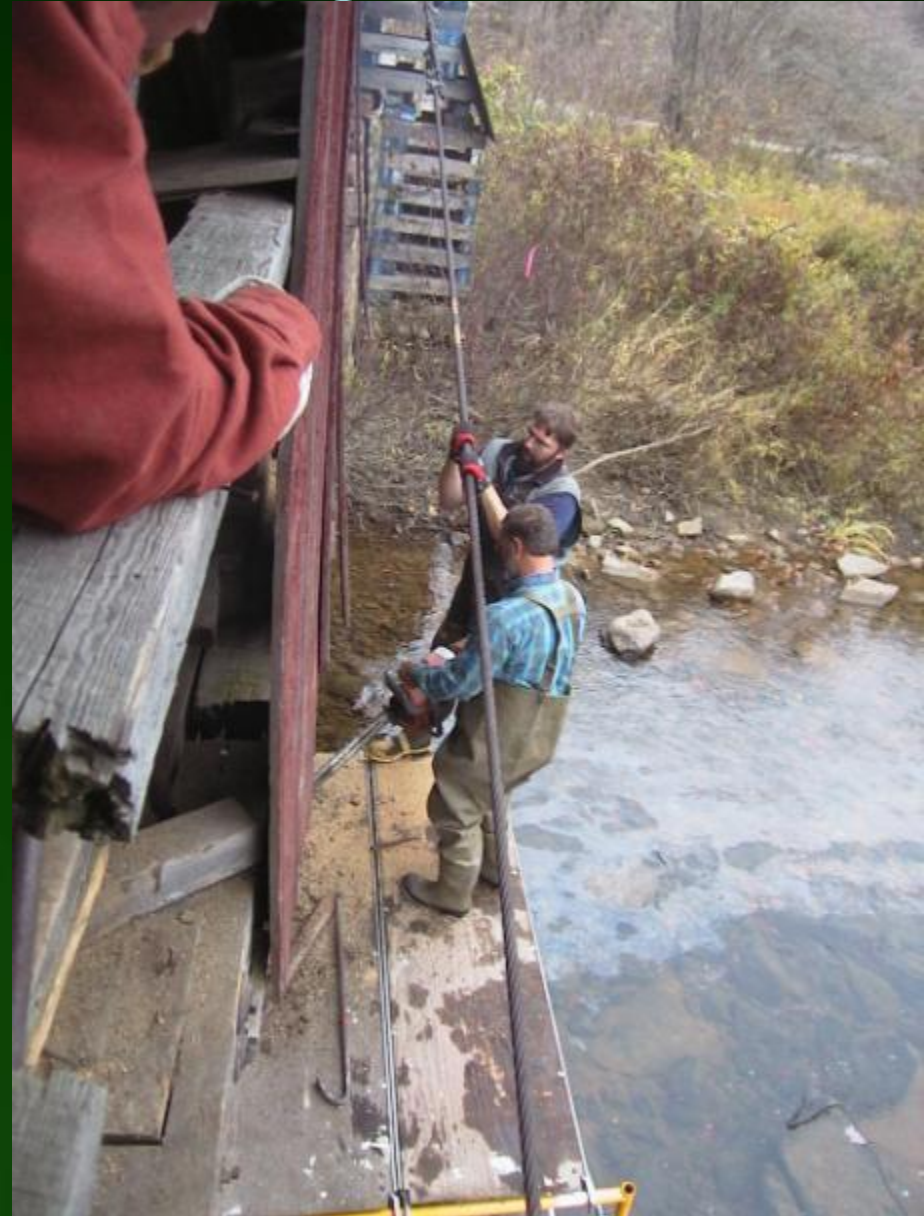
*4-foot lower chord segment
removed for species
analysis by Forest Products
Laboratory*

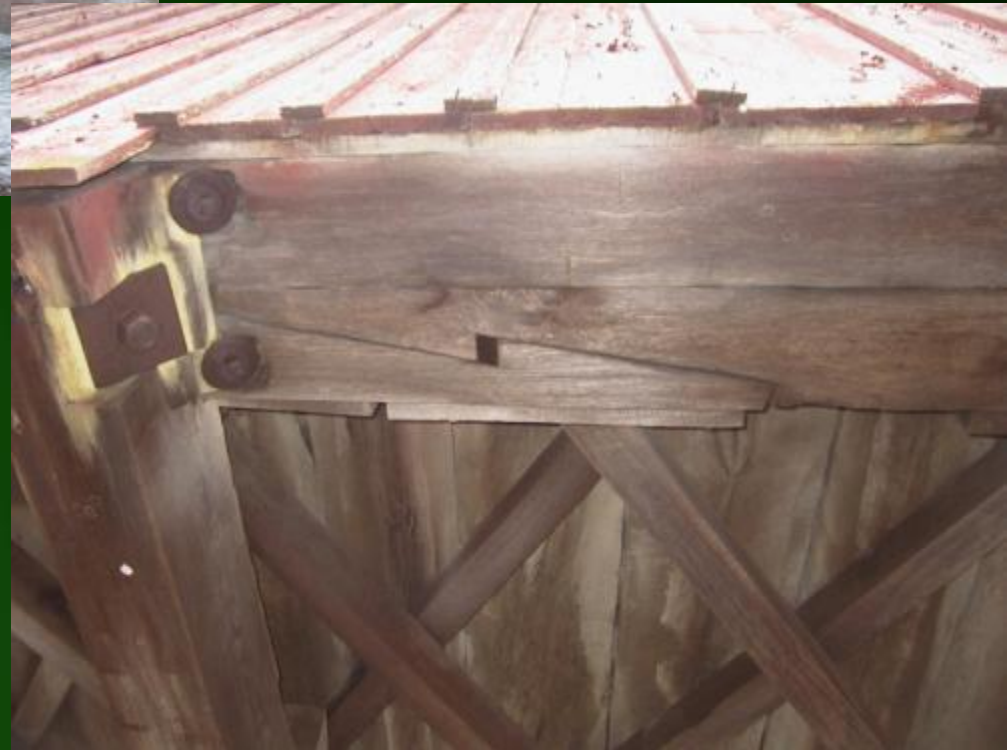
Lower tie beam / tail of truss post

Failure from compression force of truss brace

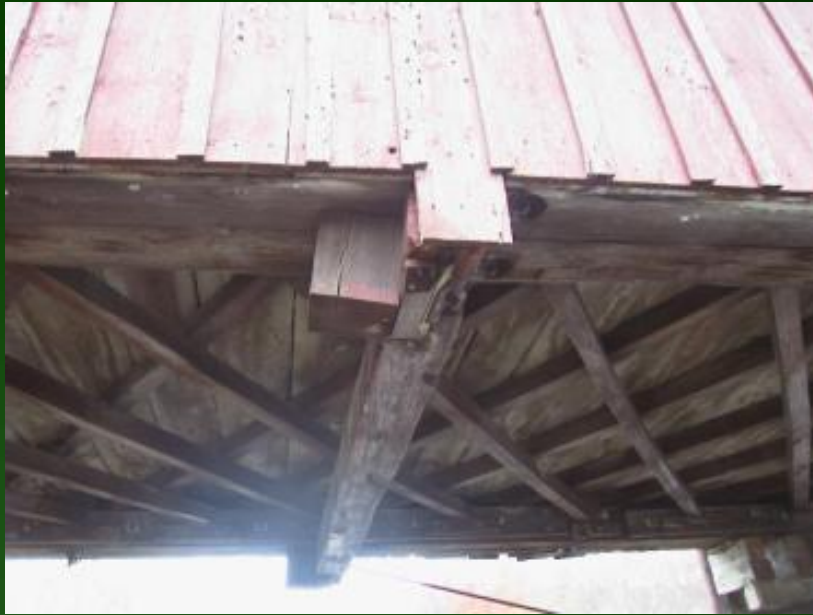
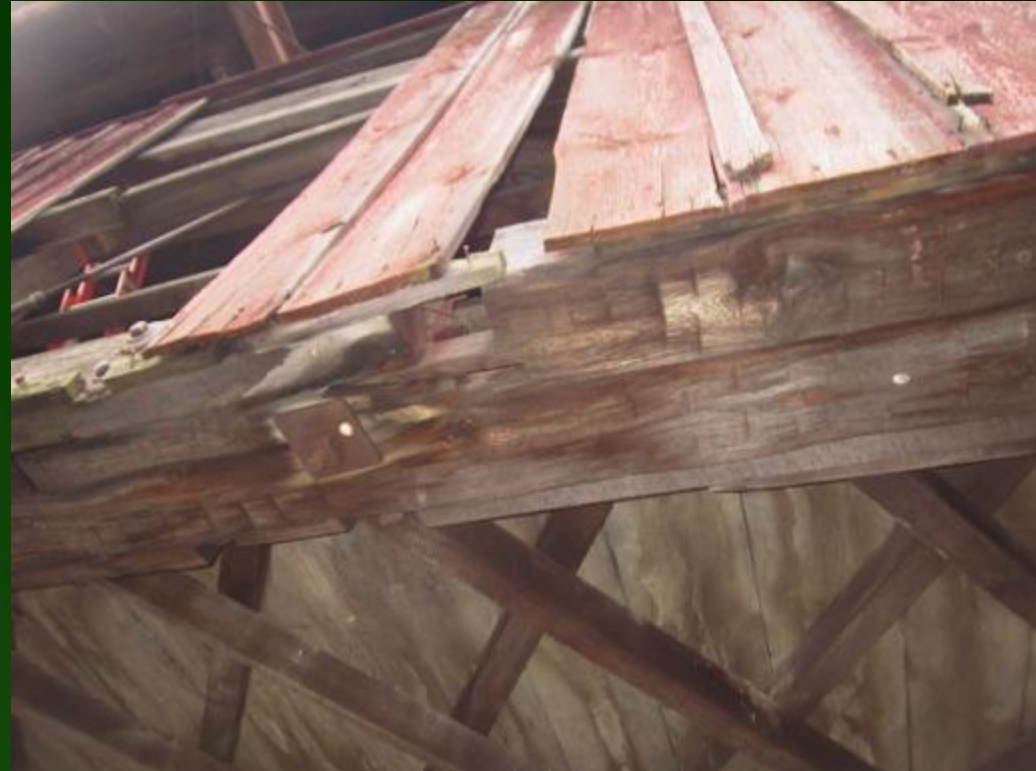
Lower Chord

Failure in both trusses

Dapped lower chords to permit laminated arches to extend forces directly into the abutments

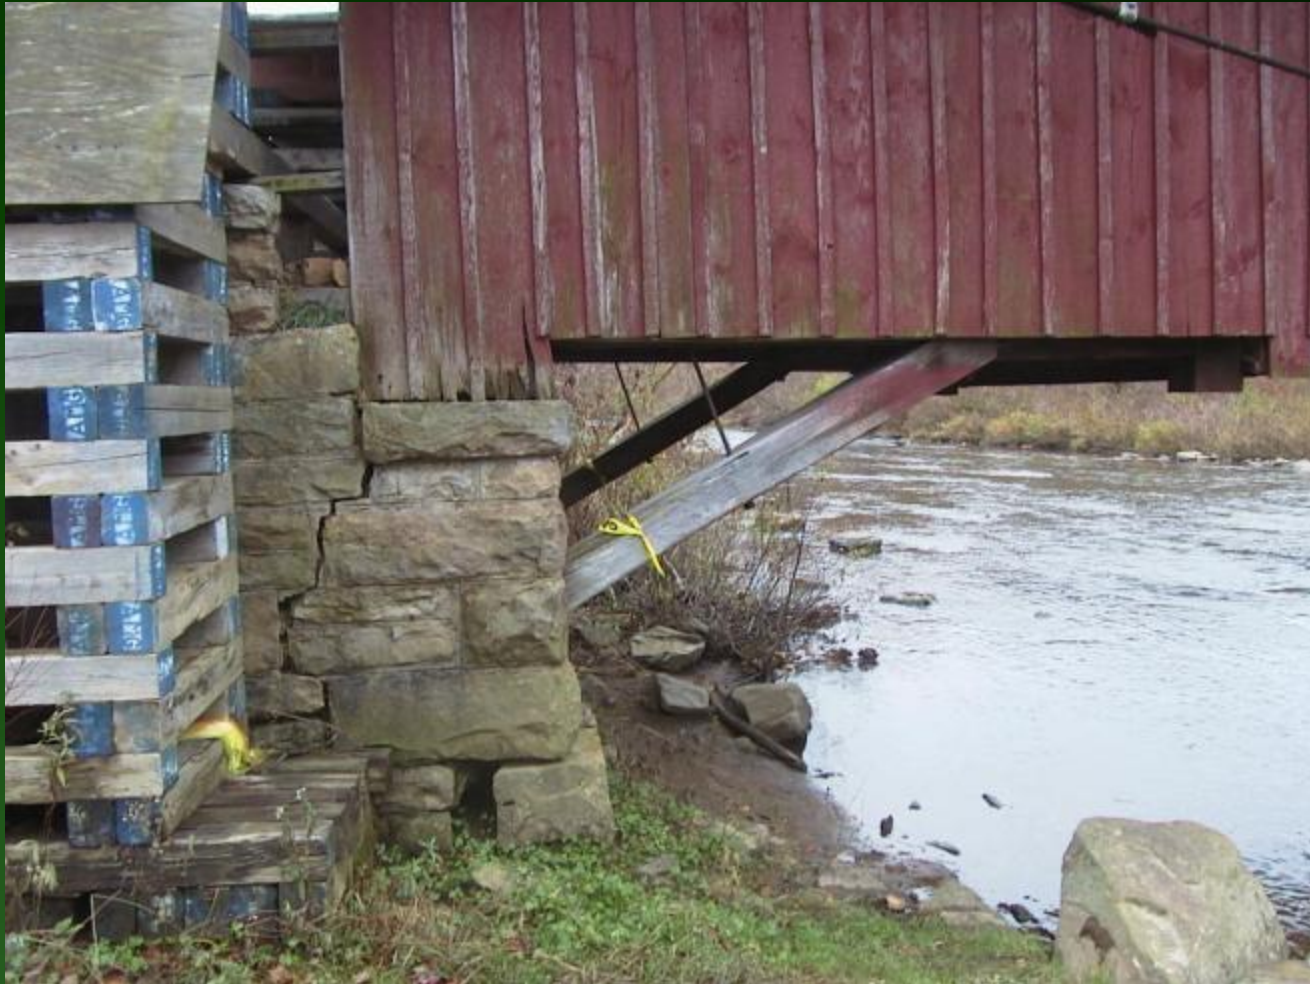
Substructure

Horizontal thrust from broken chords, struts ceased to work

Excavated abutments, buttressed with flowable backfill

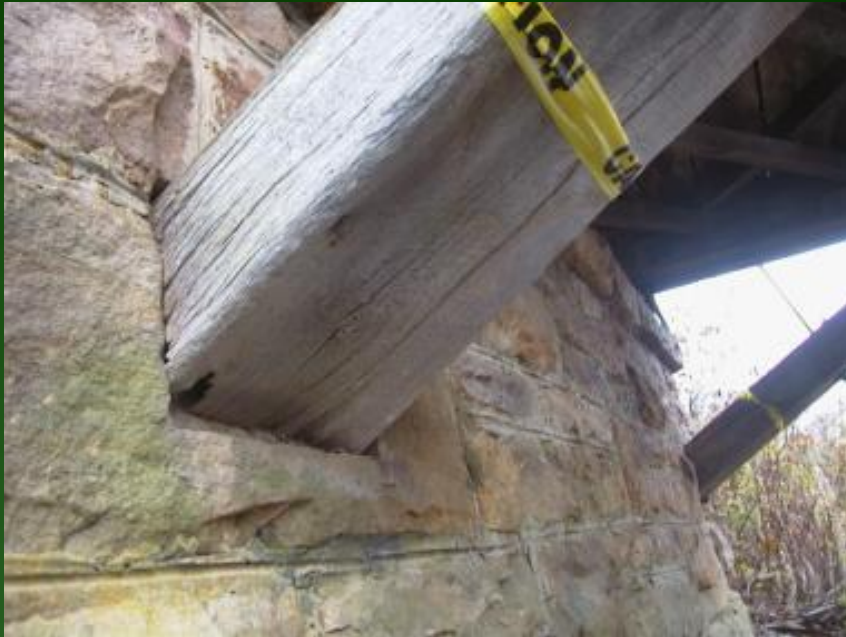
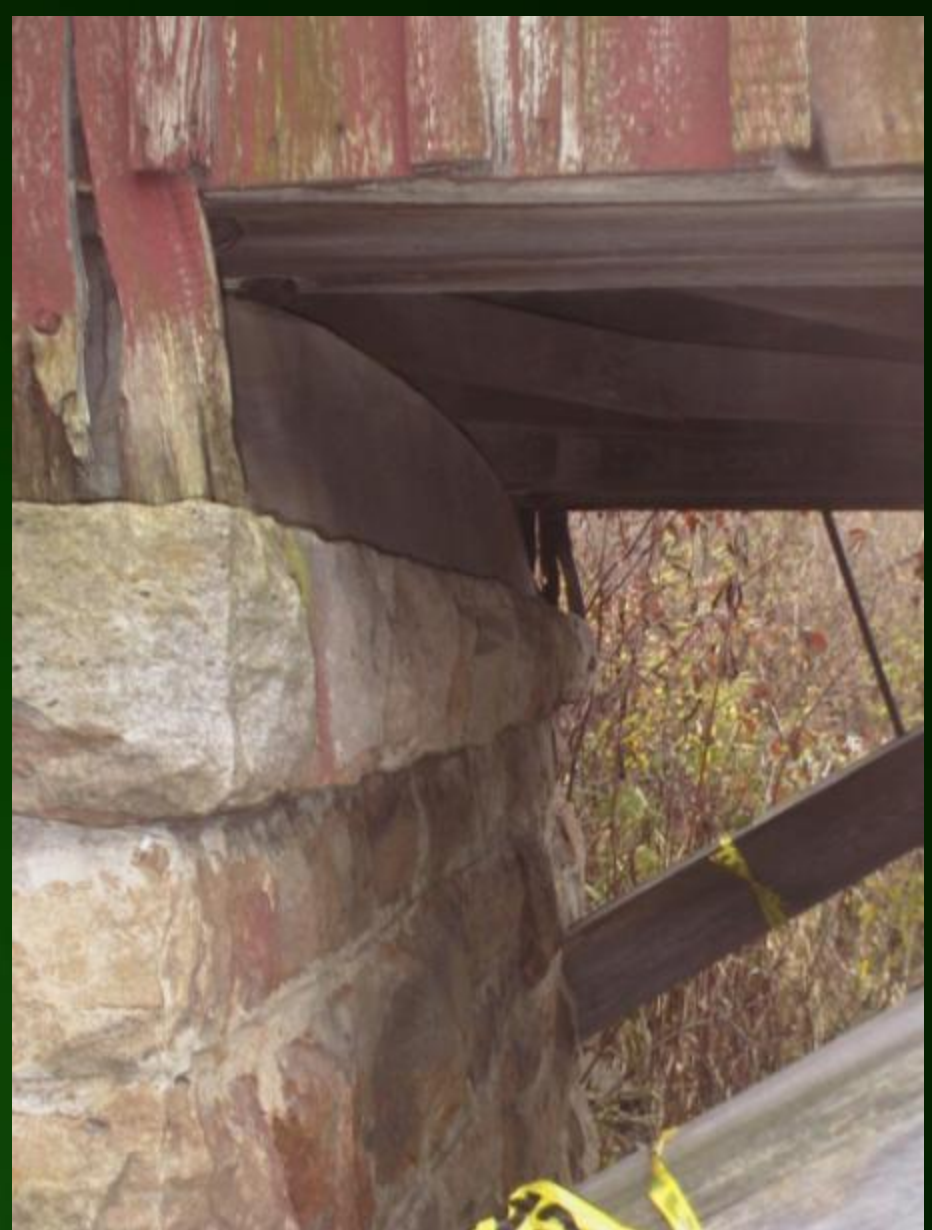
Retrofitted Struts

Typical failure at seats

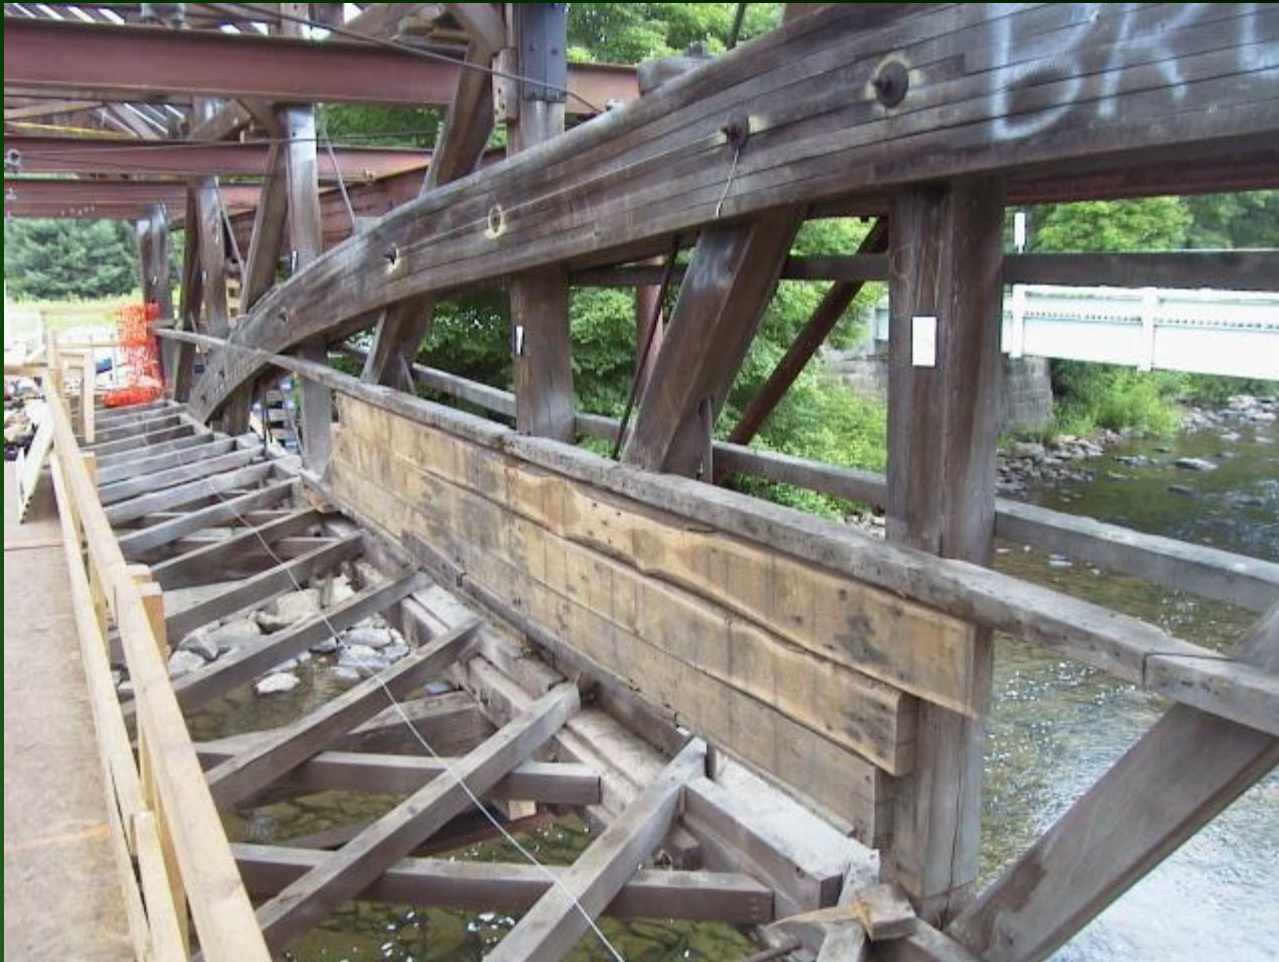
Arches

Deformation and previous interventions

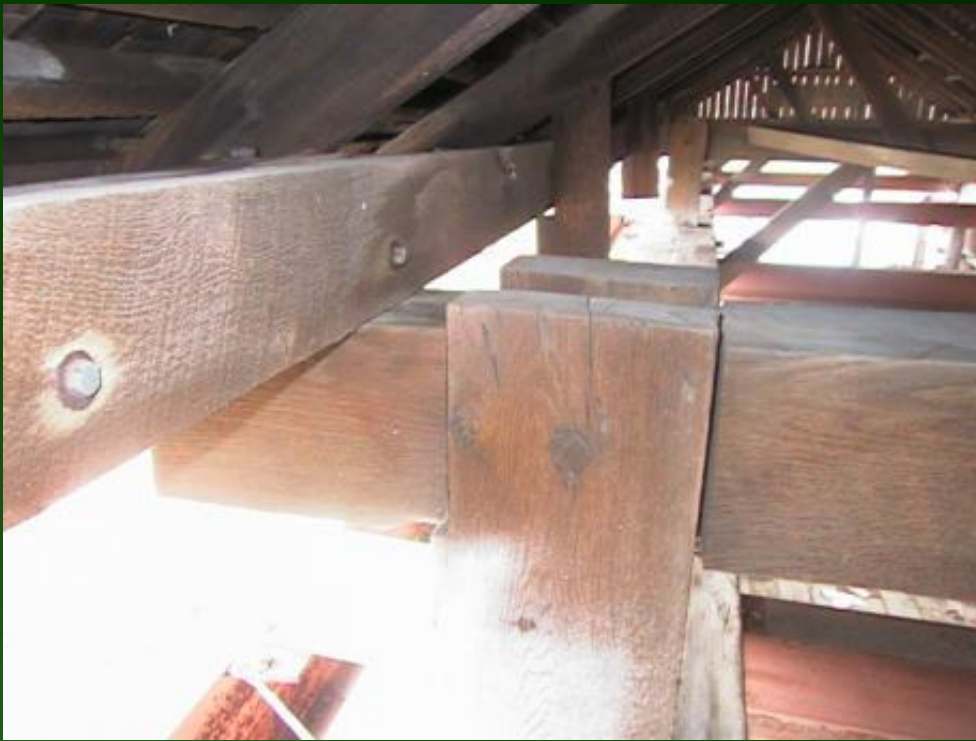
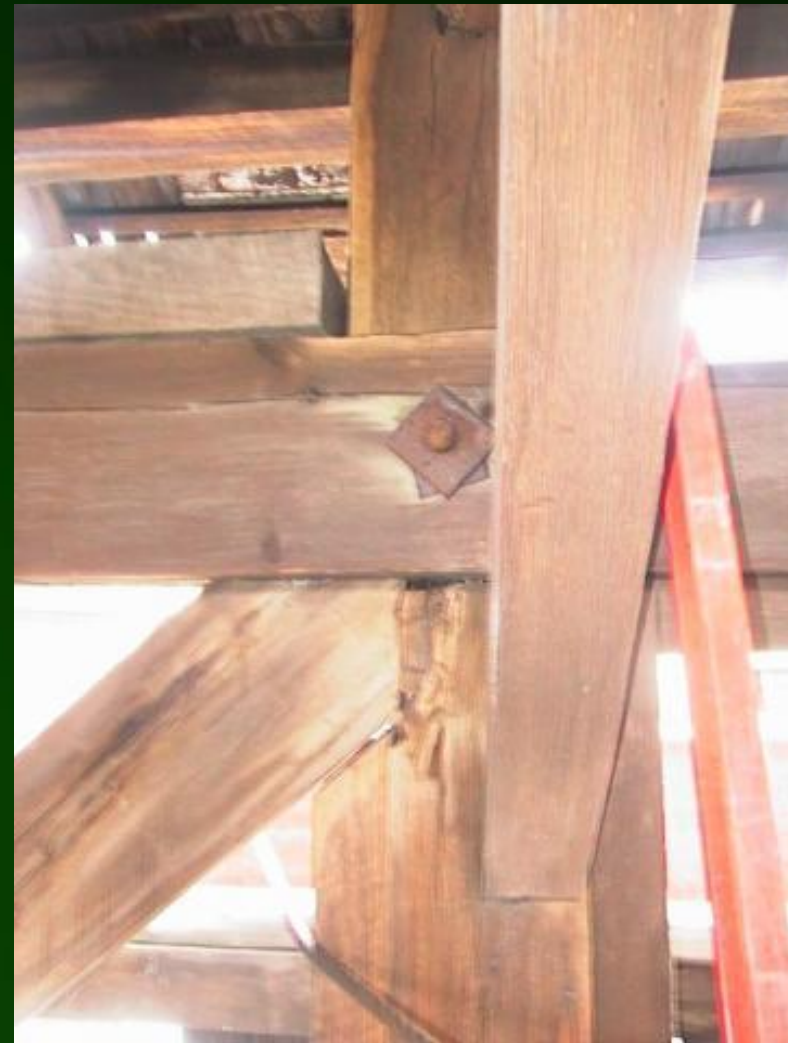
Cantilevered tie beams failed where leaks occurred

Truss Bracing
water damage
at truss post
