# Condition Assessment of Iowa Timber Bridges Using Advanced Inspection Tools

**Travis Hosteng**  
**Research Engineer**  
**Bridge Engineering Center**  
**Iowa State University**  
**Ames, IA United States**  
[kickhos@iastate.edu](mailto:kickhos@iastate.edu)

## Summary

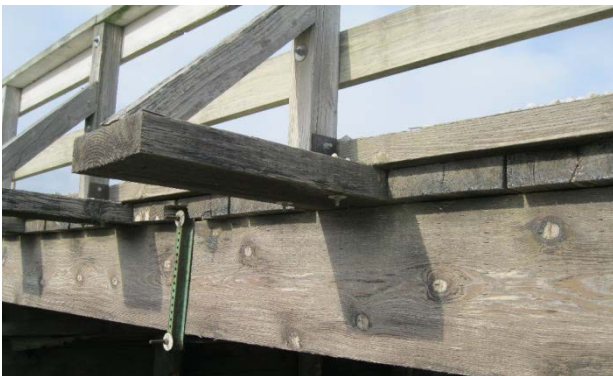
Bremer 2 is situated in a shallow sag curve on 160<sup>th</sup> St. and has a gravel wearing surface, although there were small signs of asphalt on the curbs. The deck planks were found to be in good condition, all seated well on the girders, and had gaps between adjacent planks of approximately 3 mm (0.125 in.) to 13 mm (0.5 in.). The guardrails were constructed of untreated dimension lumber which had been painted and were connected to the bridge by simply anchoring the rail posts on top of deck planks that were cantilevered off the edge of the bridge, see Fig. 8. This guardrail detail is not vehicle-impact sufficient and the members are showing sign of deterioration.

*Fig. 8 Bremer 2 guardrail detail*

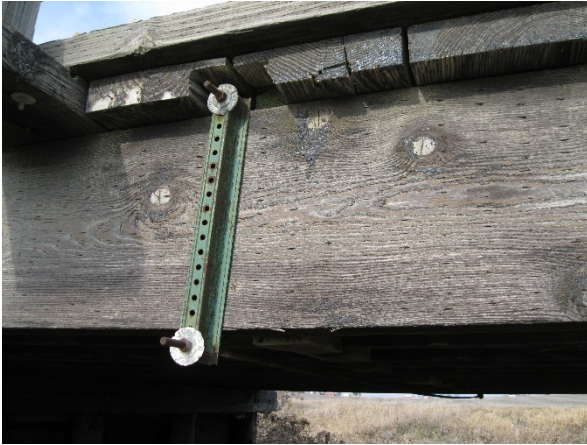
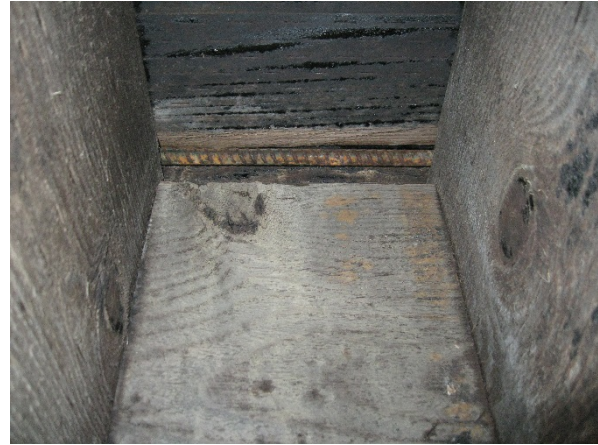
*Fig. 9 Steel tension rod on Bremer 2*

Bremer 2, like all the other Bremer bridges inspected, also had timber block diaphragms located at midspan between all girders. In addition, at midspan were steel tension rods (one above and below the girders) that ran the full width of the bridge. See Fig. 9 for photos of the timber diaphragms and steel tension rod details, respectively. Both the timber diaphragms and steel tension rods were in satisfactory condition on Bremer 2.

*a. Exterior tension rod connection*

*b. Tension rod between girder and deck*

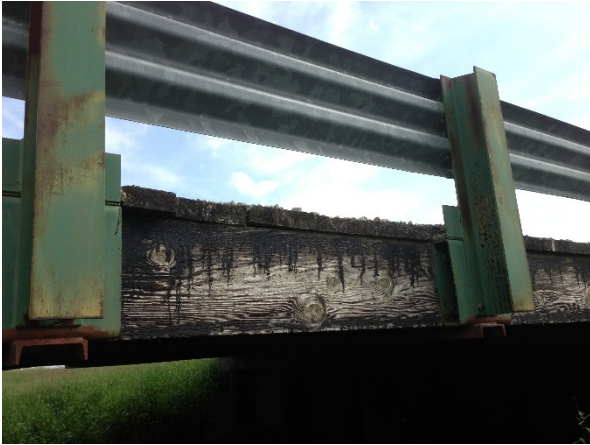
Blackhawk 5 has a gravel wearing surface and steel guardrails composed of I-beam posts and three beam rails. Each rail post was connected to the bridge via a steel plate that sat on top of the first three girders under the deck panels along with bolts through the exterior girder, see Fig. 10. In addition, attached to the bottom of the guardrail posts were steel channel sections, flanges pointing down that extended the full width of the bridge from rail post to rail post. The channel was nailed to the bottom of all girders to provide lateral support for the girders. The deck planks were found to be in good condition, all seated well on the girders, and had gaps between adjacent planks of approximately 3 mm (0.125 in.) to 13 mm (0.5 in.).

Fig. 10 Bremer 2 guardrail detail

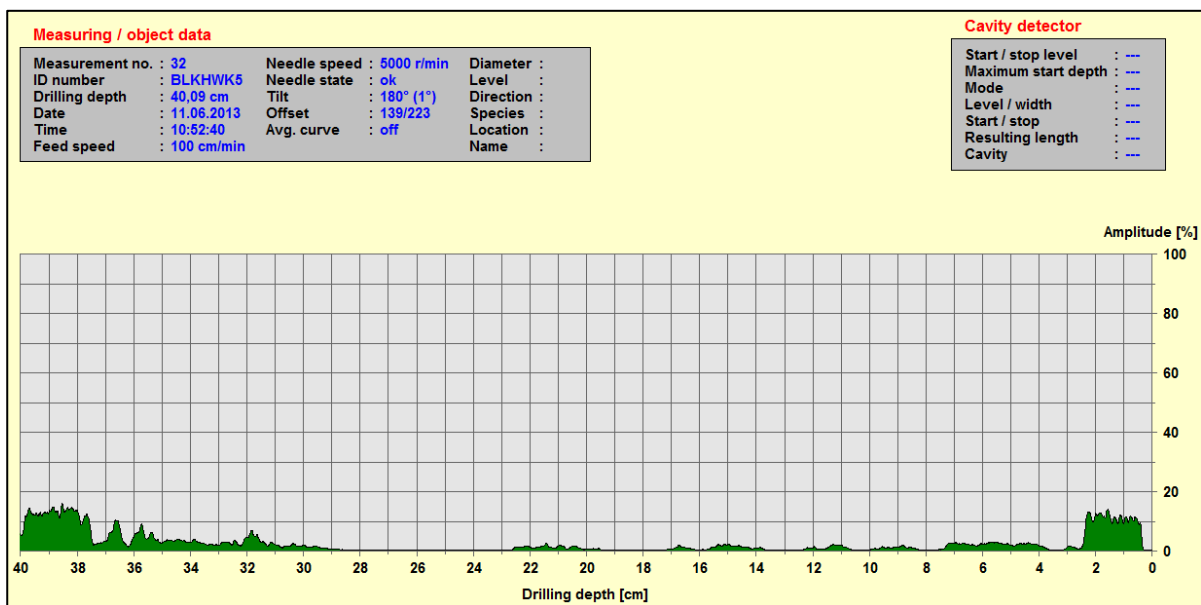
Stress wave and resistograph readings were conducted at numerous location on girder G25 of the Blackhawk 5 Bridge. A sample resistograph plot is presented in Figs. 11. The stress wave readings along the member, along with comparison of resistograph readings helped identify and bound the location of the deterioration in girder G25. Areas of the plot that flatline to zero relative resistance (y-axis) levels are indicative of advanced decay.

Fig. 11 Resistograph plot from girder G25, location 32, of Blackhawk 5

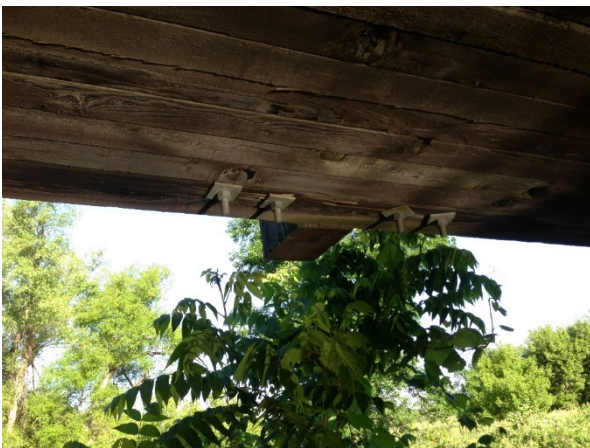
Clarke 3 has a gravel wearing surface that due to grading has all the scuppers partially to completely blocked. The most obvious signs of damage were at locations of physical connections, such as the guardrail post connections (see Fig. 12), and the longitudinal joint between deck panel sections where the lag screws have begun to push through the bottom of the deck and split the bottom of the member (see Fig. 13).

*Fig. 12 Damage at connection detail between guardrail post and deck, Clarke 3*

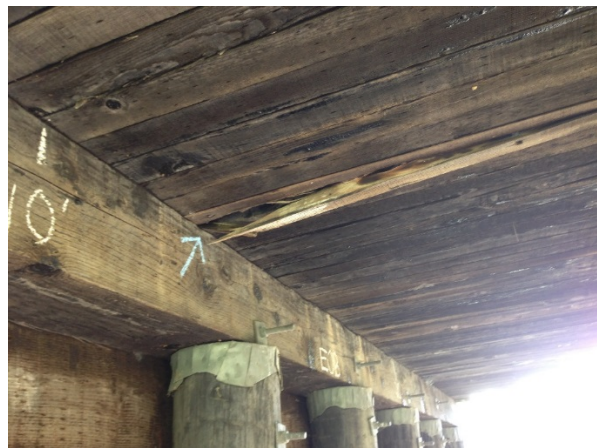
*Fig. 13 Damage at longitudinal deck panel connection, Clarke 3*

Stress wave readings and resistograph readings at random locations revealed no areas of concern even around the areas where the deck was damaged/deteriorated due to the panel connection detail.
