Contribution to Structural Details on Timber Bridges

Otto Kleppe
Senior Principle Engineer
Norwegian Public Roads
Administration
Oslo, Norway
otto.kleppe@vegvesen.no

The paper makes a contribution to details on timber bridges based on the experience gathered by the Norwegian Public Roads Administration (NPRA). The design errors which are included in this paper are selected because they are important with respect to durability. Most of what is stated in this paper may appear to be obvious. However, the problematic details are still used in the design of timber bridges and are therefore not obvious for all designers.

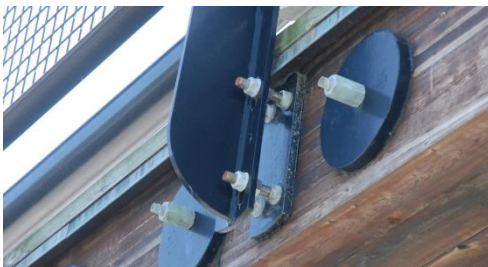
Fig. 5 Parapet post which do not lead water to the deck

Instead of a plate direct bolted to the side face, shown in the previous image, we have a bolt connection between the post and an anchoring plate which is direct connected to side face of the deck – see fig. 5. The two upper bolts is approximately 1 meter and skewed into a steel plate slotted in between to lamellas in the deck. The two lower bolts are very short. The drip nose on the deck allows the water to drip outside of the all anchoring plates.

The parapet post should have a drip nose facing away from the bridge deck. The leakage between the edge beams could be avoided by mitre-cutting the beams such that the cut faces upwards. The columns should have a cladding that conducts water away from the lower sections.

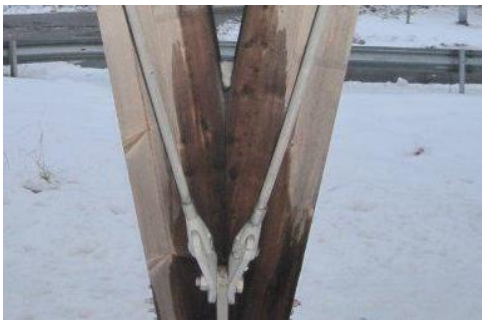
Fig. 6 A V-shaped column with stays.

In the figure to the left a wet top face of a V-shaped column is shown. Water follows the top face of the inclined members and is concentrated at their joint. From there the water runs down the side and is sucked up by the end grain.

The increased moisture at the end grain is in general probably one of the more serious problems we have with timber bridges. It occurs at several locations on a several timber bridge.

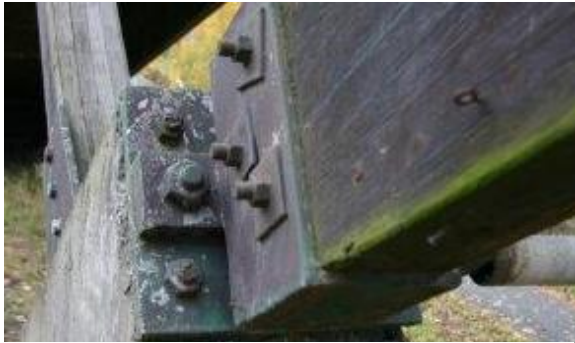
Fig. 7 Pole sleeve at support.

Sometimes adjacent structural members retard the drying of wood because proper circulation of air is prevented. This is the case with all exterior steel plates and sleeves. Even if there are drainage hole in the sleeves, the moisture will remain there for a long time and will eventually cause decay to the timber. Fig. 7 shows a typical example.

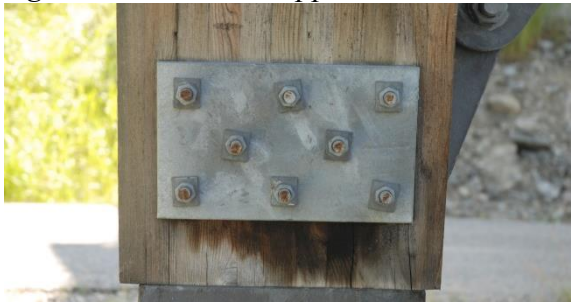
Fig. 8 Exterior steel plate collects moisture.

The steel plate on the outer side of the structure will in addition to the original intention prevent the wood from drying out. The bolts and the pressure against the wood cannot prevent moisture from penetrating behind the plate. In this particular case the moisture comes from behind the plate. In this case separate washers would most likely be a better solution.

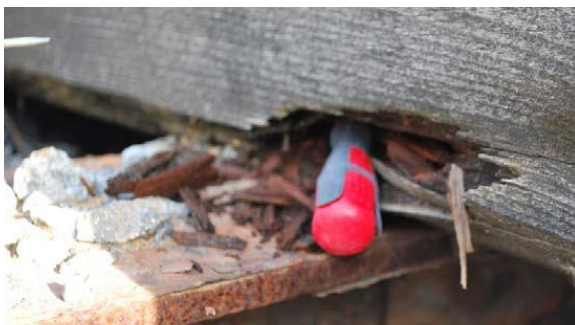
Fig. 9 Water on a steel beam has over time decayed the timber beam.

The timber bridge to the left has an open deck consisting of planks with small openings resting on beams. The underlying beams are therefore not protected and rot has developed at the cross-girders. The bridge was constructed in 1991 and is CCA-impregnated.

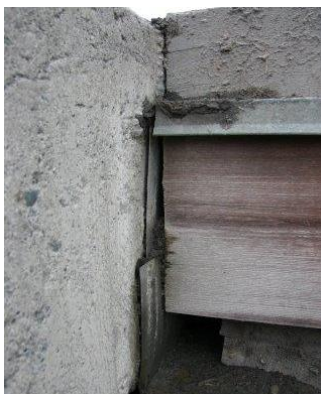
Fig. 10 Open abutment shelf which collects water, dirt and gives high moisture to the sill

Problems at the abutment are by no means only related to timber bridges. However, many of the problems at the abutment of timber bridges are often related to design solutions that are well known from concrete bridges and are applied to timber bridges without giving much consideration to the difference in material behaviour. When dealing with different types of materials, such as at the abutment, where timber and concrete will interact, special care has to be taken. Often standard solutions for concrete bridges do not constitute viable solutions.

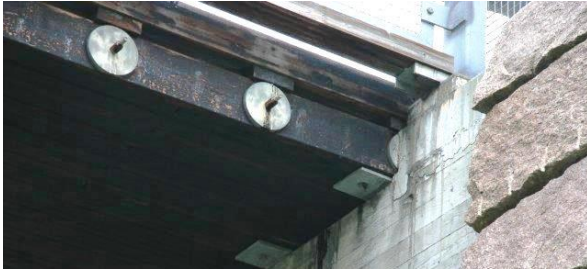
Casting concrete directly against the timber deck may look like a good solution at the outset, but over time the timber creeps and moves and cracks are created in the intersection between the two materials. Water will be trapped and remain for a long period before drying.

Fig. 11 The timber deck are in direct contact with the concrete

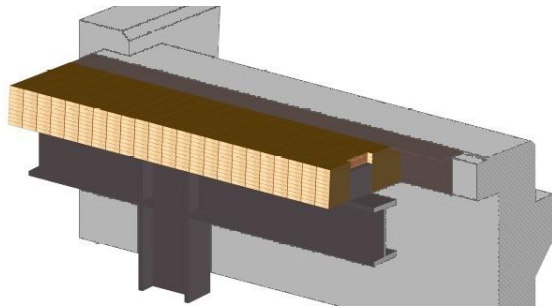
Fig. 12 Possible improved design

For the abutment a new design approach will be tested. The abutment differs from previous designs by having considerable free space below the intersection between concrete and timber in order to prevent standing water and dirt from gathering close to the end wood. In addition the joint between timber and concrete is easily inspectable from below.

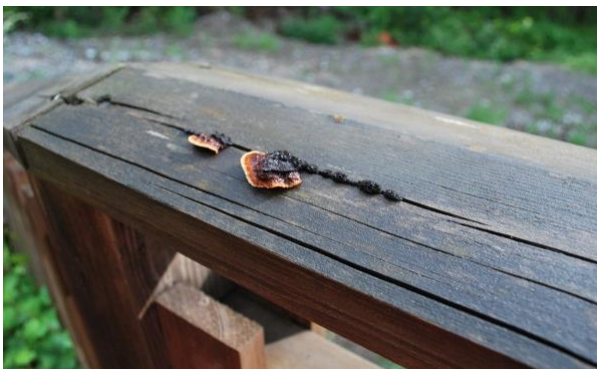
Fig. 13 Fungi is growing on a horizontal member. The photo is taken in 2009.

Horizontal members without any structural protection soon experience fungus attack in the cracks that face upwards. Cracks must be expected in members that are not creosote-impregnated. Upward-facing cracks will collect water that will remain there for some time and dry up very slowly. Fungus spore is always in the timber and starts growing when conditions are amenable to this.

Fungus attacks in cracks grow from the inside and are difficult to reveal before the attacks are severe.

All timber bridge should have structural protection on the upper side of the sections.

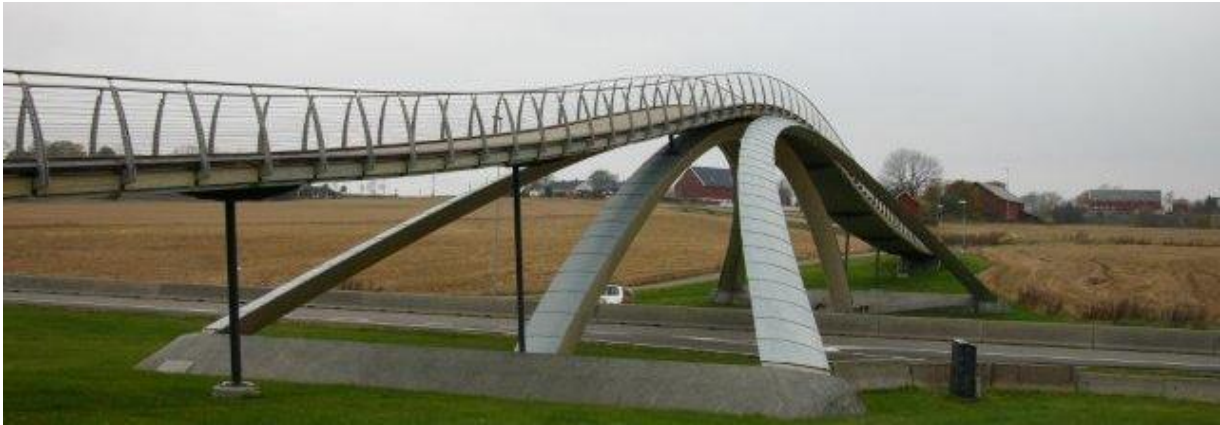
Fig. 14 The Leonardo da Vinci bridge also had fungus attack before it received structural protection to its upper face of the arcs. Constructed in 2005

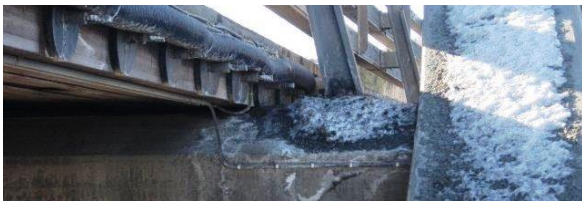
Fig. 15 Dirt on the cross-beam

A concrete cross-beam with dirt from the road gathering next to the deck. The dirt will retain moisture. The cross-beam also follows the transversal slope of the deck and road. This will conduct water to the deck. In spite of the deck is lifted up from the beam by a list the water will be transfer to the deck.

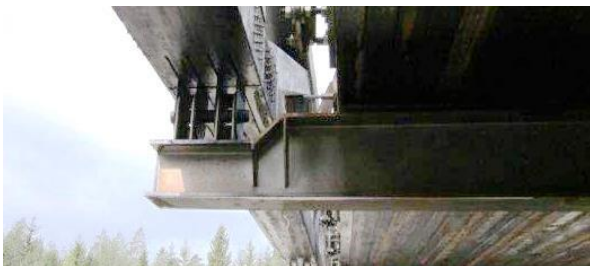
Fig. 16 A clean and better solution as above

The cross-beams to the left will most likely experience the same problem as the above-mentioned cross-beam, but in less degree. An even better design for this cross-beam would be to incline the beam before the edge of the deck see fig 17. In this way dirt and water in general would run away from the deck when washed by rain.

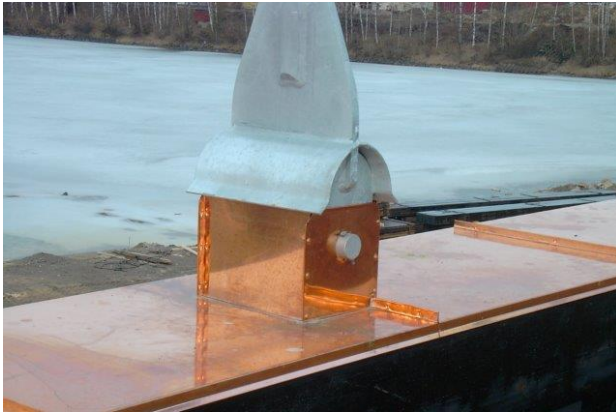
Fig. 18 Metals of different relative nobility staying in contact with each other may cause galvanic corrosion.

Using metals with different electronic potential that are in contact with one another can result in reduced service life. When ions transported in water drip from a metal with higher electronic potential onto another metal with a lower potential a bi-metallic corrosion is created. This rapidly tears into the zinc layer of galvanized steel and causes a loss of protection of galvanized members.

We have observed this problem when water runs off the cladding and onto cross-members or joints.

The metal with the lowest electronic potential will corrode and part of it will disappear. The maintenance action will be to replace the metal that has disappeared and to conduct the dripping water to another location where it does not corrode the underlying part.

The design has to include drainage from an upper section to a suitable location.

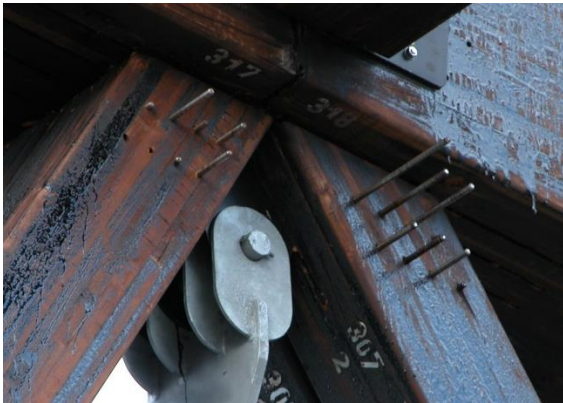
Fig. 19 Dowels dislodging from the structure

In some cases the horizontal dowels have moved out of position. This has happened on horizontal dowels with alternating load direction. The dowel is not quite horizontal, and when the load on the members alternates between compression and tension they can dislodge. The problem is observed on some bridges and only on joints which alternate load direction.

This movement of dowels may be very serious if they are not pushed back in time. This can reduce the service life of some bridges when it exceeds a certain point. In any case it will increase the maintenance cost. If damage has occurred to the bridge because the dowels have moved too far, the cost of repair may be substantial and the bridge will probably need to be closed for a period.

The improvement is to prevent the dowel from moving out of position by using nuts and bolts instead of a simple dowel – the image to the left. Inserting a screw or nail next to the dowel to prevent it from moving has been shown to be insufficient. The solution has been to use a nut at the end of the dowel as shown in figure 19.

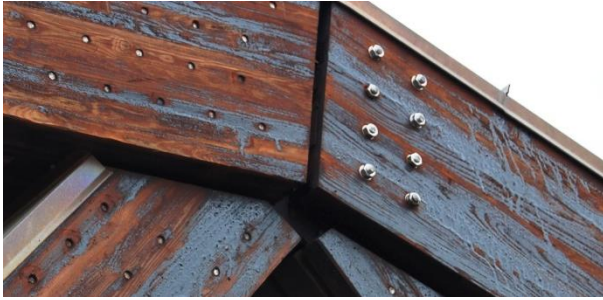
Fig. 20 Dowels fastened with nuts

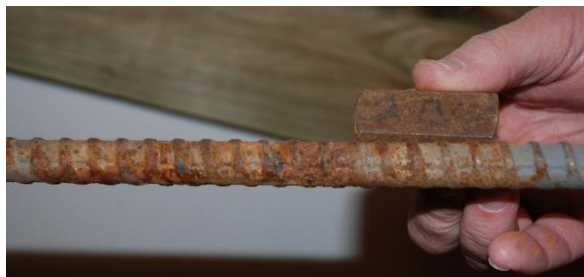
Fig. 21 Corroded tendon bar on a 17-year-old bridge

Significant corrosion on tendon bars at the anchoring plates and to some extent inwards has recently been detected. The bars are situated in pre-drilled holes in the creosote-treated deck and originally they were sprayed with zinc. This bridge was only 17 years old.

The nut was placed where the iron piece is shown and the anchored plate was to the left of the iron piece.

problem is, but it probably concerns bridges with a stress-laminated deck and may be without drip nose. This bridge has no drip nose. We suppose that a drip nose will improve the problem considerably. Depending on how extensive this problem is it will give the bridge owner an increase in maintenance costs.

At least one of the bars have serious attack. This will substantially reduce the service life of the tendon bar. However, it is not currently known how long this corrosion can remain before we have to change the tendon bars, since this depends on the stress and corrosion level of the bar. We have to take action before it breaks, since it could in some situation be dangerous for the environment if it breaks and falls from the construction. The maintenance action will be to replace the bar.

There are several ways to improve this structural detail, consisting of three main alternatives: preventing the water from touching the nut, preventing the bar from corroding, e.g. by wrapping it, or using a non-corrosive tendon bar e.g. a fibreglass bar.
