# Inspection of Louisiana Timber Bridges

## Summary

This paper reports the result of a study undertaken to assess the condition of timber bridges in four distinctly different geographic regions in the state of Louisiana. This study was carried out as part of an overall national study spearheaded by the U.S. Forest Products Laboratory to investigate the field performance of timber bridges. Louisiana, with the second highest number of timber bridges in the nation spread across the entire state, was an excellent location to assess the performance of these bridges under different environmental conditions. The bridges inspected were representative of the various types of timber bridges in the state and covered different exposure conditions. The inspections were conducted with the assistance of the Louisiana DOTD (Department of Transportation and Development) bridge inspection team. The inspection teams utilized advanced assessment tools such as the resistance micro-drill and acoustic devices to evaluate the condition of the suspect regions of the timber sub- and super-structure elements. The availability of the advanced inspection tools eliminated the bridge inspection teams from havi

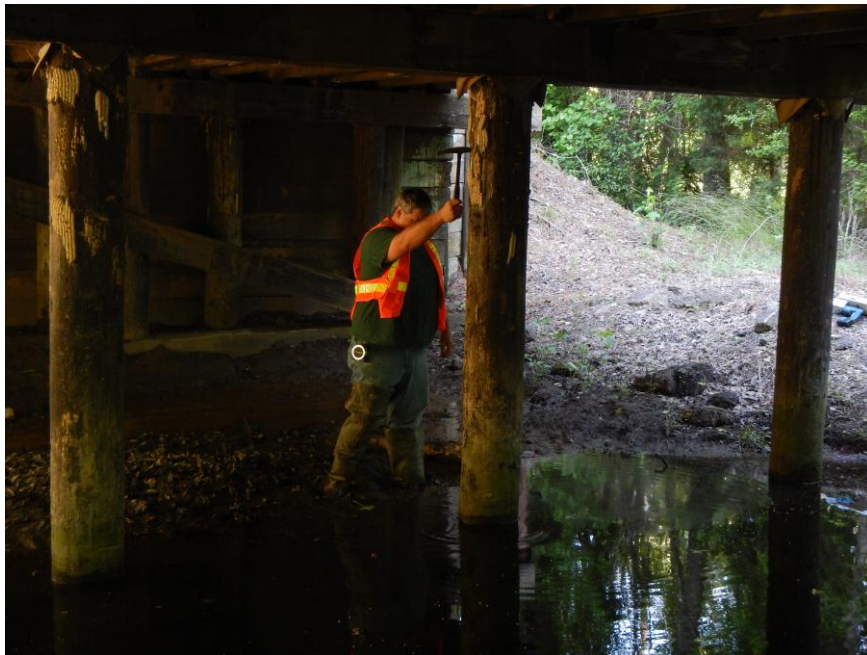
Fig. 3 Inspector using hammer to assess condition of pile from sound

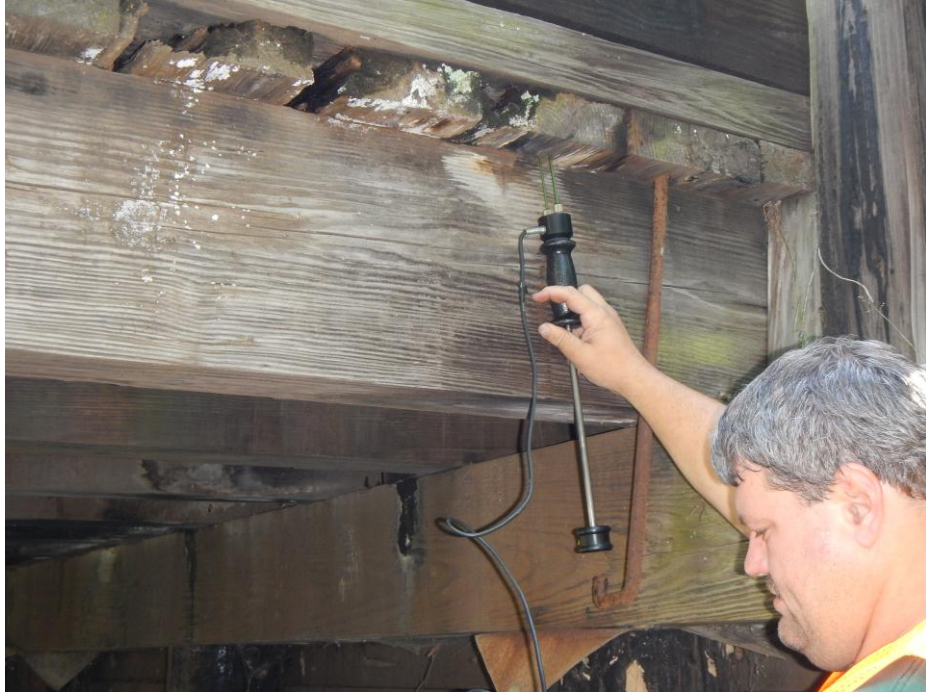
Fig. 4 Determining moisture content of wood deck with moisture meter

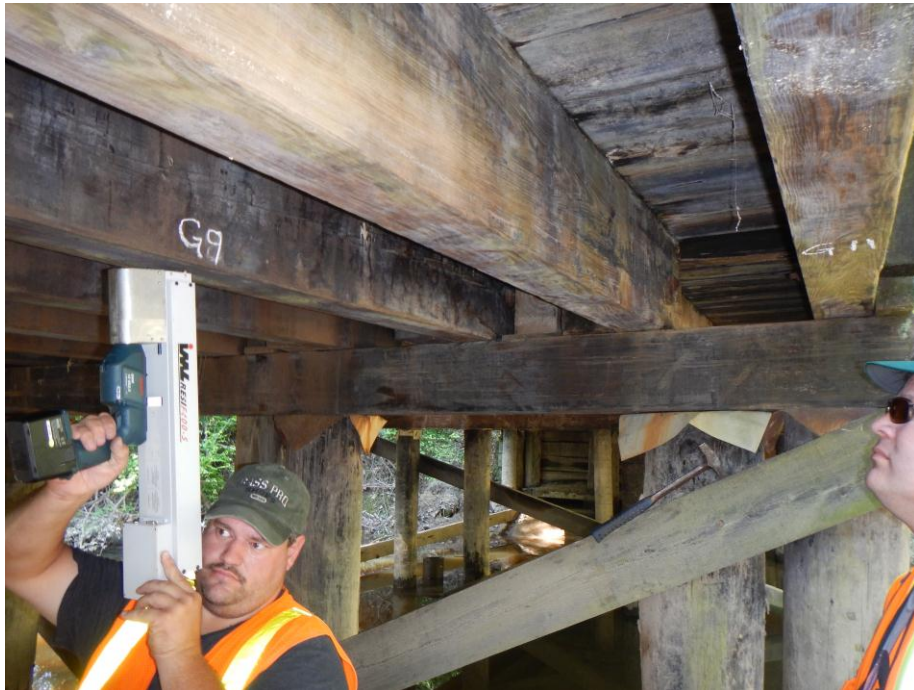
Fig. 5 Resistance Microdrilling to assess condition of stringer

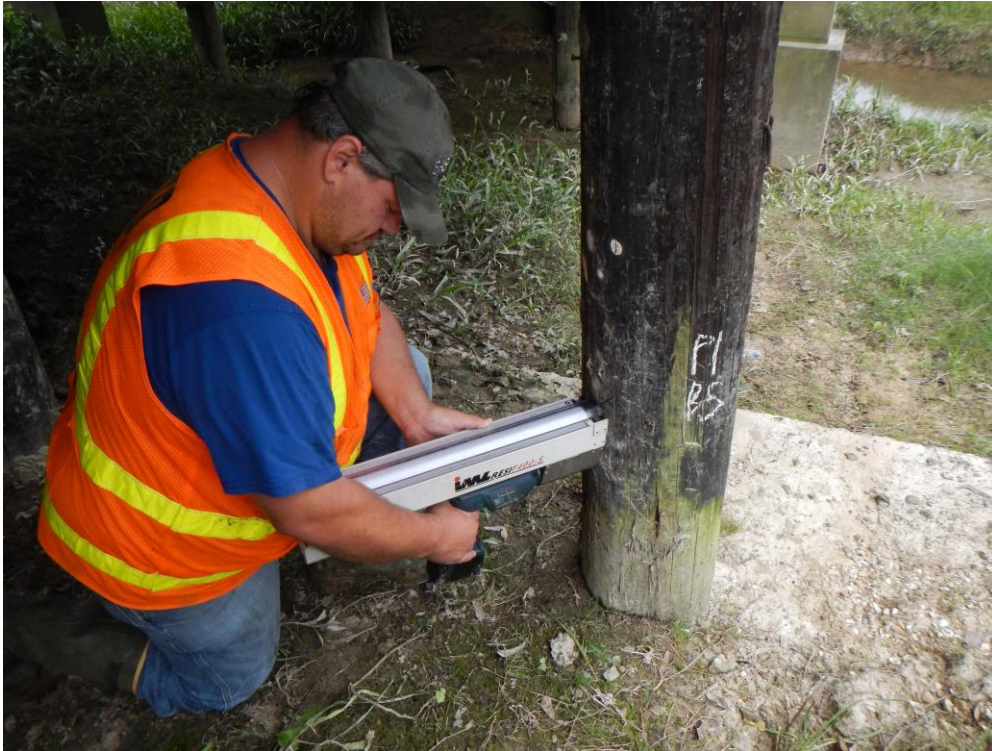
Fig. 6 Resistance Microdrilling to assess condition of pile suspected of being hollow

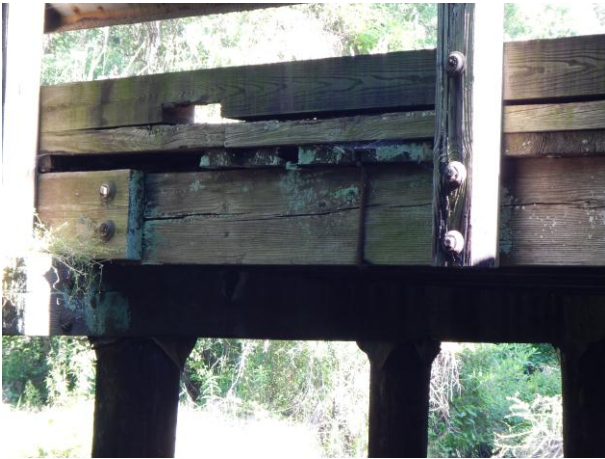
Fig. 12 View of deteriorated wood deck

This timber bridge has been in service for over 70 years and appears to be in very good condition. Though the bridge is load posted for 40T for trucks, it was evident during the inspection that it was carrying significantly higher loads imposed by the logging trucks. The heavy creosote treatment used for the timber members contributed to a longer than expected service life for the structural elements.

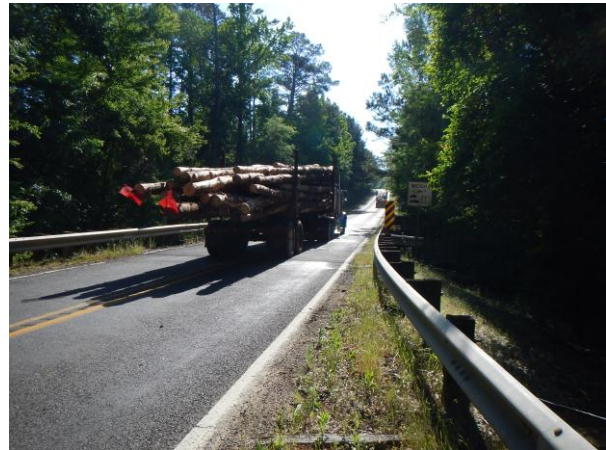
Fig. 13 View of logging trucks traversing bridge

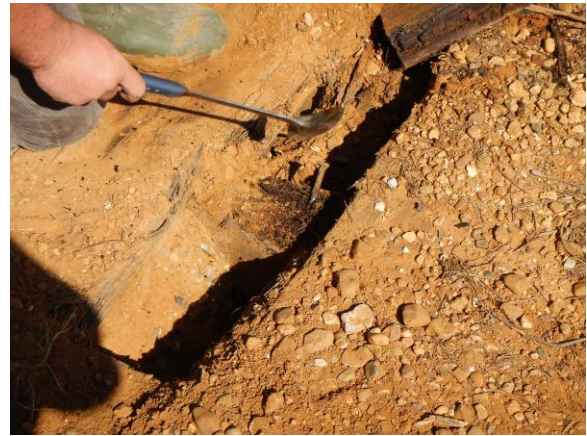
Fig. 17 Deteriorated deck exposing stringers

This major concern with this timber bridge is the loss of deck due to the grader. The inspection clearly indicated the need to replace the gravel topping with timber runners that can provide protection to the deck. The absence of adequate railing was of concern since the railing currently in place only serves the purpose of identifying the edge of the bridge and does not provide any impact resistance. Extreme caution is necessary to cross the bridge in its current condition.

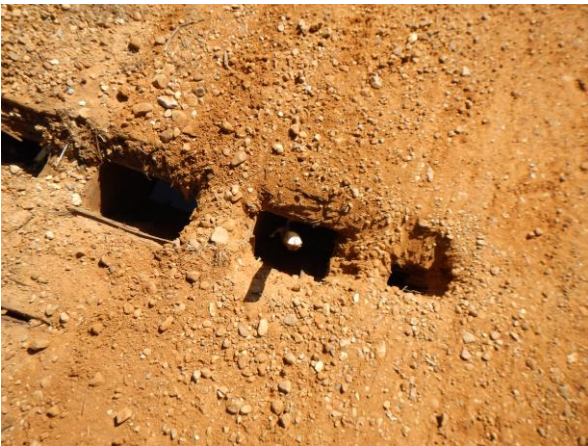
Fig. 18 Loss of deck section spanning stringers
