Rehabilitation of a Two-Lane Covered Bridge

Second National Covered Bridge Conference
June 6, 2013

Hoyle, Tanner
& Associates, Inc.
Manchester, NH USA

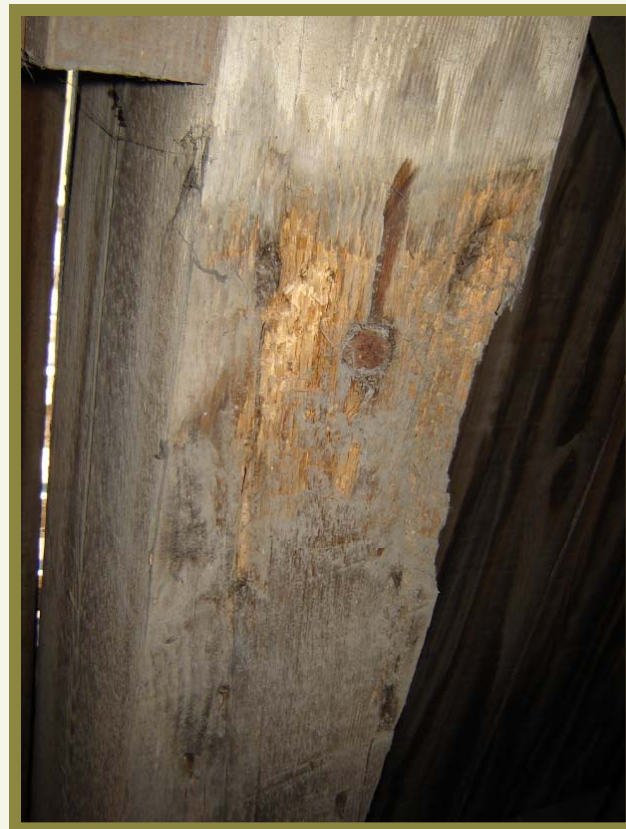
Member Split

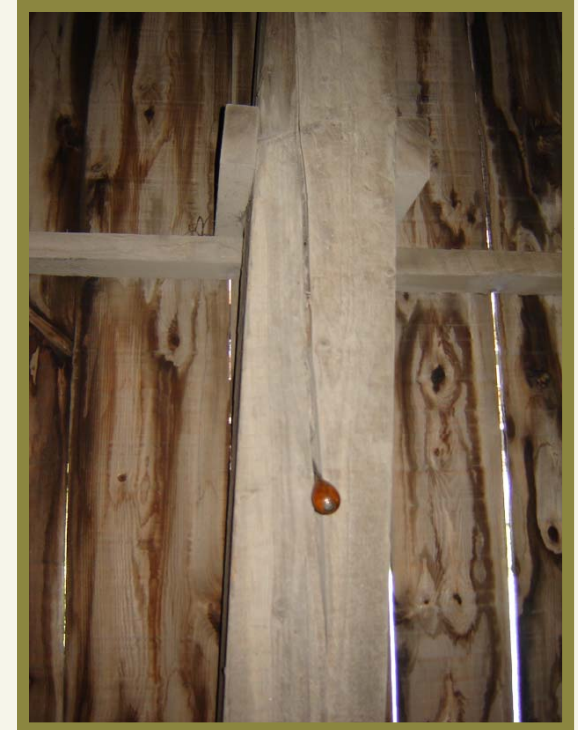
Member Impact Damage

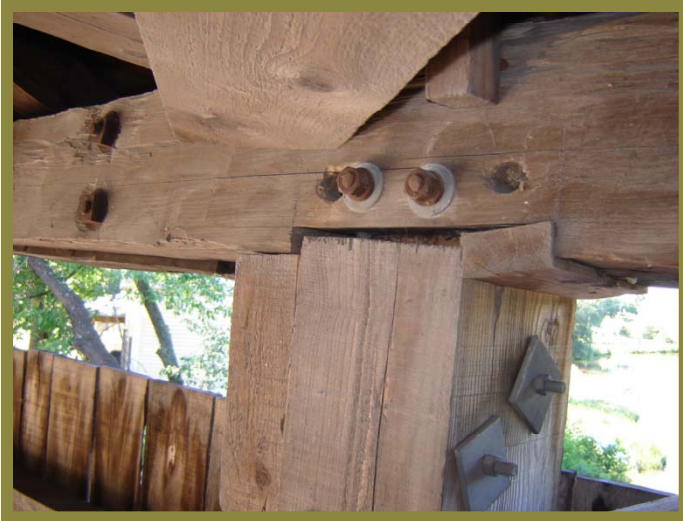
Break

Rot

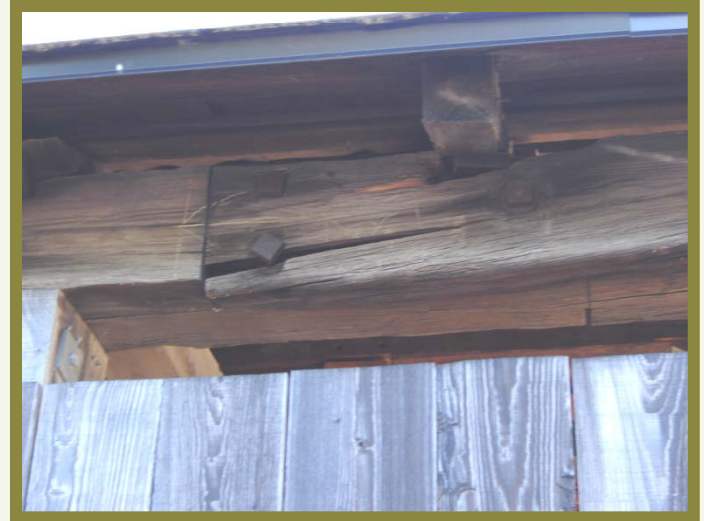
Break

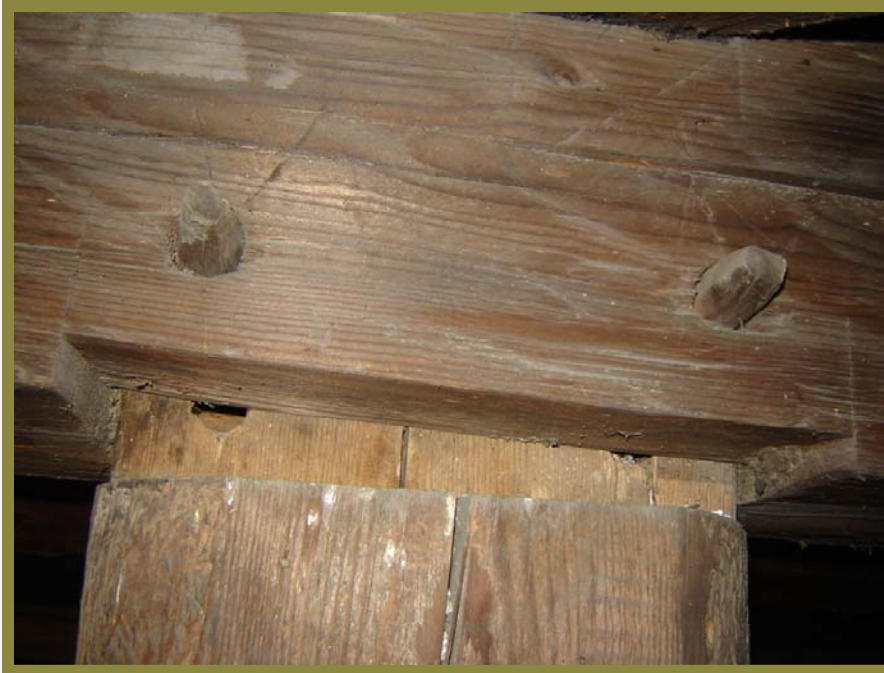
Broken Tenon – Truss Vertical

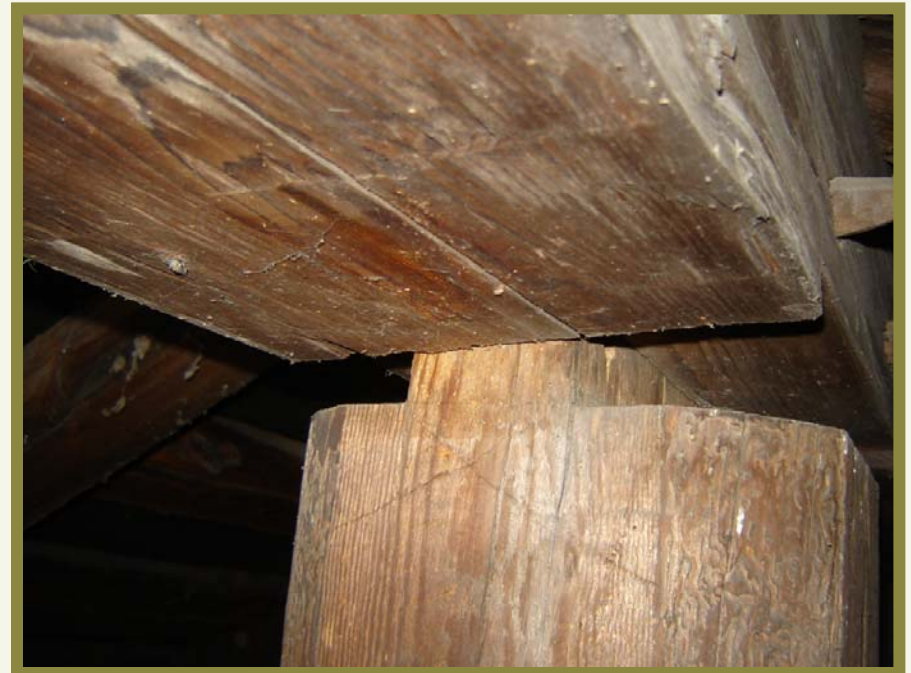
Broken Tenon – Truss Vertical

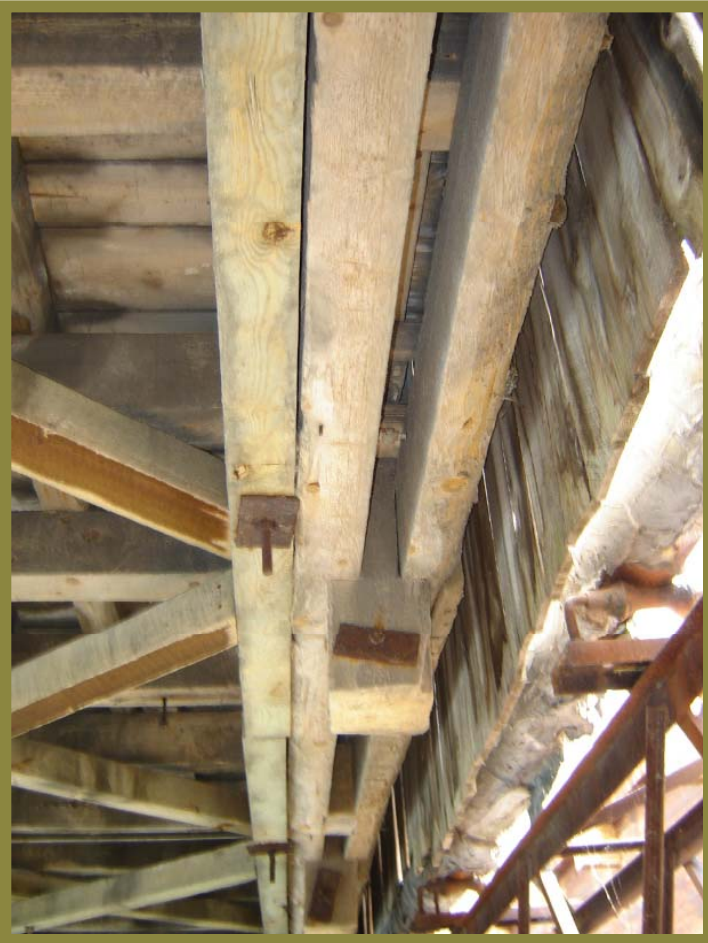
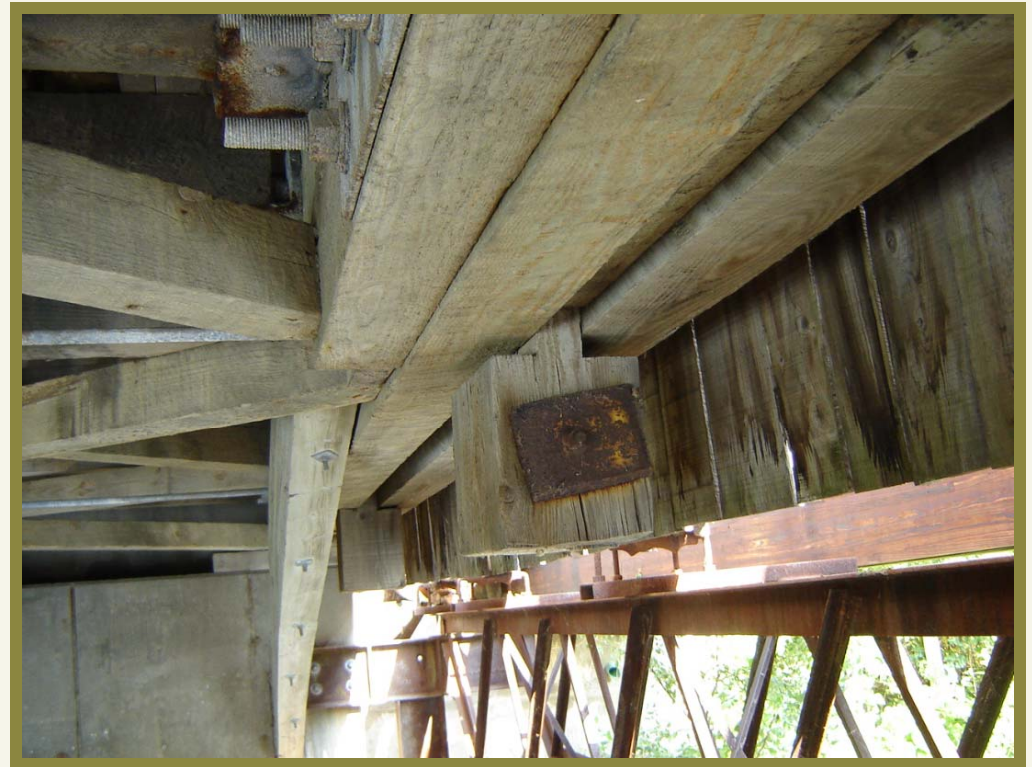
Undersized Verticals At Notch

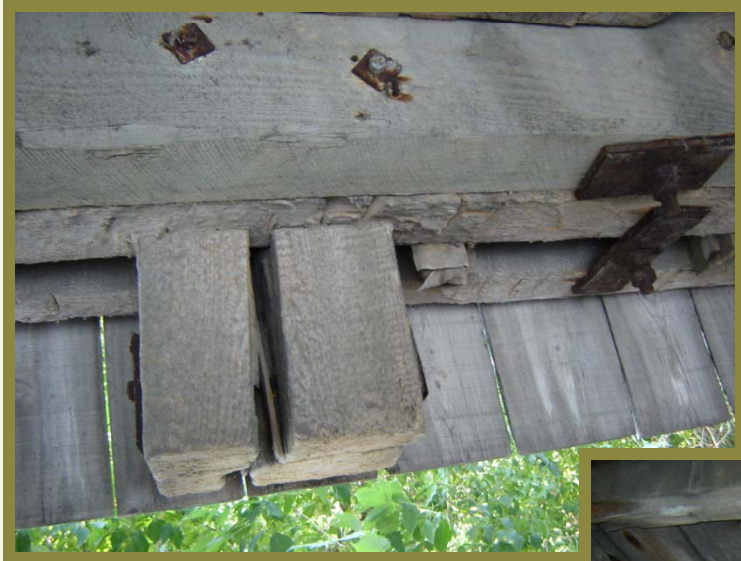
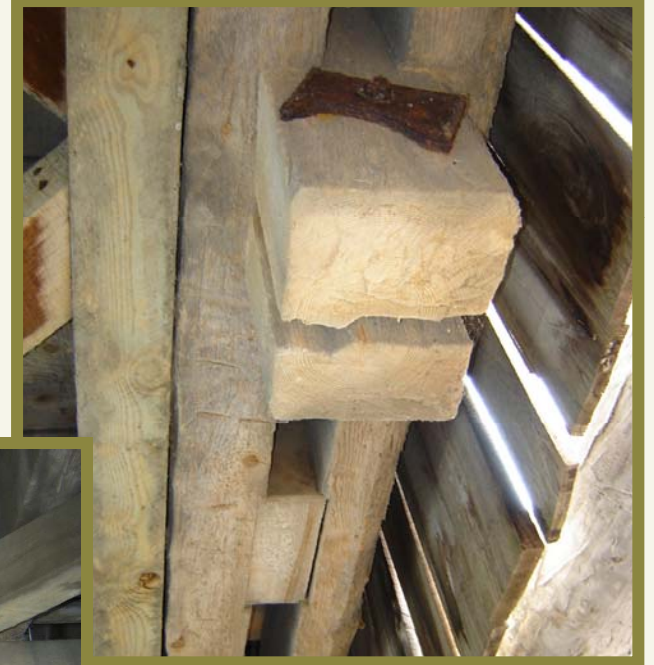
Split Verticals

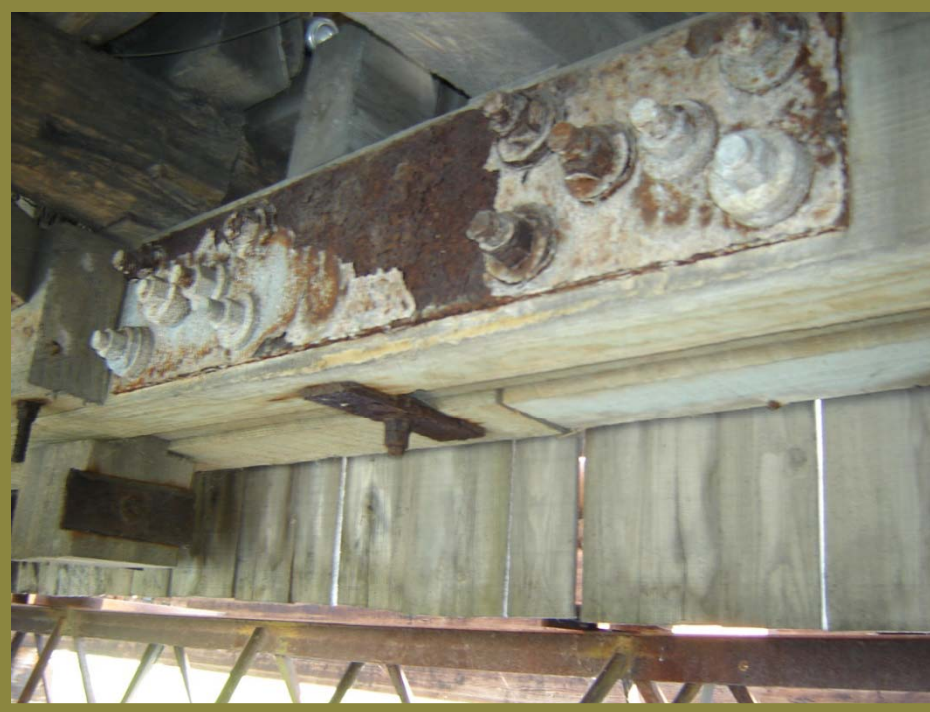
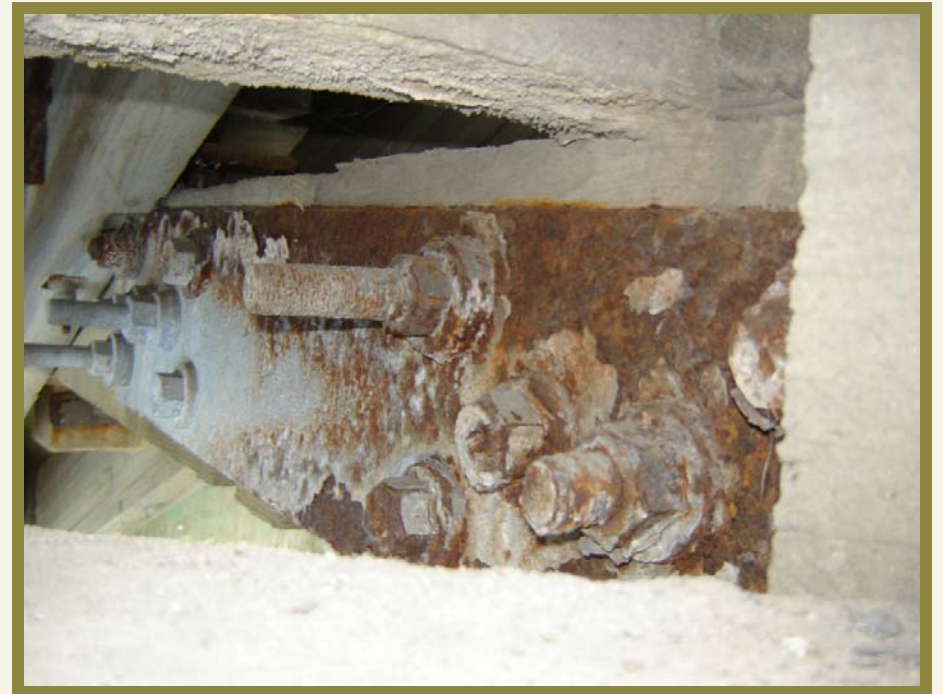
Previous Repairs

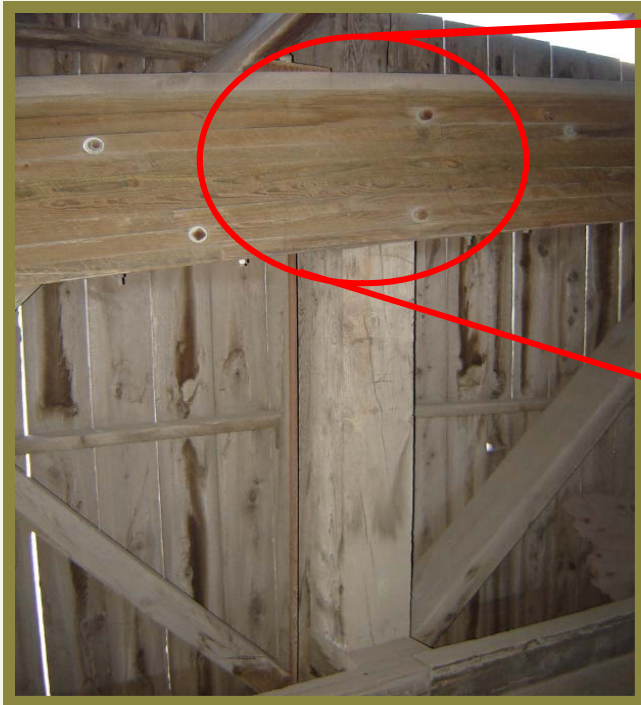
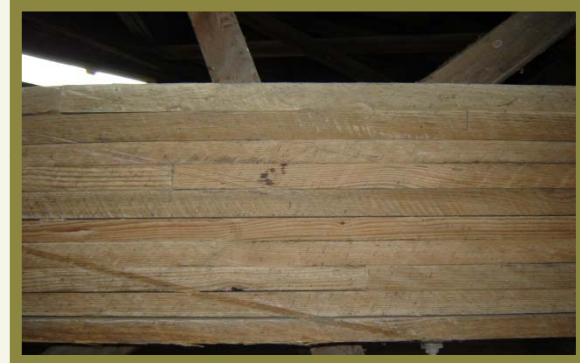
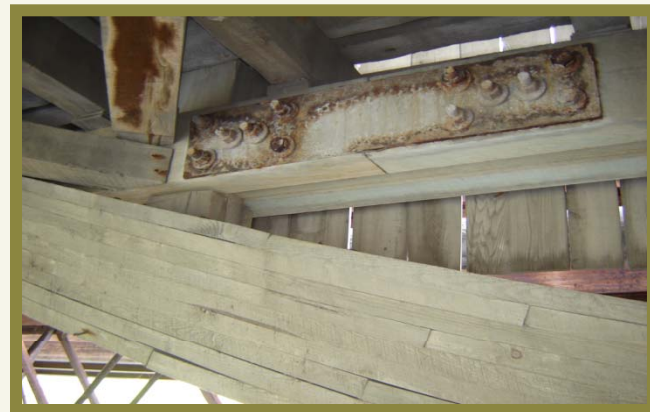
Arch Interaction / Condition
