Effective Shoulder Design and Maintenance

tech transfer summary

June 2007

Iowa Highway Research Board (TR-531)
Iowa Department of Transportation
(CTRE Project 05-198)

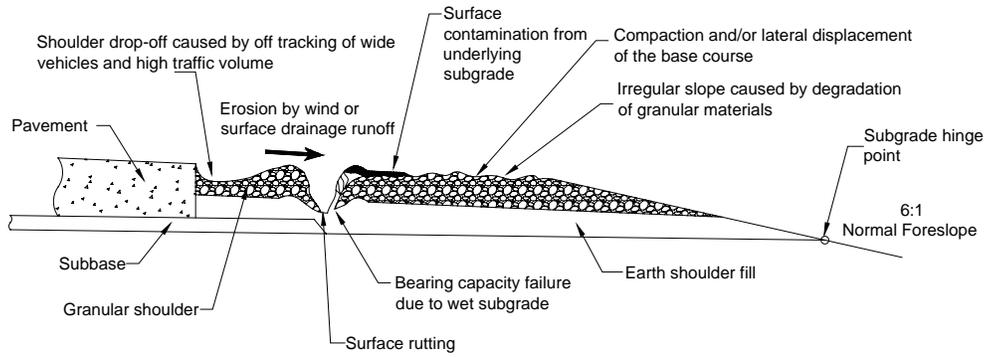
Common granular shoulder problems

Granular shoulders are a commonly used shoulder option. Although the construction of granular shoulders is initially less expensive than that of paved shoulders (by up to 70%), granular shoulders often add expense later because they require more frequent maintenance and have performance problems. Common granular shoulder problems include edge drop-off, shoulder rutting, erosion by water or wind, irregular slope, and settlement of the subgrade soil.

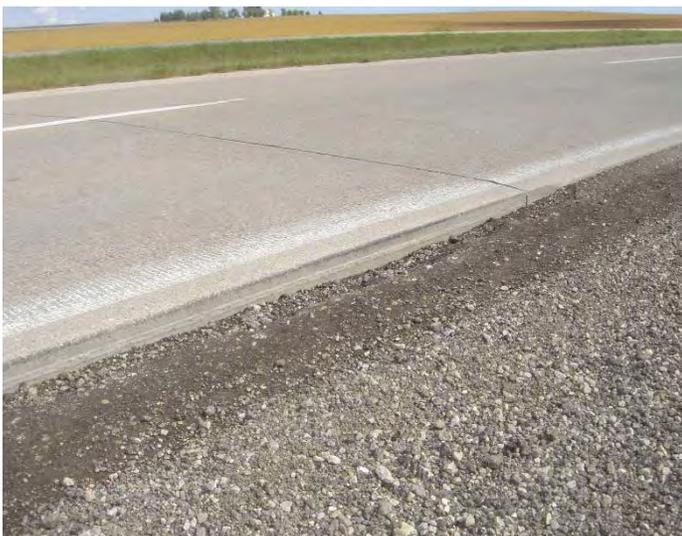
Edge drop-off along the outside shoulder caused by vehicle off-tracking

Vehicle off-tracking is a prime contributor to the development of edge drop-off. An approach was therefore conceived to study vehicle tire-aggregate interaction for unpaved shoulders using high-speed cameras. To capture the vehicle tire-aggregate behavior, a pickup truck was driven on an unpaved shoulder at 40 mph while the high-speed camera captured the aggregate trajectories. The results show that aggregates are elevated upward and pushed in the opposite direction of vehicle travel.

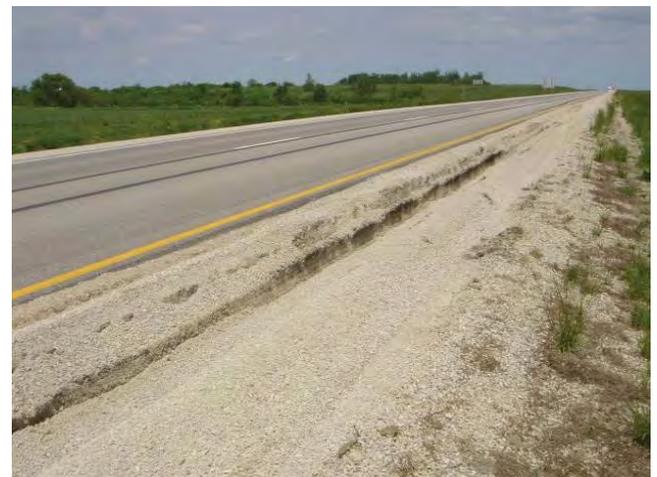
Severe shoulder rutting caused by bearing capacity failure of the soft underlying subgrade

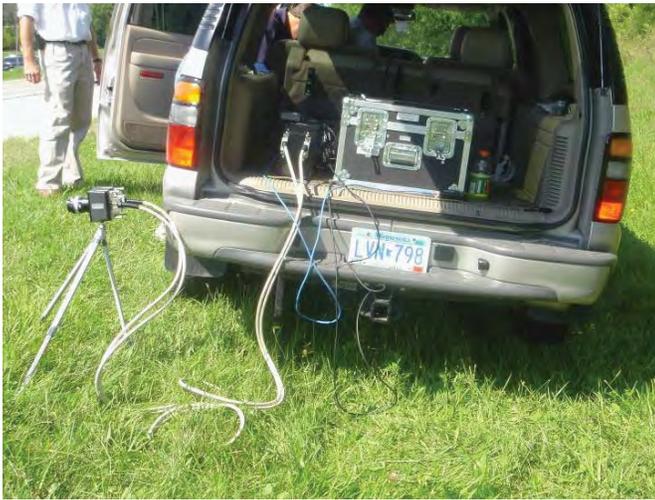
Monitoring tire-aggregate interaction using stationary high-speed camera

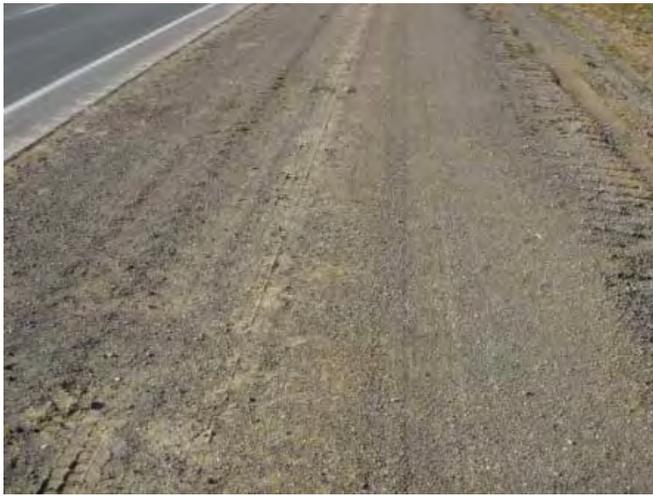
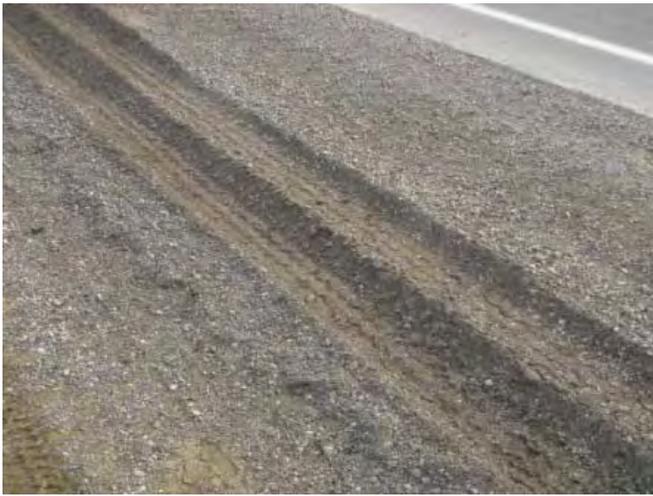
Performance of the fly ash–stabilized shoulder section after seven months: stabilized section (top) and control section (bottom)

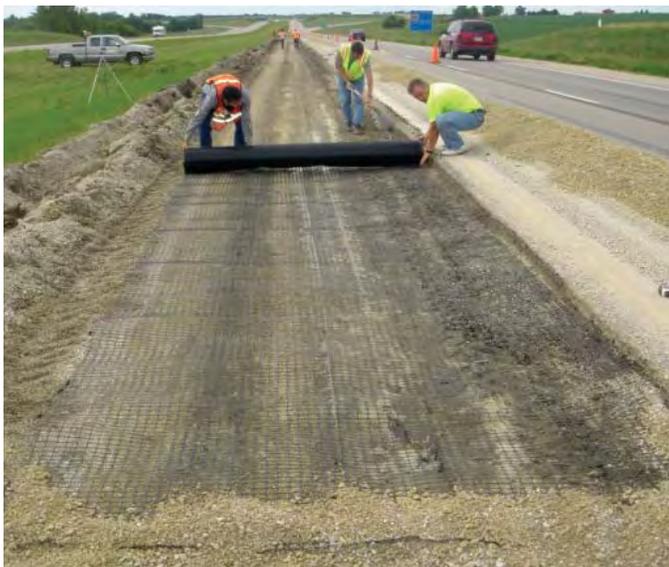
Rolling the geogrid over the soft subgrade layer near Nashua, Iowa

For the geogrid stabilization techniques, the inside granular shoulder on Highway 218 near Nashua, Iowa, was experiencing severe rutting due to soft subgrade conditions. The section was stabilized by placing various types of geogrid at the interface between the granular and subgrade layers, and the test section was monitored for 10 months. Four different geogrids were evaluated, and all considerably improved the performance of the shoulder test section and eliminated shoulder rutting.

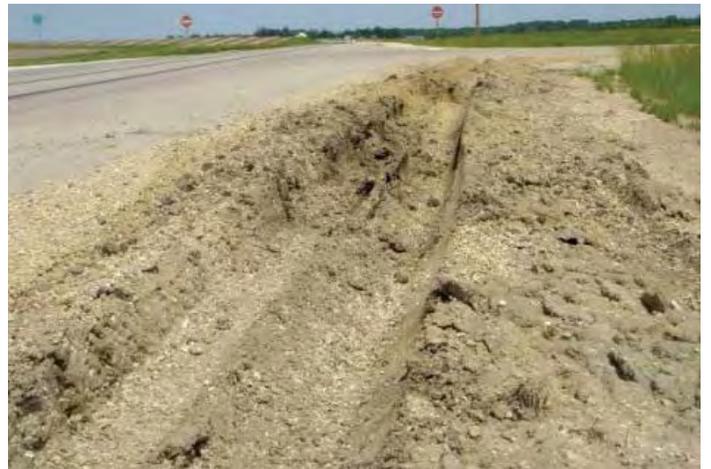
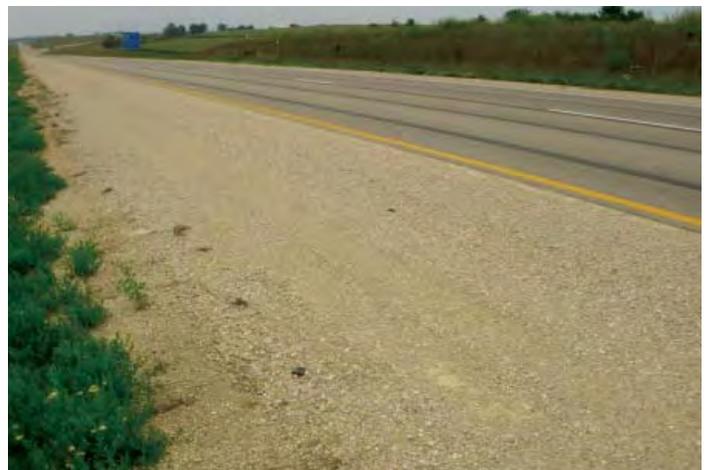
Inside shoulder near Nashua, Iowa: before stabilization (top) and two months after stabilization (bottom)

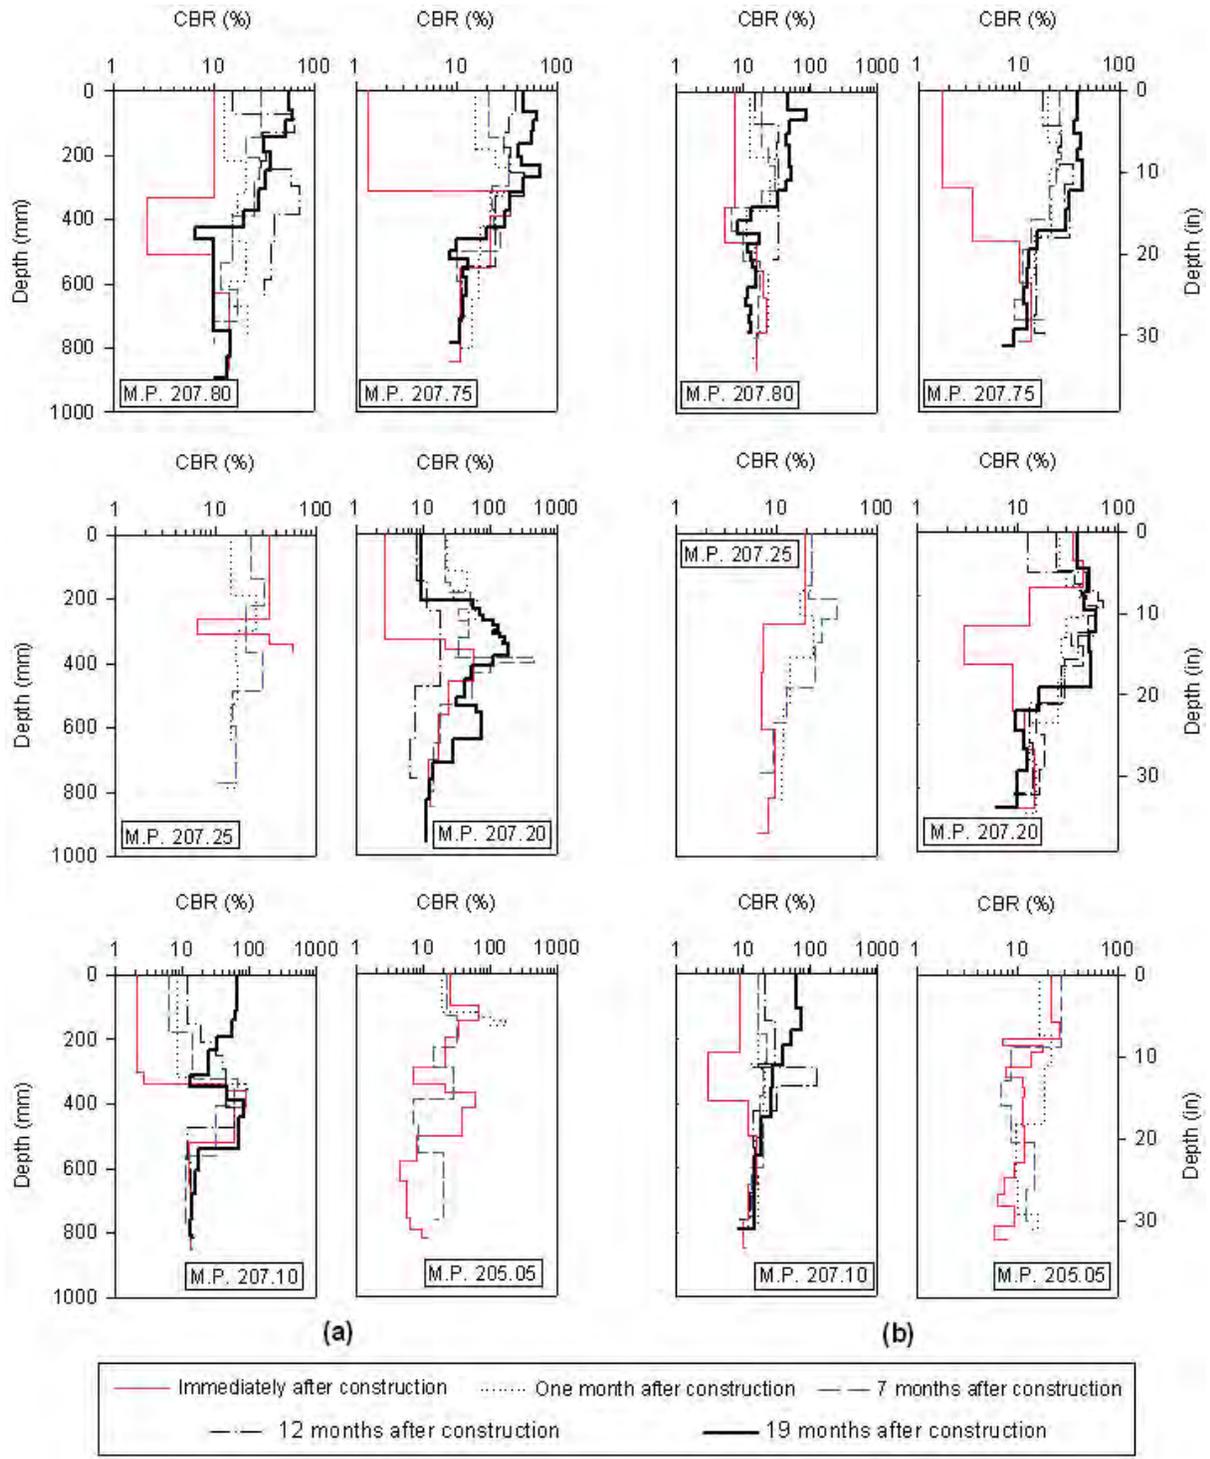
Dynamic cone penetrometer test results with time for the fly ash-stabilized sections:
 (a) 3.0 ft and (b) 6.0 ft from the pavement edge

For the fly ash stabilization techniques, shoulder sections located on Highway 34 near Batavia, Iowa, were undergoing severe rutting due to soft subgrade layers. The upper 12 in. of the subgrade were stabilized with 15% to 20% class C fly ash. The section was monitored for 19 months. Fly ash stabilization was successful in eliminating shoulder rutting and improving the overall long-term performance of the shoulder section.

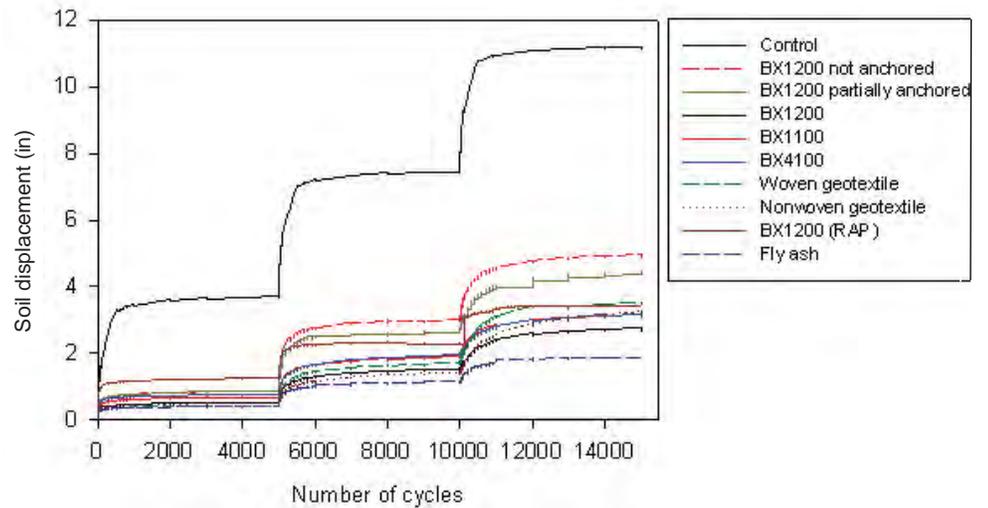
Summary of cumulative measured soil displacement for all laboratory box tests

To simulate a shoulder section overlying a soft subgrade, a laboratory study was conducted. Cyclic loading with three loading stages was used to study the performance of the laboratory model under different mechanical and chemical stabilization techniques. At each stage, a pressure was applied and sustained for 5,000 cycles at a frequency of 1 Hz. These pressures were 40, 80, and 120 psi. The soil properties before and after each test and the cumulative soil displacement over an increasing number of cycles were recorded.

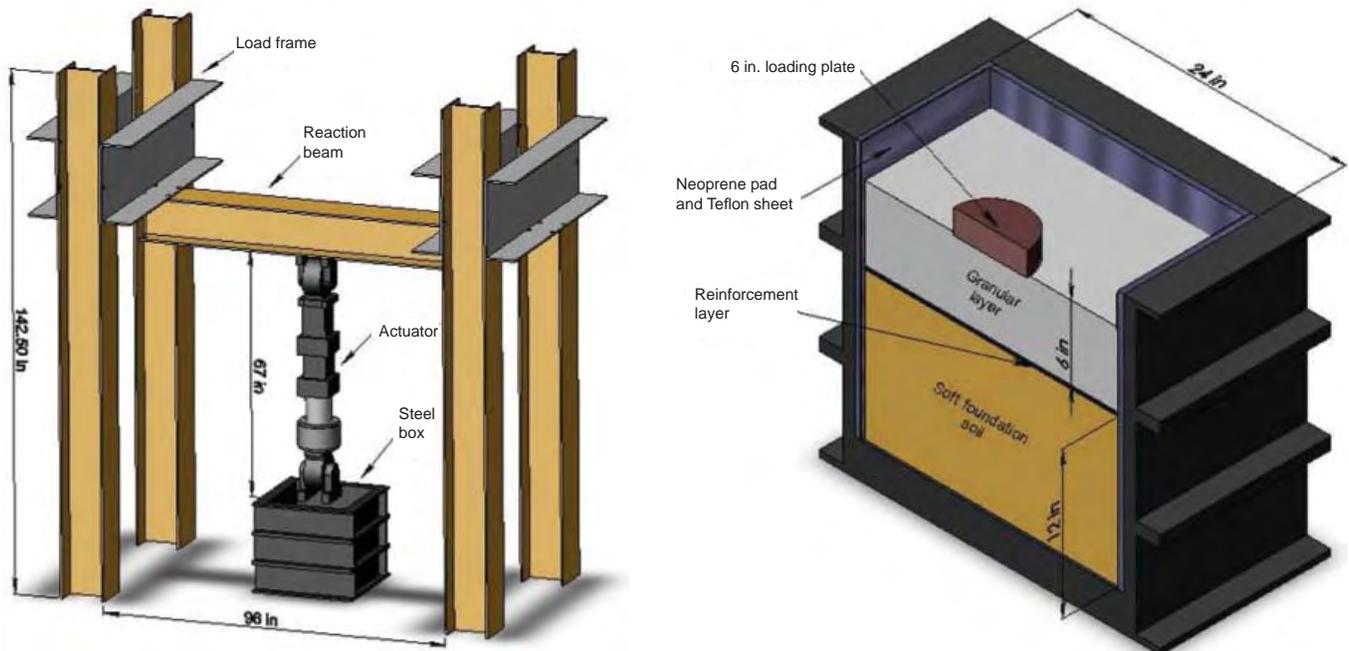
Schematic of the laboratory apparatus setup: Steel frame and hydraulic actuator for loading the stabilized soil (left) and steel box used to contain the soil (right)
