Laboratory Investigation of Bridge Strip Seal Joint Termination Details

tech transfer summary

February 2016

Federal Highway Administration
Iowa Department of Transportation
(InTrans Project 14-502)

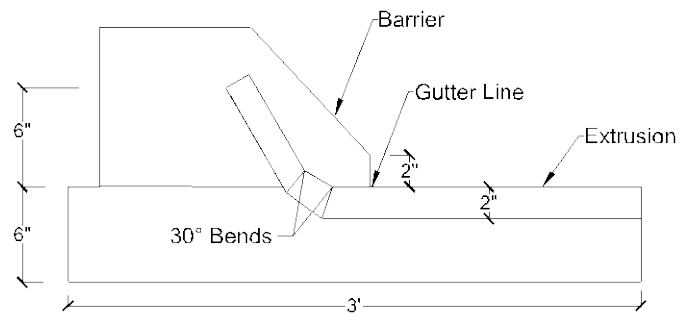
Section view of turn-up termination detail

Strip seal termination details vary from state to state. In Iowa, strip seals run transverse to the bridge deck and terminate by turning up and into the barrier rail in a two-step turn. The turn-up prevents water from flowing over top of the strip seal, where it could then reach and cause deterioration to substructure elements below.

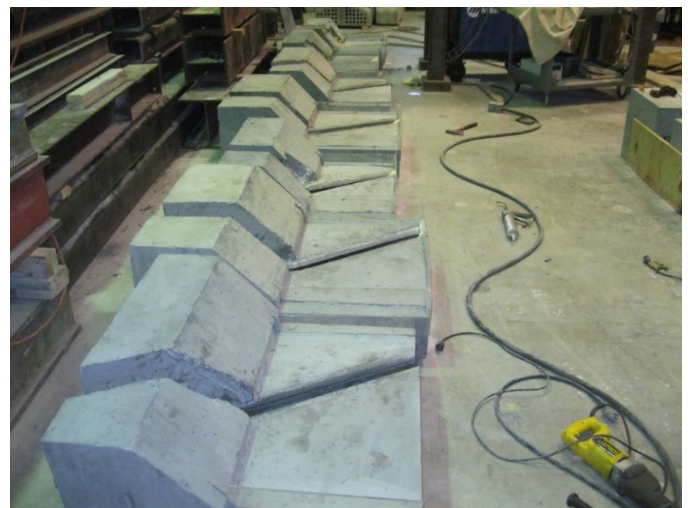
Laboratory specimens before testing

Given that the Iowa DOT experiences the most severe problems with the strip seal termination detail on skewed bridges, all laboratory specimens were constructed at a 30 degree skew. This ensured that recommendations for new or improved details were tested under the most critical circumstances.

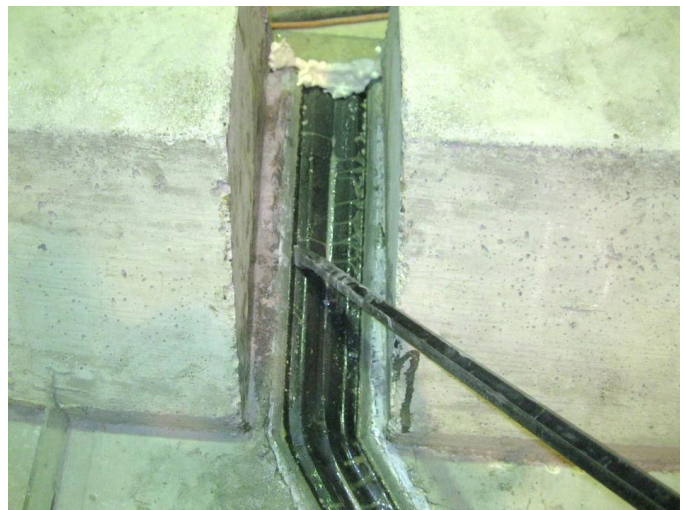
Use of a crowbar to install D.S. Brown gland

For the D.S. Brown strip seal, the gland installation between the barrier rails proved to be simple, taking a total of 10 minutes, and was achieved using a basic pry bar. Both the dogleg and straight-through of the D.S. Brown specimens passed all ponding tests.

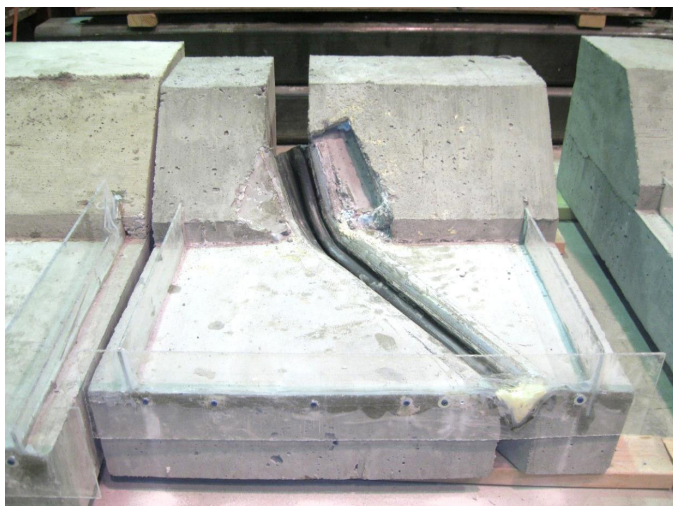
Turn-up specimen with blackout formed using blue insulation board

For evaluation purposes, two different foams were utilized: blue foam insulation board and a spray foam product. In both cases, after the formwork or foam was removed, the resulting finish was desirable and the blockout area allowed for full installation of the gland. Furthermore, through trial and error, the research team found that the blockout area of the current Iowa detail can be modified so that the blockout is only as wide as the steel extrusions of the strip seal. In fact, the research team found that the smaller blockout area improved installation of the gland because the new surface provided better tool leverages.

- If a blackout is to be utilized around the current strip seal termination turn-up, forming the blackout with blue foam board is both efficient and results in a quality product. If spray foam is utilized, the face of the metal extrusion should be scraped and scrubbed clean of all spray foam residue prior to casting the barrier rail.
