Feasibility of Forming Transverse Joints with Joint Forming Devices

tech transfer summary

Evaluation of Transverse Joint Forming
Methods for PCC Pavement

Iowa Highway Research Board (TR-532)

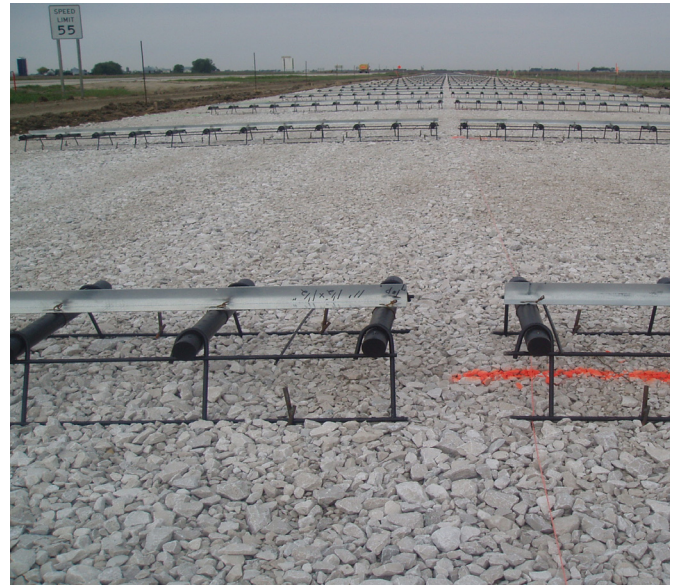
Cross-section of joint-forming device on top of the dowels

The joint-forming devices tested each consisted of a galvanized, L-shaped piece of metal placed in the area of the dowel basket to form the joint.

Six separate installations of six joints each (a total of 36 joint-forming devices) were made. The joint formers were placed either below the dowel baskets or on top of the dowels. The joint formers placed on the base were secured with dowel basket pins on approximately 610 mm centers along the joint formers. The pins were driven behind the L-shaped metal of the joint-forming devices (away from the paver) to prevent the metal from being overturned during paving. The joint formers above the dowels were secured with wire ties to the dowels themselves at 305 mm intervals to prevent rollovers.

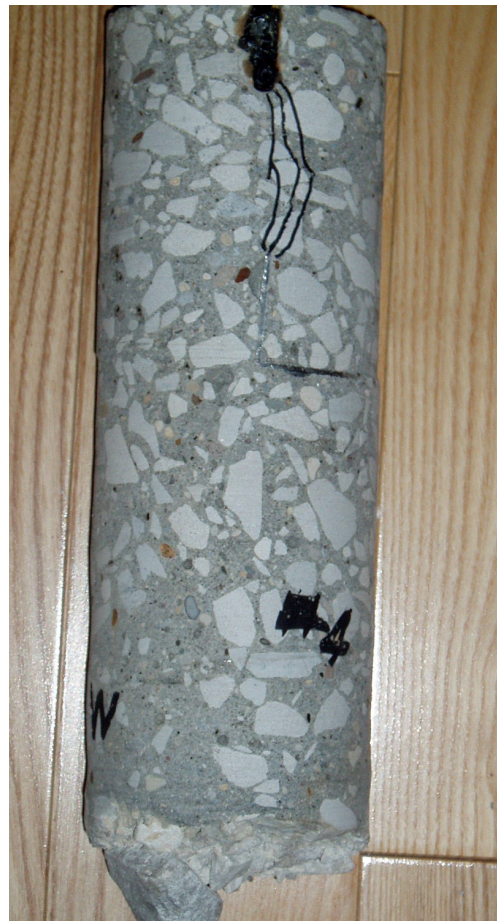
Core sample showing a crack extending from the joint former

- Most of the sawed joints around the test sites did not crack completely through the slab in the first 30 days after paving. In many cases, a crack only occurred late in the month on every sixth to eighth joint.
- Weather may have significantly influenced the results. The cool spring temperatures and small amounts of rain may have hindered the slab from curing and cracking.
- One core, taken from a section where the joint former is above the dowels, contains a crack that extends between the top of the joint former and bottom of the sawed joint. However, it is not possible to determine which way the crack initiated.
- In the cores taken across the test sections, the joint former is offset from the sawed joint by up to 25 mm. This process may have initiated a long-term spalling problem or an irregular surface crack, but to date no such activity has been noted.
