# Remote Health Monitoring for Asset Management

**Final Report**  
**July 2008**

# REMOTE HEALTH MONITORING FOR ASSET MANAGEMENT

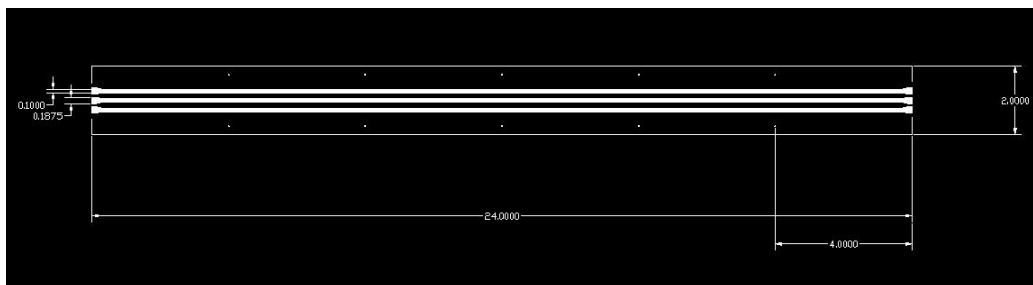
**Figure 3.3. AutoCAD drawing used for printing circuit boards**

The AutoCAD drawing of the trunk line design is shown in Figure 3.3. The trunkline design consisted of three conductor lines that run the length of a 24 in. board, a commonly available size for the circuit board materials. Solder tabs are etched at either end of the trunklines to enable the board to be connected by short wires, so that a 24 in. module can be manufactured and then several boards could be connected to create the appropriate length sensor array. The sensors themselves can be soldered to the trunk lines at any spacing interval; a sensor every three or four in. was selected as a suitable spacing for this project. This allows for up to four measurements per ft of pile, adequate for estimating the soil line depth along the pile. This spacing was based on discussions with bridge maintenance engineers that indicated that information on the depth of scour holes to the nearest ft was adequate for effective decision making and asset management. By placing three sensors per ft, measurement redundancy would exist to provide improved reliability in field applications, and ensure that system resolution met the requirement of determining the depth of a scour hole to the nearest foot.

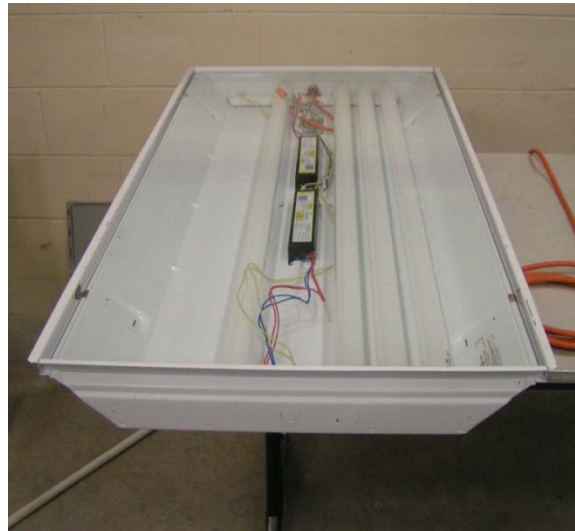
**Figure 3.4. Setup for exposing circuit boards**

Figure 3.4 below shows the setup used for exposing the circuit boards to ultraviolet (UV) light. Four fluorescent UV lights were used to maximize the amount of UV light along the entire length of the circuit boards. The large (24 in. long) circuit boards that were required for this project exceeded the size of the exposure beds that were available, and as such a new exposure bed needed to be developed. The exposure bed consisted of a common, 48 in. fluorescent light

fixture with a custom-made tempered glass lens. Testing was conducted to determine the optimum exposure times for properly exposing the board so that it could be etched to produce a clear pattern of conductive lines on the surface of the board. Several different commercially available ultraviolet lamps were tested to determine the appropriate wavelength of light to effectively expose the board to generate sharp, clear lines through the etching process.

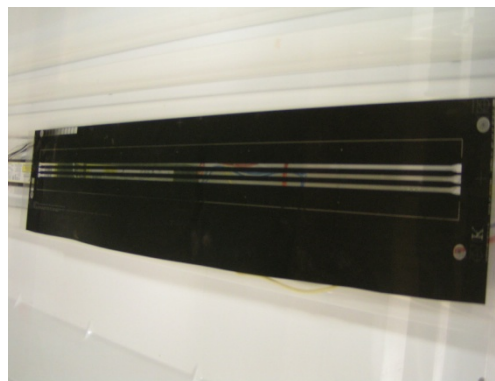
**Figure 3.5. Photonegative used for exposure**

Figure 3.5 shows the photonegative produced for exposure of the circuit board. This photonegative was produced by a local photography lab based on the AutoCAD drawing of the pattern for the board (See Figure 3.3). This photonegative was used to shield the stock board material. The UV light hardens the exposed film that covers the circuit board, so that the exposed areas of the board will not be etched in subsequent acid baths.

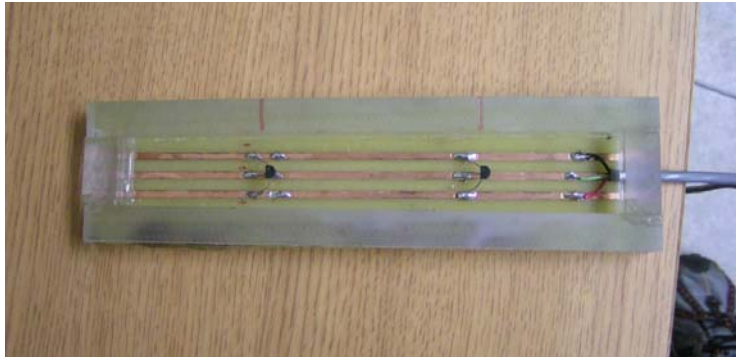
**Figure 3.8. Photograph of small test sensor array with two sensors**

Two different sized test arrays were created in the lab. The goals were to prove that the temperature measurement system worked effectively and expand our knowledge of what to expect from the actual pile deployment. A photograph of a small, two-sensor array can be seen below in Figure 3.8. In this photograph, the two DS18S20 sensors are soldered to the trunk lines along with the attachment cable that leads back to a standard PC. Communication with the sensors is achieved through the serial port of a standard personnel computer. The board material was attached to a polycarbonate frame as shown in the photograph. This frame allowed for the sensors to be potted inside a special epoxy that provides protection from damage to the sensors and supporting trunk lines, and has a high thermal conductivity (close to that of steel). Potting of the sensor array in the special epoxy allows for rapid conduction of changes in the thermal environment of the array, in addition to stabilizing the sensors to provide protection from the environment.

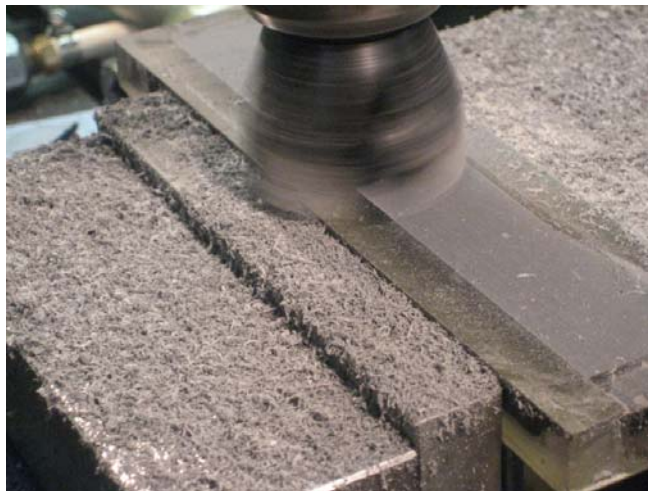
**Figure 3.9. Photograph of the milling operation to level epoxy**

After allowing the epoxy to harden for over 24 hr, it went through a mill to level the surface of the epoxy to the elevation of the polycarbonate walls. This provided a machined surface that could then be mounted onto the surface of any type of structure, for example, the side of a steel pile. The flat surface of the sensor array allowed for direct contact with the surface of the steel to ensure effective heat transfer across the joint.

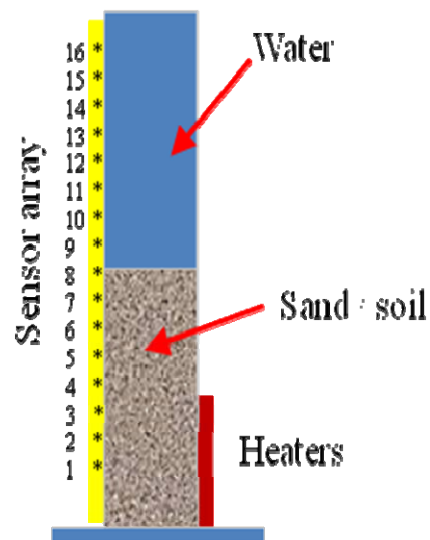
**Figure 4.1. Schematic diagram of test set-up showing heaters, sensor array, and sand/water interface**

The laboratory set-up included a 6 x 6 x ½ in. HSS member 48 in. in length to provide a model test pile as shown in Figure 4.1. This test pile was mounted on a 18 x 24 in. steel plate by angle clips. A rubber gasket was used to ensure that the HSS would hold water without leaking. The sensor array was attached to the outside of the pile. Inside the test pile, sand was placed in the pile up to a height of approximately 24 in., then the pile was filled to the top with water. During subsequent testing, the sand was replaced with soil. The test setup was intended to model the installation of the pile in the field, with the array and soil/water interface on opposite sides of the pile. In a field installation, the water and soil would be outside the pile and the sensor array would be installed within the pile, to measure the thermal behavior of the pile by attachment to the surface of the steel. This configuration was reversed for laboratory testing for convenience. This enabled the evaluation and testing of the effect of changing the temperature of the soil and water, and measuring these changes through the ½ in. steel pile wall.

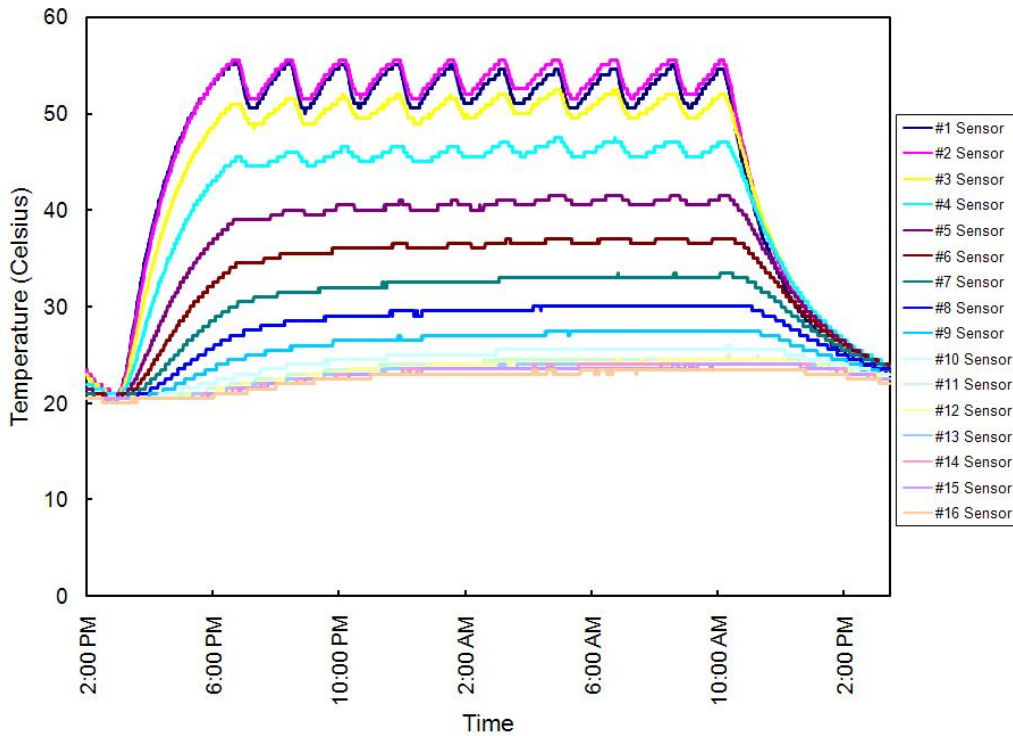
**Figure 4.6. Sensor array output during one-day, 55° test**

Results are plotted in Figure 4.6 for a test where the target temperature of 55 °C was maintained for about 18 hrs. Again, it took about the same amount of time to heat and cool, but this time the ninth and tenth sensors registered a significant differential from adjacent sensors. The maximum temperature reached by the coldest sensor was 25 °C. The figure illustrates that sensors 1 and 2 responded rapidly to the application of heat from the ceramic heaters mounted on the test pile.

The control system for these ceramic heaters turned the heaters on and off as a result of temperature measurements received from sensor 2. As a result of the thermal inertia of the steel pile filled with soil and water, there was a delay in the response of the system to applied heat. This delay manifested itself in the variations in the temperature measurements in time shown in the figure.

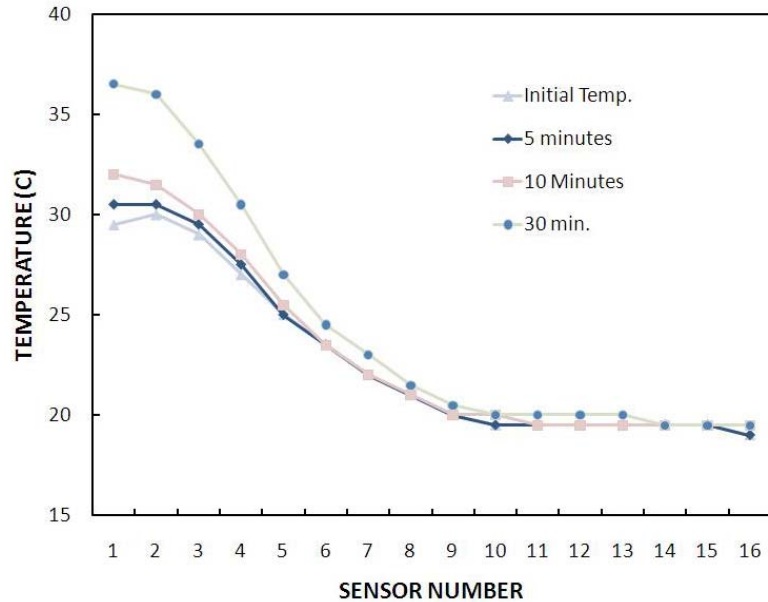
**Figure 4.7. Temperature gradient in the test pile during heating**

It is as useful to examine data from the test pile as the thermal gradient along the pile. Figure 4.7 shows the thermal output of the sensors along the length of the pile, starting with sensor 1 located nearest the heaters and ending with sensor 16, which is the furthest sensor from the heaters, located at the top of the pile. The vertical axis is temperature as usual. The figure shows the development of the thermal gradient in the pile as heat is applied by the ceramic heaters. As shown in the figure, the sensors nearest the heaters responded to applied heat, and a thermal gradient was developed in the pile as intended. Sensors farthest from the pile did not respond to the applied heat. It is also easier to see how much each sensor changed during the test; for example, the output of sensor 1 significantly changed in the final 20 min of the test. Graphing data as the gradient along the length of the pile improves the ability to identify where the soil/water interface exists, and how this interface changes over time. This is achieved by rotating the graph 90° so that it is aligned with the pile in the ground and with the sensors on the vertical axis from deepest in earth to the water on top.

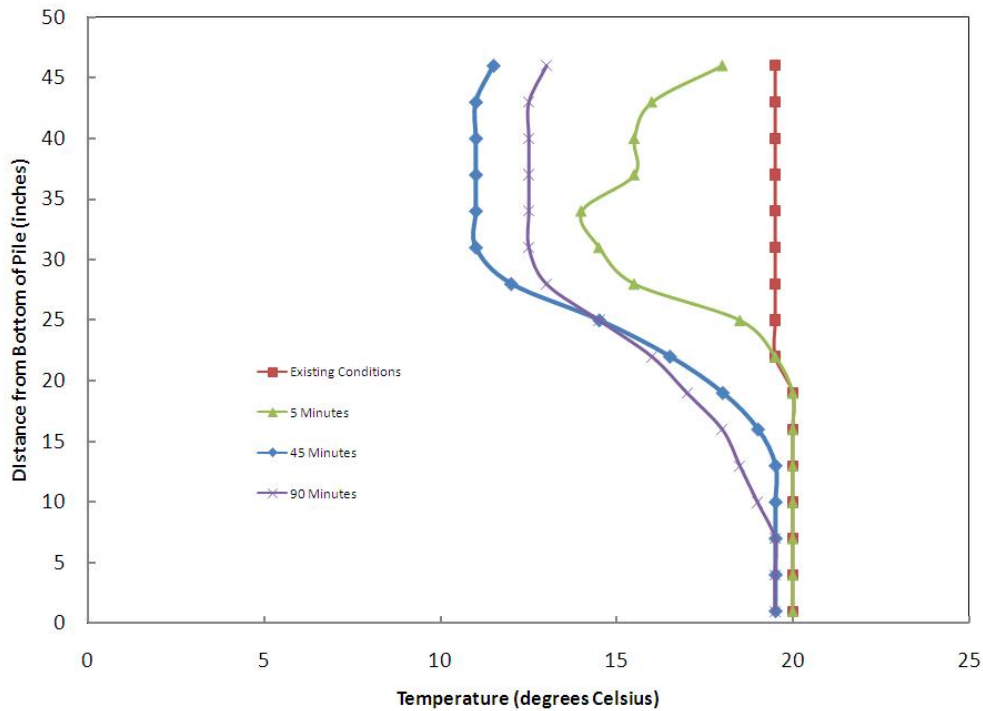
**Figure 4.10. Thermal gradient along the length of the test pile during cold water test**

fill the test pile with cool water during the testing, to model the behavior of running water in a streambed. The water in the test pile was replaced with cool water. This was done by using two siphons, one deep in the pile to remove the ambient temperature water, and one pouring cool water into the pile. The results of this test are shown in Figure 4.10, which shows a number of thermal profiles of the pile at different times after the initiation of the water exchange in the test pile. The figure shows the thermal profile in the pile at the initiation of the test (existing conditions), and 5, 45, and 90 min. after the test initiation. The large difference in temperature of the water and dirt created results that clearly showed the interface to be between the fifth and the 11th sensor, corresponding to 13 and 31 in. from the bottom of the test pile. The actual interface is located at approximately 24 in. from the bottom of the pile. As illustrated in the figure, the interface resulted in a significant change in the thermal gradient along the pile that was detected by the sensor array. This test illustrates that the sensor array prototype is capable of making the desired measurement to monitor changes in this water/soil interface. A total temperature difference of 8.5°C existed between the hottest and coldest sensor.

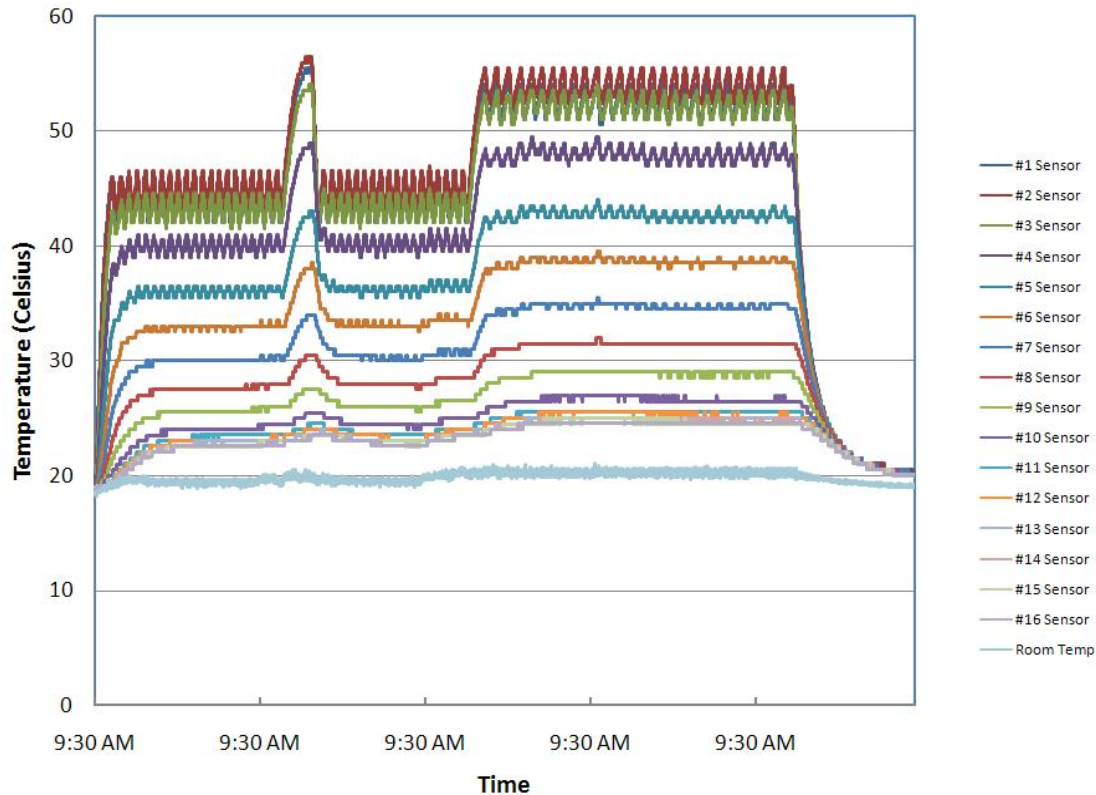
**Figure 4.11. Results of monitoring the sensor array over a five-day period**

Figure 4.11 shows the output of the sensor array mounted on the test pile over a time period of five days, with several changes in thermal conditions impressed on the pile by the ceramic heaters. During this particular test, the temperatures ranged from 18.5°C to 56.5°C. Room temperature remained just below 20°C for the duration. When the test began, the whole pile was at room temperature. The heater control temperature was set to 45°C for over 24 hours. The control temperature was then raised to 60°C and returned back to 45°C as it approached this control temperature. The control temperature was again raised to 55°C and allowed to stay there for almost 48 hr. The heater was then shut off so that the pile could return to room temperature.

This test and others that have been run in the lab illustrate that the software developed is capable of storing data over long time periods, and that the sensor array performs as expected. The array responded effectively to temperature changes, illustrated very little noise, no electronic drift over time, and consistently registered data.
