Sponsored by
the Federal Highway Administration (Project 16)

IMPACT OF CURLING, WARPING, AND OTHER EARLY-AGE BEHAVIOR ON CONCRETE PAVEMENT SMOOTHNESS: EARLY, FREQUENT, AND DETAILED (EFD) STUDY

**Phase I Final Report
December 2005**

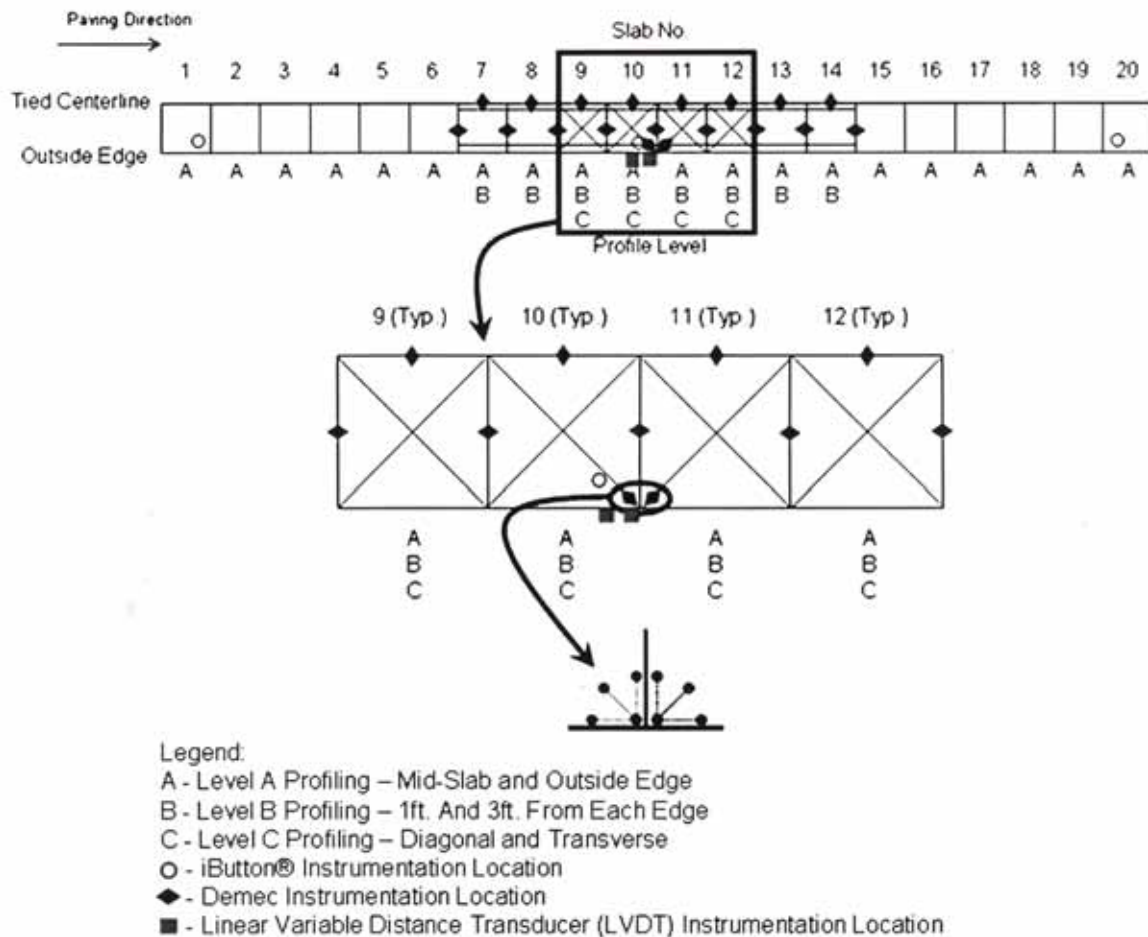
Figure 4. Instrumentation layout

Two test sections, as shown in Figure 3, were selected to represent the entire pavement length. The selection criteria outlined in the overall testing plan included selecting a relatively flat grade and avoiding horizontal curves. Figure 4 diagrams the test sections and depicts the location of instrumentation within the 300-ft sections, including the corner Demec instrumentation at the free edge corners of slabs 10 and 11 (typical).

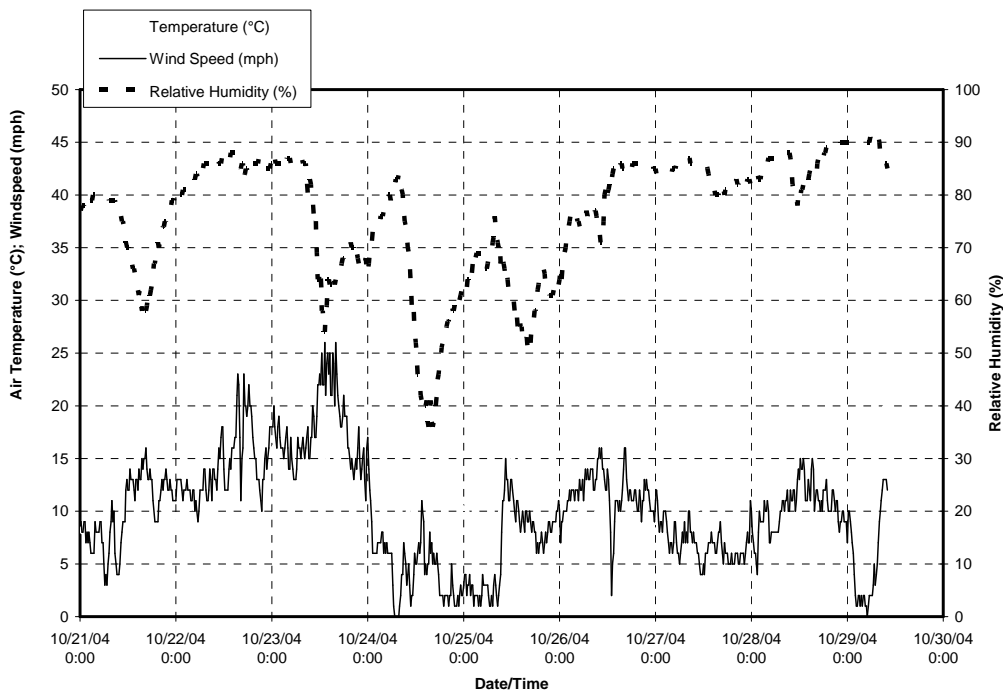
Figure 5. Recorded environmental conditions

warmer at the bottom than at the top. The maximum upward curling condition generally occurs during early morning hours, just before sunrise. In a similar manner, downward slab curling occurs when the top of the slab is warmer than the bottom. The maximum downward curling condition generally occurs around noon or in the very early afternoon, when the surface of the slab is heated by the sun. These maximum conditions are highly dependent on climatic conditions, such as cloud cover, but in general these are the timeframes for the maximum slab temperature gradient. The project team documented the diurnal cycles by continuously recording the environmental conditions before, during, and after construction, as shown in Figure 5.

While the degree of slab curvature ultimately depends on the curvature “built in” during construction, the majority of JPCP pavements exhibit diurnal changes in slab curvature. To accommodate for the additional effects of heat generated through cement hydration, two test sections were instrumented to correspond to morning and afternoon construction. This diurnal testing of multiple sections provides a better understanding of the changes in slab curl that occur on a daily basis.
