Evaluation of the 24th Street Bridge

tech transfer summary

November 2010

Accelerated construction methods using precast deck panels were implemented and evaluated on the 24th Street bridge in Council Bluffs, Iowa.

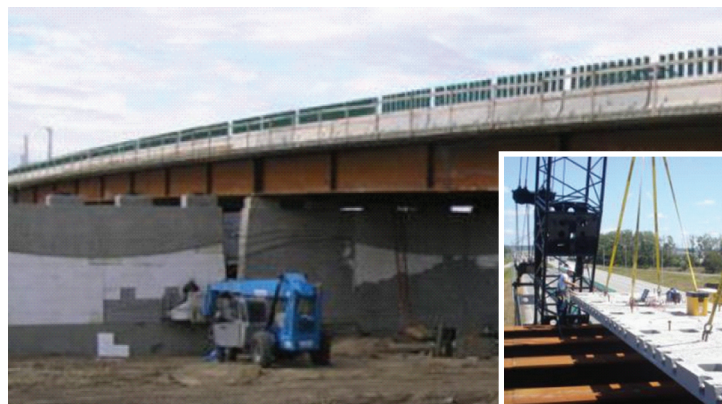
Girders on west center pier during Phase I construction

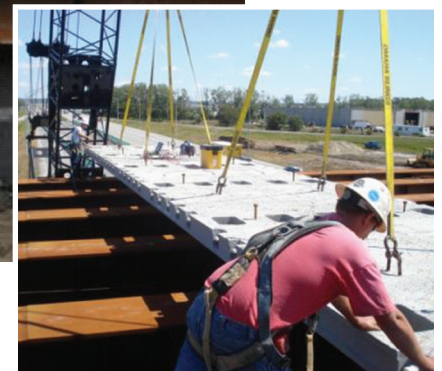
Placing precast deck panel on girders

The deck panels are 10 ft long x 52 ft-4 in. wide x 8 in. thick. Each panel has 28 1 in. x 3 in. embedded ducts to house four longitudinal post-tensioning strands, which run the full length of the bridge. Each panel is transversely prestressed with 10 1/2 in. diameter strands.

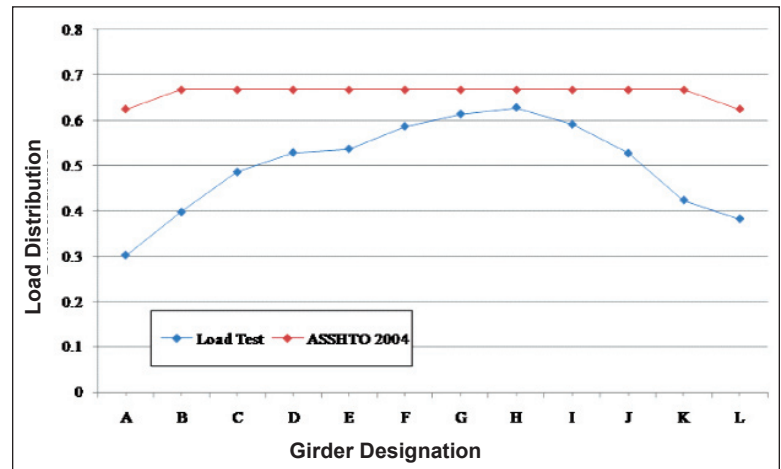
Experimental and codified load distributions for 24th Street bridge

- The largest load distribution factor was 0.63. The load distribution factors obtained from field testing were within the American Association of State Highway and Transportation Officials (AASHTO) Load and Resistance Factor Design (LRFD) load distribution requirements.
