Evaluation and Testing of a Lightweight Fine Aggregate Concrete Bridge Deck in Buchanan County, Iowa

Final Report
May 2016

Sponsored by
Iowa Highway Research Board
(IHRB Project TR-648)
Iowa Department of Transportation
(InTrans Project 12-434)
Federal Highway Administration

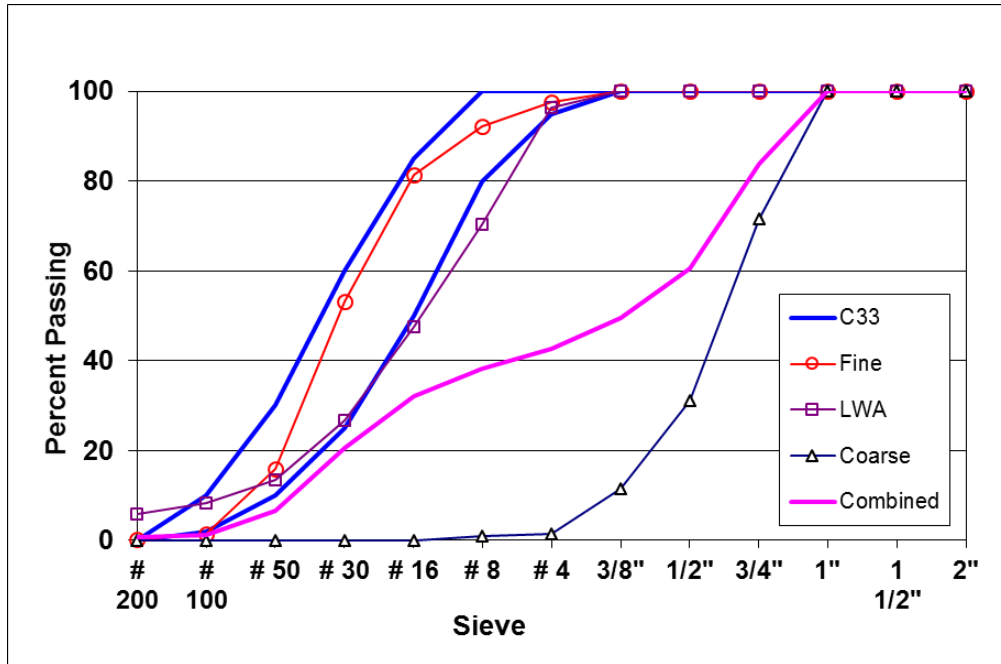
Figure 1. Aggregate gradations

The gradations of aggregate used in both the control and IC mixes are shown in Figure 1.

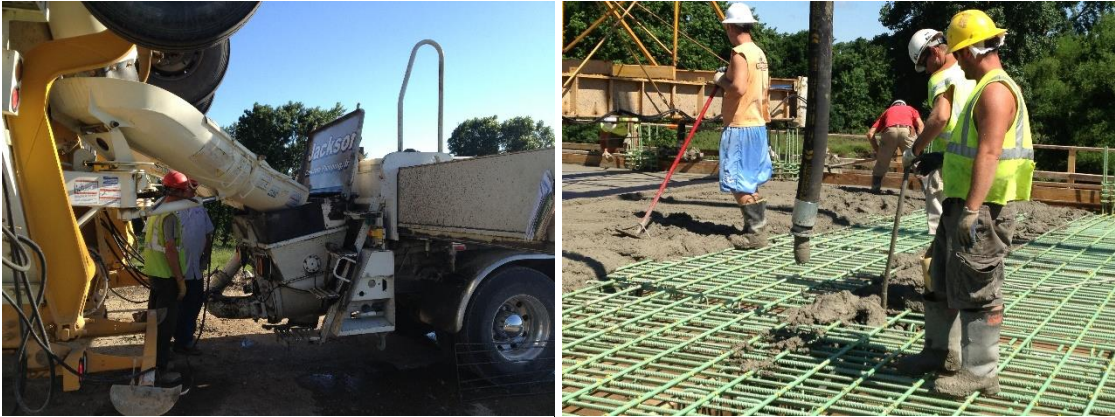
Figure 8. Concrete being discharged to a pump truck and then to the deck

Figures 8 through 11 illustrate some activities during the placing process.

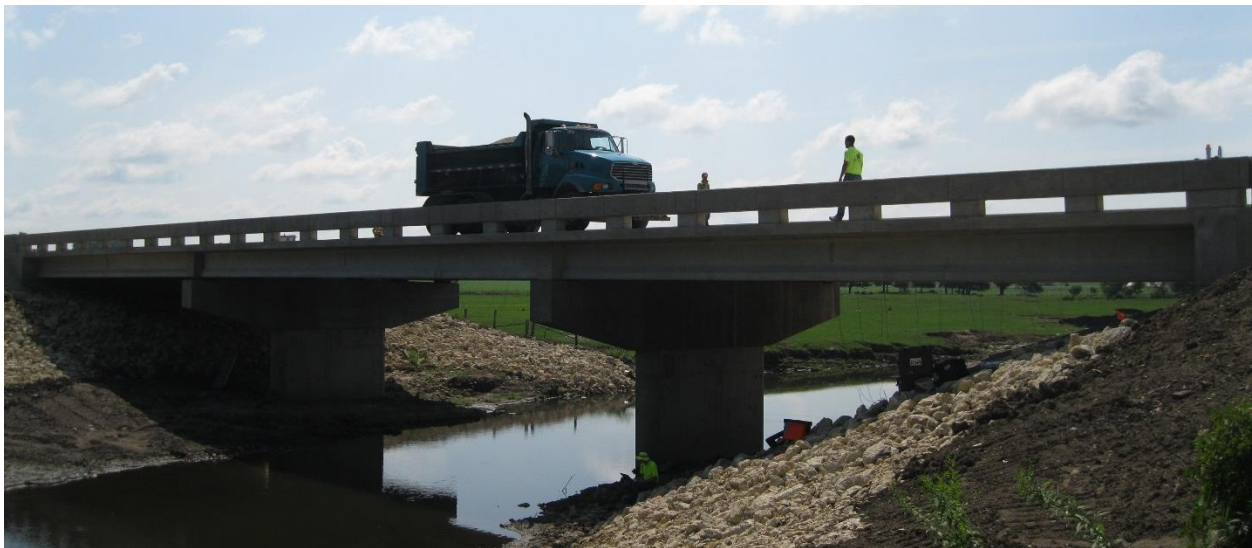
Figure 12. Live load testing of LWFA bridge, 2013

Following construction of the LWFA bridge, the Bridge Engineering Center (BEC) conducted live load tests of the bridge on three separate occasions: (1) immediately following construction just before the bridge was open to traffic (August 2013), (2) approximately one year after the initial load test (August 2014), and (3) approximately two years after the initial load test (November 2015). All three load tests involved instrumenting the bridge girders and deck with strain transducers and conducting static load tests using a fully loaded tandem-axle dump truck of known weight (see Figure 12).

Bridge Diagnostics, Inc. (BDI) strain transducers and structural testing system were utilized for the testing, and the load truck was provided by the Buchanan County Secondary Roads Department.

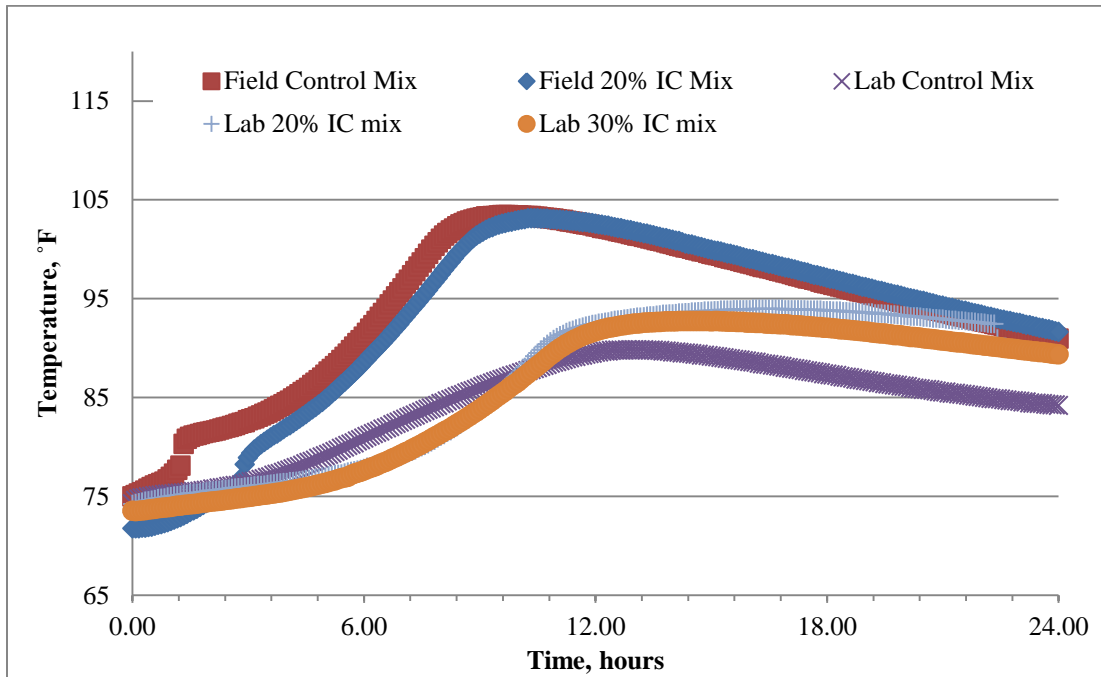
Figure 16. Calorimetry results for laboratory and field samples

Calorimetry results for both laboratory and field samples are shown in Figure 16.

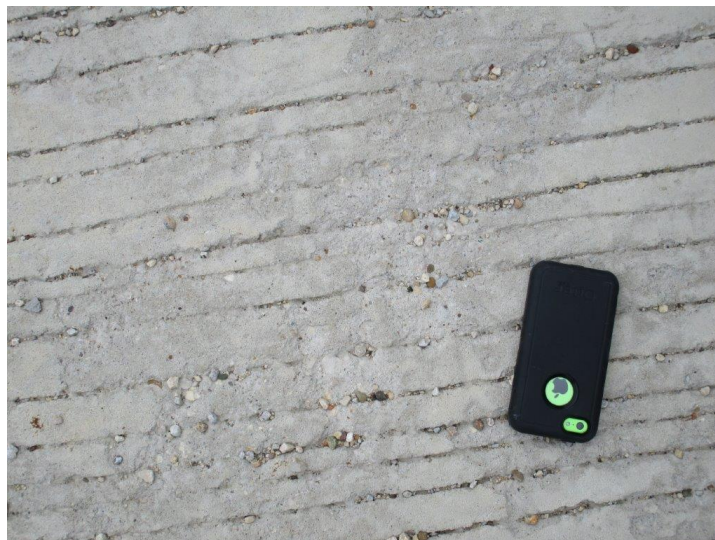
Figure 21. Limited scaling observed on the surface near drains

- No cracks were found.
- Slight scaling was observed on both control and IC sections near drains (Figure 21).
- Little observable difference was found between the IC and control sections.
