IMPACT OF DECK CRACKING ON DURABILITY

Sponsored by the Project Development Division
of the Iowa Department of Transportation
and the Iowa Highway Research Board
Iowa DOT Project TR-405
CTRE Management Project 97-5

MARCH 2000

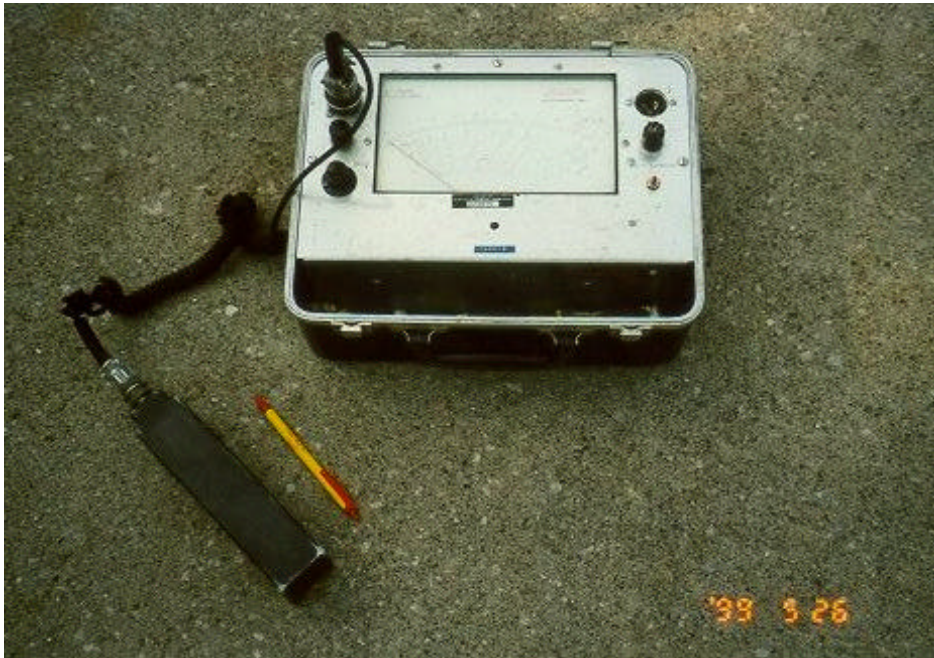
FIGURE 4.1 Pachometer Used to Locate Reinforcing Steel in a Bridge Deck

The depth of cover can be obtained by using a nondestructive pachometer or a “covermeter,” by drilling small diameter holes to expose reinforcing steel for direct measurement, or by measuring the cover depth in extracted cores (8). Covermeters determine the depth of cover by measuring variations in magnetic flux caused by the location of steel. For the covermeters to be accurate, the size of reinforcing steel has to be known so that the readings can be interpreted for depths.

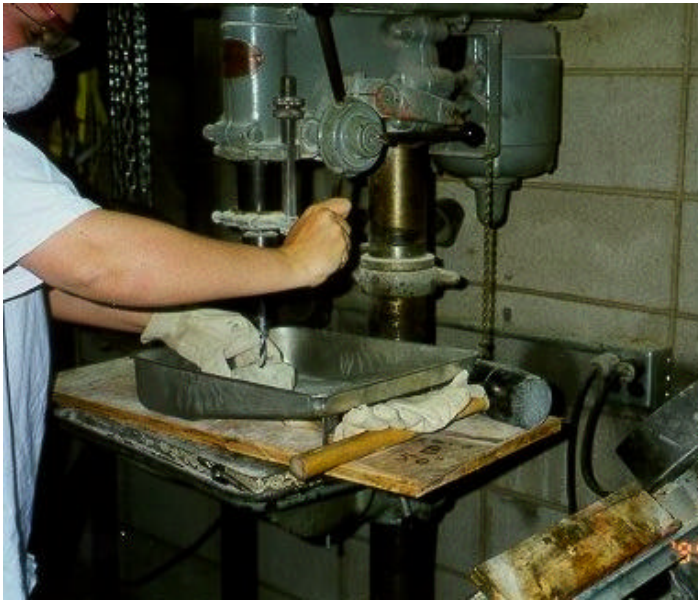
Figure 4.8 Collection of Powder Samples

Collection of powder samples is shown in Figure 4.8. At least 20 grams of powder were collected for chloride content analysis. Four powder samples were collected from each core using three-eighths-inch drill bit. The location of these samples were at 0.5 inches below the surface, midway between the first sample and rebar level, rebar level, and one inch below the rebar level.

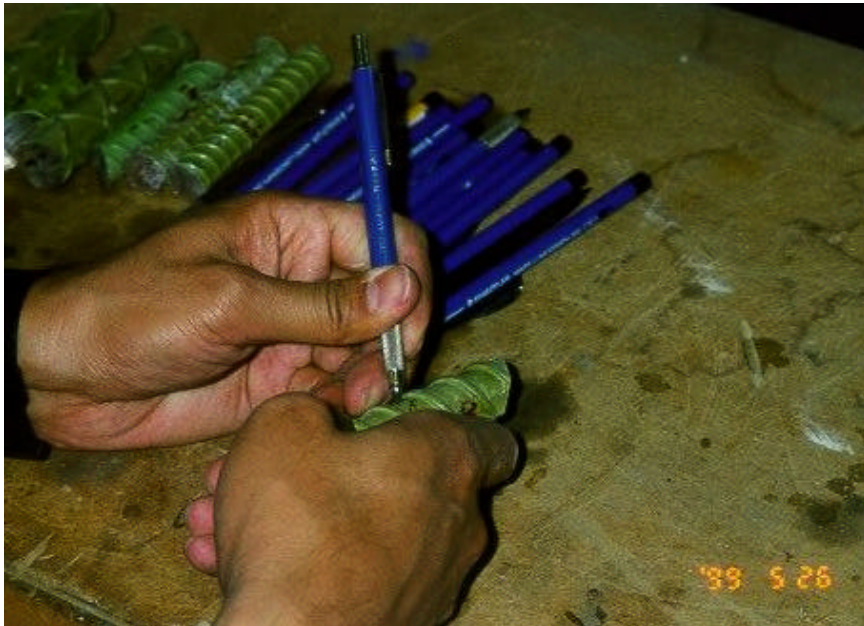
FIGURE 4.9 Coating Hardness Test

The pencil hardness ratings (see section 4.2.5) of the epoxy coatings gave results ranging from four to seven, with most rebar samples exhibiting a rating of six. There was a slight trend showing an increase in hardness with bridge age. Also, the rebar samples with ratings of 7 (the hardest samples seen in the study) all came from bridges built from 1980 to 1983. An insignificant difference in hardness between the most discolored areas and the least discolored areas of the epoxy coatings was noticed. Therefore, no relationship between epoxy hardness and rebar rating or epoxy hardness and chloride content was observed from the data.

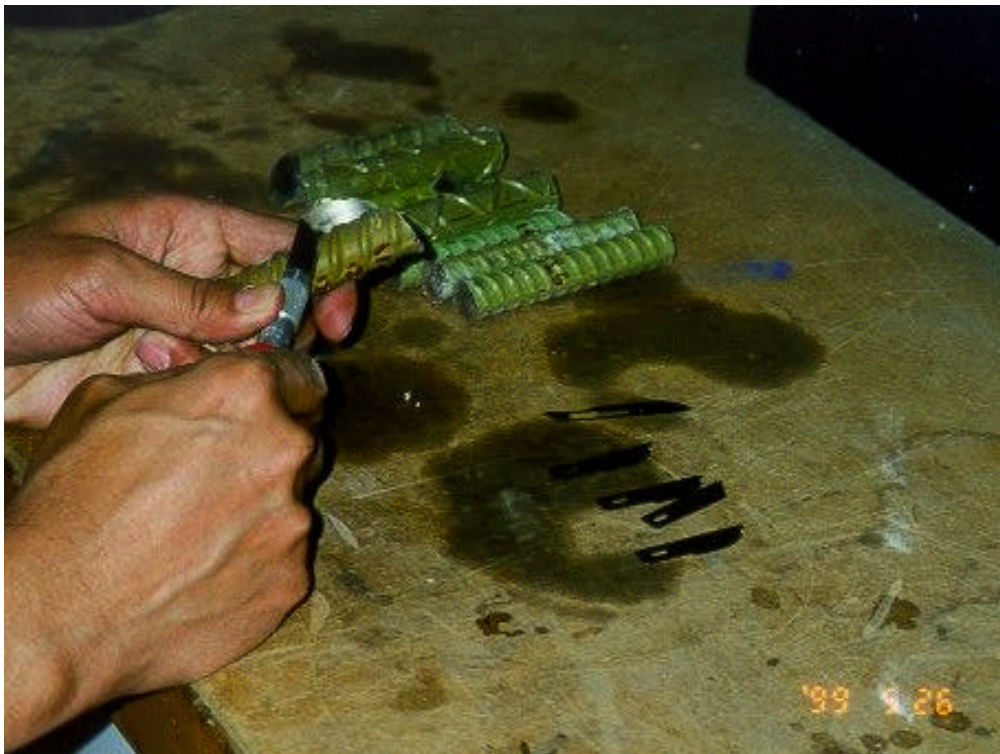
FIGURE 4.10 Epoxy Coating Bond Test

To determine the coating bond in between steel and coating film, the dry knife adhesion test was performed for each rebar as shown in Figure 4.10. The recommended standard procedure is described in NACE TM-0185, section 5.3.2.1, as follows:

The recommended method for determining adhesion is to cut the coating to the base metal using a Number 22 hobby knife blade. The point of the blade shall be drawn across the film (using multiple cuts if necessary to cut a single V-shaped groove. Using the sharp side of the blade as a wedge, the coating film should be pried up within the groove. The exposed base should be observed under a 10 to 15X microscope to determine adhesion performance. An average of three attempts shall be used to rate the sample.

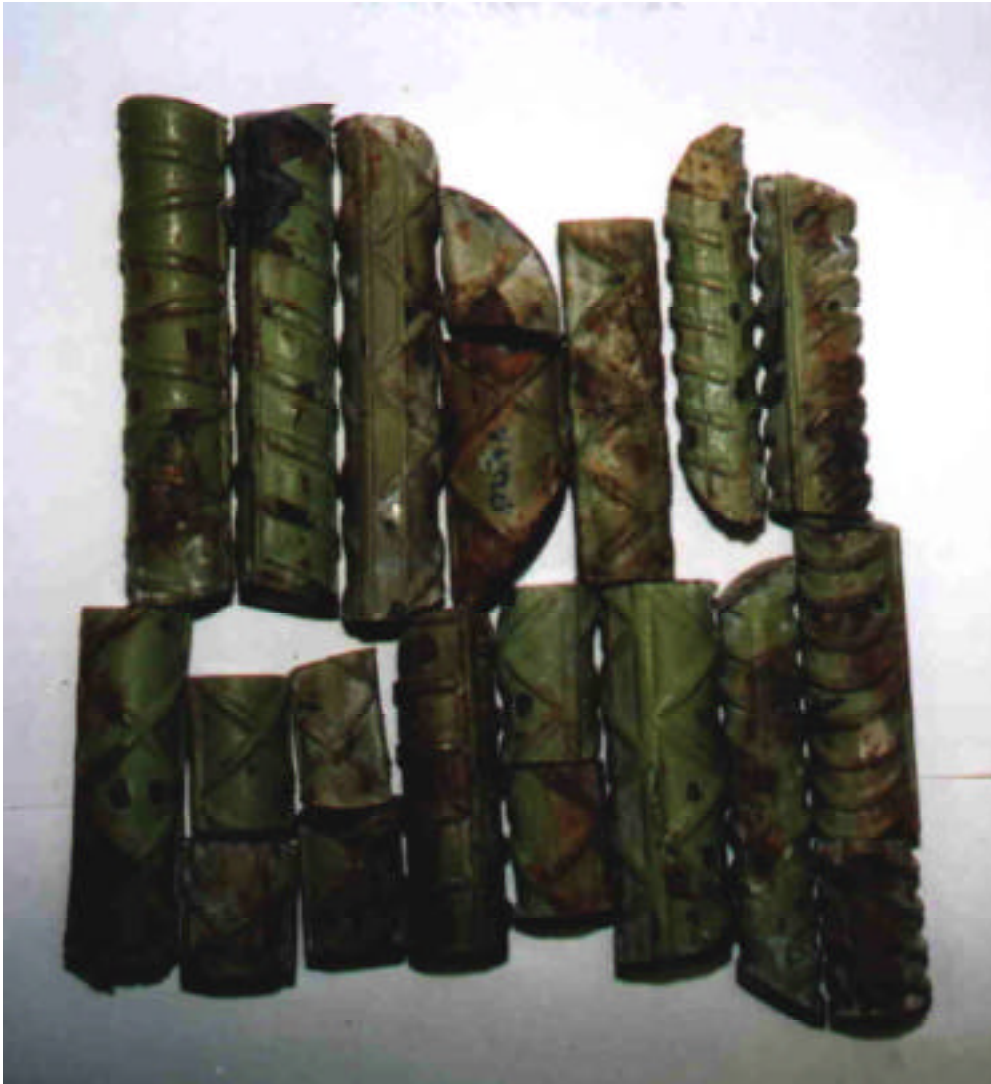
FIGURE 6.3 Rebars Samples with Significant Corrosion

Evaluation of the rebar samples collected from the bridge decks that were included in this study indicated a range of deterioration. The most corroded rebar samples were those collected from cracked locations. Although most of this corrosion was only on the surface of the steel, a couple samples were observed to have spots where corrosion product had built up slightly underneath the epoxy coating. The largest area of these spots observed was about two centimeters squared and bulged out to a depth of about one to two millimeters. One of the most significant findings from this study was that all of the rebar samples that were evaluated as having a rebar rating of one, two, or three came from cores that were taken from cracked locations. On all of the rebar samples rated one, two, or three, it appeared that surface corrosion was undercutting the epoxy coating. Figure 6.3 shows some of the rebar samples evaluated in this study that were given a rebar rating of one, two, or three.
