**Material and Construction Optimization for
Prevention of Premature Pavement Distress
in PCC Pavements**

**Annual Report (Phase I)
September 2004**

**Study TPF-5(066)
Transportation Pooled Fund Program
Federal Highway Administration
U.S. Department of Transportation**

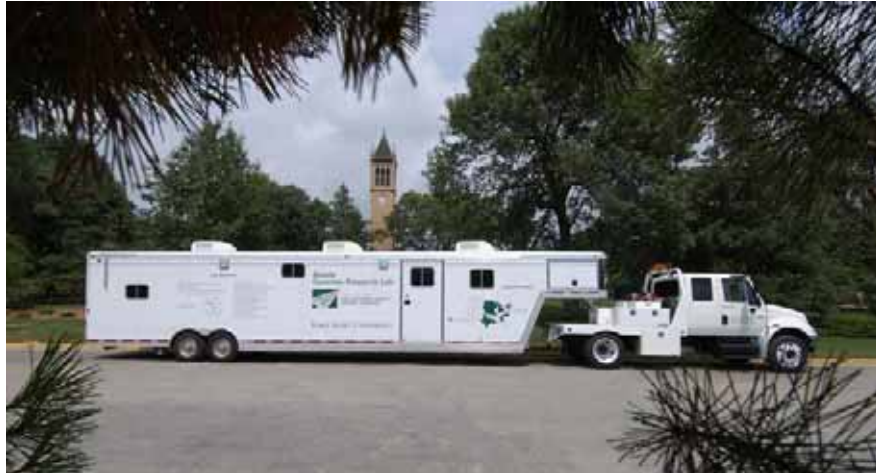
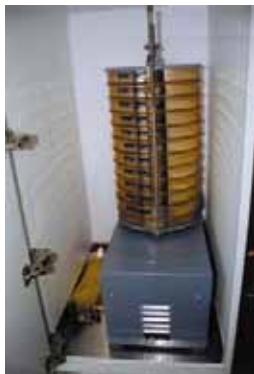
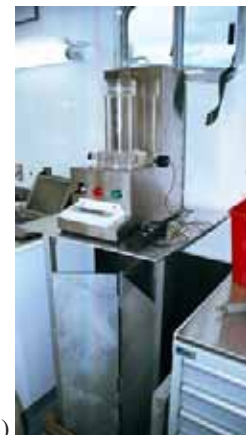
See Figure 2.

The AVA is a very sensitive machine that has been considered only usable in permanent buildings, thus limiting its use in field control. Because any vibration, such as that caused by wind, can dramatically skew the AVA's results, the trailer was designed with a trapdoor in the floor to accommodate the AVA. When the lab is parked, the base of the AVA will rest on the ground through the hole so that it is protected by the trailer but not touching the trailer. This will allow accurate use in the field.

Weather data will be recorded using the lab's weather station and GPS capabilities from the beginning of testing at a project site until the testing is complete.
