Innovative Solutions for Slope Stability Reinforcement and Characterization: Vol. I

Final Report
December 2005

Sponsored by
the Iowa Highway Research Board
(IHRB Project TR-489)
and
the Iowa Department of Transportation
(CTRE Project 03-127)

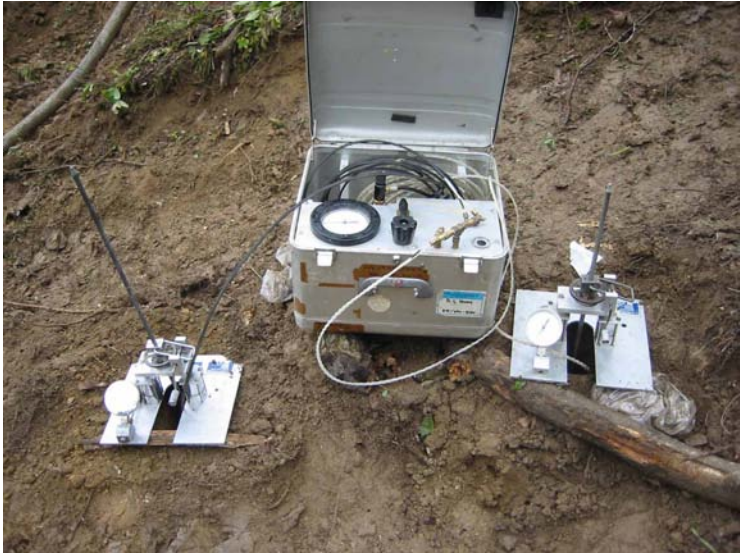
Figure 1. Borehole shear test device

(a) base plates and pressure console

(c) high pressure shear plates after shearing

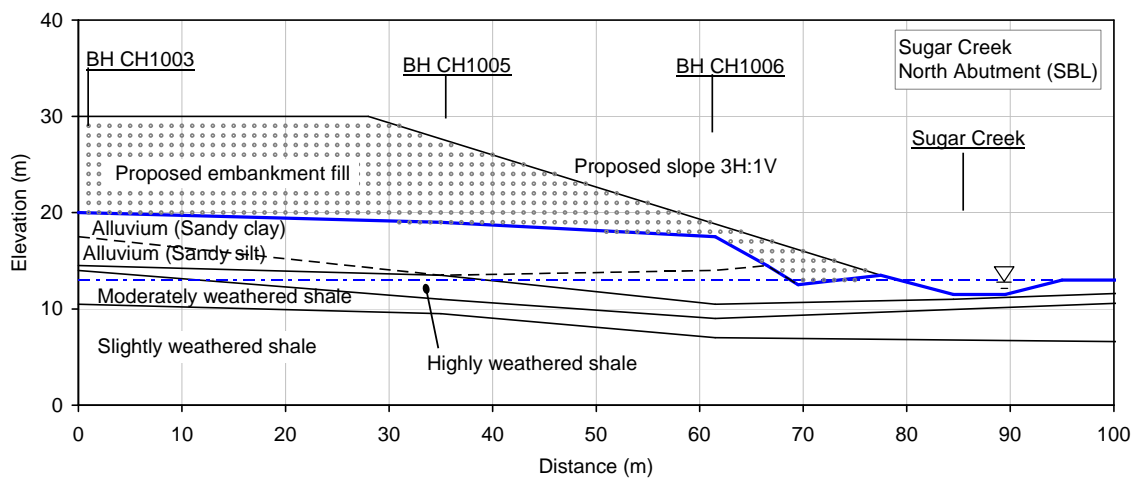
Figure 3. Soil profile for the embankment slope

The site for the Sugar Creek embankment slope project was characterized, and engineering properties for soils were investigated. Both the stratification and shear strength values of the soil were highly variable. The classification of weathering of the shales that was specific to the site was proposed as an aid in characterizing the slope instability. It was found that the classification of weathering could not be purely relied on the index properties of the shales, but it was consistently correlated with shear strength values of the shales. The shear strength values obtained from different methods did not exactly match, but were comparable and showed reasonable agreement, considering the variable nature of the soil. The internal friction angles obtained from BST were generally lower than those obtained from direct shear tests, while the cohesion intercepts obtained from BST were generally larger than those from direct shear tests, for both the alluvium and the highly weathered shale. This observation could be mainly attributed to soil variability, test methods, and shear strength anisotropy. The use of the weathering classification and the measured shear strength values are expected to be economical and safe for the slope design and ground improvement measures.

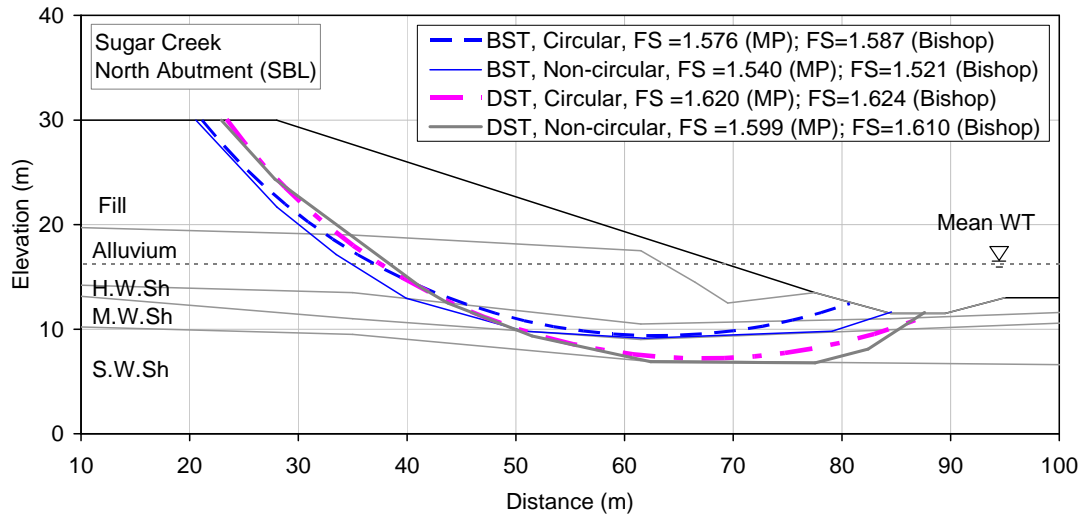
Figure 5. The circular and non-circular critical slip surfaces corresponding to the different shear strength parameter values obtained from BST and DST

- With respect to the assumed slip surfaces, the non-circular critical slip surfaces gave lower factors of safety, but the circular “critical” slip surfaces gave higher probability of failure, indicating the inconsistency on the locations of the “critical” slip surfaces resulted from the uncertainties of the input parameters.

- Morgenstern-Price method and Bishop simplified method gave very close results on circular slip surface, but gave considerably different results on non-circular slip surface, especially with respect to the probability of failure. This may be due to the limitations of Bishop simplified method on non-circular slip surface.

- The results of the probabilistic slope stability analyses performed on the Sugar Creek embankment slope show that the location of the critical slip surface using the BST shear strength parameter values is different from that using the DST values. The calculated factors of safety against slope instability are slightly smaller and the probability of failure is higher, when using the BST values compared to the DST values. The difference in results is due to the BST measurements providing a lower mean value but larger variability than the DST measurements.

- With respect to the assumed slip surfaces, the non-circular critical slip surfaces gave lower factors of safety, but the circular “critical” slip surfaces gave higher probability of failure, indicating inconsistency on the location of the “critical” slip surface resulted from the variability in the input parameters.

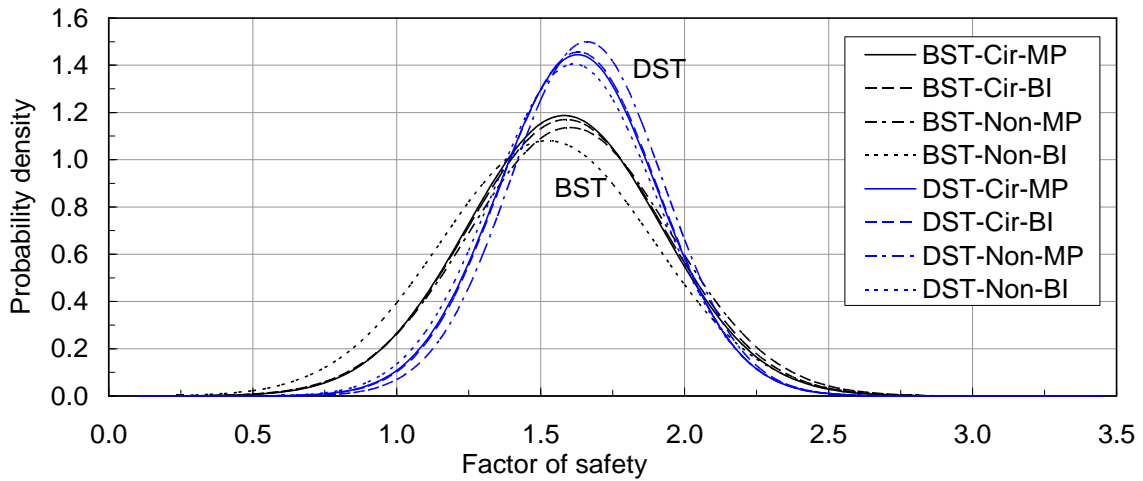
Figure 6. Probability density functions of factor of safety

- The calculated factors of safety against slope instability are slightly smaller and the probability of failure is higher when using the BST values compared to the DST values. The difference in results is due to the fact that BST measurements have lower mean values but more variability than the DST measurements. The higher variation in BST measurements may be a result of testing on the same soil, while DST averages three or more soil samples.

- The highly weathered shale contributes much more to the overall probability of failure when using the BST measurements compared to the DST measurements.

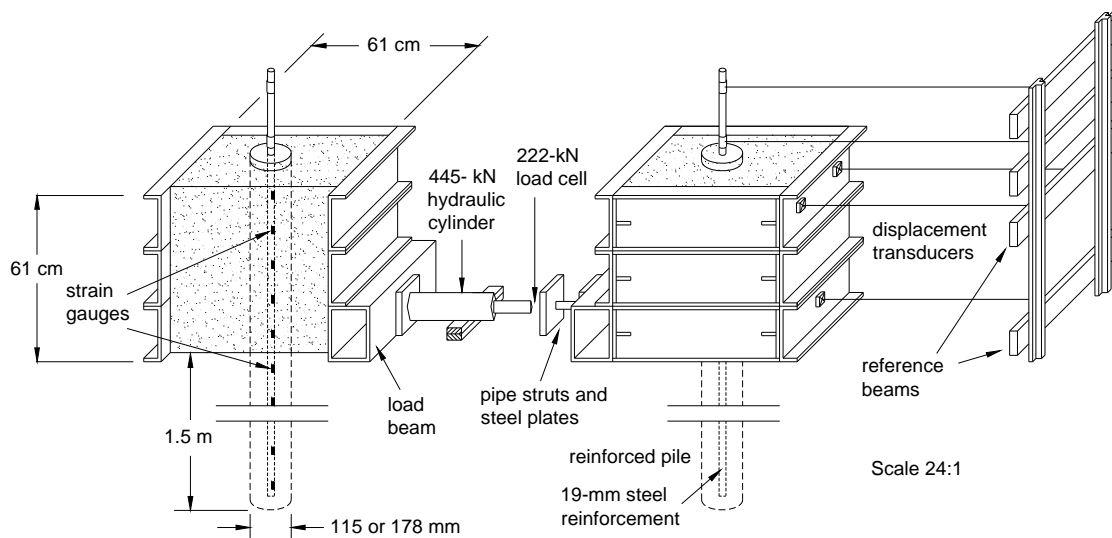
Figure 7. Large-scale direct shear test set-up

The field testing program consisted of measuring the shear strength of soil reinforced with pile elements. The pile load tests were performed in a manner similar to large-scale direct shear tests. The direct shear boxes contained compacted soil with known properties and piles that extended through the box into existing ground. The shear boxes were pushed laterally to impose uniform lateral translation of soil, modeling the movement of a unit cell of a sliding soil mass. The interface of the shear box and the at-grade elevation resembled the failure surface of a slope failure, and the soil below grade resembled the stable soil of a slope in which piles are installed to provide passive resistance to movement. Instrumentation of the direct shear boxes (displacement gauges and load cell) was installed to measure the load-displacement response of the reinforced soil. Instrumentation of the pile reinforcement (strain gauges) indirectly indicated the loads induced on the piles due to lateral soil movement and the pile response to the loads. Figure 7 shows the large-scale direct shear test set-up.

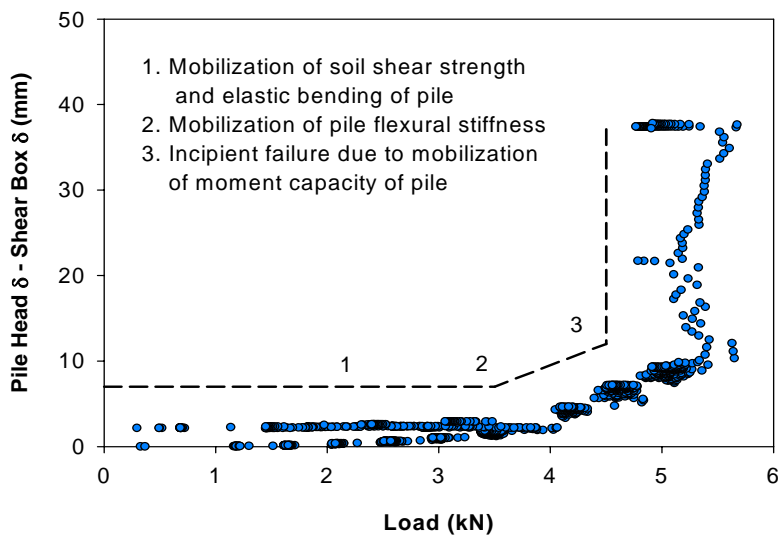
Figure 8. Behavioral stages of piles subject to lateral soil movement (Pile 4)

The relative displacement of shear boxes and pile heads are provided to support the observed pile behavior during the performance of the load tests. During loading, a gap formed in front (i.e. load-side) of the pile at the soil surface. Figures relating gap width (corrected pile head δ – shear box δ) and load, in addition to displaying the test data, indicate the behavioral stages of piles subject to lateral soil movement. Figure 8 illustrates the behavioral stages, as follows:

- Stage 1 – mobilization of soil shear stresses and elastic bending of pile,
- Stage 2 – mobilization of pile flexural stiffness, and
- Stage 3 – incipient failure due to mobilization of pile moment capacity

Stage 1 is characterized by relatively linear behavior of the soil and the intact pile element. The stress development at the soil-pile interface is insufficient to cause yielding of soil or cracking of the pile, such that a gap of negligible width forms. Stage 2 commences with the development of a bending moment in the pile element that causes the tension-carrying concrete to crack. The pile stiffness immediately drops, and the pile element becomes more flexible. Further loading of the pile causes more rapid pile rotation and pile head deflection. Coincidentally, the gap formation occurs more rapidly. Stage 3 commences with the mobilization of the pile moment capacity. Gap formation which occurs during Stage 3 occurs under constant load. The failed pile element is incapable of carrying additional load. Gaps of significant width (approximately 10 mm) form with the mobilization of pile moment capacity. Table 7 provides the loads corresponding to each behavioral stage of loading.

- The relative soil-pile displacement at the soil surface indicates the behavioral stages of small-diameter piles as (1) mobilization of soil shear stresses and elastic bending of pile, (2) mobilization of pile concrete compressive strength, and (3) incipient pile failure due to pile moment capacity mobilization. The behavioral characteristics of slender piles are controlled by structural pile behavior through moment-curvature relationships as much as they are by soil behavior.
- Displacement-based lateral response analysis methods which use soil p-y curves accurately predict the deflection and bending moment of piles subject to lateral soil movement. From these pile behavior characteristics, pile shear may be calculated and applied to the limit equilibrium equation for evaluating global stability of reinforced slopes.

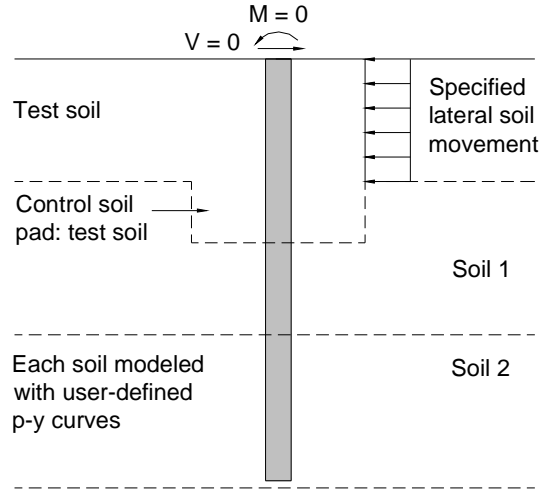
Figure 9. LPILE analysis setup

The *LPILE* analysis setup and corresponding free-field slope movement assumption is illustrated in Figure 9. Structural behavior of piles followed the moment-curvature relationships of reinforced concrete pile sections, as previously discussed. The shear and bending moment at the pile head equaled zero to satisfy pile head fixity conditions. The final input for performing the analysis was the free-field horizontal soil movement. Soil movements corresponded to the uniform lateral translation of the shear boxes imposed during the experimental testing. This soil movement was measured and, therefore, available for input into the analysis.

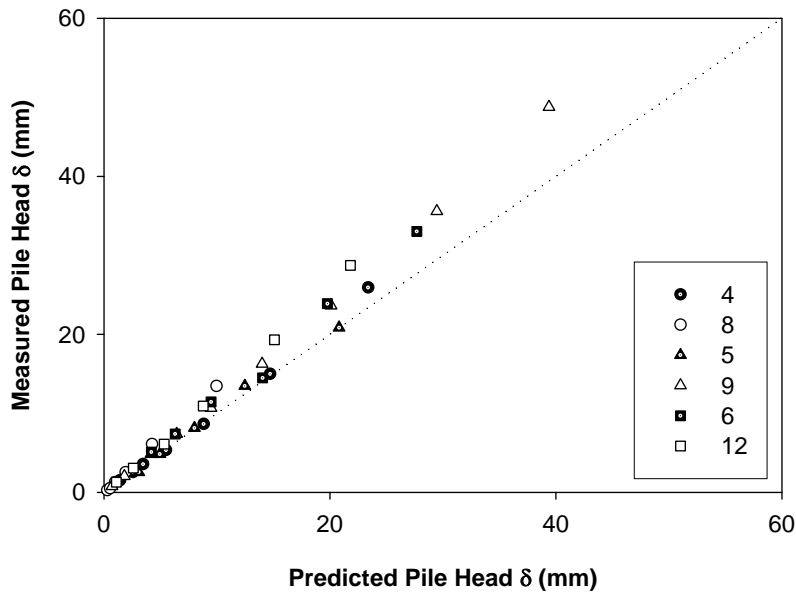
Figure 10. Pile head deflection correlation for isolated piles

The objective of the load test analysis was achieved by comparing measured pile behavior with predicted pile behavior estimated from the finite difference method. Correlation of pile head deflection and maximum moment values indicated that the predicted soil reaction matched the loading condition achieved during testing. The correlations of measured and predicted values of pile head deflection and maximum moment were linearized by plotting measured data against predicted data. Ideal correlation, in which measured data equals predicted data, was indicated by a 1:1 line, provided in the figures as a reference. Figures 10 and 11 indicate that statistically-significant correlation of measured and predicted pile behavior was achieved.
