RCC Design Future? Results from LTRC's Accelerated Loading Facility

LTRC Project 12-7P

Spring TTCC/NCC Meeting, Columbus, OH

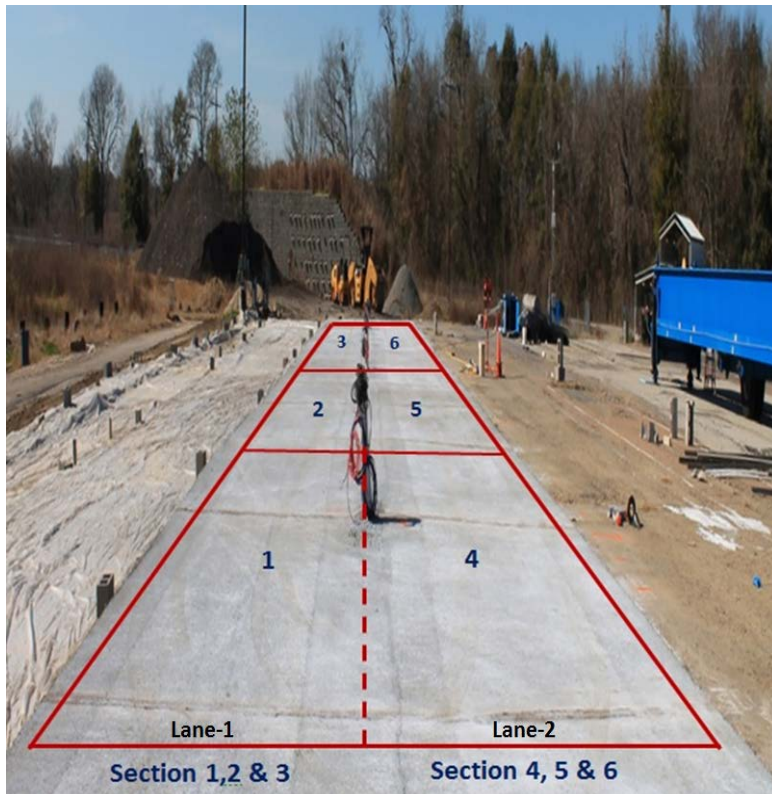
Constructed RCC Test Sections

- Six full-scale RCC pavement test sections were constructed at Pavement Facility of Louisiana Transportation Research Center (LTRC)
 - Each section: 71.7-ft long and 13-ft wide

8 " RCC
12 "Cement Treated Base
Existing Subgrade

Section 1
(8+12RCC)

6 " RCC
12 "Cement Treated Base
Existing Subgrade

Section 2
(6+12RCC)

4"RCC
12 "Cement Treated Base
Existing Subgrade

Section 3
(4+12RCC)

8 " RCC
8.5" Soil Cement Base
10" Cement Treated Subgrade
Existing Subgrade

Section 4
(8+8.5RCC)

6 " RCC
8.5" Soil Cement Base
10" Cement Treated Subgrade
Existing Subgrade

Section 5
(6+8.5RCC)

4"RCC
8.5 "Soil Cement Base
10" Cement Treated Subgrade
Existing Subgrade

Section 6
(4+8.5RCC)

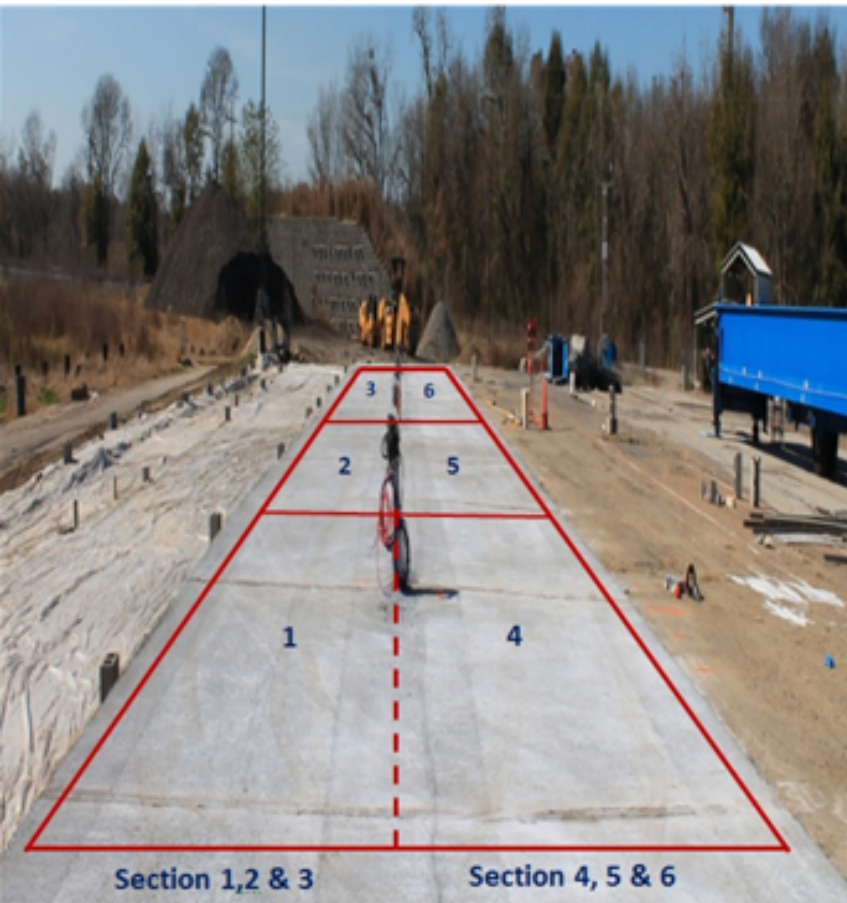
FWD Backcalculated Layer Moduli

$E_{RCC}=3587\text{ksi}$
 $E_{base}=258\text{ksi}$
 $E_{sub}=27\text{ksi}$

$E_{RCC}=2361\text{ksi}$
 $E_{base}=181\text{ksi}$
 $E_{sub}=24\text{ksi}$

$E_{RCC}=2904\text{ksi}$
 $E_{base}=139\text{ksi}$
 $E_{sub}=22\text{ksi}$

$E_{RCC}=3767\text{ksi}$
 $E_{base}=418\text{ksi}$
 $E_{sub}=31\text{ksi}$

$E_{RCC}=3763\text{ksi}$
 $E_{base}=352\text{ksi}$
 $E_{sub}=28\text{ksi}$

$E_{RCC}=4384\text{ksi}$
 $E_{base}=305\text{ksi}$
 $E_{sub}=26\text{ksi}$

Those backcalculated results consistent with FWD deflections obtained from individual layers

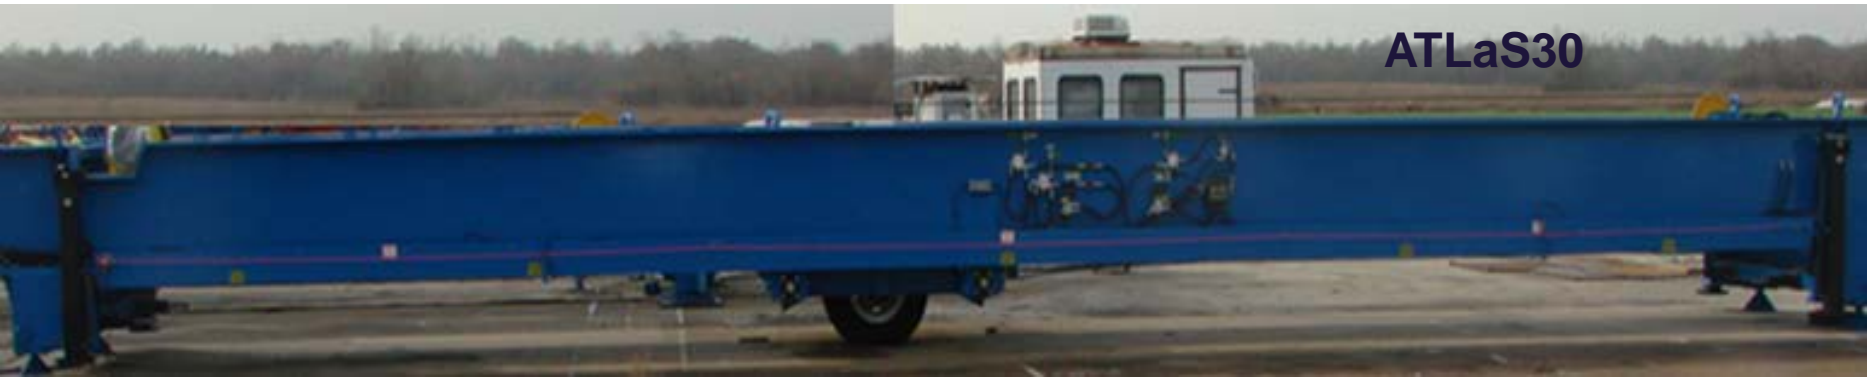
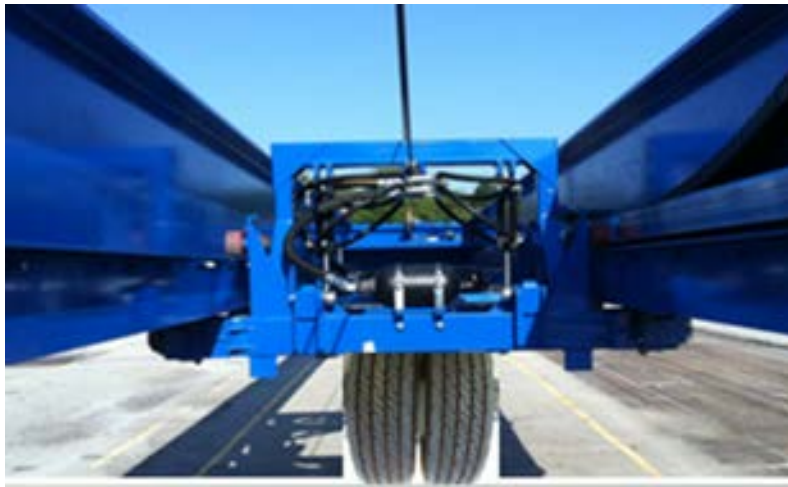
Accelerated Pavement Testing - ATLaS30

Dual-tire load, 130psi
Load: up to 30 kips
Speed: 4~6 mph
Bi-directional loading
Effective length: 42-ft
About 10,000 passes/day

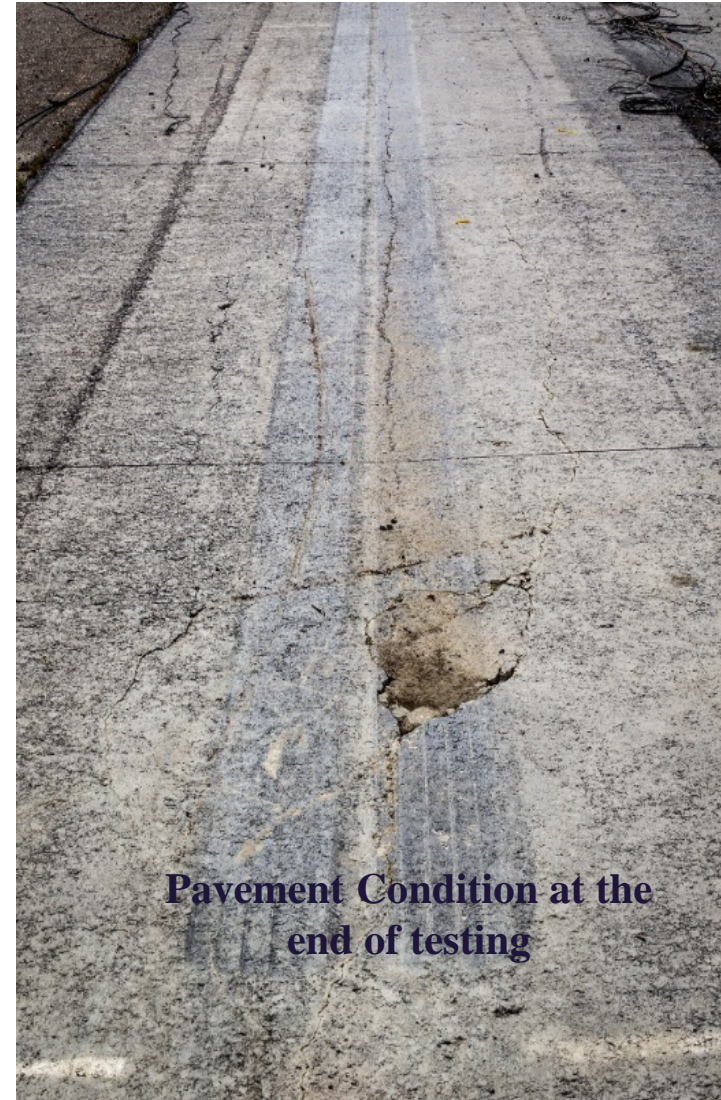
1.75 million Passes

Distress Observed (6+8.5RCC) – Section 5

- Longitudinal cracks were observed along the wheel path and at the edge of the tire print
- Pumping action was observed through cracks and joints
- 87.4 million ESALs to failure
- *1.9 million ESALs predicted*

Pavement Condition at the
end of testing

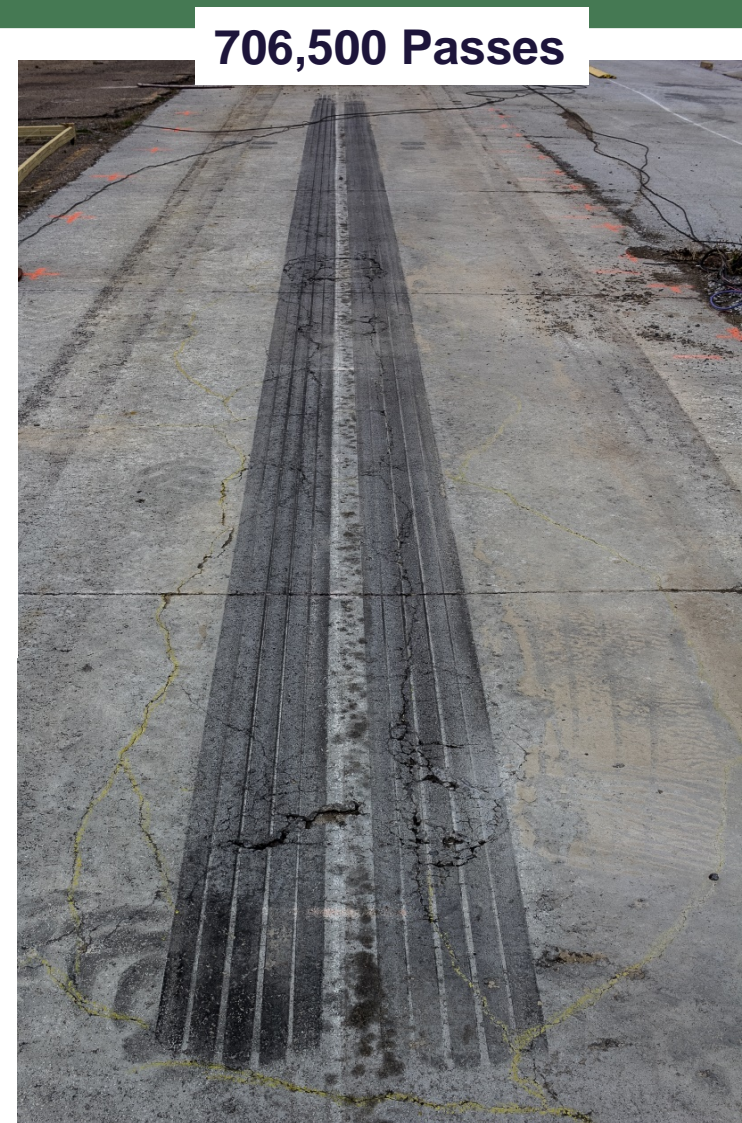
Distress Observed (4+8.5RCC) – Section 6

- Longitudinal cracks were observed along the wheel path and at the middle of the tire print
- Pumping action was observed through the cracks and joints
- 19.2 million ESALs
- *0.7 million ESALs predicted*

Pavement Condition at the
end of testing

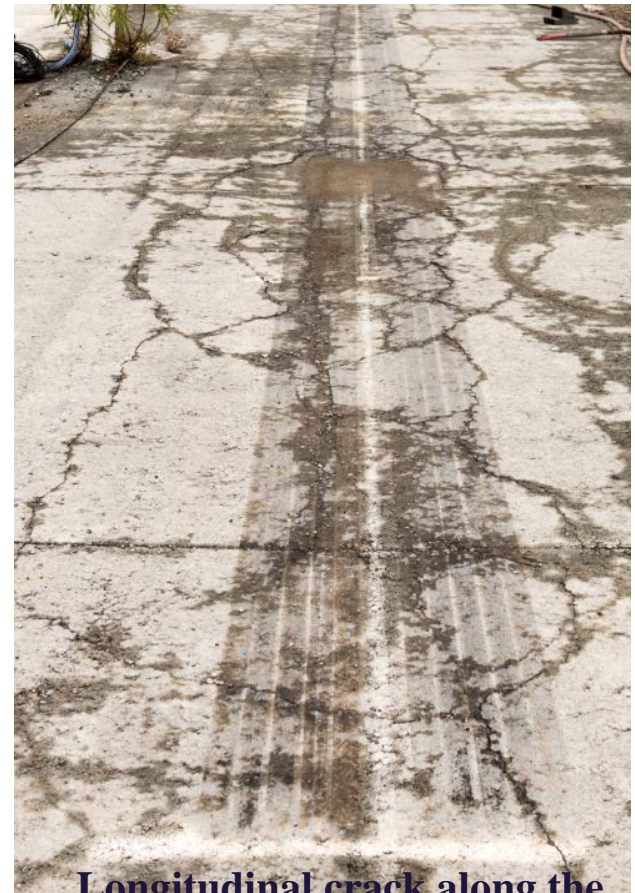
196,000 Passes

Distress Observed (4+12RCC) – Section 3

- Due to relatively weaker support, an early longitudinal crack was observed after 55,000 passes under 9 kip dual tire loading.
- This section failed at about 3-million ESALs of loading with extensive cracking
- *Predicted 0.7 million ESALs to failure*

Longitudinal crack along the wheel path

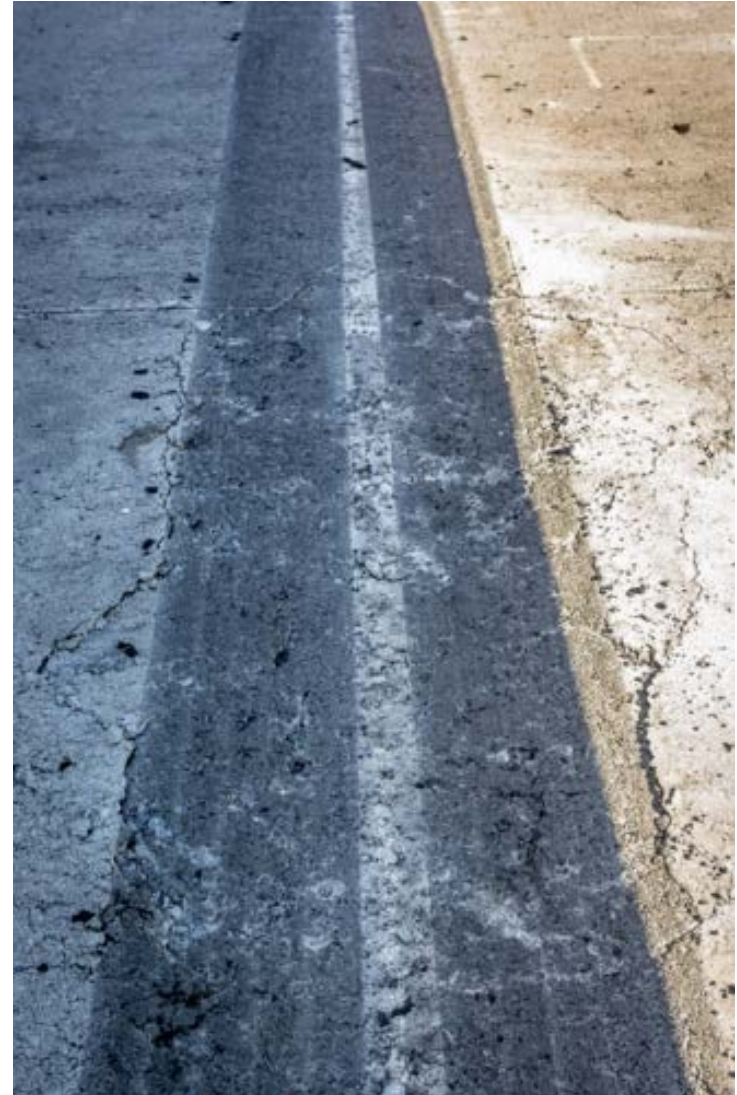
637,000 Passes

Distress Observed (6+12RCC) – Section 2

- Longitudinal cracks
- Pumping and Local failure
- **Completed now with about 19 million ESALs**
- *Predicted 1.9 million*

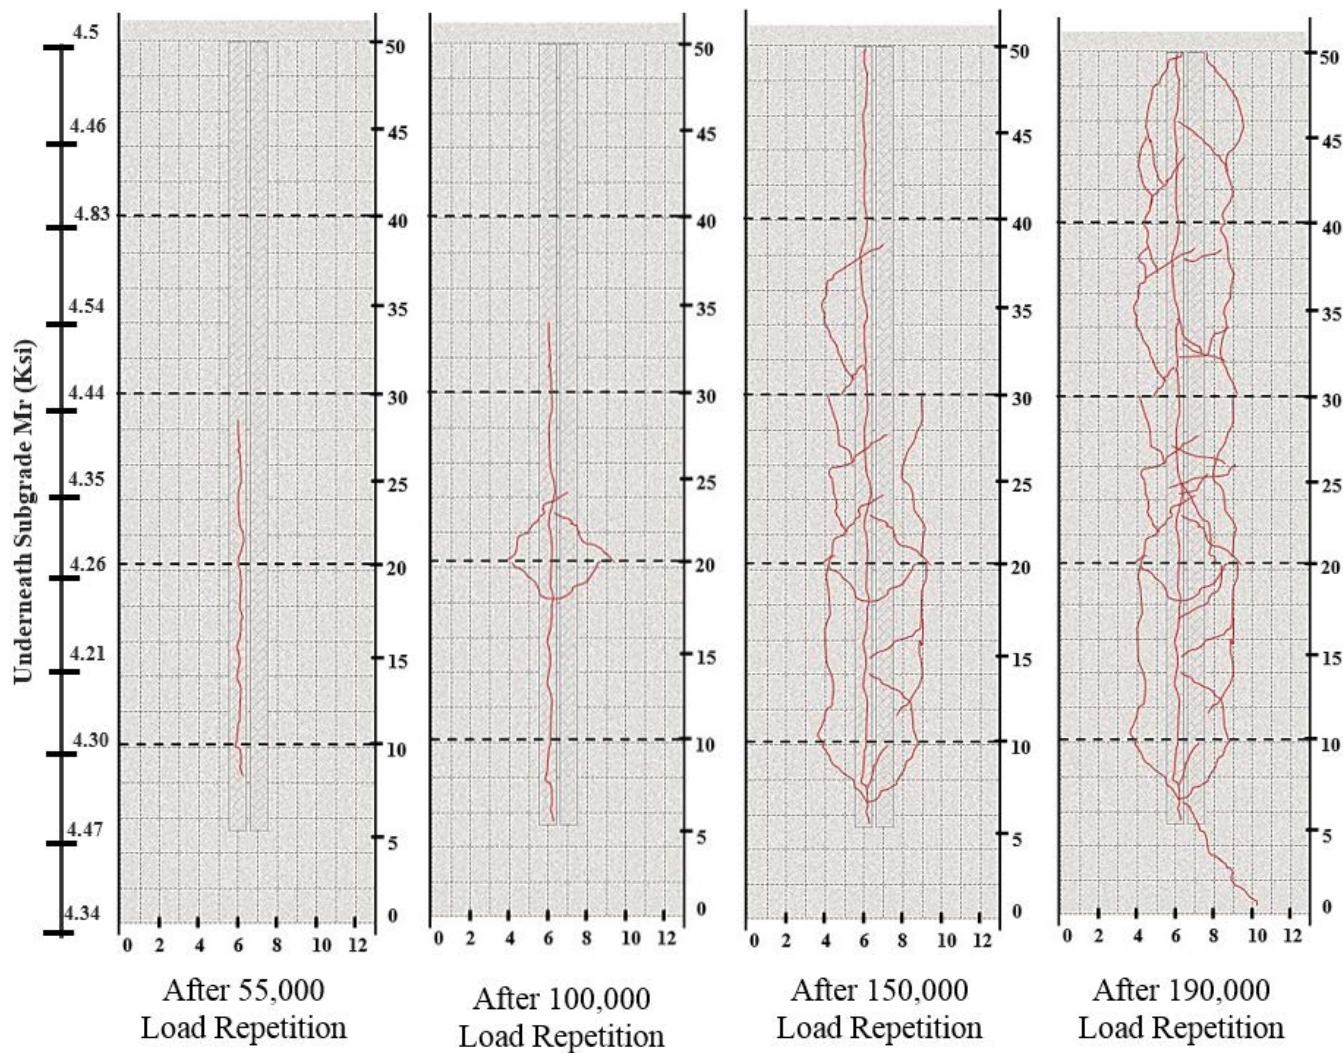
Crack Mapping on (4+12RCC) – Section 3

□ Crack Mapping

- Crack initiated at the weakest subgrade location
- Cracking pattern for thicker section was much wider than the thinner section
- Uniform subgrade resulted in a final cracking failure covering the entire loading area for 6+8.5RCC & 4+12RCC

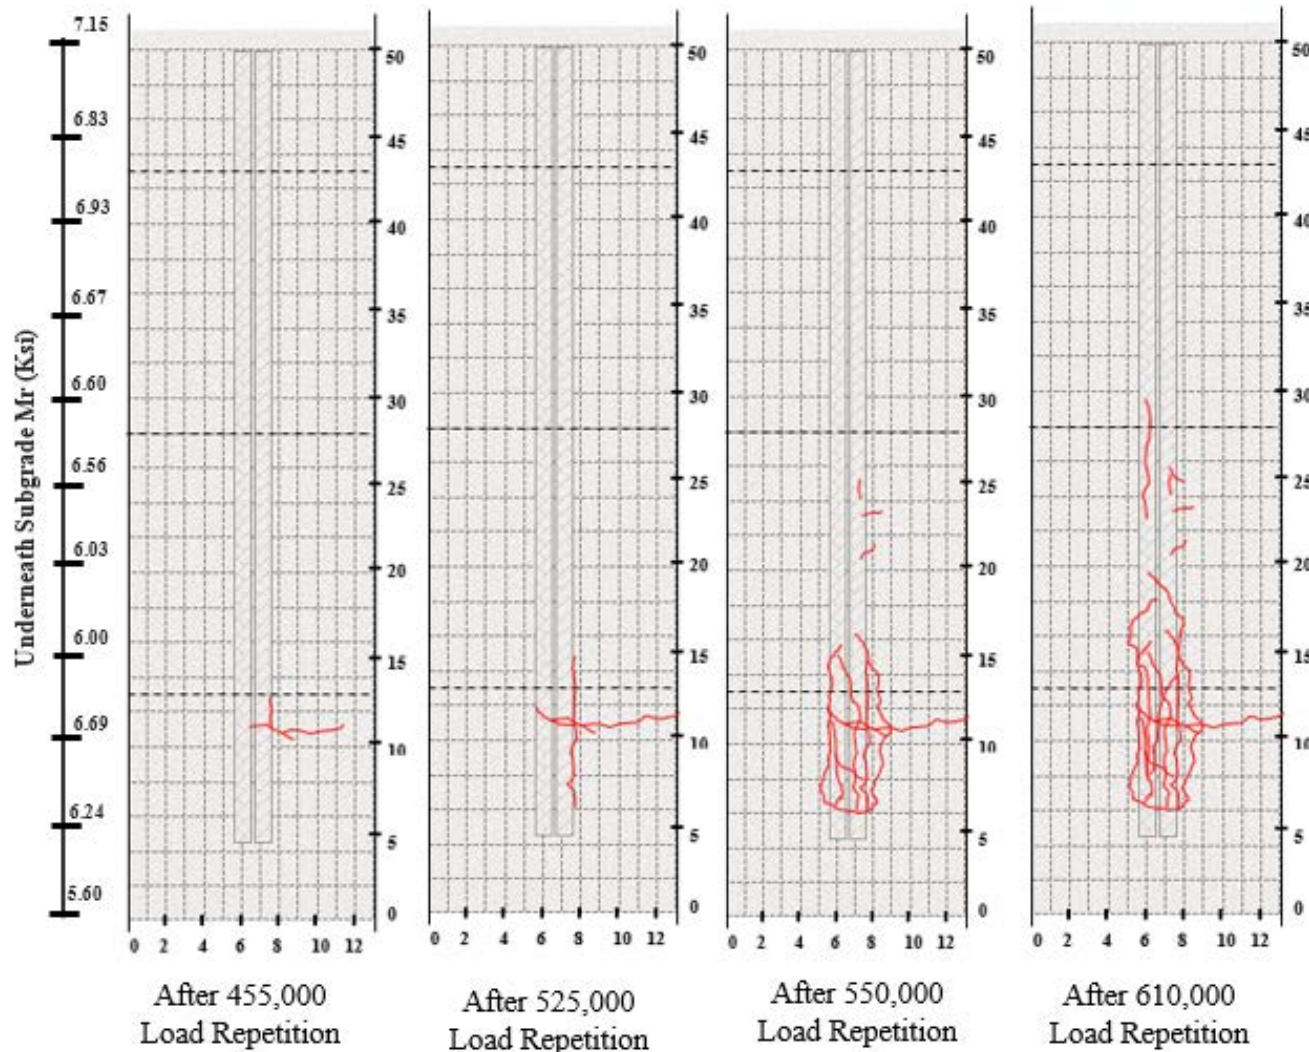
Crack Mapping on (6+12RCC) – Section 2

□ On-going
