# First Winter Joint Damage in Airfield Pavement – Offutt AFB, NE

Toy Poole

September 23, 2008

Engineer Research and Development Center

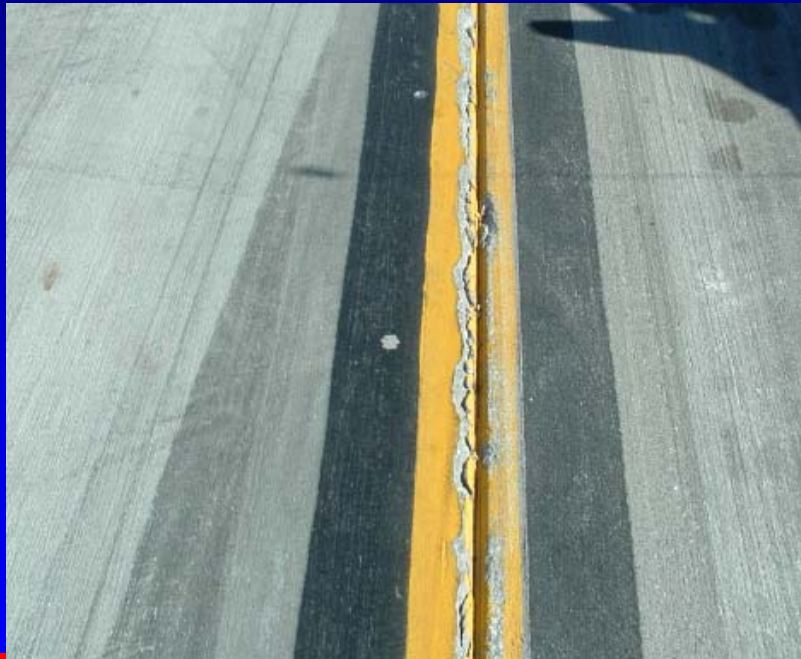
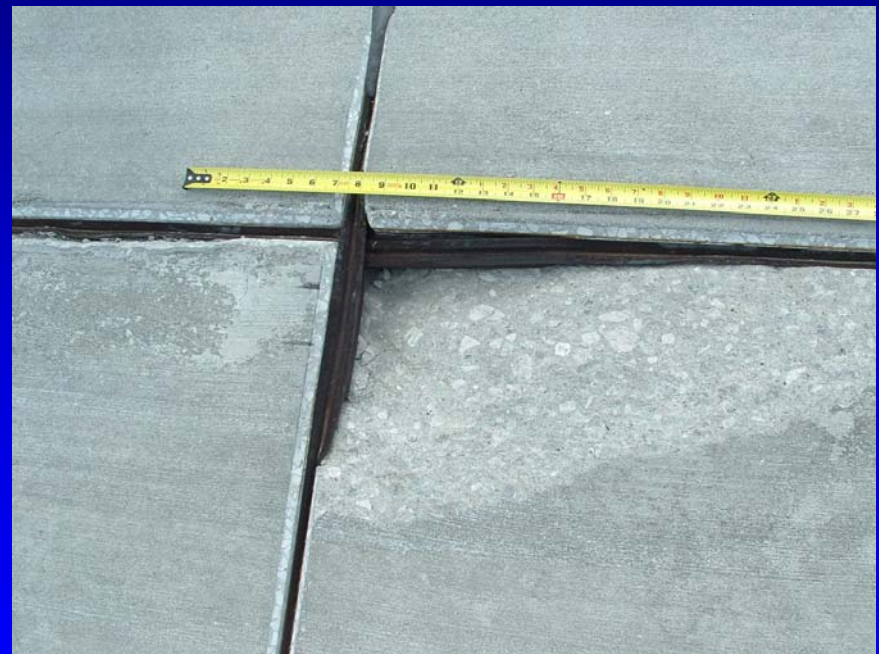
- Concrete placed summer and fall 2006
- Opened for traffic – early Dec 2006
- First winter - major damage to spalls and corners
- Second Winter – little new damage – some expansion of old damage

# Major Form of Damage

## First Winter

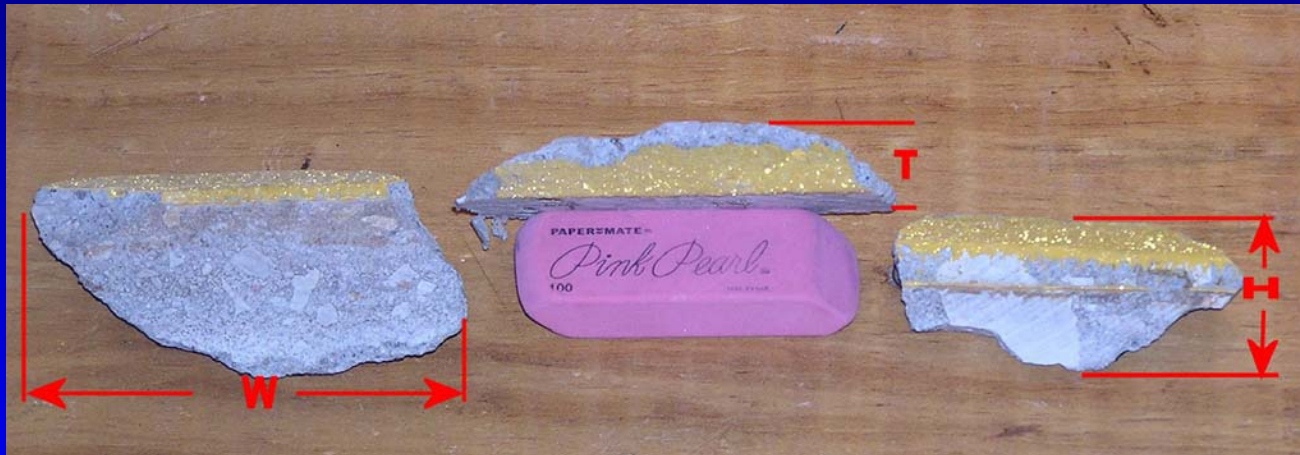
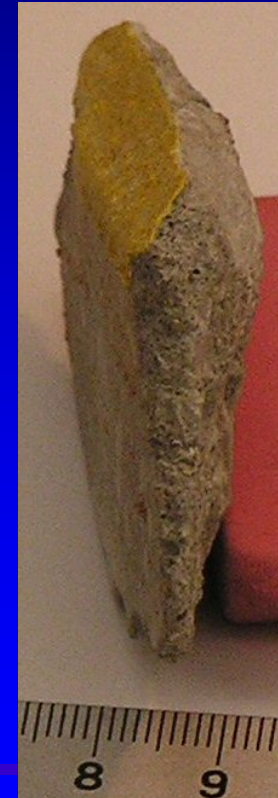
# Shape of Sliver Spalls

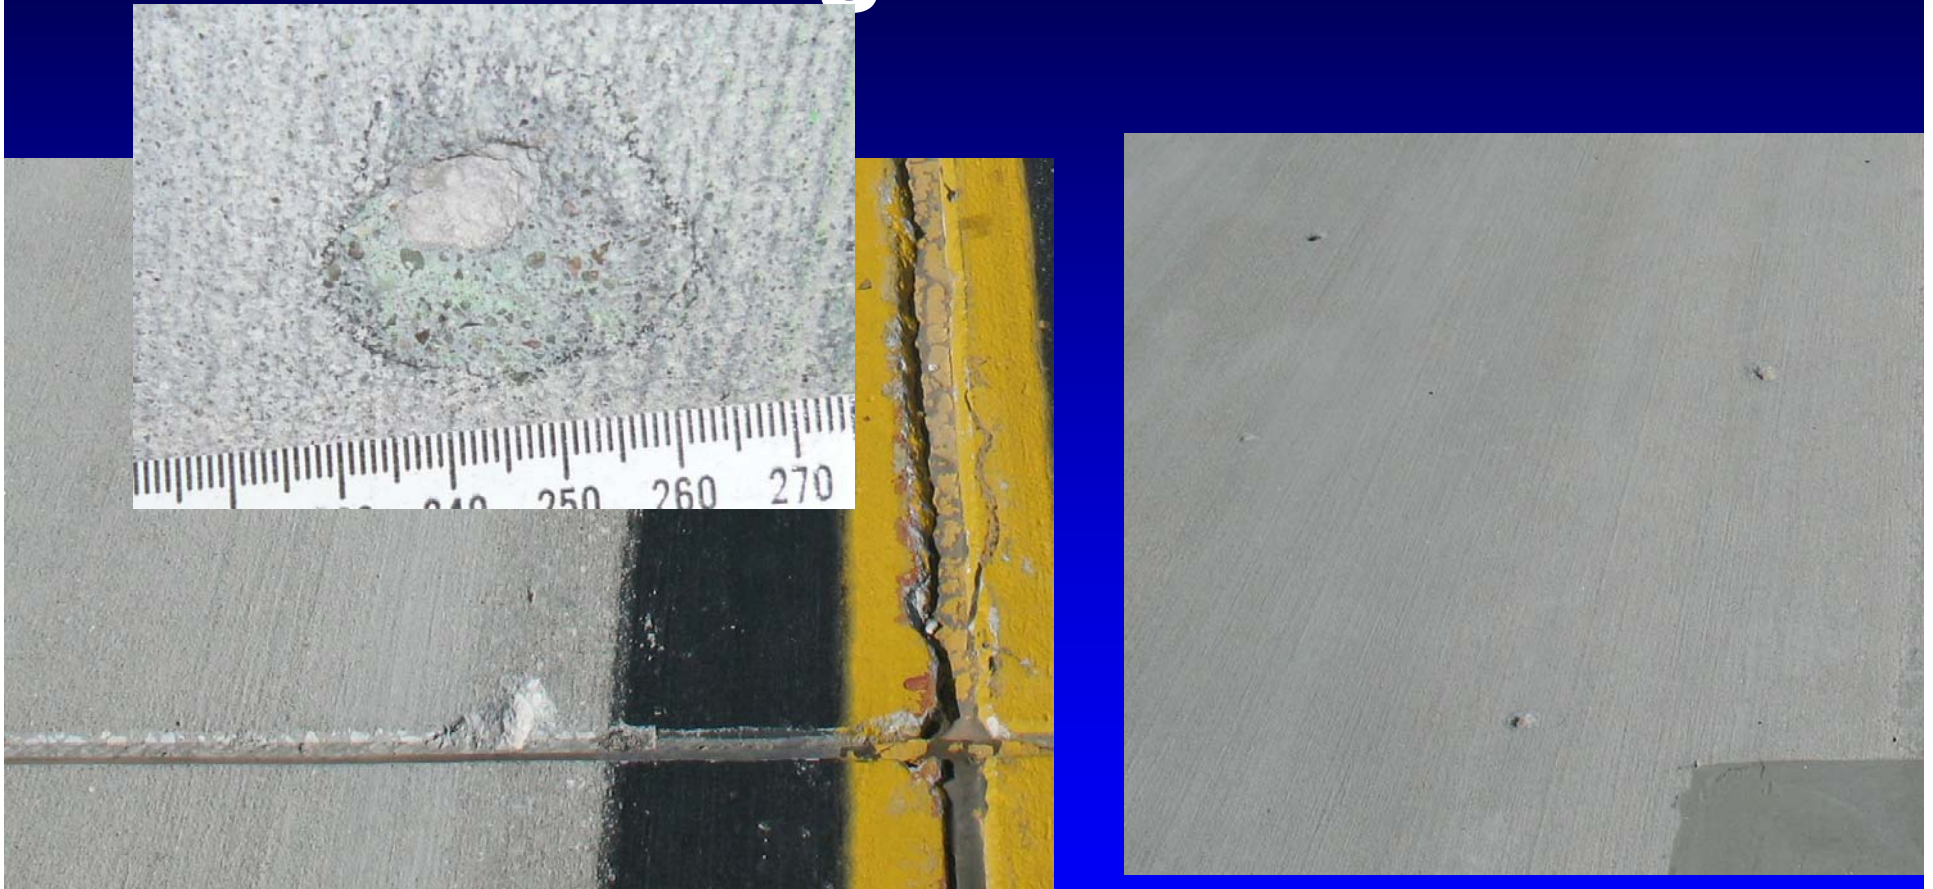
# Damage – cont'd

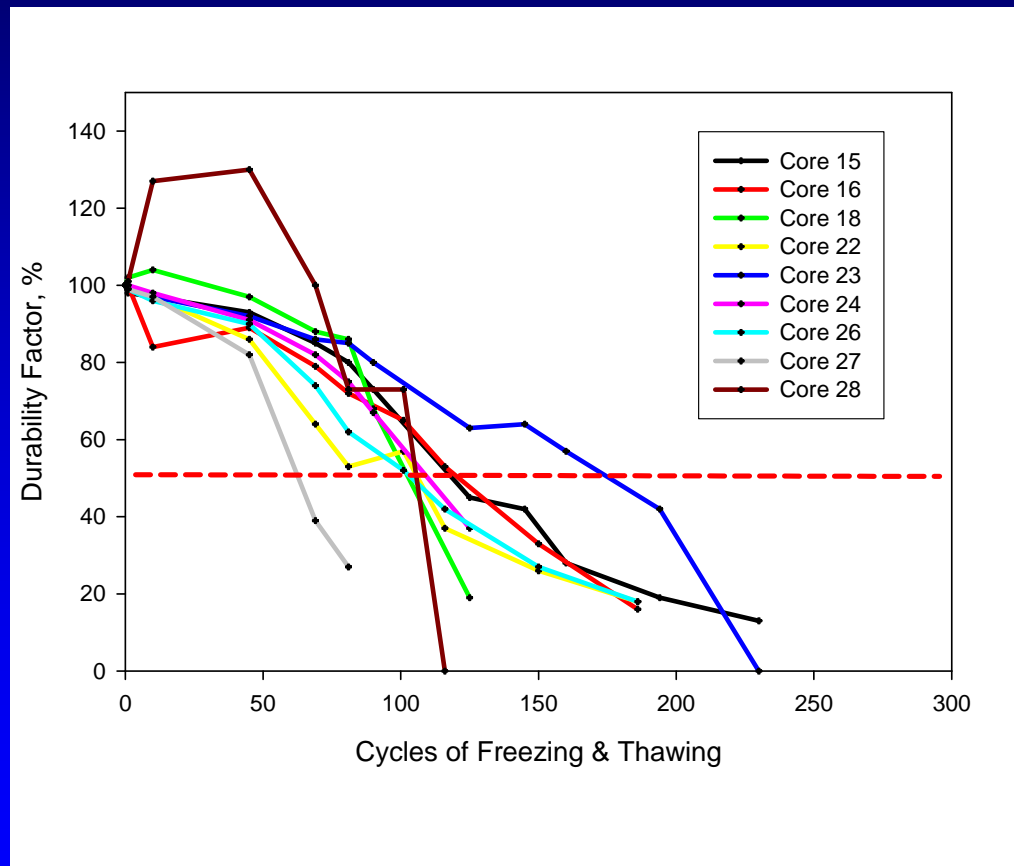
# ASTM C 1646 – Cycles of Freezing and Thawing

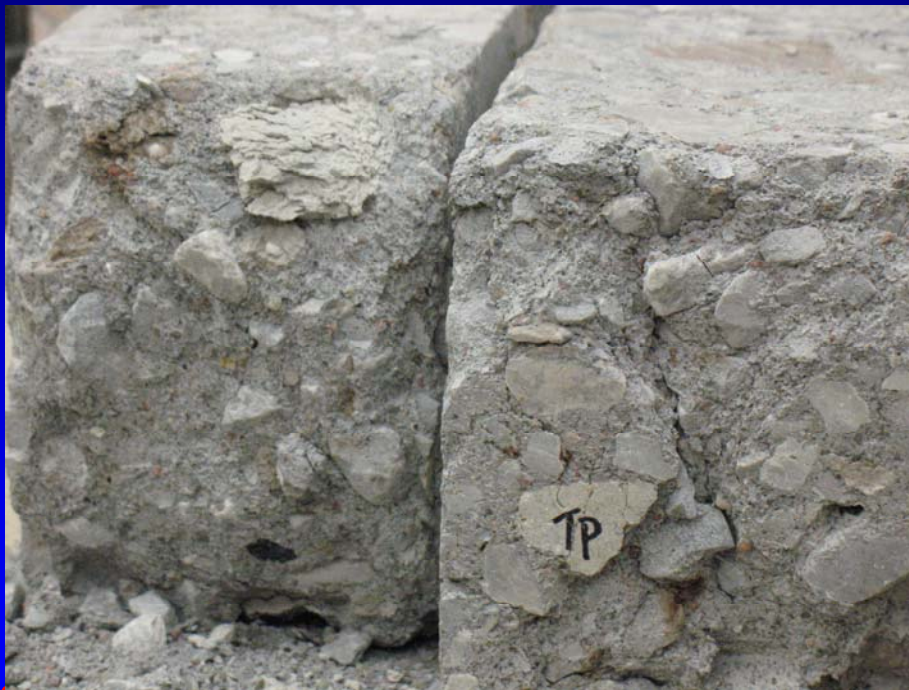
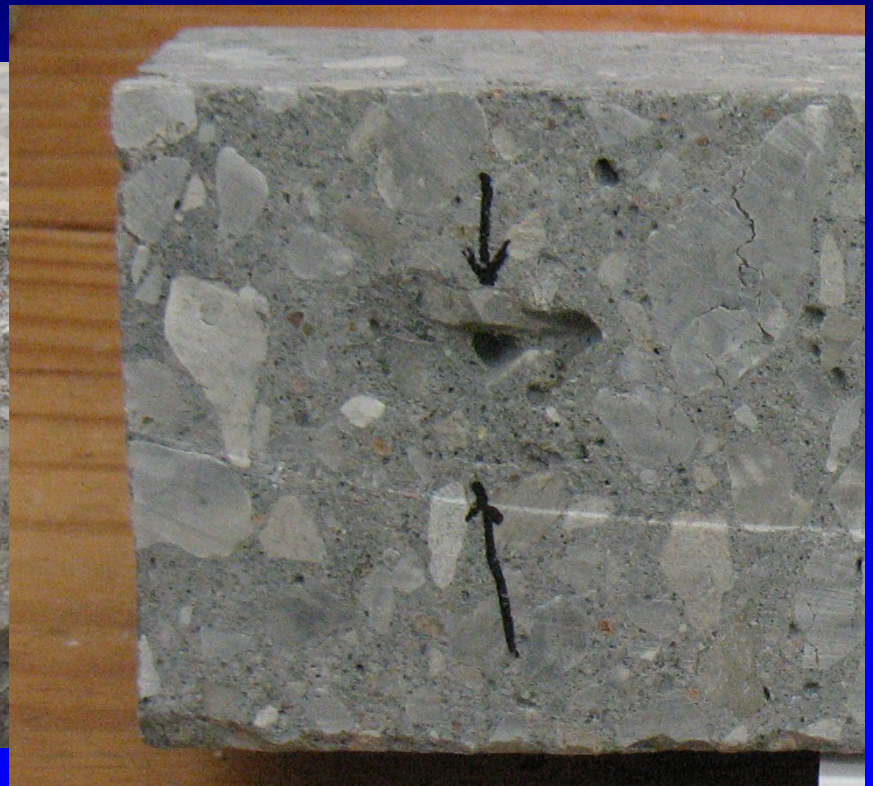
# Petrography – Gross Reaction

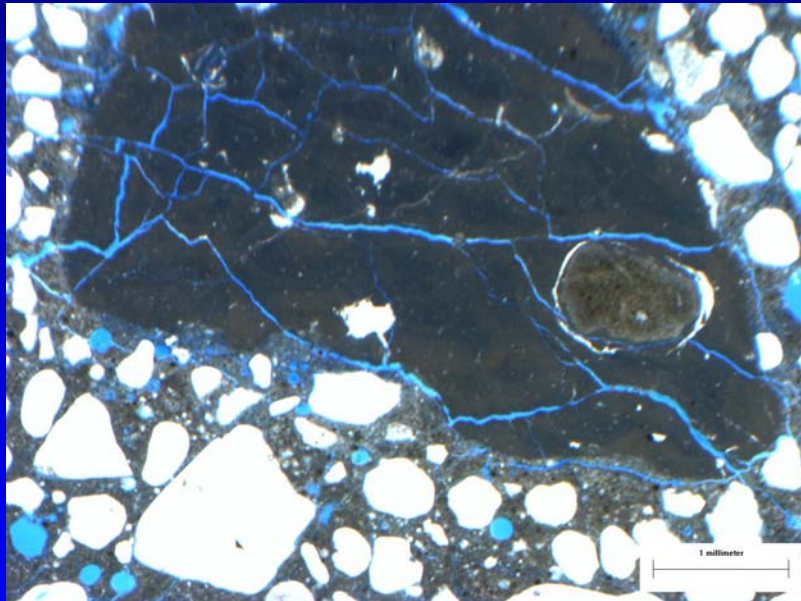
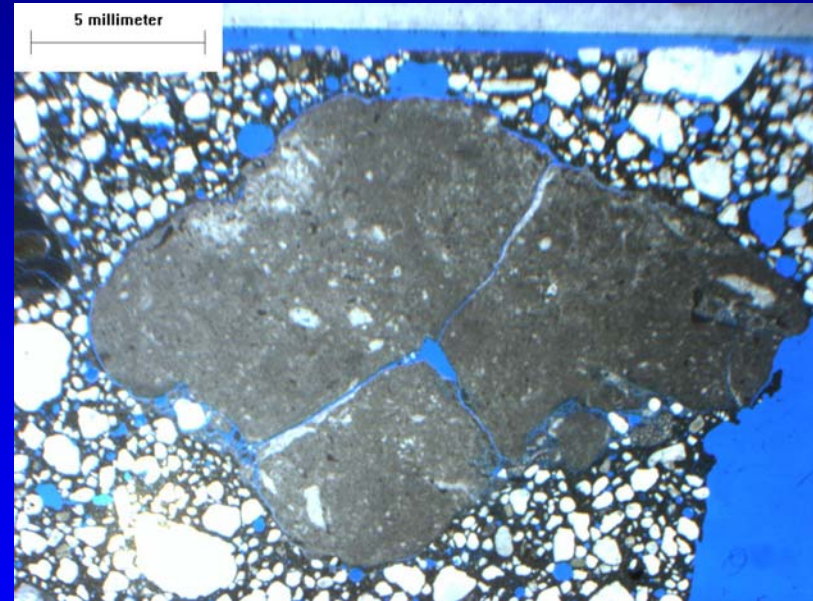
# Petrography – Thin Sections

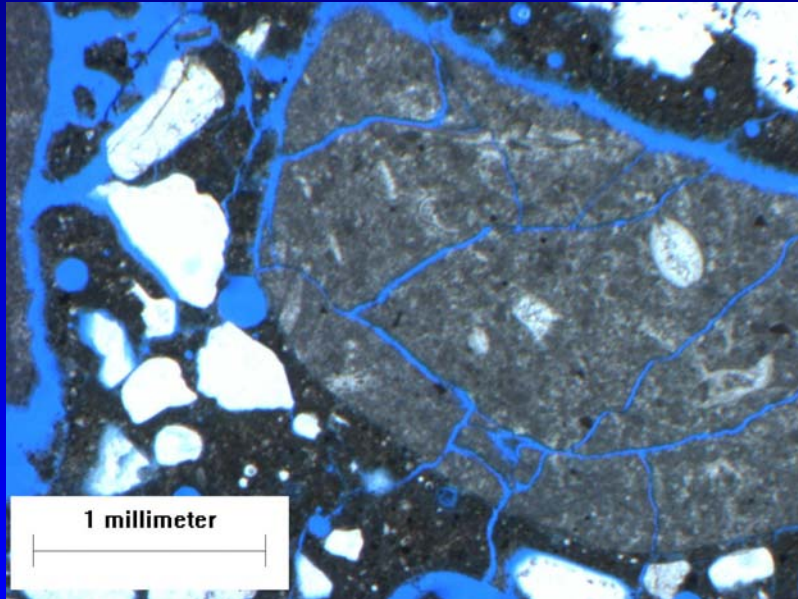
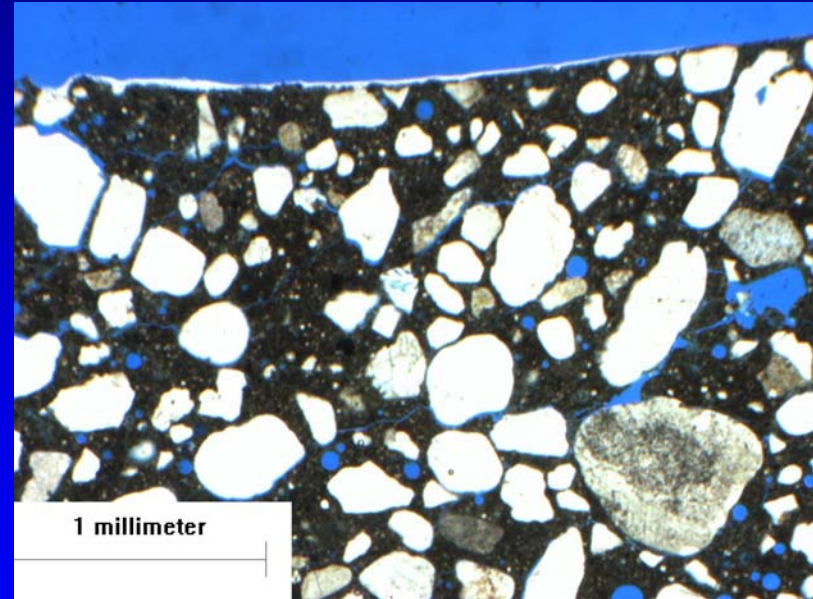
# Petrography – Thin Sections

Paste damage

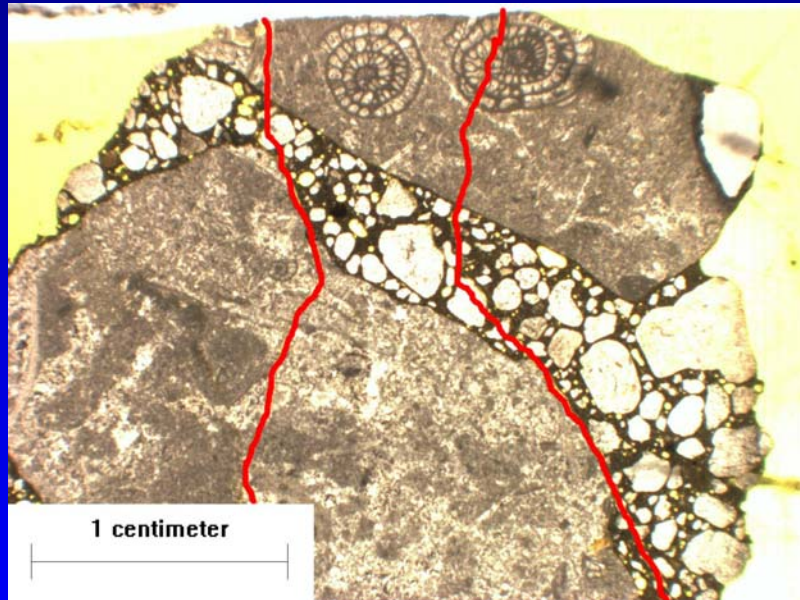
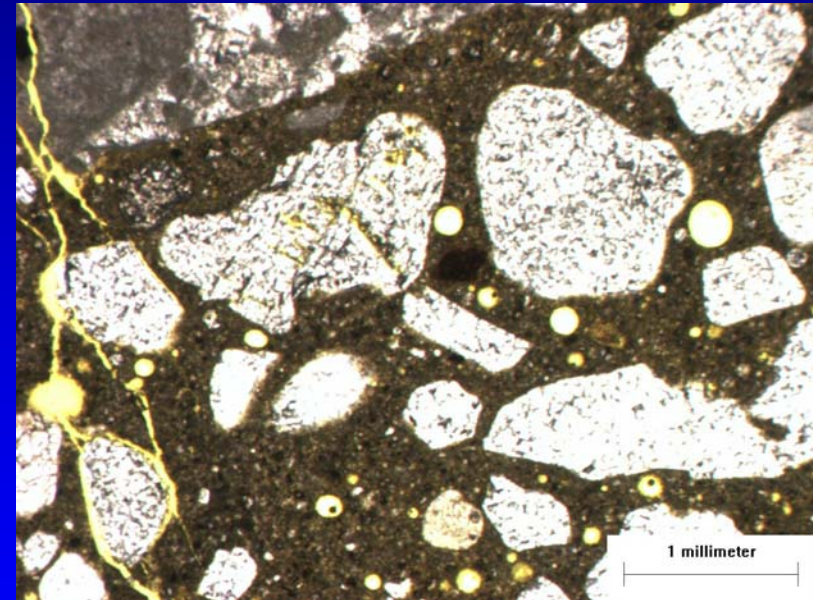
# Field Damage

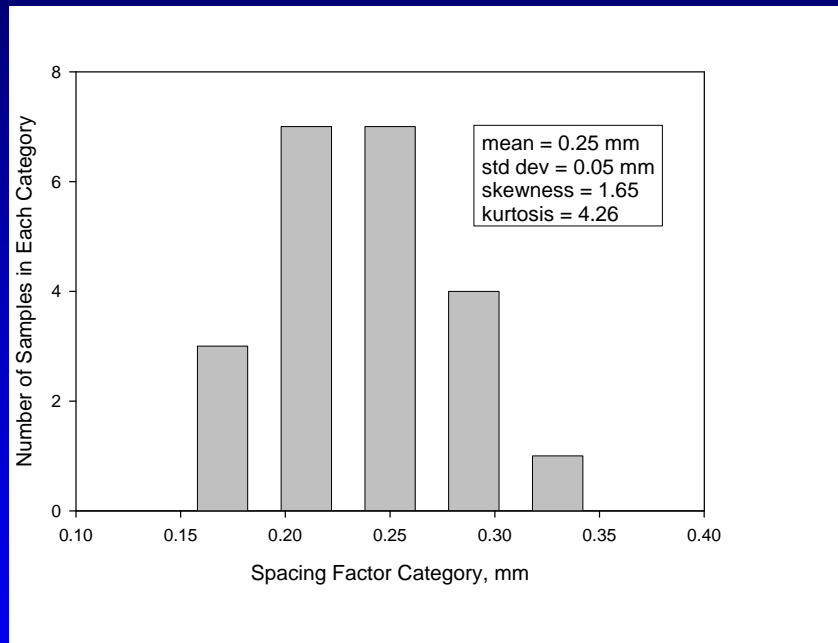
# Distribution of Spacing Factor

Spacing Factor of small areas near C 1646 damage ranged from ~0.4 to 0.6 mm

Guidance: ACI 0.20 mm  
CSA 0.23 (max 0.26 mm)

Spacing Factor – std C 457 samples

- Increase target air content
- Use of the air void analyzer to verify distribution of air voids
- Revise aggregate acceptance protocols
- Look into effects of deicing salts in more detail

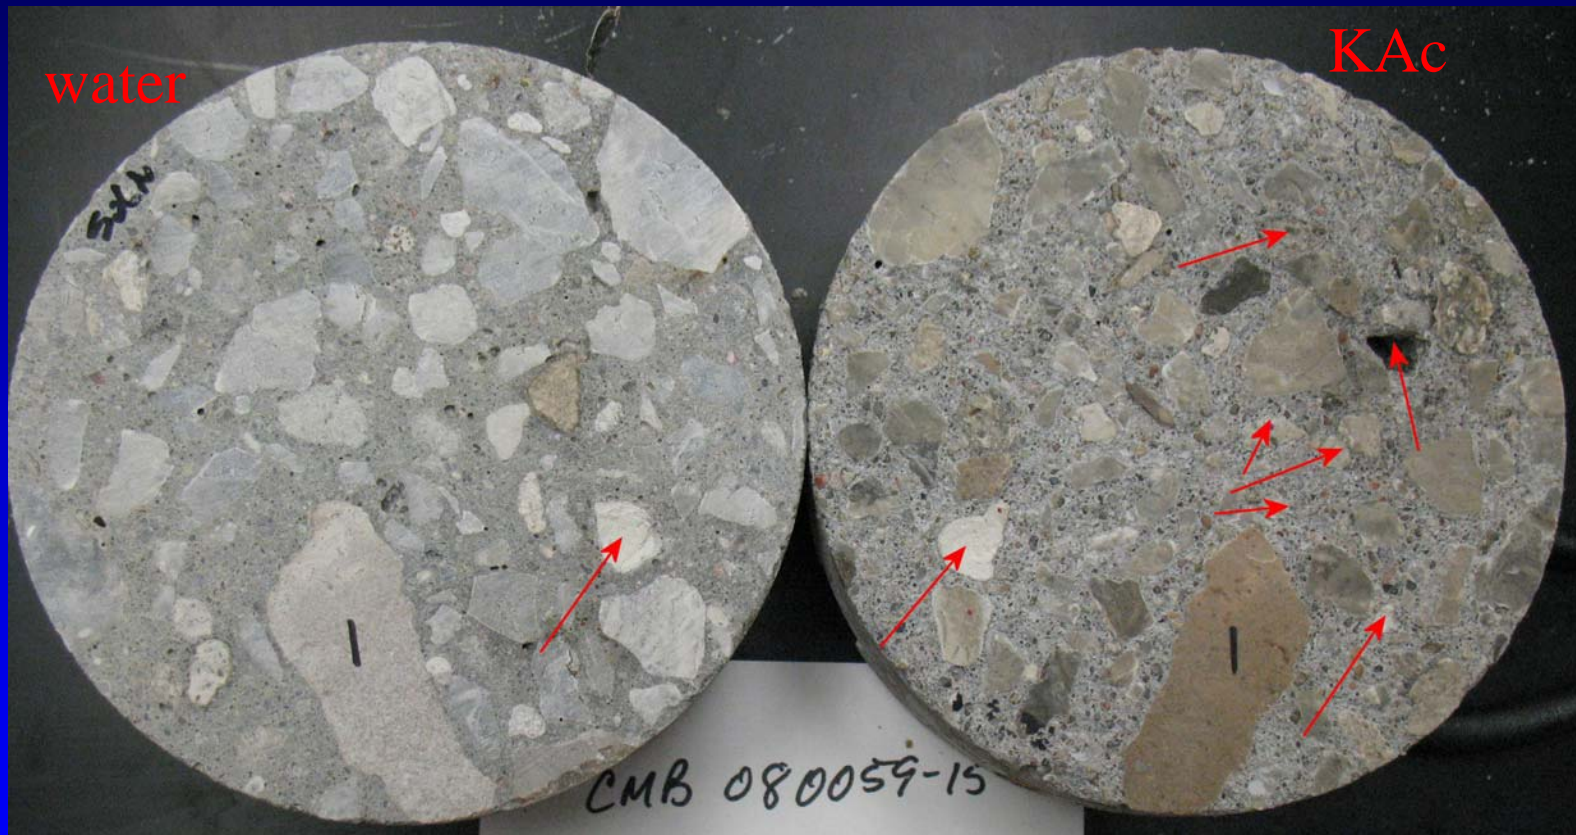
# D 5312 – Deicer Effects

19 cycles of freezing & thawing

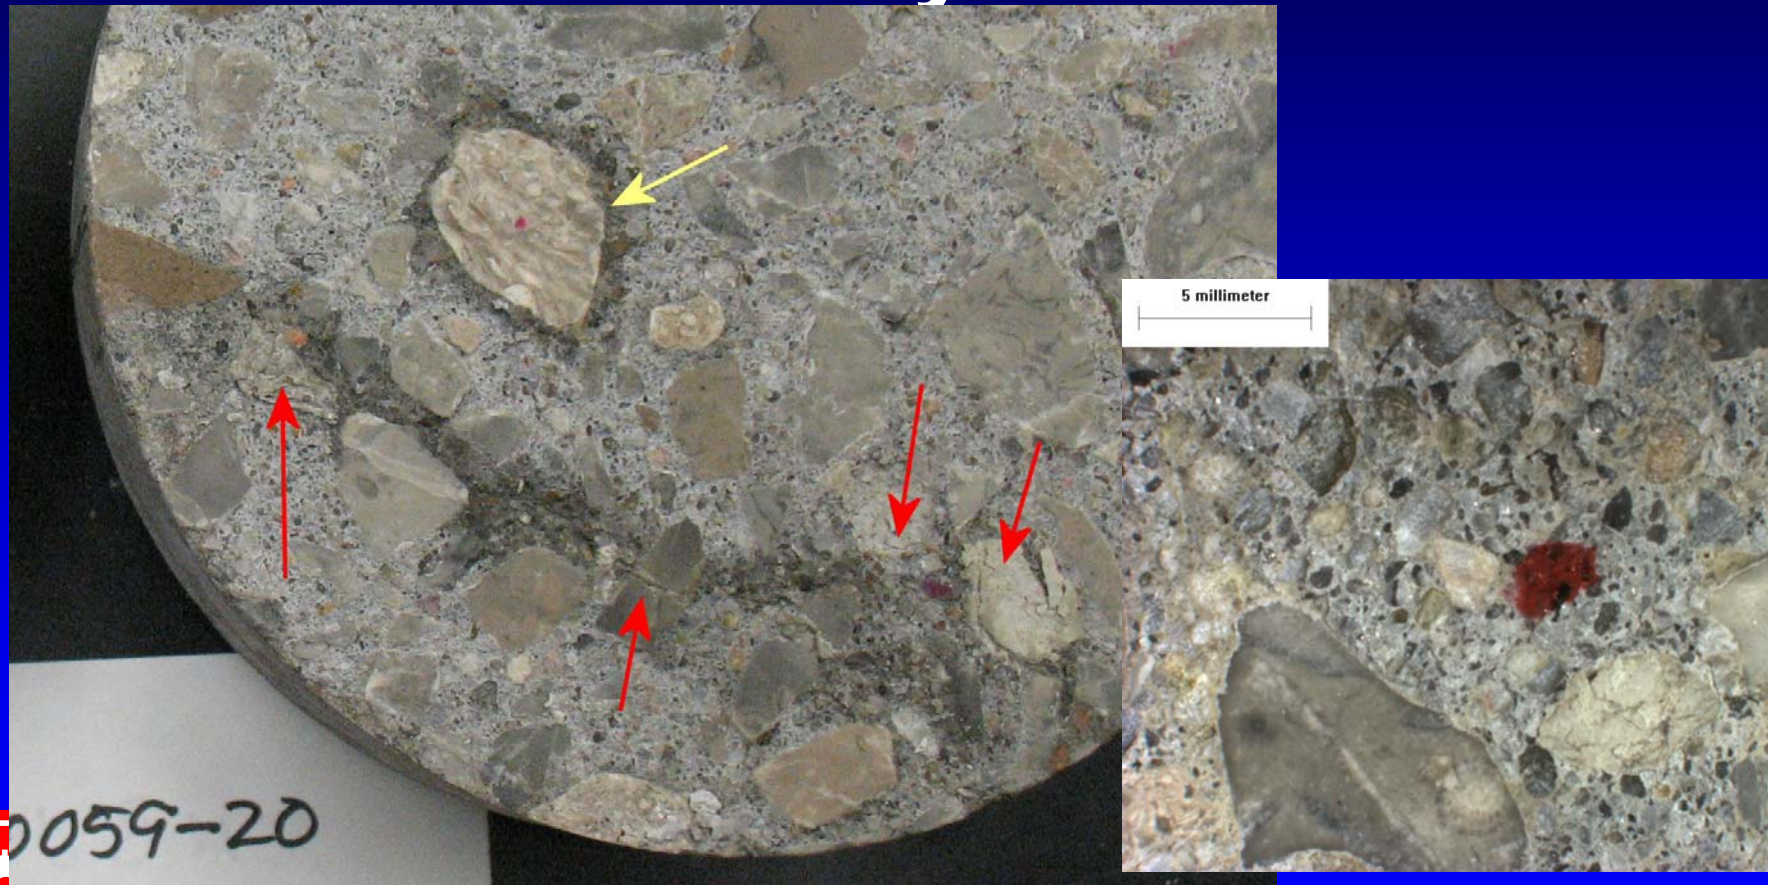
# Potassium Acetate Exposure >19 F/T Cycles

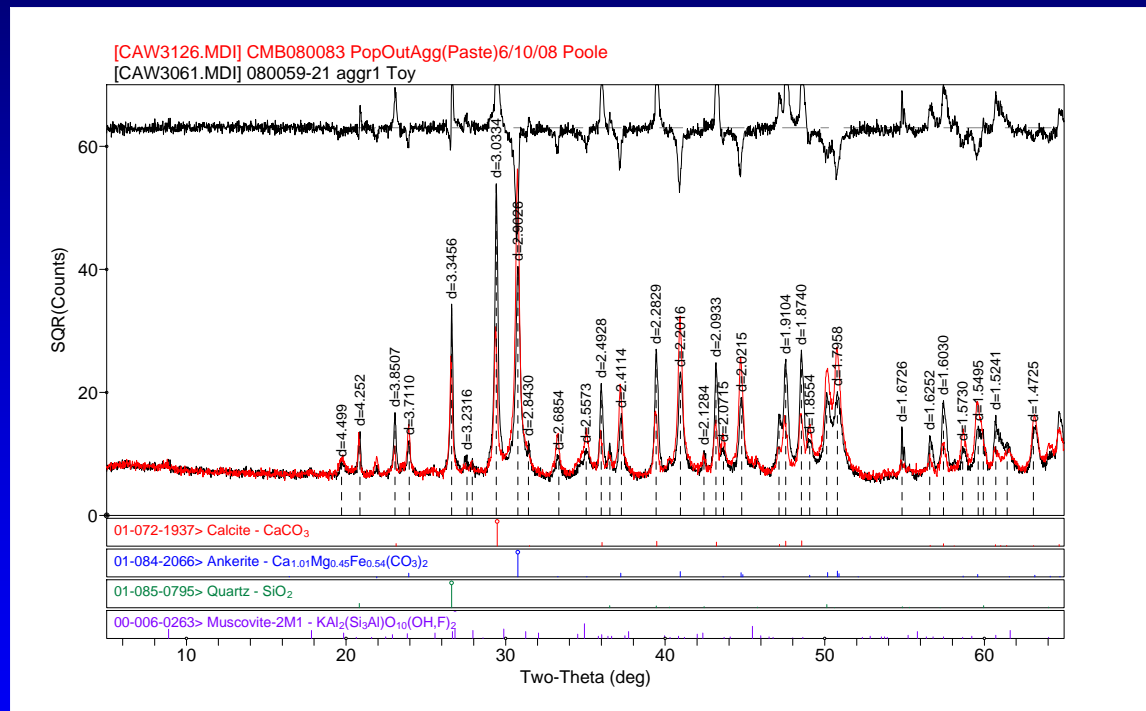
# Offending Aggregate

- Air void spacing factor
  - Slightly deficient on average
  - Maybe more than slightly in specific locations
- Non-durable coarse aggregate
- Deicing salt damage to paste & aggregate

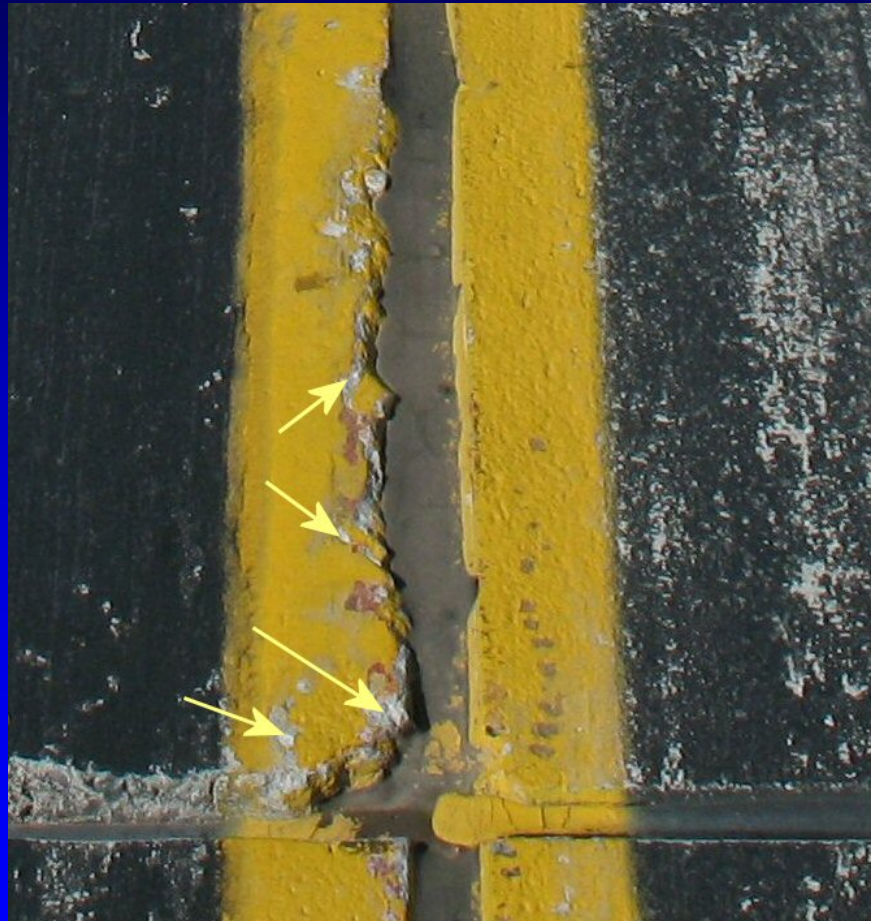
# Monitoring 2<sup>nd</sup> Winter

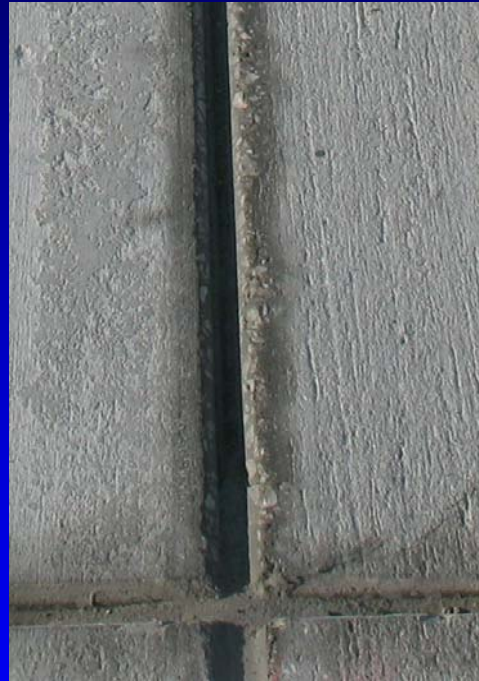
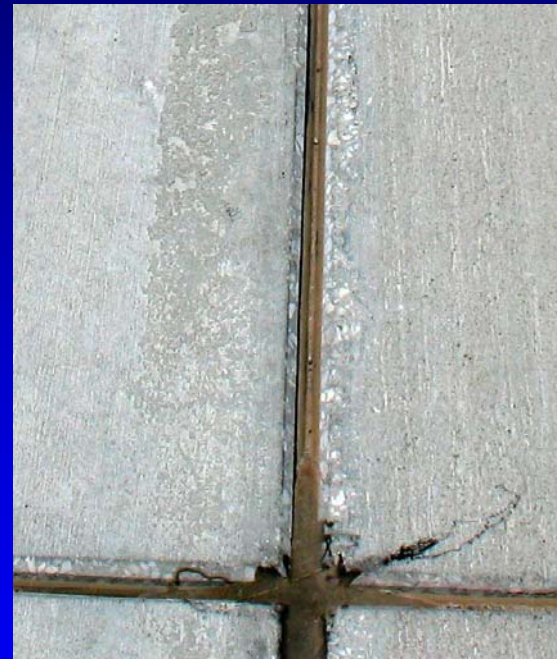
# Possible Deicer Effect

Dec 07

Jun 08

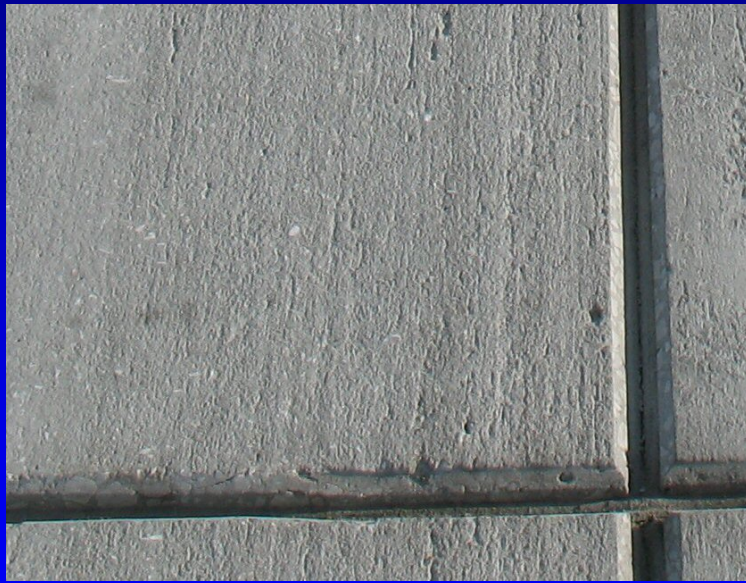
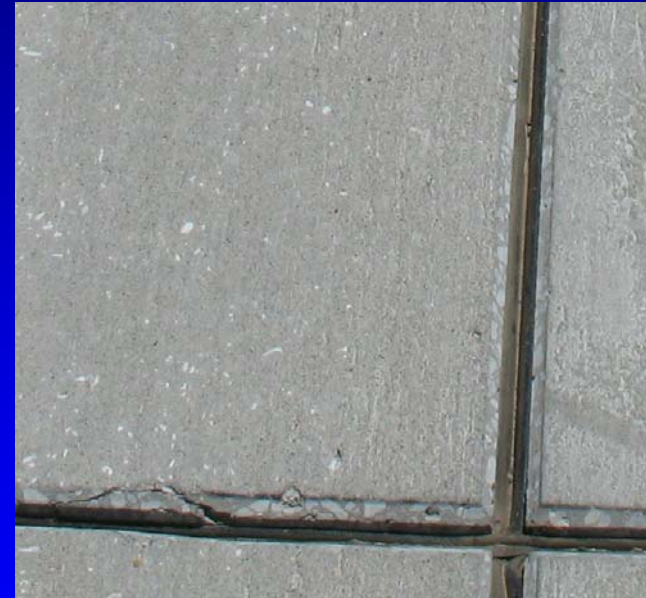
# Non-Random Aggregate Dist?

Dec 07

Jun 08

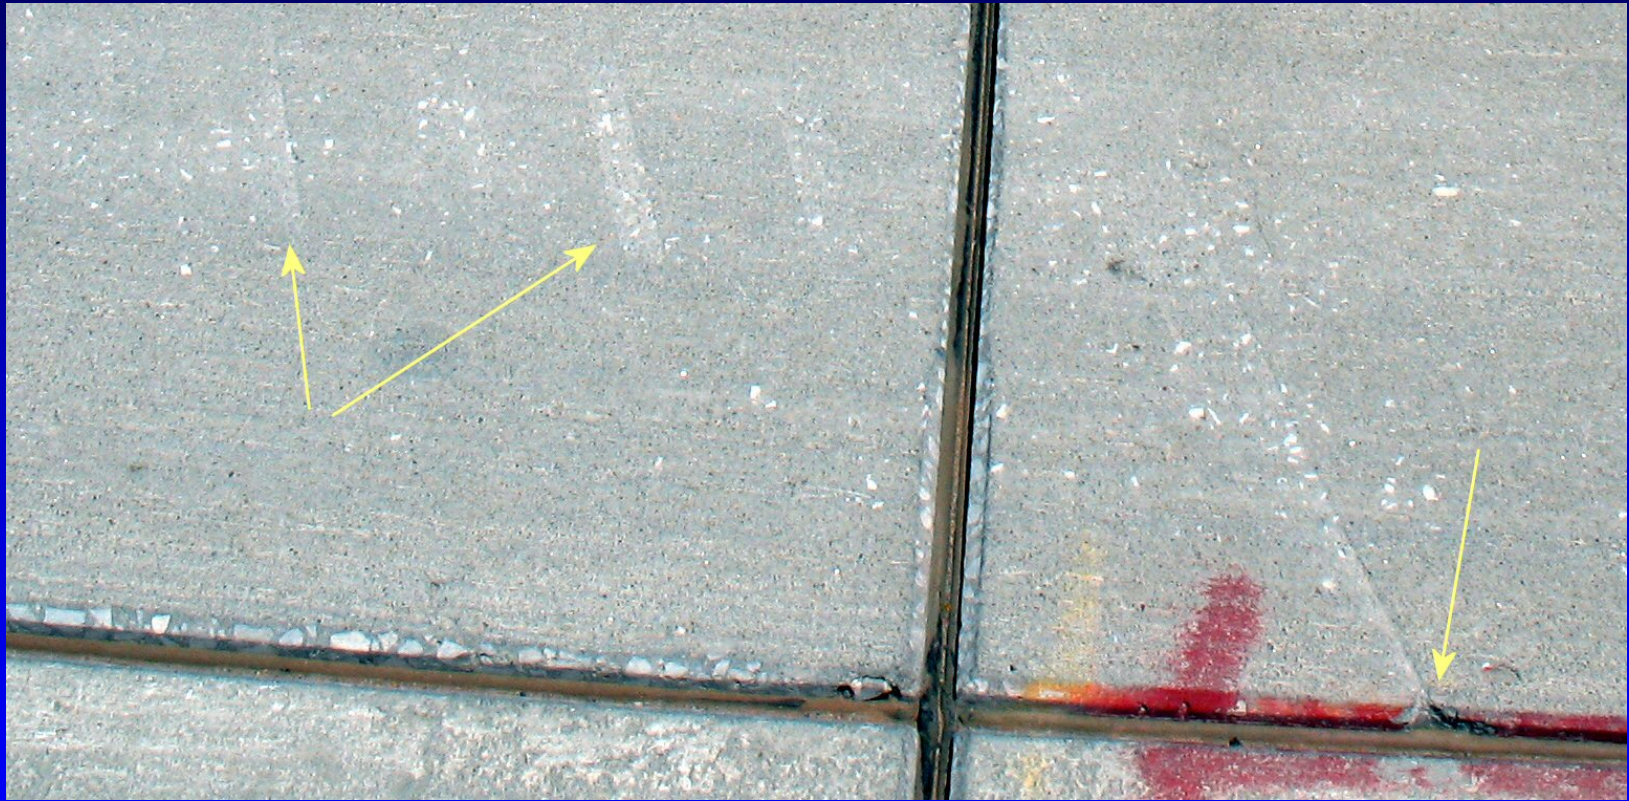
# Snow Plow?

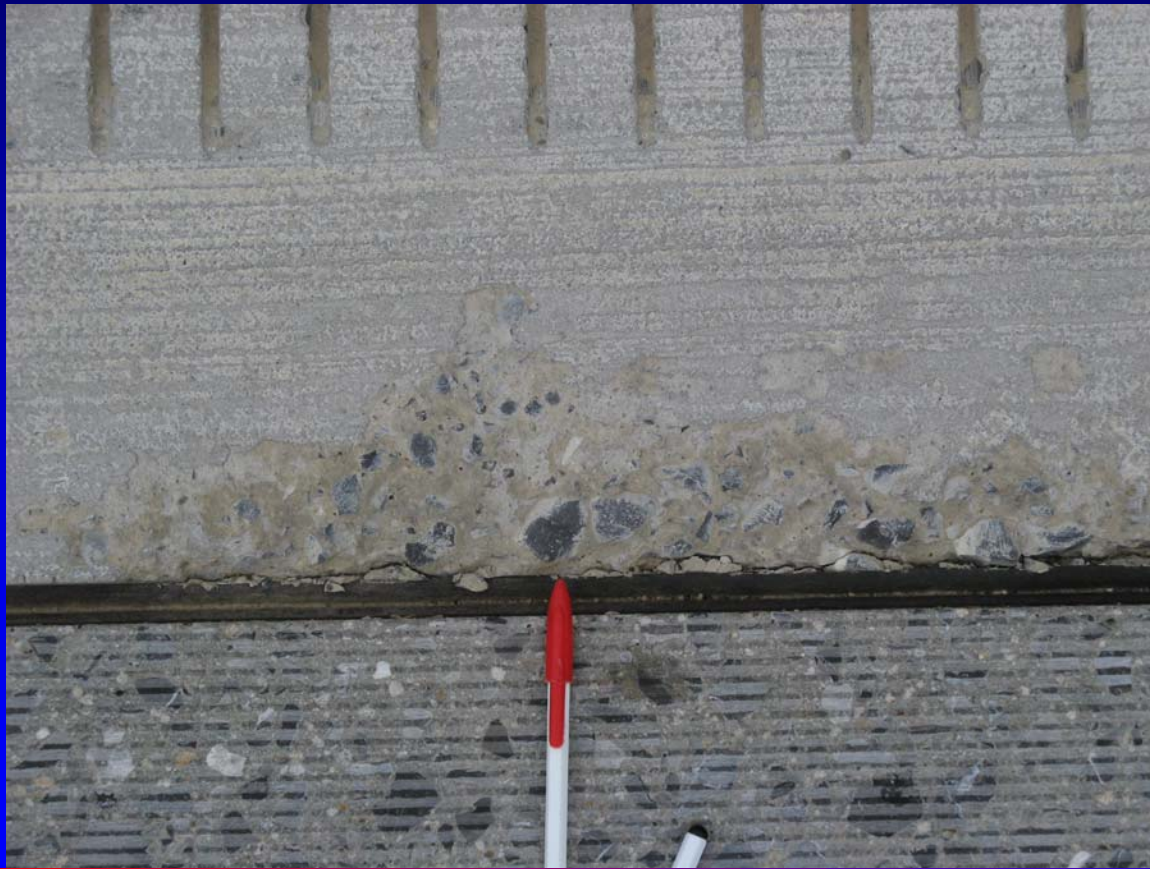
# Typical Snowplow?

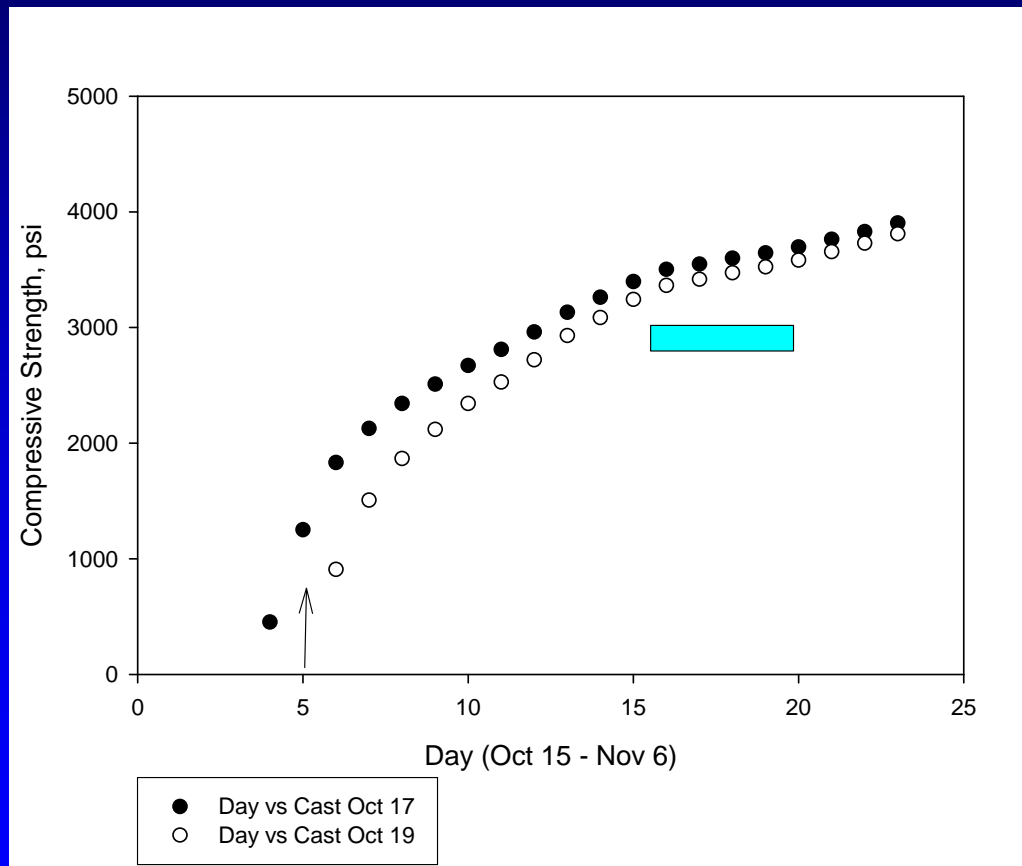
# Maturity
