Joint Deterioration

Dr. Peter Taylor PE (IL)
Associate Director

National Concrete Pavement
Technology Center

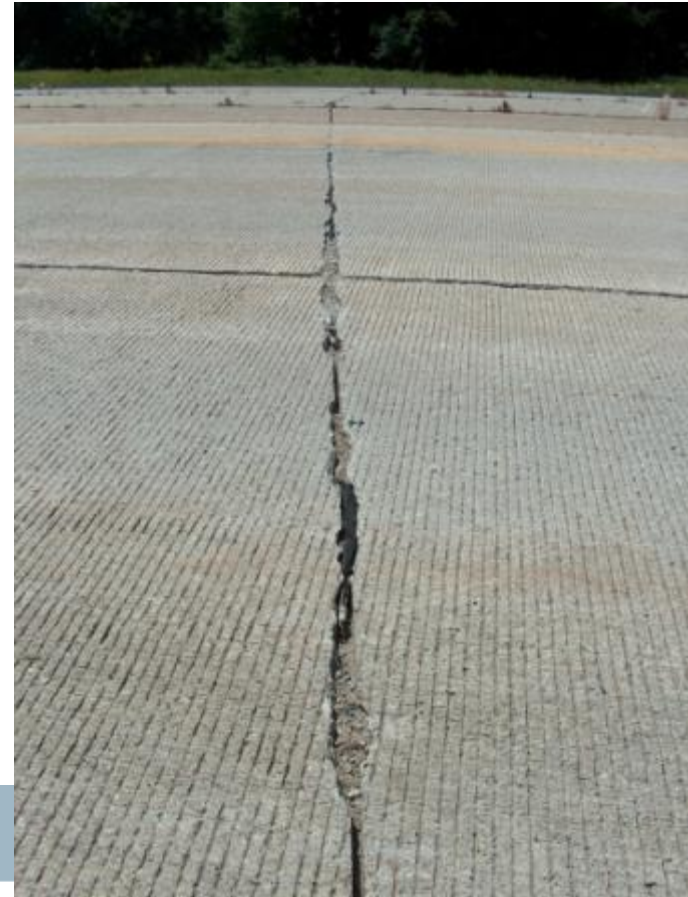
The problem?

- Some joints are deteriorating faster than we would like
- We are not sure why

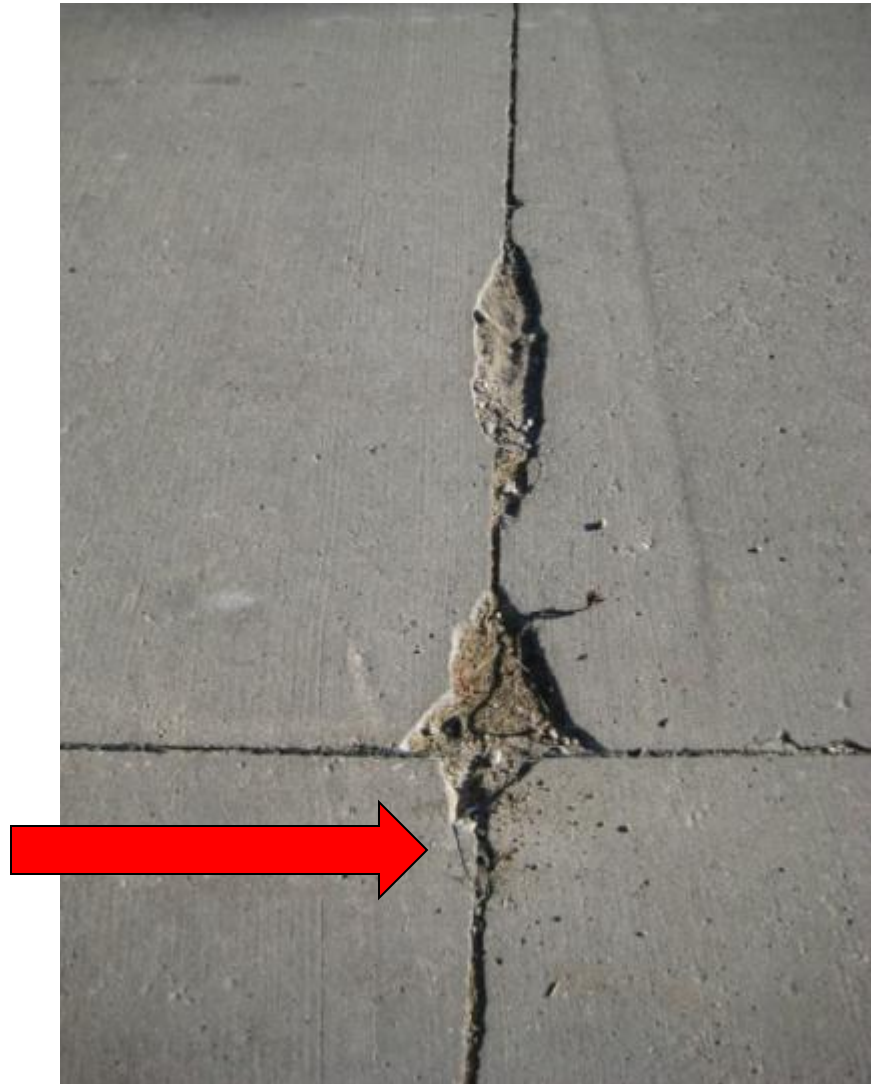
Mechanical

- Narrow
- Shallow
- Crescents

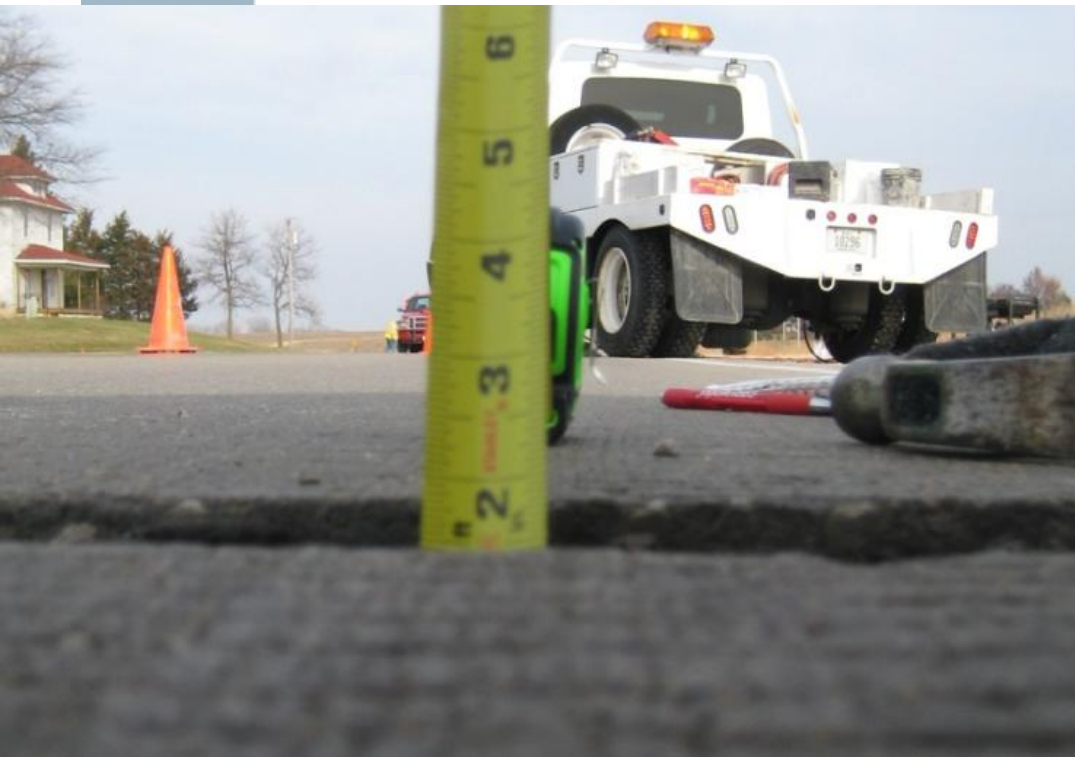
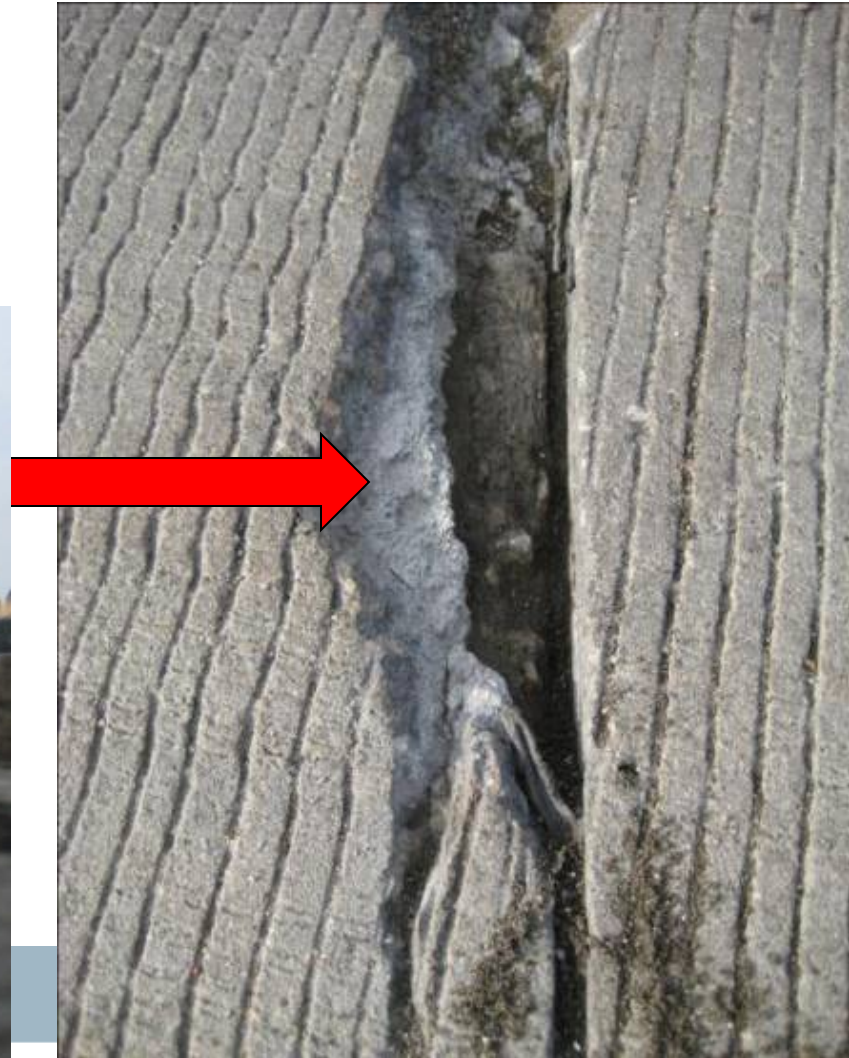
Mechanical

- Early age

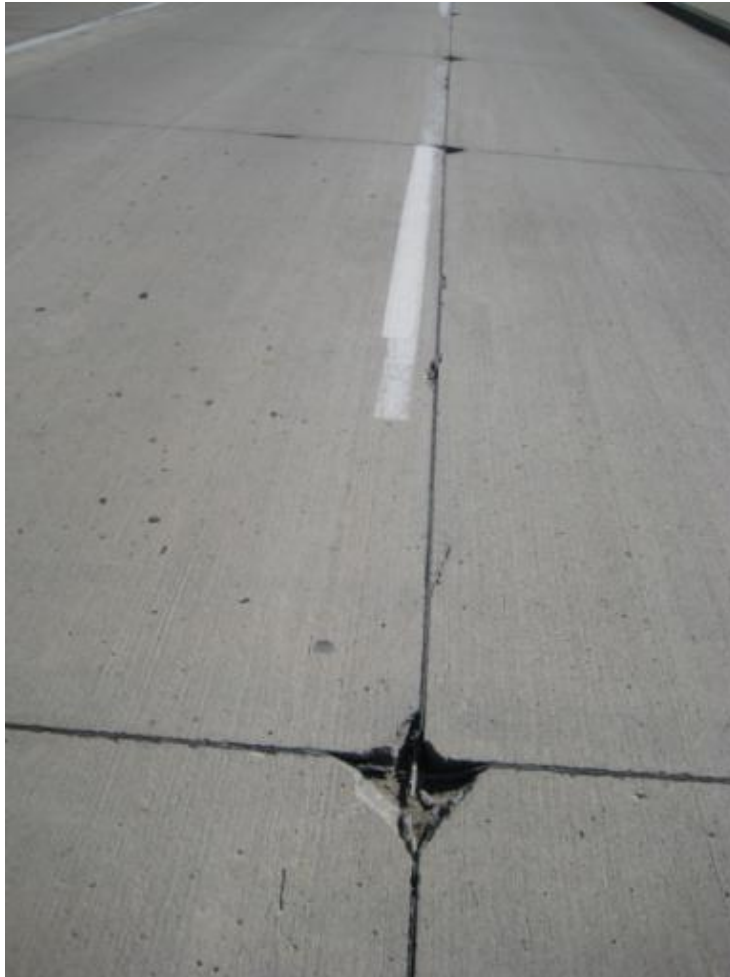
September,
2009

Mechanical

- Pretty stable

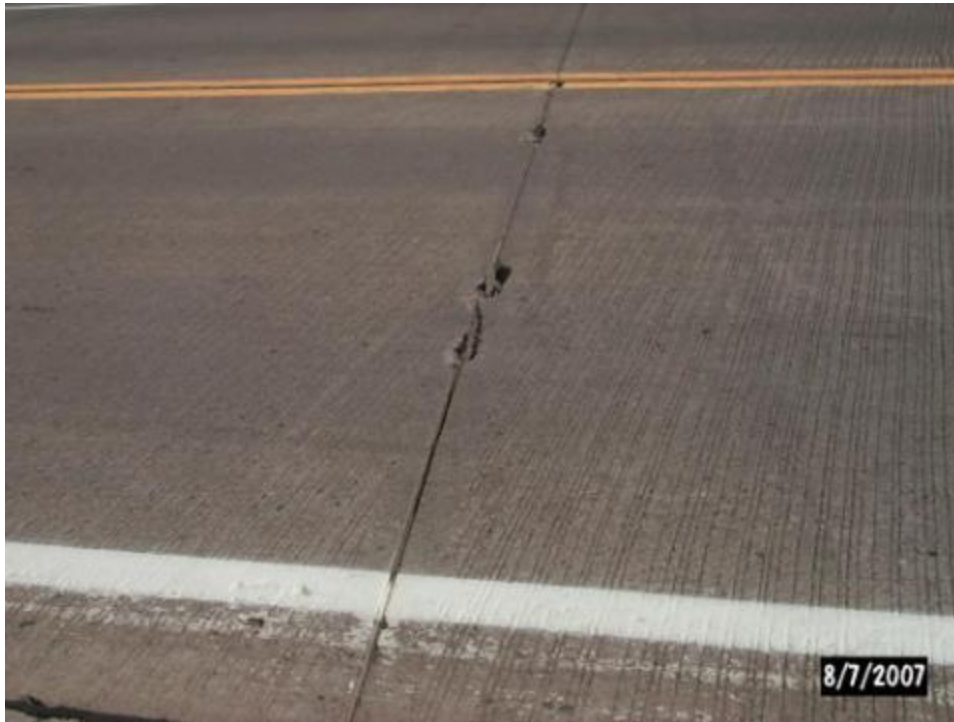
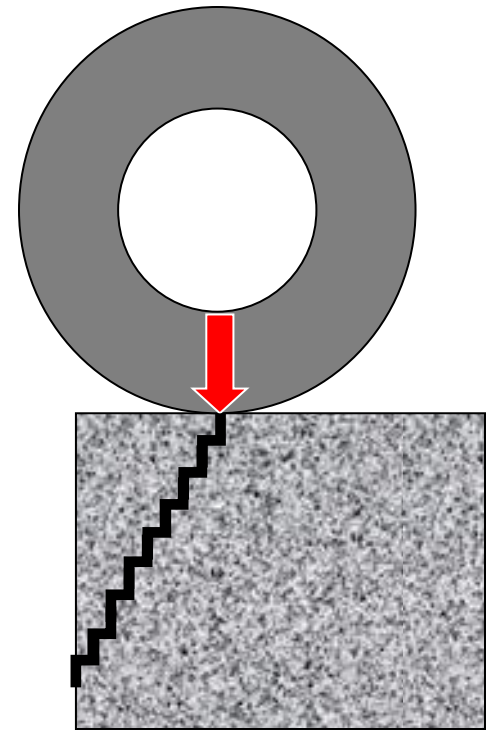
Mechanical?

- Traffic
 - Unlikely – stress is $\sim 50\text{psi}$

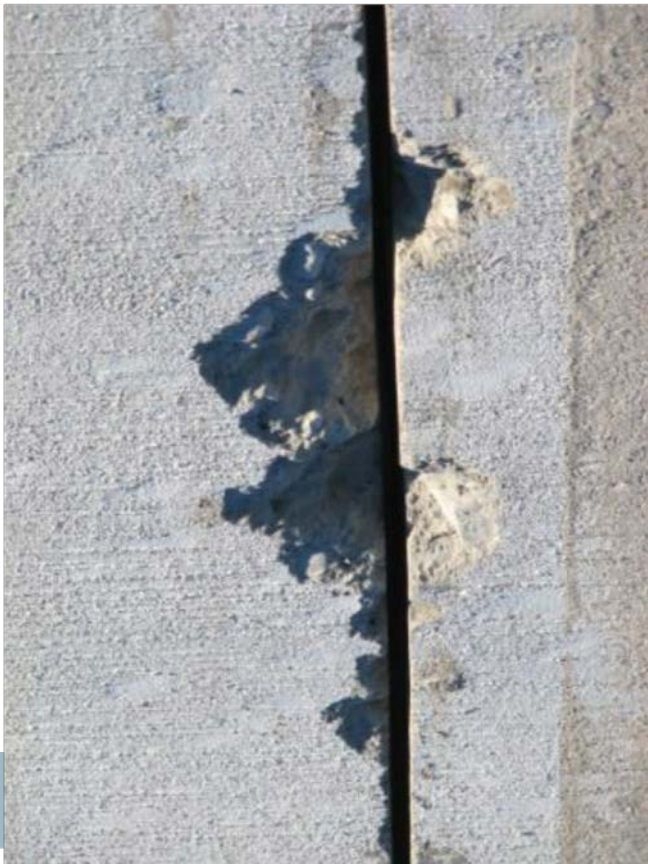
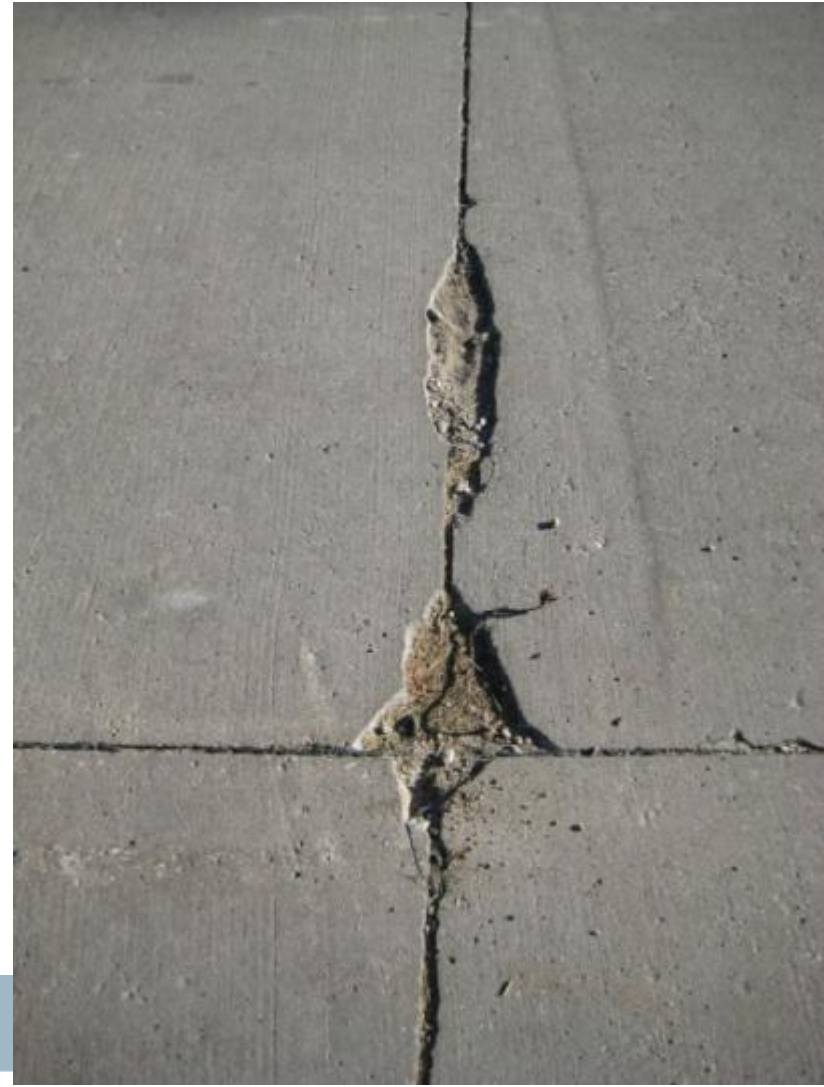
Mechanical?

- Sawing
 - Maybe

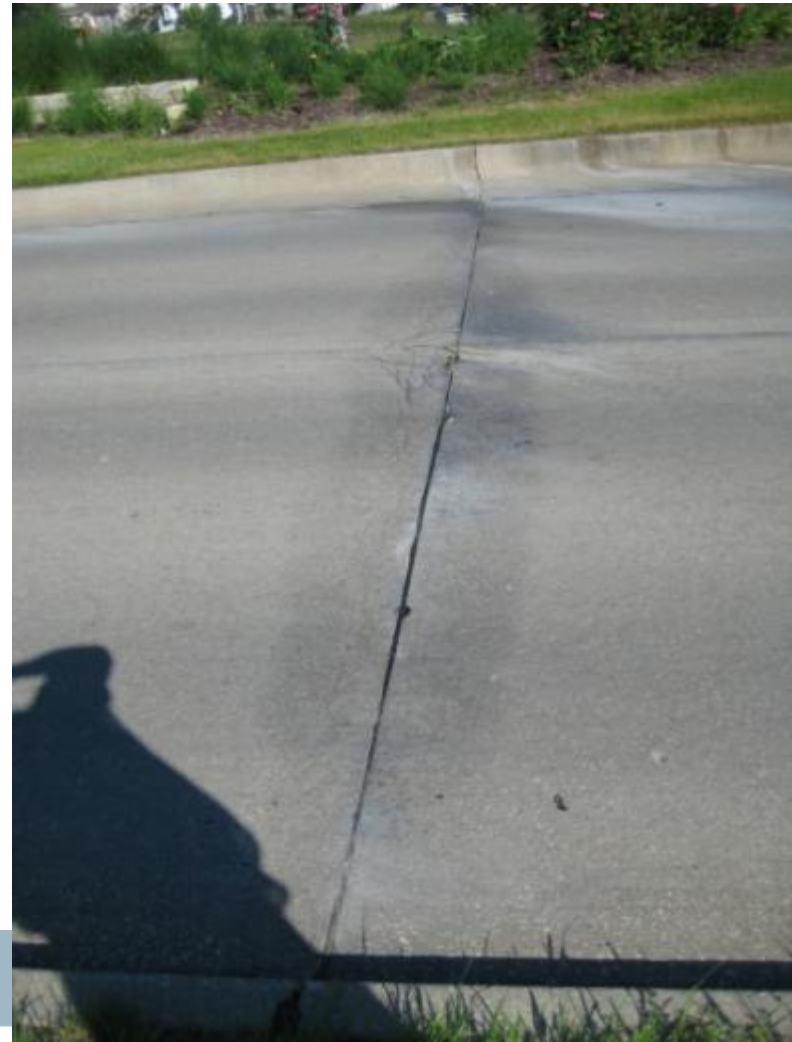
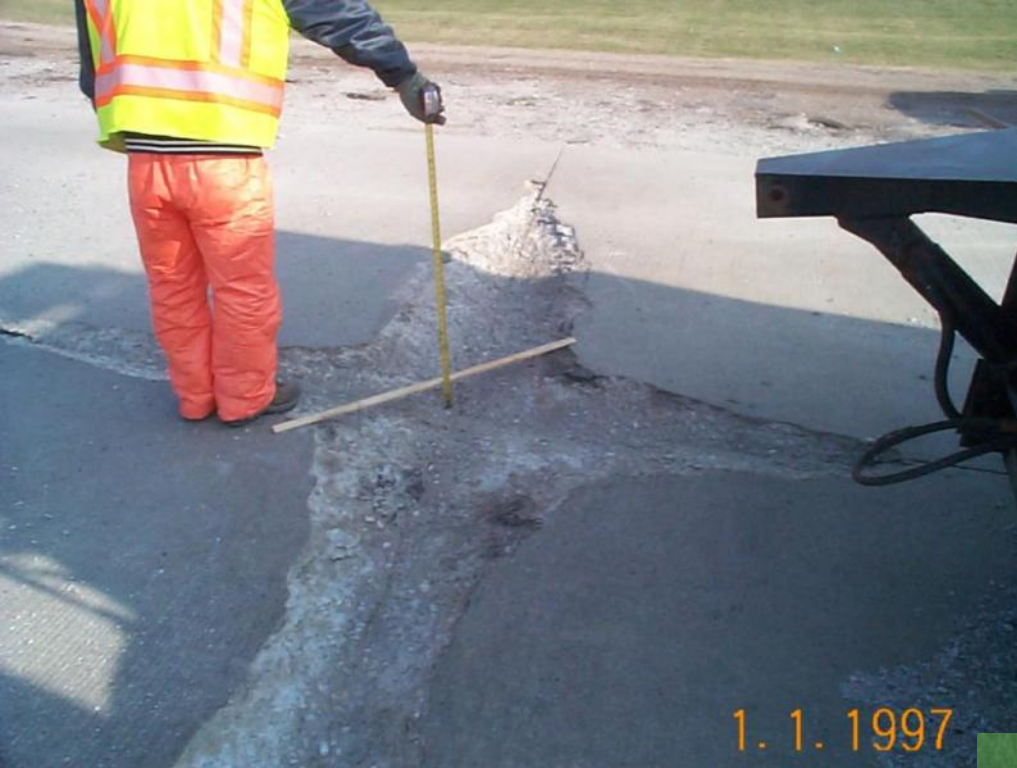
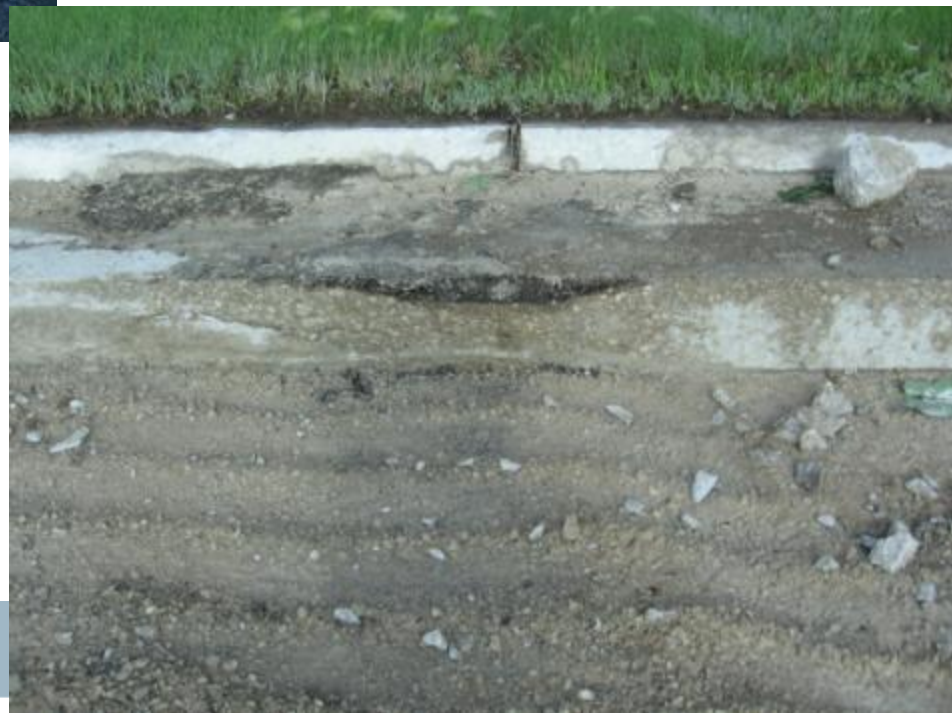
Frost

- Common features
 - Marginal air
 - Abundant water
 - Deposits in air voids

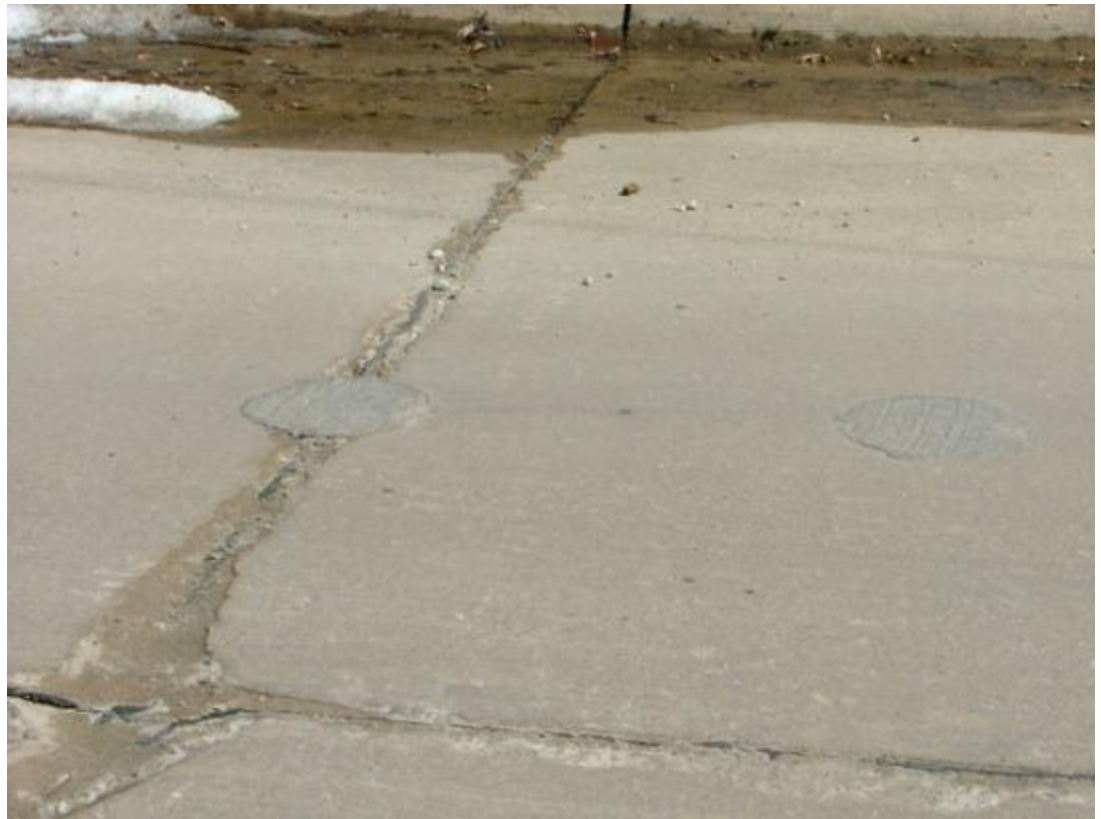
Frost

- Trapped water

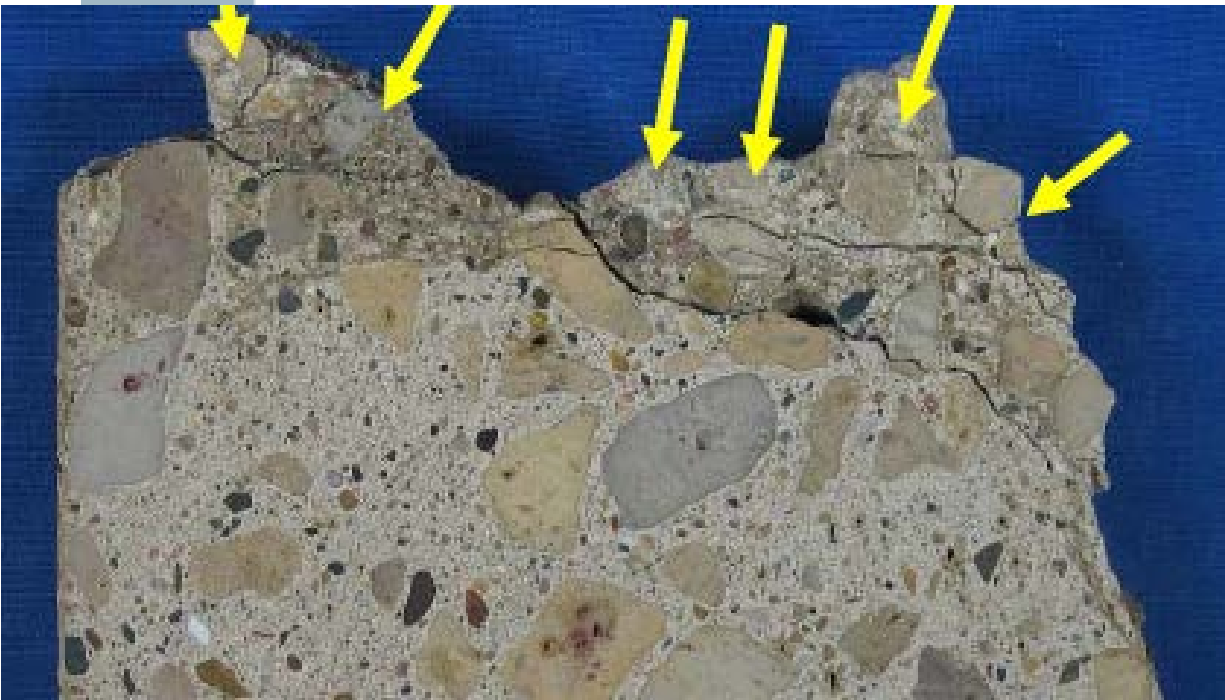
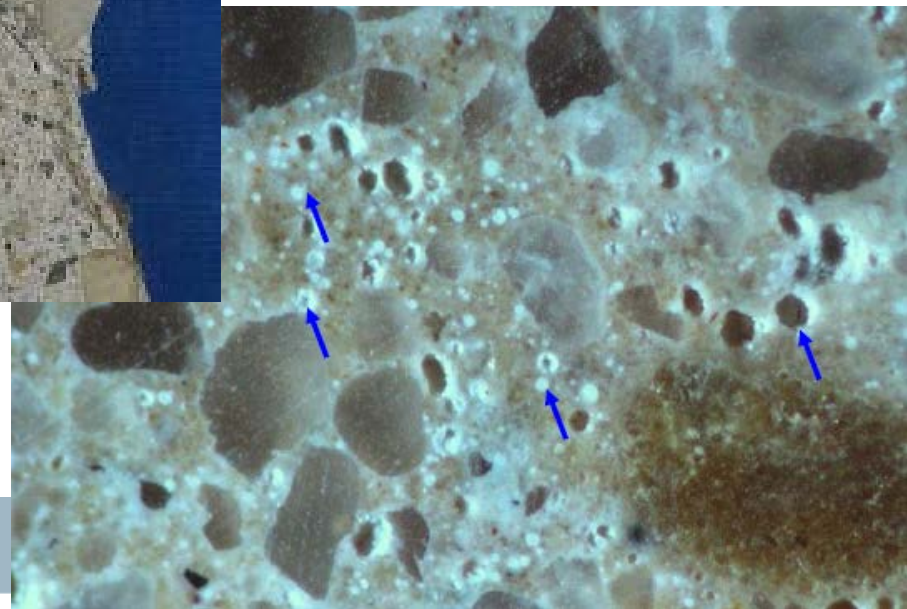
Frost

- Trapped water
