Constructing Concrete Pavements with Durable Joints

**MAP Brief June 2014**

**Constructing Concrete Pavements with Durable Joints**

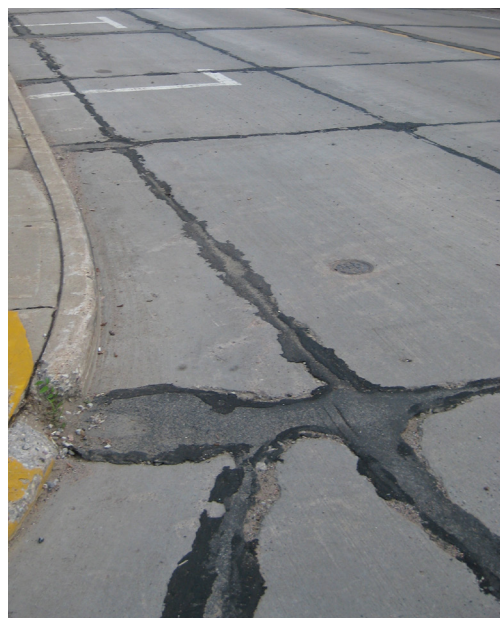
Figure 1: Typical distress in a city street

Joint deterioration is most commonly observed in city and county streets, both in longitudinal and transverse joints (Figure 1), though local variations are reported.

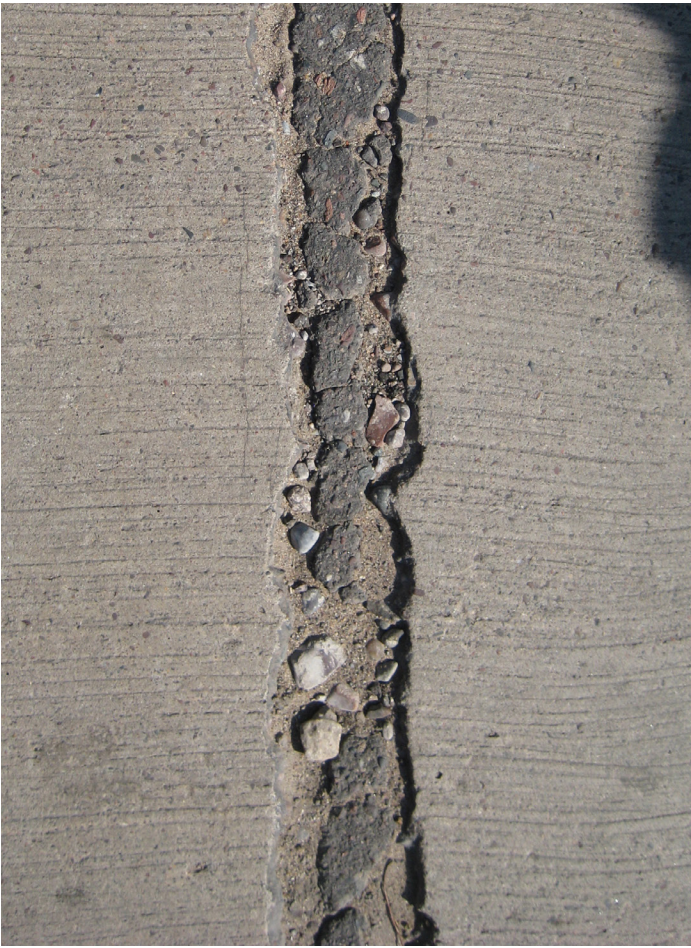
Figure 3: Cracks formed at inch increments from sawn face

Joint distress is commonly observed in the form of thin flakes in the paste. A variation in the distress is the observation of cracks that form about an inch from and parallel to the sawn face and are repeated away from the sawn face.

The depth of this distress is about the same as the saw cut (Figure 3). The pieces that come out tend to be sound rather than flakey. In both cases, the exposed face leaves aggregate particles exposed, indicating that the mechanisms are affecting the paste rather than the aggregate.

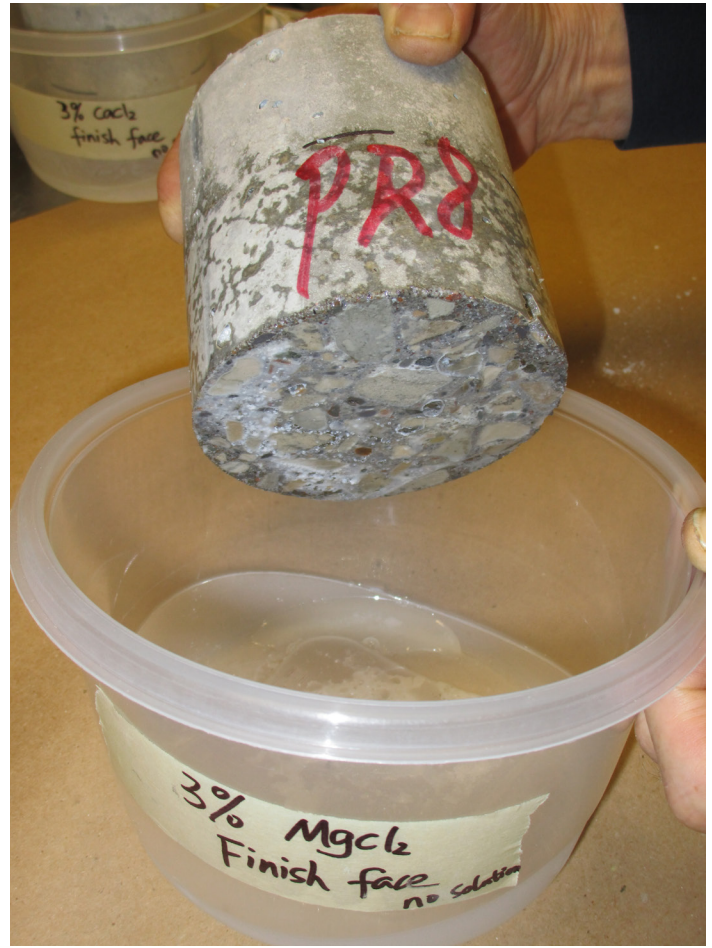
Figure 4: A cylinder that had been soaked in  $MgCl_2$  solution then exposed to air for 6 months. Note that it still appears wet – demonstrating the effect of  $MgCl_2$  in increasing saturation.

A factor that is likely contributing to the relative novelty of this form of distress is the growing use of de-icing salts, such as magnesium chloride and calcium chloride. Both of these compounds tend to absorb water from the atmosphere and therefore have the effect of preventing surfaces in contact with them from drying out. A joint that has either of these salts inside will therefore exhibit much higher saturation and a higher risk of freeze-thaw damage (Figure 4).
