Report Title		Report Date: 2000
Removable Orange Rumble Strips		
Principle Investigator Name Maze, Tom Affiliation Iowa State Univ Address 2901 S. Loop Drive, Suite 3100 Ames, IA 50010 Phone 515-294-9523 Fax 515-294-0467 Email tmaze@iastate.edu		Vendor Name and Address Advanced Traffic Markings Ron Sims PO Box H Roanoke Rapids, NC 27870-8082 (252) 536-4940
Author(s) and Affiliation(s)		
Supplemental Funding Agency Name and Address (if applicable)		
Supplemental Notes		
Abstract

REMOVABLE ORANGE RUMBLE STRIPS

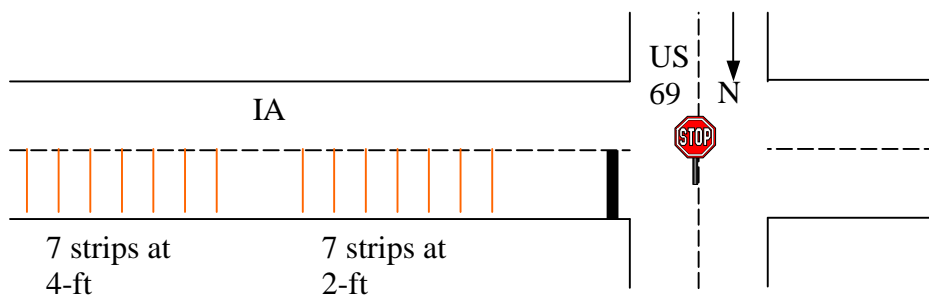
Figure 2-25 Rumble strips layouts – US 69 and IA 210 – Site A (asphalt pavement).

The schematics of the sites are shown in Figures 2-25 through 2-27. Site A is a rural location at the intersection of two highways IA 210 and US 69. As can be seen in Figure 2-25, two sets of seven nine-foot strips (approximately 500 feet apart) were applied on the asphalt pavement of the eastbound approach of IA 210 roadway that leads to an all-way stop-controlled intersection. The first set of strips had a four-foot spacing. The second set (the one closer to the stop bar) had a two-foot spacing. The average daily traffic on the westbound approach of the IA 210 is 3,090 vehicles.

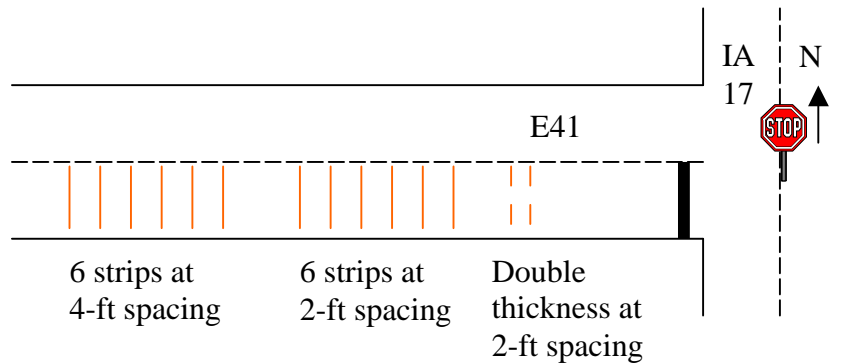
Figure 2-26 Rumble strips layouts – IA 17 and E41– Site B (concrete pavement).

Site B is also a rural location at the intersection of E41 county road and IA 17 highway. Two sets of six nine-foot strips, approximately 500 feet apart, were applied on the concrete pavement of the eastbound of the E41 roadway. Similar to site A, the first set of strips had a four-foot spacing and the second set (the one closer to the stop bar) had a two-foot spacing. A third set of two double-thickness strips was also applied on the pavement under vehicles' wheel paths at about 500 feet upstream of the stop bar. The purpose of placing this last set of strips was to examine the rumbling sensation and durability of the strips when they are double layered. The average daily traffic on the eastbound approach of the E41 roadway is 3,220 vehicles.

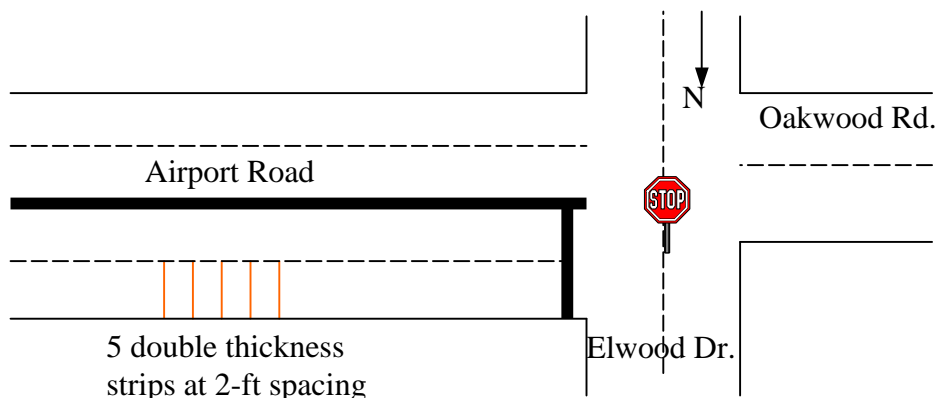
Figure 2-27 Rumble strips layouts – Airport Road – Site C (concrete pavement).

Site C is an urban location at the eastbound approach of Airport Road in Ames, Iowa. To more extensively examine the durability and rumbling sensation of the double-thickness strips, a set of five nine-foot double-stacked strips at a two feet spacing were applied on the concrete pavement of the outer lane of the approach at about 500 feet upstream of the stop bar. According to the 1995 traffic count records, the average daily traffic on the eastbound approach of the Airport Road was 2,450 vehicles. However, due to recent development of the area, the average daily traffic should have increased significantly during past the two years (approximately 5,000 vehicles).

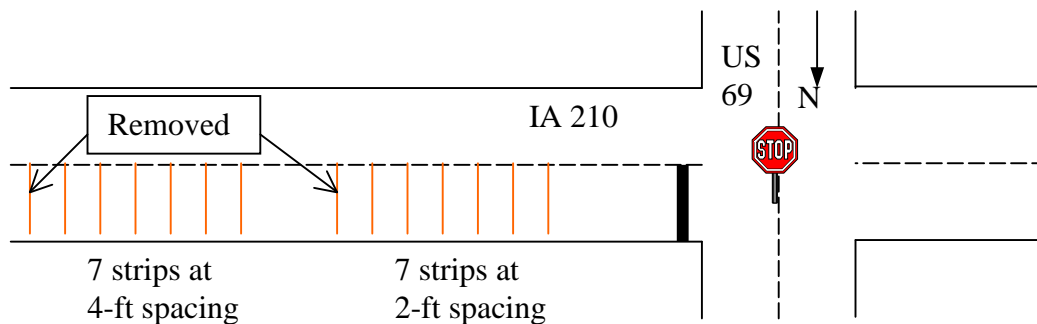
Figure 2-28 Rumble strips removals – August 18,1999 visit – Site A.

August 18, 1999 – In order to examine the ease of removing the strips, 24 hours after their initial installation, one strip from each set at site A and one of the sets at site B were removed (see Figures 2-27 and 2-28). Strips lifted up very easily from both pavement types. No residue remained on the pavements.

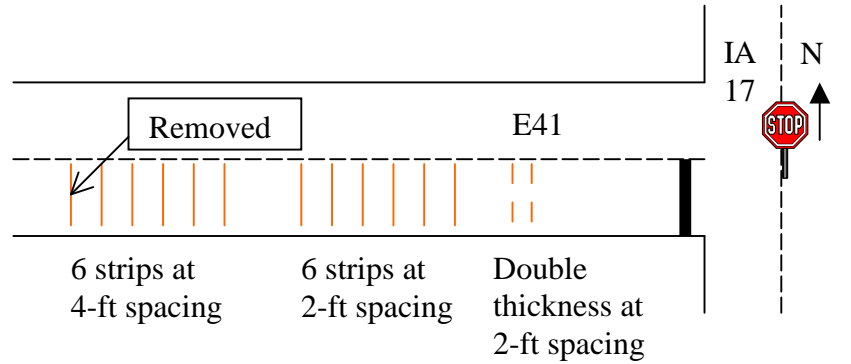
Figure 2-29 Rumble strips removals – August 18, 1999 visit – Site B.

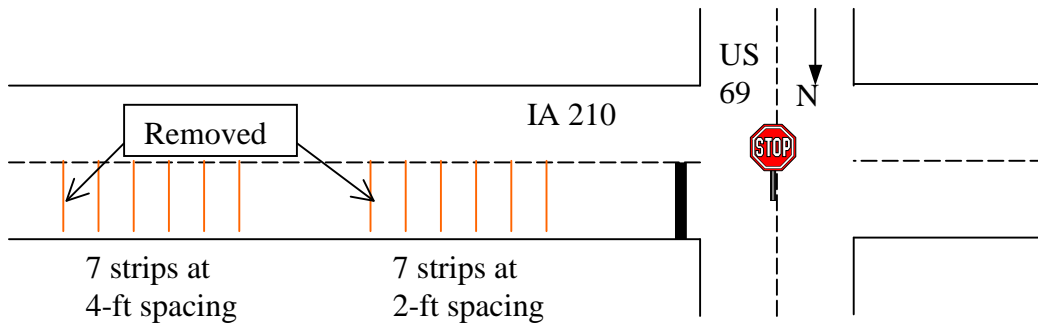
Figure 2-30 Rumble strips removals – August 28, 1999, Visit – Site A.

August 28, 1999 – During this site visit another strip from each set at site A and one of the sets at site B were removed (see Figures 2-29 and 2-30). There were no signs of color fading and wear. Strips were perfectly stuck to the pavements, however, they peeled off relatively easy without using any tools. More than 90 percent of adhesive remained on the removed strip backings. It was, therefore, decided to reapply these strips on the concrete pavement at site B (see Figure 2-31) to evaluate their performance upon reapplication.

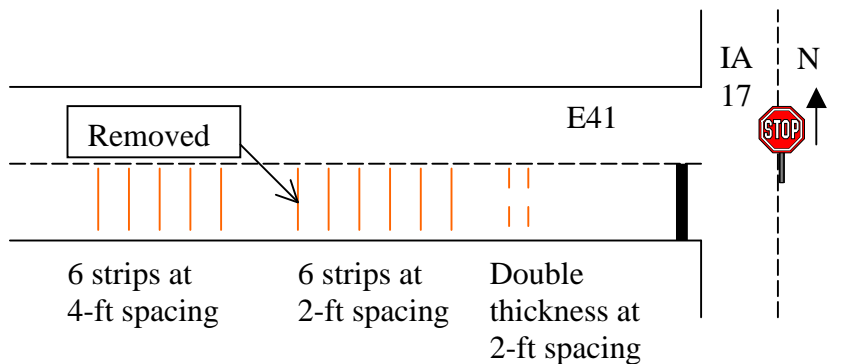
Figure 2-31 Rumble strips removals – August 28, 1999, Visit – Site B.

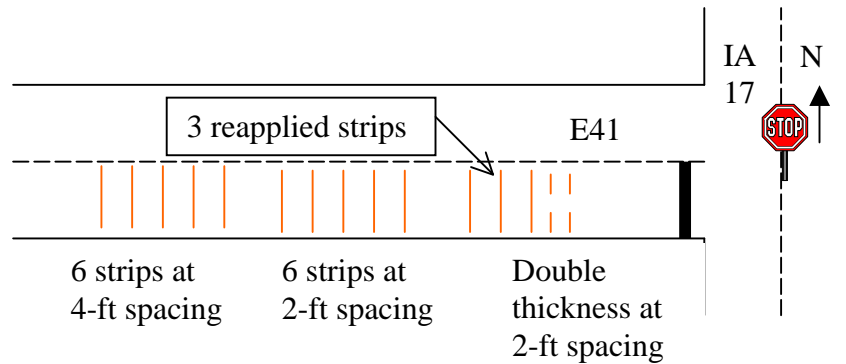
Figure 2-32 Rumble strips reapplication – August 28, 1999, Visit – Site B.

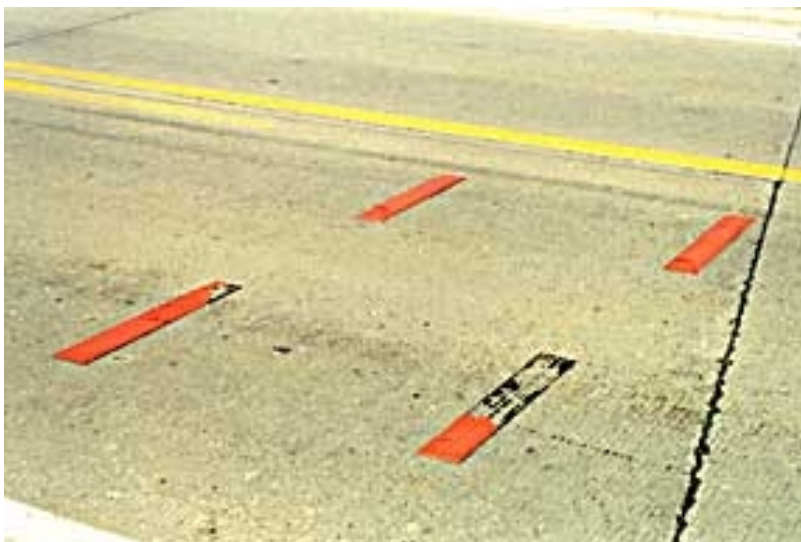
FIGURE 2-33 Damaged rumble strips – Site B.

October 5, 1999 – The rumble strips were removed from sites A and B on October 5, 1999. They were easily removed once their edges were loosened by inserting a screwdriver under a corner of each strip. All strips at site A were still in good shape. However, due to gravel shoulder scrapings, a few of the strips at site B were damaged. Damage to the two double-layered strips was more noticeable. Figures 2-33 and 2-34 show some of this damage. It should also be noted that two of the three reapplied strips at site B were still affixed with some minor damage.

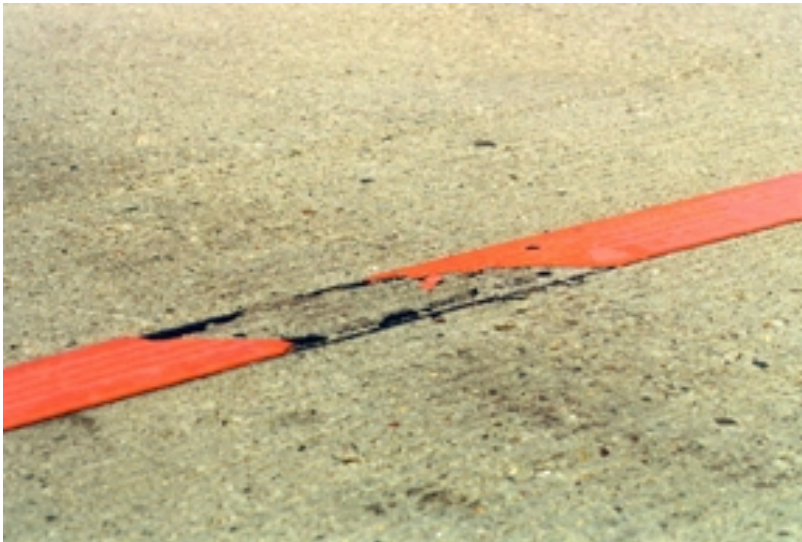
FIGURE 2-34 A damaged rumble strip – Site B.
