Report Title		Report Date: 2000
<b>CB Wizard Alert System</b>		
Principle Investigator Name Virkler, Mark Affiliation Univ of Missouri, Columbia Address E2509 Engineering Building East Columbia, MO 65211-2200  Phone (573) 882-7434 Fax (573) 882-4784 Email VirklerM@Missouri.edu		Vendor Name and Address Highway Technologies, Inc.
Author(s) and Affiliation(s)		
Supplemental Funding Agency Name and Address (if applicable)		
Supplemental Notes		
Abstract

## WIZARD CB ALERT SYSTEM

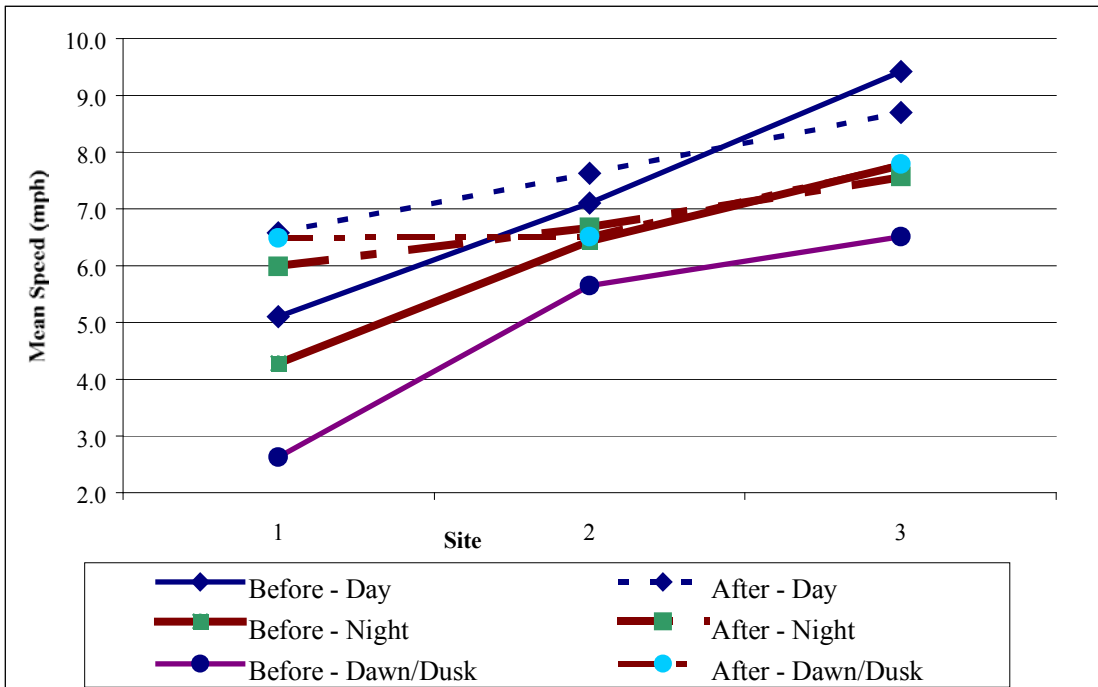
FIGURE 4-45 Standard deviation of mean speed profiles for open lane – *passenger vehicles*.

Figures 4-44 to 4-46 show changes in standard deviation by site for the before and after cases. At Site 1, all three categories had higher speed variation in the after case. At Sites 2 and 3, results were mixed.

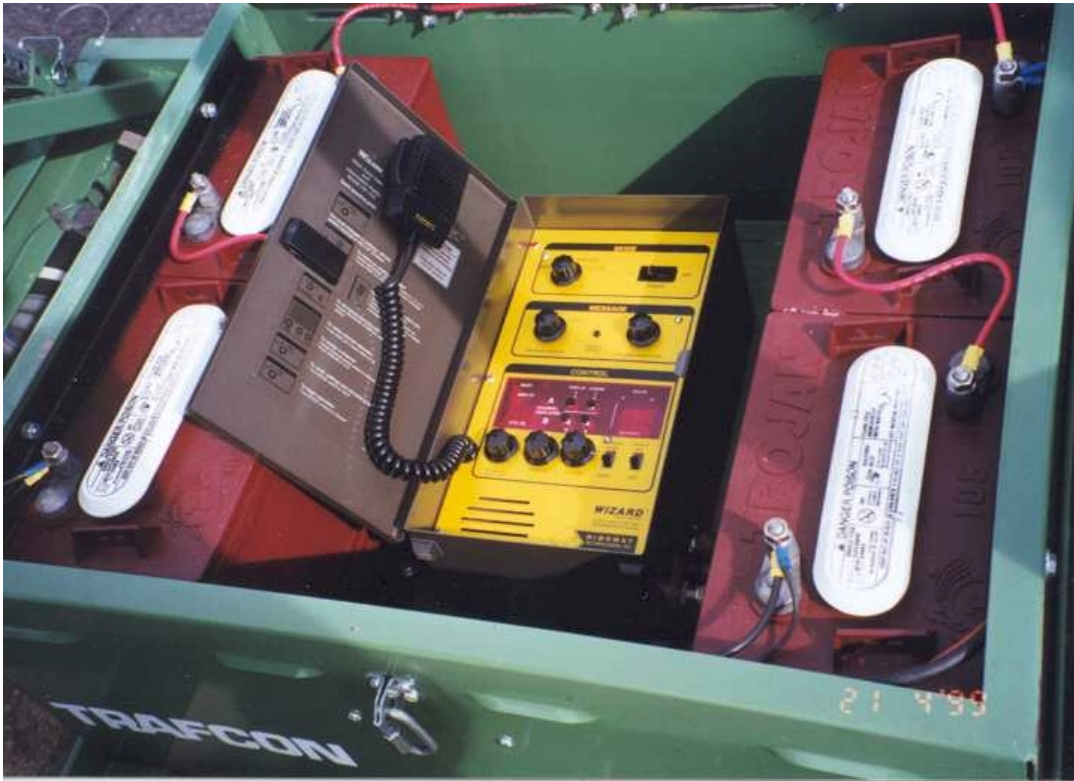
**FIGURE 4-48** Inside of CB Wizard alert system.

The CB message exhibited no great difficulty in set-up or use (figures 4-48 and 4-49). Roughly one-half hour was required to become familiar with the equipment, with instruction by a company representative. As part of this process, three individuals recorded trial messages. Particular effort was required to produce a succinct, clear script. One individual required several attempts to record a clear message, free of verbal mistakes. Once a successful message was recorded, the recording equipment, mounted on its trailer, was then towed to its deployment site, near a MoDOT maintenance shed.

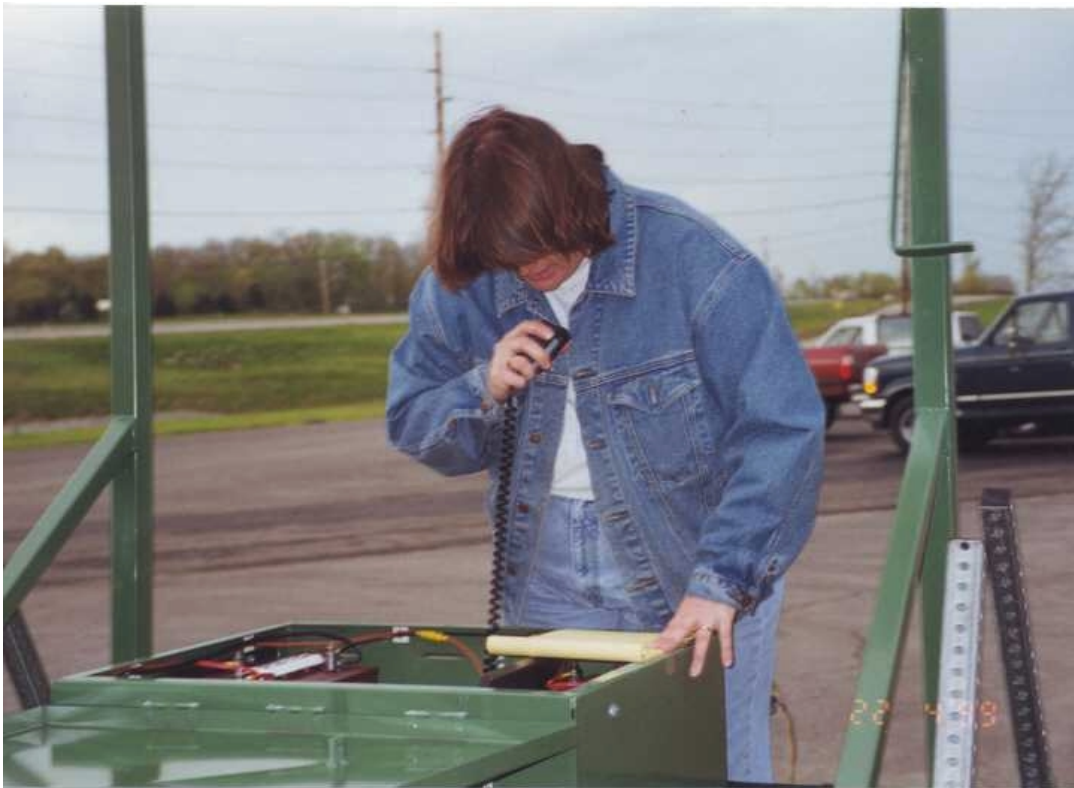
**FIGURE 4-49** Recording CB message.
