PROJECT TITLE
Performance Experience and Lessons Learned from the SPS 2 test sections of the Long Term Pavement Performance Program (LTPP)

AUTHOR
Kevin Senn
Nichols Consulting Engineers (NCE)
Reno, NV

Performance Experience and Lessons Learned from the SPS 2 Test Sections of the Long Term Pavement Performance Program (LTPP)

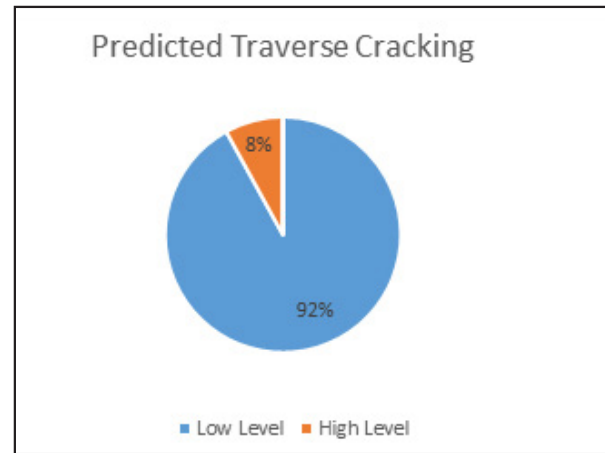
Transverse Cracking: Of the 205 test sections, the software predicted low levels of cracking on 189 (92%) tests sections and 16 (8%) tests sections at high levels. See Figure 2.

Figure 2. Predicted transverse cracking on SPS-2 test sections

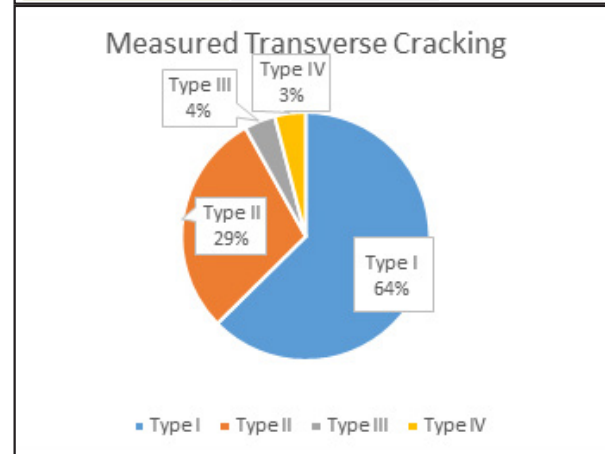
Predicted vs. Measured Transverse Cracking on SPS-2 Test Sections: See Figure 3 and Table 2.

Types I- 132 (64%) test sections predicted low levels of cracking matched measured low levels

Types II- 57 (29%) test sections predicted low levels of cracking but measured high levels

Type III- 9 (4%) tests sections predicted high levels of cracking but measured low levels

Typed IV- 7 (3%) tests sections predicted high levels of cracking matched measured high levels

As can be seen, for the majority of the test sections the software predicted low levels of cracking and that is also what was measured (Type I). However, there were a significant number of sections where higher than predicted cracking was measured (Type II). Much smaller in number were test sections with less measured cracking than predicted (Type III) and test sections where cracking occurred and the amount was correctly predicted (Type IV).

Predicted Slabs Cracked	Measured Slabs Cracked	
	LOW	HIGH
LOW	Type I	Type II
HIGH	Type III	Type IV

Figure 3. Definition of type of cracked slabs and measured transverse cracking on SPS-2 test sections (Note the predicted and measured cracks refers to the number of cracks not the severity)

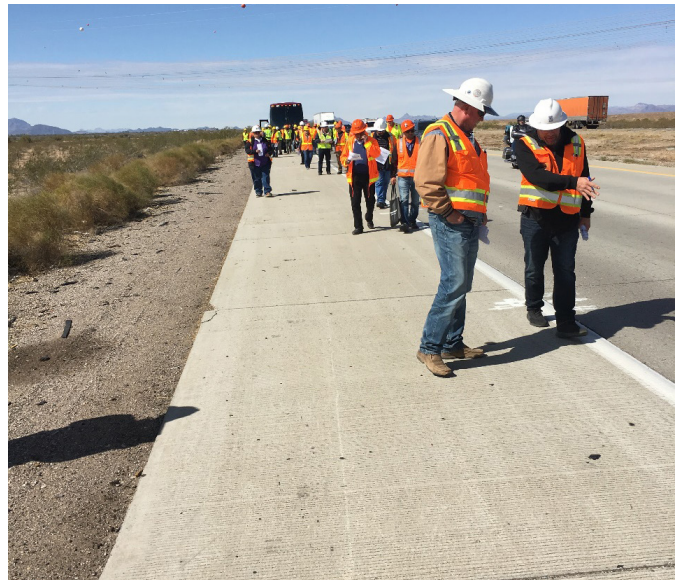
- Substantial surface cracking is present on most of the 900 psi test sections, with the cracking in the truck lane wheel-paths being more pronounced than in the passing lane.
- The 550 psi mixes showed substantial paste wear in the wheelpaths.
- The LCB sections have the most cracking, with the thin PCC sections on aggregate base also having significant cracking.
- The PATB and thick PCC section on aggregate base look very good, as do most of the Arizona supplemental test sections.

Figure 4. Arizona SPS-2 field visit

- With the shoulders not being tied, there was both horizontal and longitudinal movement of the truck lane with regards to the shoulder.
- The silicone joint sealant was predominantly in very good condition.
- Many of the supplemental test sections without dowels had significant faulting.

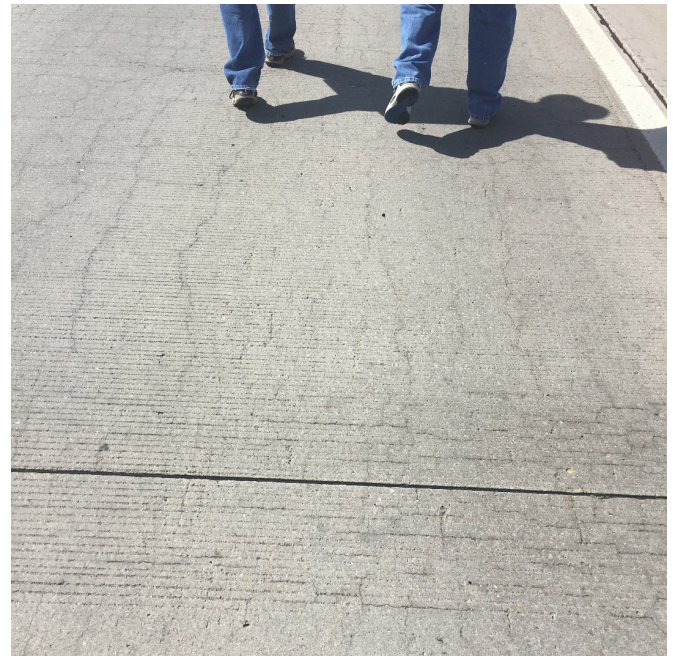
- The 550 and 900 psi pavement sections were visibly different to the eye, with surface cracking visible on most 900 psi pavements and the paste being worn off (particularly in the wheel paths) on the 550 PSI pavements.
- Several sections had small longitudinal cracks along transverse joints that looked to align with the locations of the dowel bars—primarily on the 8” 900 psi sections.
- Grinding had been performed in several sections, and some sections (mostly on LCB base) had substantial cracking and patching.
- The passing lane exhibited more spalling of transverse joints than the truck lane.
- Both spalling and corner breaks were present in a few sections.

Figure 5. Kansas SPS-2 field visit, 900 psi surface cracking

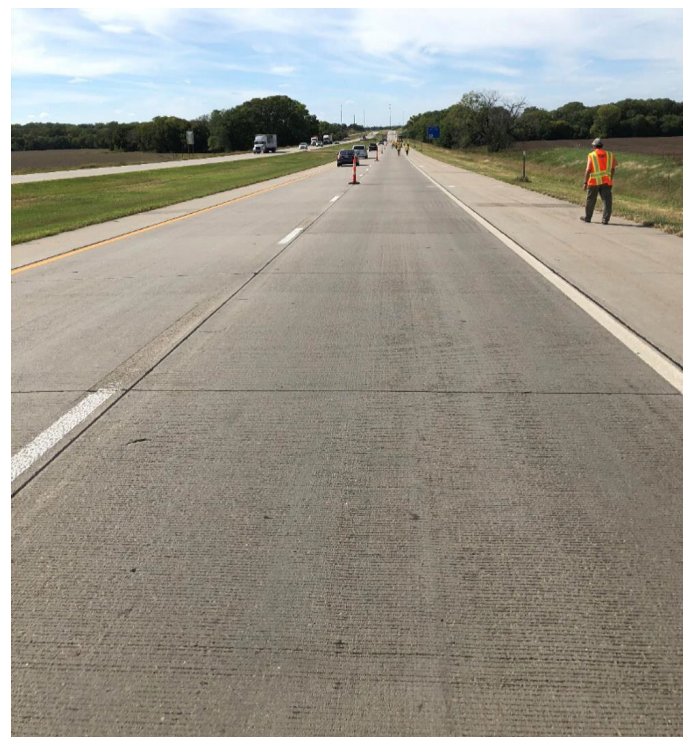
Figure 6. Kansas Section 0209 (8 in. PCCP on 4 in. PATB and 4 in. DGAB, 550 psi mix, 12 ft. shoulder)

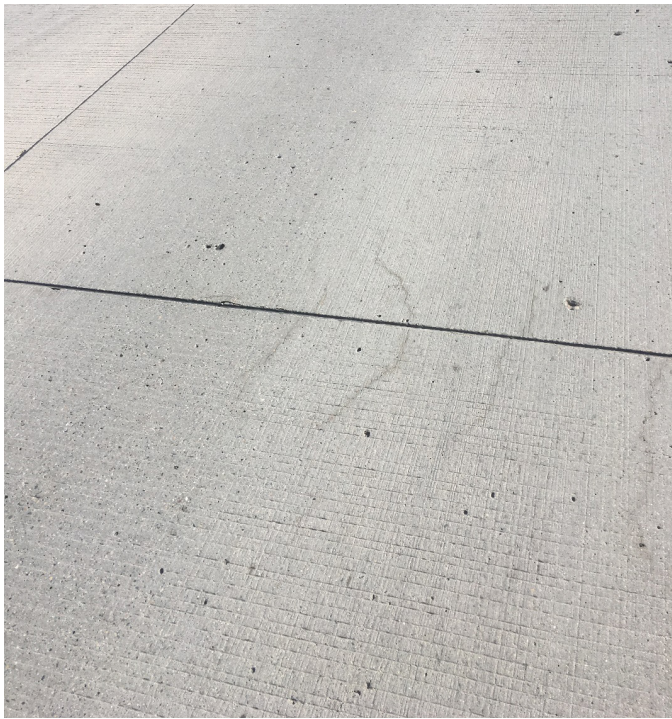
- Very few of the 900 psi pavement sections had visible surface cracking (other than over the dowels), and the minor surface cracking was mid-panel.
- The 550 psi mixes showed substantial paste wear in the wheel-paths.
- Cracking over the dowels on many test sections, similar to those in Kansas—reported by the agency to have occurred shortly after construction and not further deteriorated thereafter.
- CPR was performed in 2009 and 2016, so there were areas that previously had substantial cracking and/or spalling where the panels were replaced.
- The interface between the truck lane and the AC shoulder was in poor condition, and had been replaced twice since original construction.
- Grinding had been performed on several sections.

Figure 7. North Dakota SPS-2 field visit, cracking over dowels

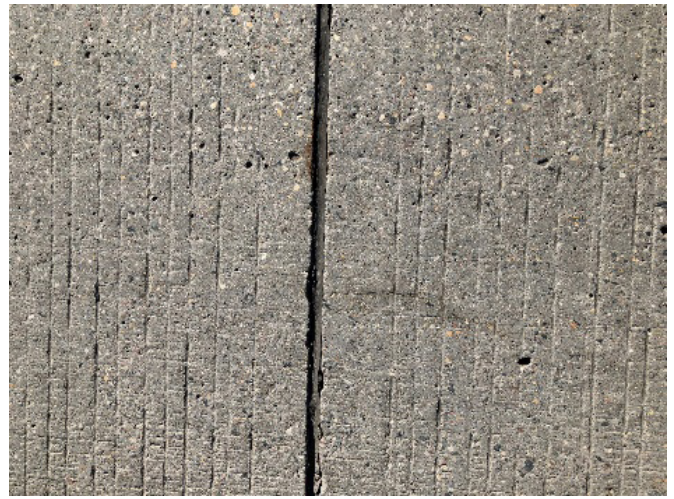
Figure 8. Closeup on North Dakota SPS-2

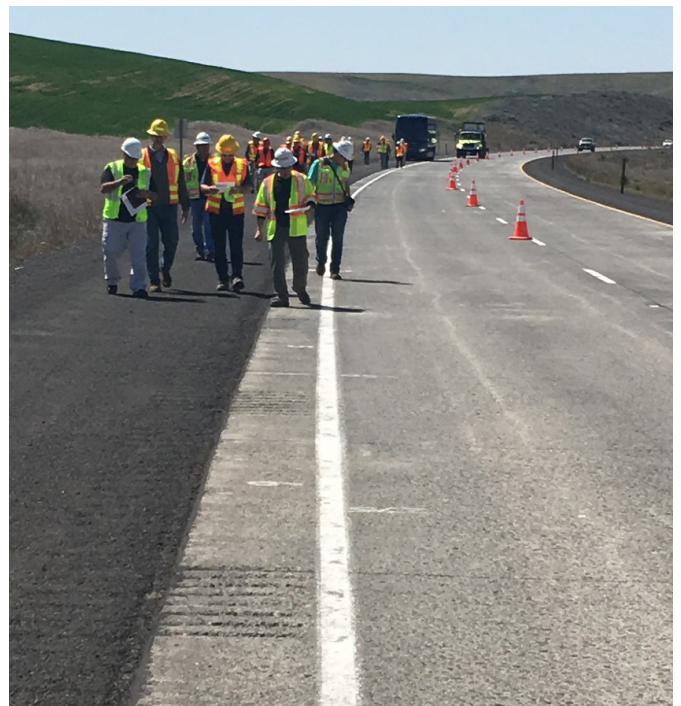
- The 550 and 900 psi pavement sections were visibly different to the eye, with surface cracking visible on most 900 psi pavements and the paste being worn off (particularly in the wheel paths) on the 550 PSI pavements.
- The interface between the truck lane and the AC shoulder was in poor condition.
- Most sites are in excellent condition, including the standard state section.
- Joint sealing was done with a hot pour sealant.
- The most substantial distress was in the first test section that was paved—likely due to construction issues more than loading or environmental influences.

Figure 9. Washington SPS-2 field visit
