Evaluation of the Performance of A1010 Bridge Steel

tech transfer summary

Iowa Department of Transportation
(InTrans Project 16-562)

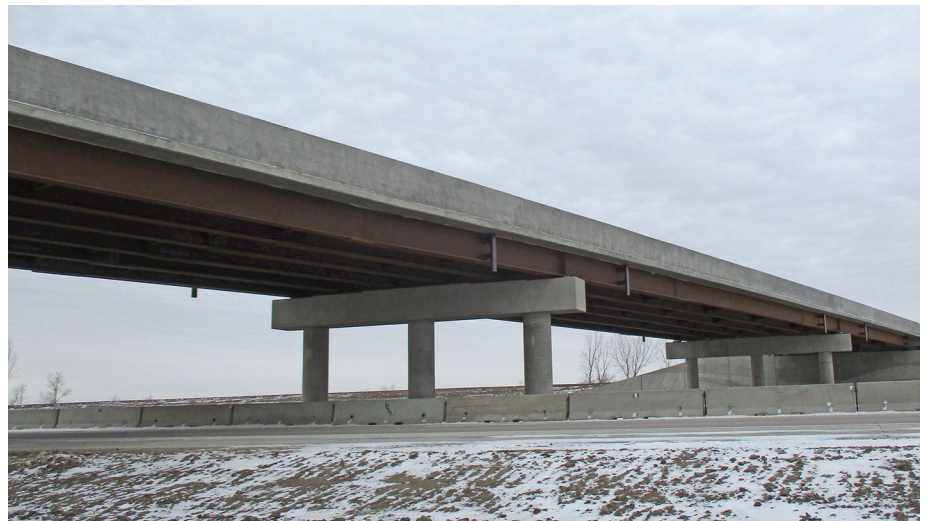
Salix Interchange Bridge on County Road K25 over I-29 in Woodbury County, Iowa

In 2016, the Iowa Department of Transportation (DOT) replaced a bridge in Woodbury County (on County Road K25 over I-29 at the Salix interchange) with a two-lane, four-span, continuous, steel-girder bridge partially constructed using ASTM A1010 bridge steel, i.e., for the two southernmost girders.

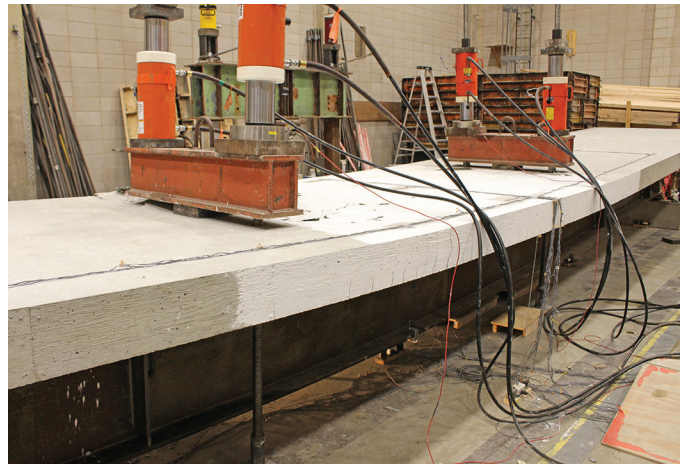
Ultimate flexural performance testing for the A1010 specimen

A comprehensive experimental program was carried out to investigate the performance of A1010 steel under a four-point bending scenario to determine the plate girder and composite flexural behavior.

A 52 ft 9 in. long A1010 steel girder like the two used in the bridge was designed, fabricated, and laboratory tested, with the results also compared to the current American Association of State Highway and Transportation Officials (AASHTO) Load and Resistance Factor Design (LRFD) Bridge Design Specifications. Additionally, tensile and fatigue tests were conducted to obtain the mechanical and fatigue behavior for the A1010 steel.

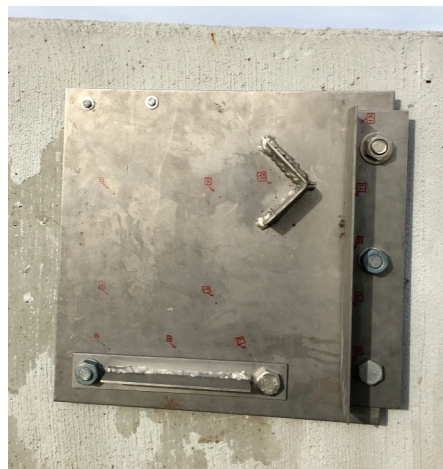
A1010 steel plate with stainless steel and galvanized steel bolts and welded connection

Both of these test specimens were constructed using different types of steel bolts and welds for comparison purposes, and corrosion testing on them will be ongoing.

- Long-term observational monitoring of galvanic corrosion on the full-scale cross frame will collect data for two types of bolted connections: stainless and galvanized steel.
- Likewise, long-term monitoring of the A1010 steel plate placed at the bridge site will be conducted and periodically documented for the development of corrosion.

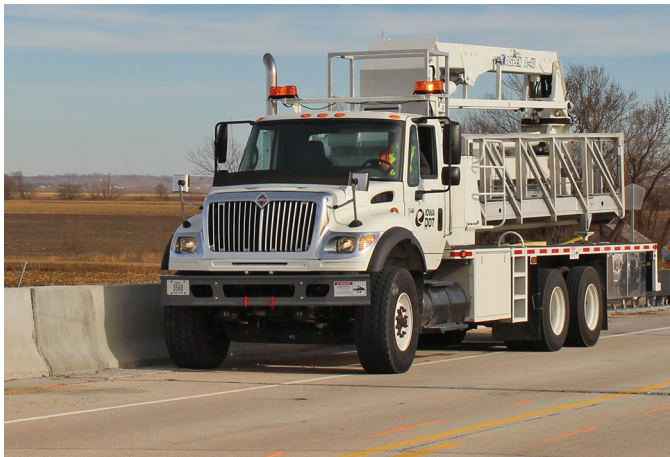
Live-load testing on the bridge

Two field tests for the Woodbury County (Salix Interchange) Bridge, which was designed utilizing A1010 steel and A709 weathering steel girders, were conducted with the goal of characterizing the difference in responses between the two types of steel.

Instrumented live-load tests on the bridge were conducted to identify any changes in behavior that occurred with time. The data were also analyzed for differences in response between the A1010 and A709 steel girders.

- The calculated distribution factors from the measured field strains and the AASHTO-recommended equations were investigated for comparison, and, for all cases, the maximum measured distribution factors were less than those calculated using the equations.

- In general, the results showed that the changes of structural performance for the girders when subjected to static live load tests over the two years were minimal.
