## Early Loading to Deploy Overlay Joints: Does It Work?

**Presenter:** Tom Burnham, Senior Road Research Engineer, MnDOT

*2022 NCC Spring Meeting*

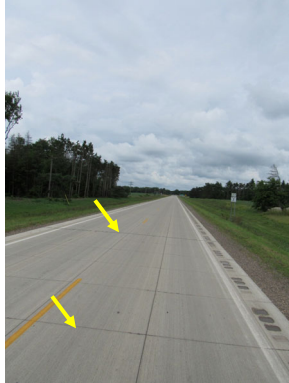
## Non-Uniform Joint Deployment in COAs

- Dominant joints (sealant bumps)
- Inconsistent faulting patterns
- Increased potential for buckled panels?

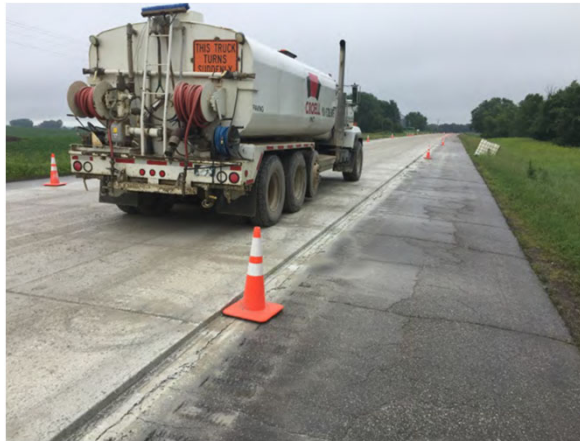
## Joint Deployment via Early Loading

- **Apply heavier loads earlier to encourage joint deployment**
  - Must be careful not to damage pavement

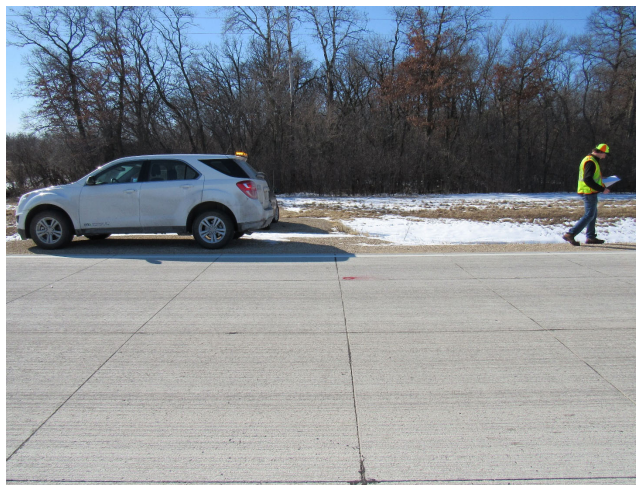
Visual surveys
