# Evaluation of Penetrating Sealers for Concrete

**Final Report**  
**June 2022**

National Concrete Pavement  
Technology Center

**Sponsored by**  
Iowa Highway Research Board  
(IHRB Project TR-765)  
Iowa Department of Transportation  
(InTrans Project 18-682)

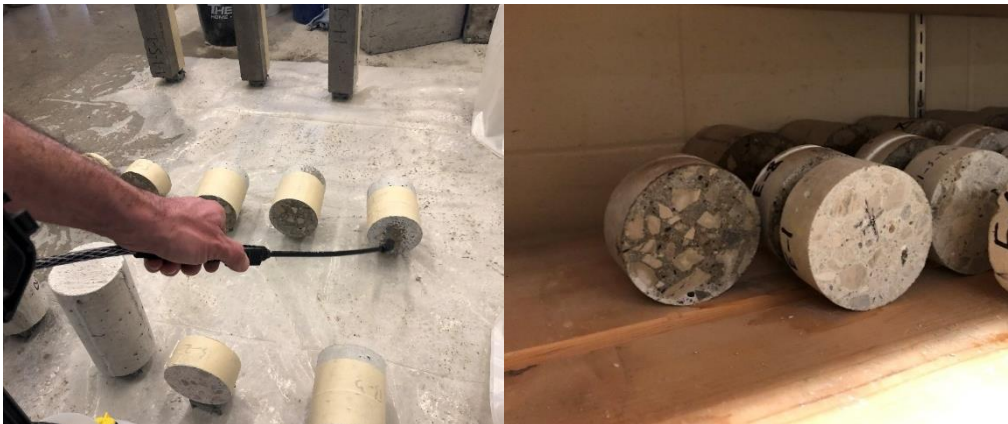
Prior to sealer application, all of the specimens were cleaned with high pressure air to remove dust and small particles, and the sides of the specimens were taped (as shown in Figure 1 left) to prevent overspray.

**Figure 1. Application of sealer (left) and curing specimens vertically (right)**

The sealers were then applied on vertically oriented sawn surfaces (to mimic saw-cut faces) at 7 days of age before the specimens were then returned to the environment chamber (Figure 1 right) for 28 days. The sealers were applied at a minimum of 200 ft<sup>2</sup>/gal with 50% or more observed to be draining off.

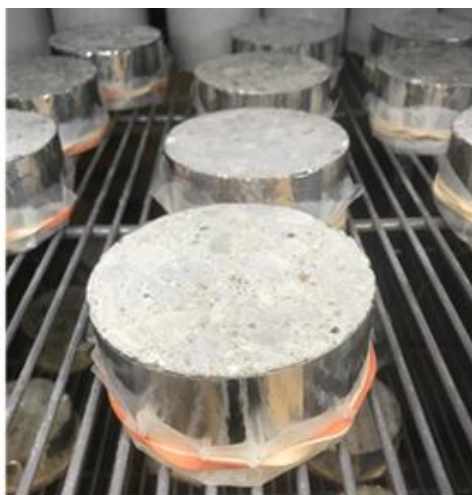
To simulate the drying process at the surface after the absorption rate test, the specimens were kept in same exposure condition, but face up this time to measure the desaturation rate in a controlled environmental chamber (72°F, 50% RH), as shown in Figure 2.

**Figure 2. Desaturation of specimens in environmental chamber**

In a similar manner to absorption rate measurement, the weights of the specimens were recorded to determine the rate of water evaporation from the exposed surfaces for 15 days.

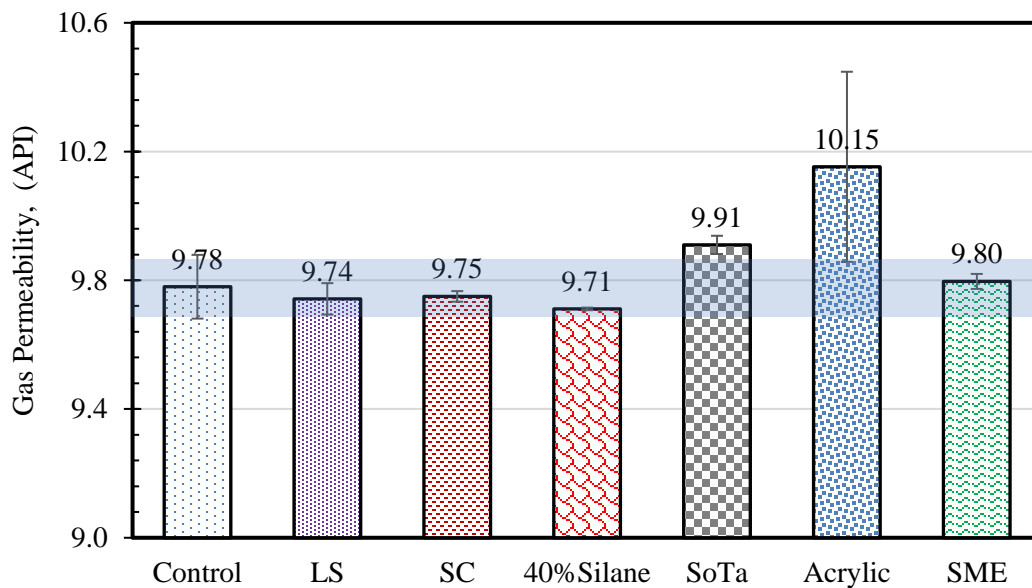
Air permeability results are shown in Figure 5.

**Figure 5. Air permeability results**

LS, SC, and silane exhibited pore-lining behavior and did not influence air permeability. SoTa and SME-PS are pore blockers and did reduce air permeability. The acrylic is a surface coating and provided the greatest reduction in air permeability. Thus, once the concrete element is not in contact with water and %RH is lower than 100%, the vapor can leave the concrete and decrease the degree of concrete saturation, which is a vital parameter in concrete deterioration in cold regions.

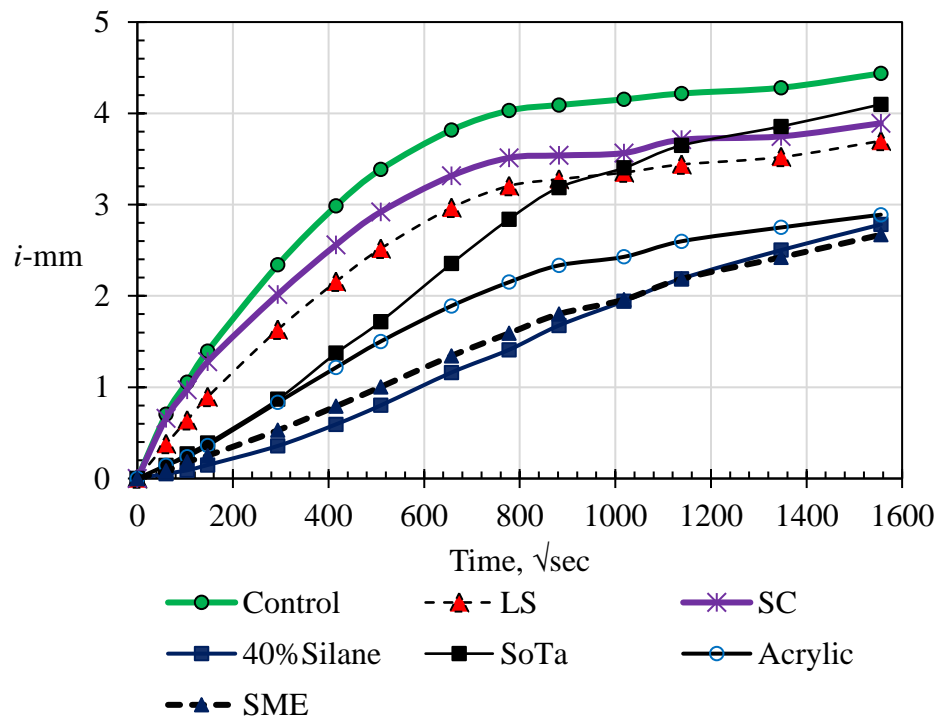
Figure 6 shows the amount of water absorbed by the specimens ( $i$ ) normalized by the cross-section area in contact with water according to ASTM C1585.

**Figure 6. Moisture uptake results with time**

LS and SC did not significantly reduce water ingress, and performance was similar to that of the untreated control. Application of these types of sealers cannot guarantee improved durability enhancement.

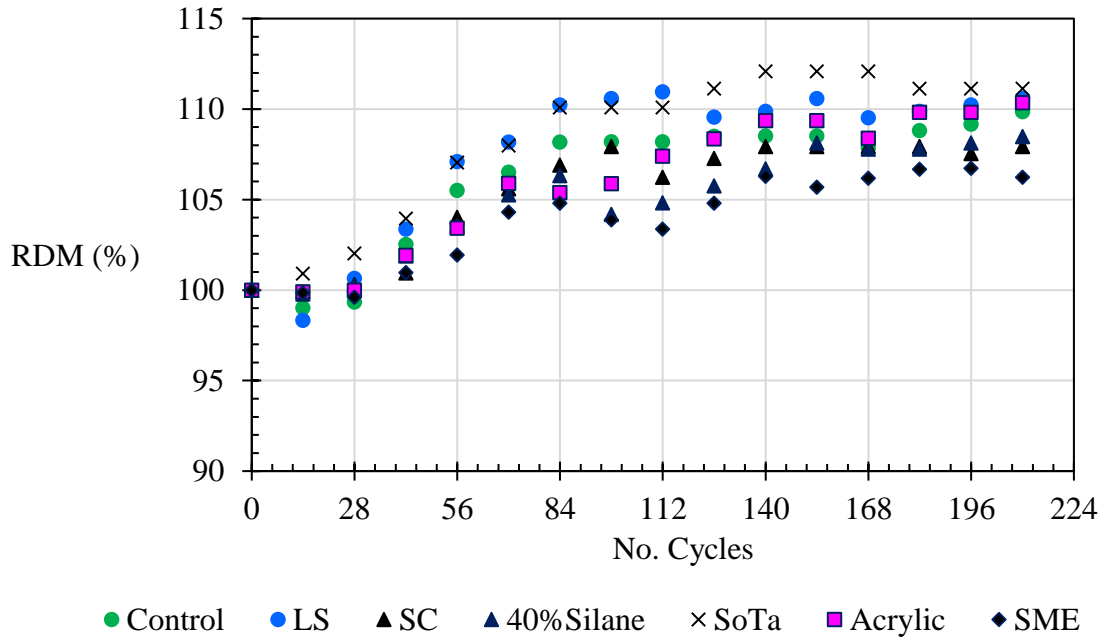
Figure 9 shows performance of the concrete treated with sealers for 210 F-T cycles over 15 weeks.

**Figure 9. RDM changes with F-T cycles**

None of the samples failed the test, which is not surprising considering the air-void system in the concrete. Specimens treated with acrylic visibly shed the coating after a few cycles. The RDM for all the specimens increased with time, which is not typical for conventional tests performed in pure water.

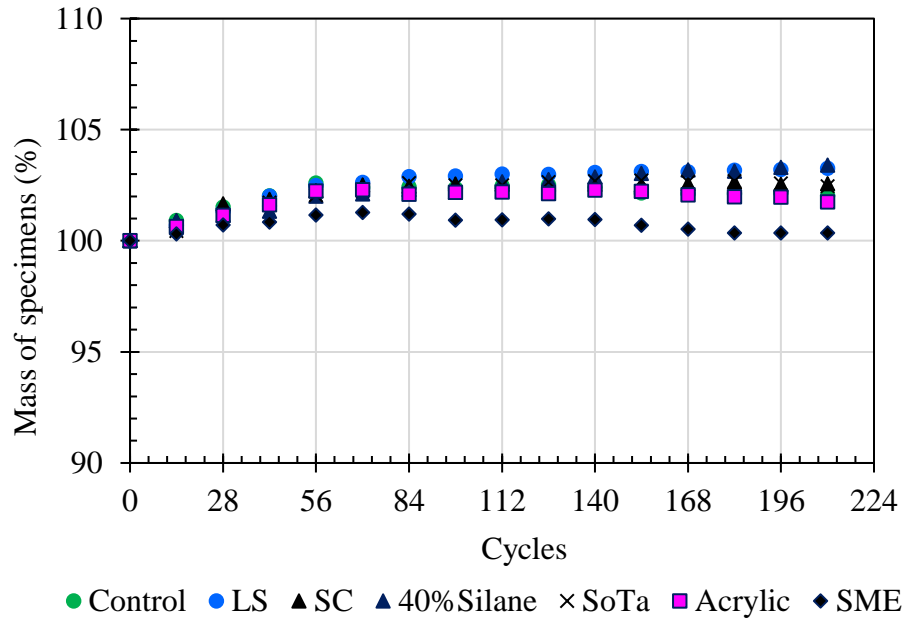
Figure 10 shows the mass changes for the concrete specimens with 210 F-T cycles over 15 weeks.

**Figure 10. Specimen mass changes with F-T cycles**

Sutter et al. (2008) stated that, when concrete is subjected to deicer salt solution and F-T cycles, both physical and chemical interactions occur. The physical interaction stems from internal stress, which is amplified by the presence of deicing salt solutions and surface salt scaling; whereas, the chemical interaction is the interaction between the salt ions and the concrete chemical composition. The increasing RDM of the specimens might be associated with the interaction of unhydrated cement with fluid solution, thus refining the microstructure of the concrete and ultimately increased RDM.

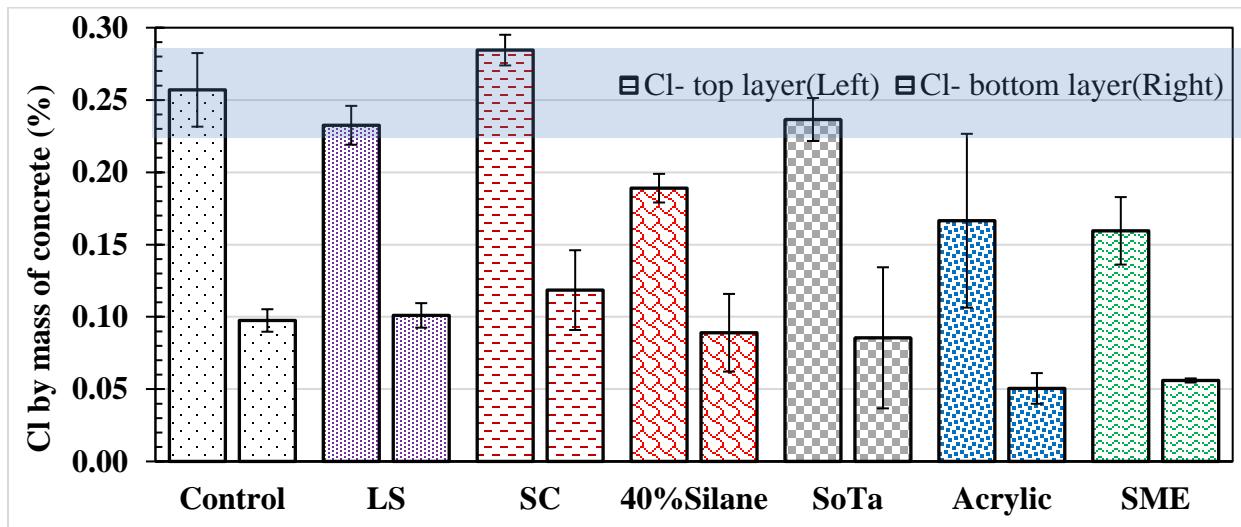
Diffusion is a dominant mechanism in the transport of chloride ions. Figure 11 shows the chloride content percentages by mass of the concrete after 91 days of ponding at depths of 0.0625–0.5 in. (top layer) and 0.5–1.0 in. (bottom layer).

**Figure 11. Chloride content percentage results**

Concrete treated with LS, SC, and SoTa did not show any improvement in reducing chloride ingress, given the chloride content in their top and bottom layers are close to those for the untreated control. The 40% silane and SME treatments reduced chloride ingress in the top layer by 26% and 36%, respectively. Similarly, SME significantly reduced the chloride in the bottom layer by 43% with a small standard deviation while the reduction for silane was 10%. The correlation between chloride content and water progression in treated concrete can be observed. Treatments that significantly reduced water absorption, likewise, effectively reduced the progression of chloride.

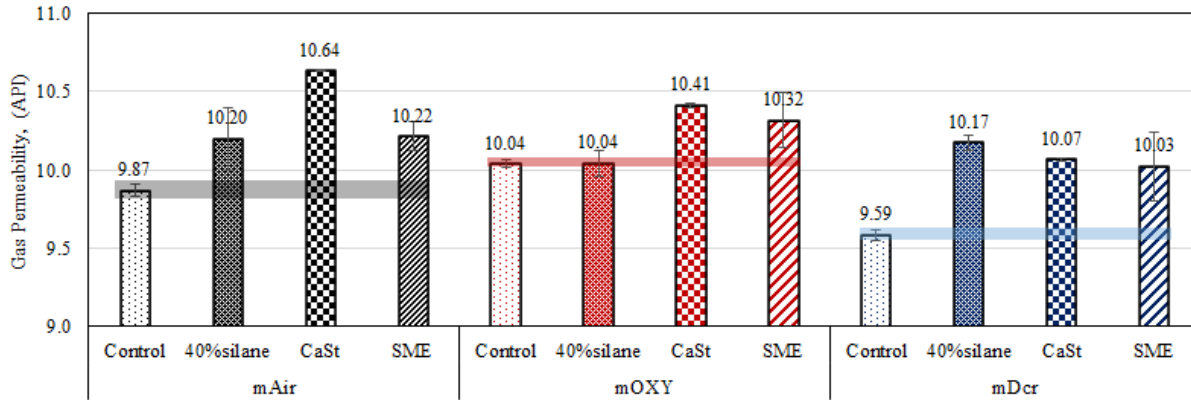
API results are presented in Figure 13, and based on the API rating, an increase in the API indicates a reduction in air permeability (Alexander et al. 2009).

**Figure 13. Air (gas) permeability index for concrete**

As shown in Figure 13, the 40% silane and SME treatments demonstrated at least a slight reduction in air permeability for mAir and mCaOXY concrete. All of the sealer treatments on the mDcrack specimens significantly reduced the air permeability. Substantial reduction of air permeability was observed (as anticipated) in specimens treated with SoTa (CaSt in Figure 13) given it acts as a partial pore blocker/liner. A similar trend, but with a smaller reduction, was observed for specimens treated with SME.

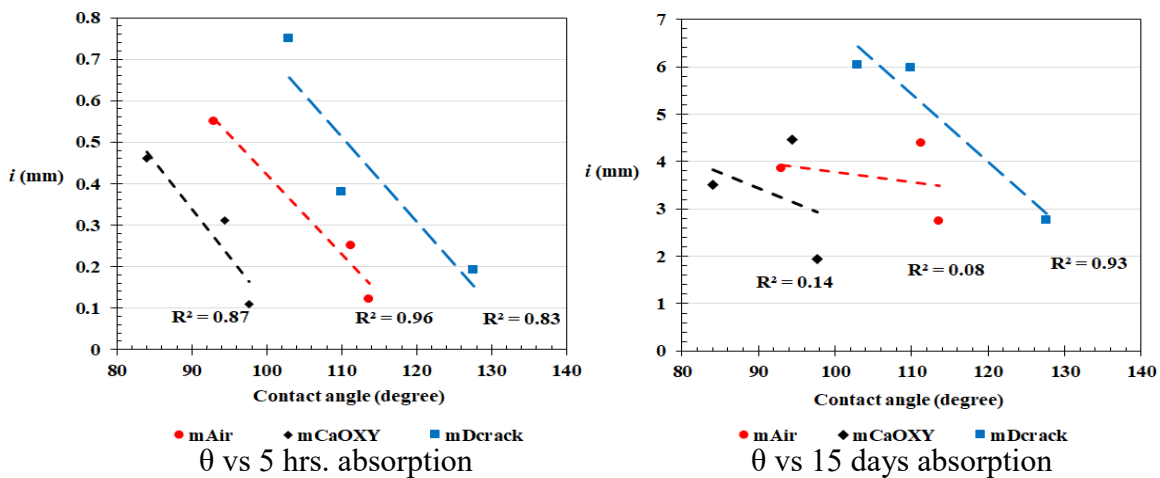
Figure 15 presents the water contact angle results as a function of water absorption.

**Figure 15. Relationship between contact angles and water absorption of coated specimens at 5 hrs and at 15 days**

The results suggest that initial water absorption was strongly correlated with the water contact angle (Figure 15 left). Contact angle was not particularly well correlated with absorption after 15 days of exposure. Based on this observation, the effect of sealer treatments on the reduction of initial water absorption can be predicted via a simple laboratory contact angle measurement, which is consistent with the Young-Laplace equation, because, as the water contact angle increases, capillary suction decreases.

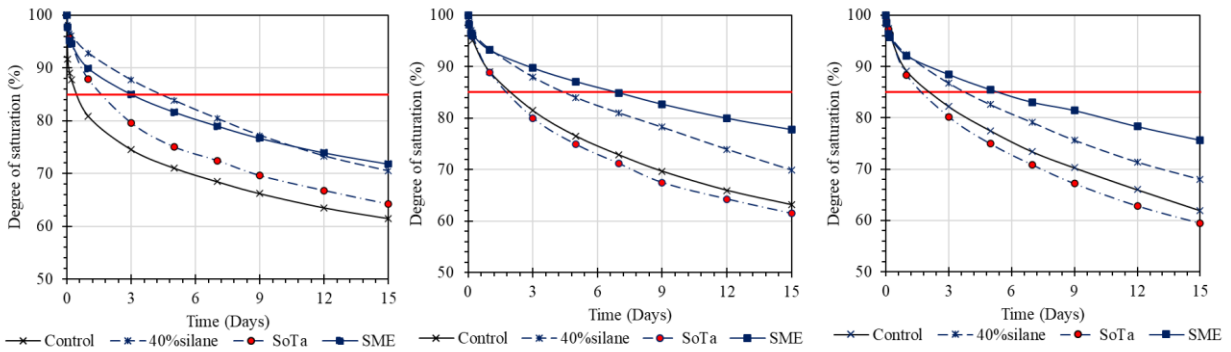
Figure 17 shows the water loss at the exposed surfaces as a function of time after the specimens had been immersed in saturated solution of calcium hydroxide for 30 days.

**Figure 17. Evolution of absorption and desorption for concrete specimens: mAir (left), mOXY (center), and mDcrack (right)**

In this condition, it was assumed that all specimens had reached saturation.

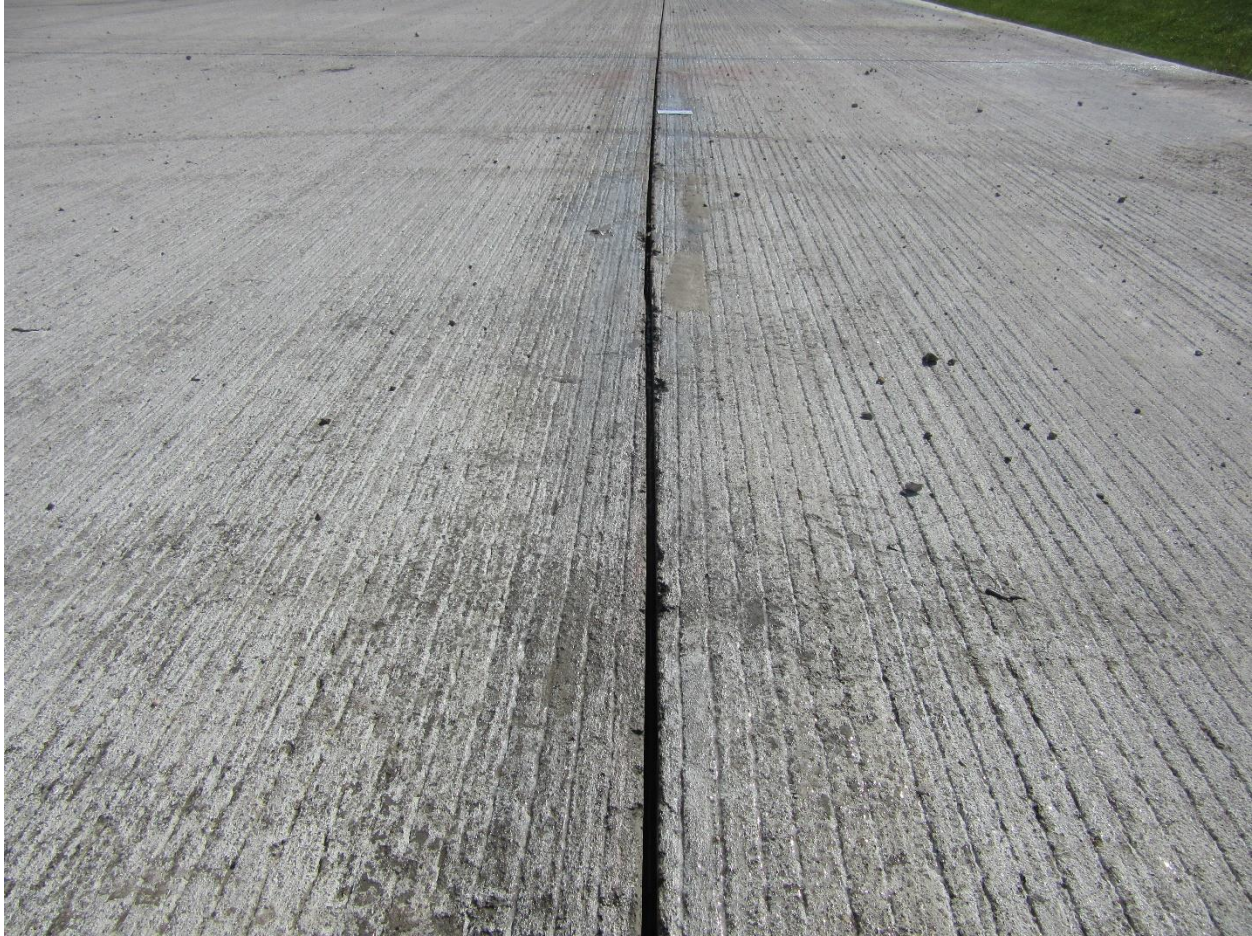
A typical section of CR W-61 just after application of the sealer is shown in Figure 23.

**Figure 23. SoTa application on CR W-61 in Washington County**

It is difficult to distinguish the untreated and treated pavement surfaces alongside the joint in the image due to the sunny conditions.

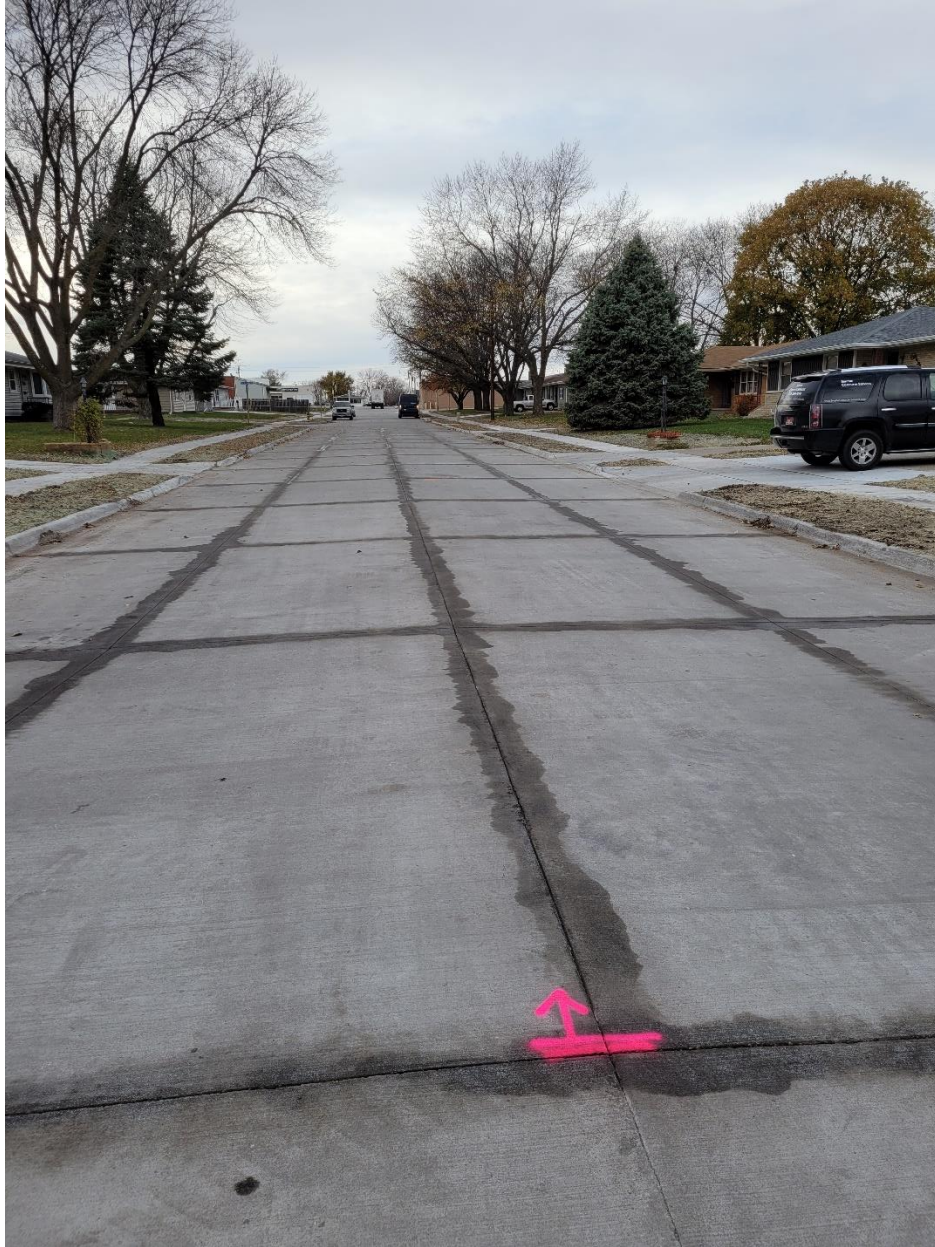
Figure 26 shows SE 8th Street just after application of the sealers.

**Figure 26. Sealer application on SE 8th Street**

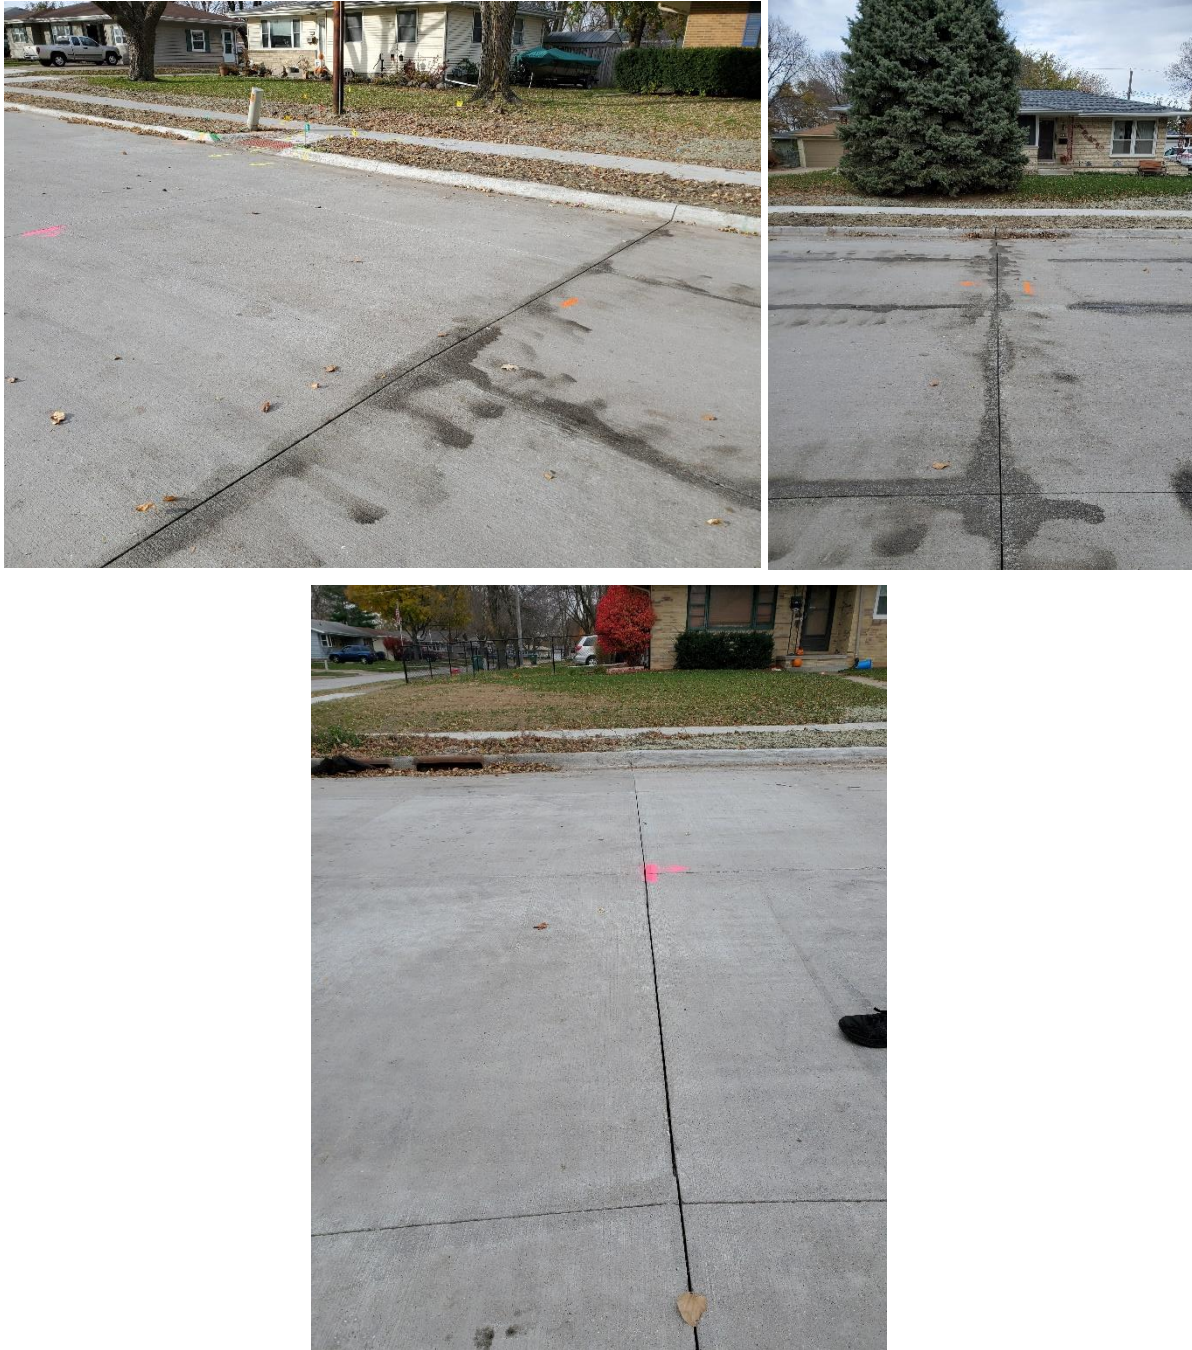
Figure 27 includes images to help identify the boundaries of the treatments with the two different sealers.

**Figure 27. Landmarks showing western edge of SoTA application (top left), mid-point where sealers were switched (top right), and eastern edge of 40% silane application (bottom)**
