TYPE II CEMENT CASE STUDY

I-40 PORT OF ENTRY - BECKHAM COUNTY, OKLAHOMA

CASE STUDY

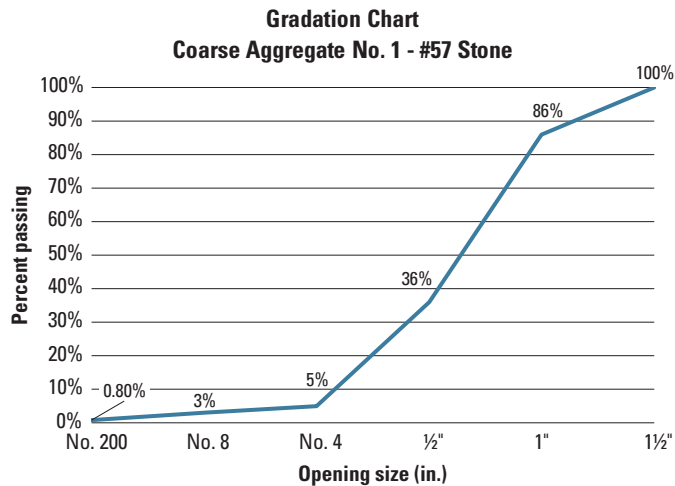
Figure 7. Coarse aggregate

Material	Source	Proportions
Type II cement	Holcim, Ada, OK	439 lb/yd ³
Class C fly ash	Lafarge, Amarillo, TX	78 lb/yd ³
Coarse aggregate - #57 stone (Figure 7)	Dolese Cooperton Quarry, Mountain View, OK	1,982 lb/yd ³ at SSD
Fine aggregate - C33 river sand (Figure 8)	Kline Materials, Woodward, OK	1,285 lb/yd ³ at SSD
Water	Local potable water	194 lb/yd ³
Admixture (AEA)	Master Builders Solutions	6.8 oz

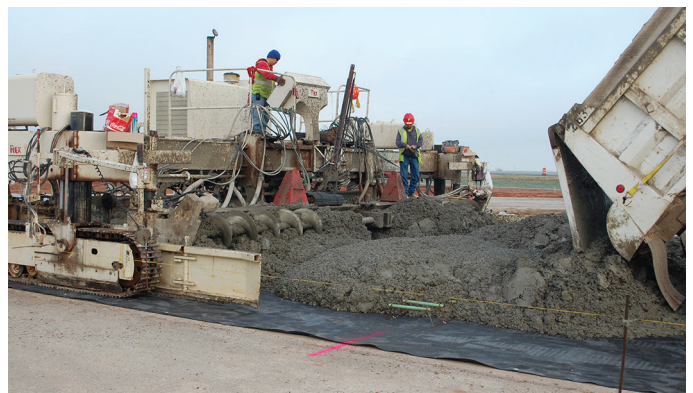
Placement of the 12.5 in. thick, plain jointed, dowelled concrete was conducted using a Rex slipform paver (Figures 9 and 10). The curb was placed by a Commander III or slipformed monolithically accompanied by miscellaneous hand-forming.

Figure 9. Slipform paving – front of paver

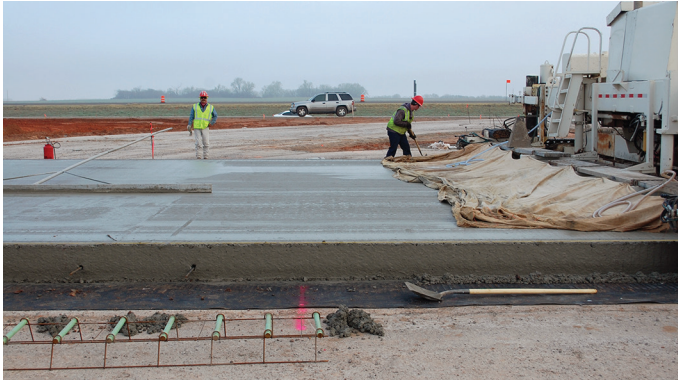
Figure 10. Slipform paving – finishing and hand-floating

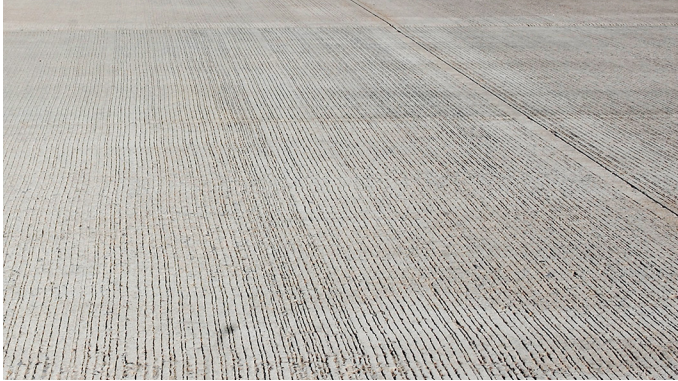
The concrete was finished with a burlap drag followed by hand-floating and tining (Figure 11). Curing compound was placed by means of a hand sprayer (Figure 12). Finally, early-entry sawcutting provided 1/8 in. wide and 1 1/2 in. deep saw cuts spaced transversely at 15 ft intervals. Joints were not sealed.

Figure 11. Surface tining

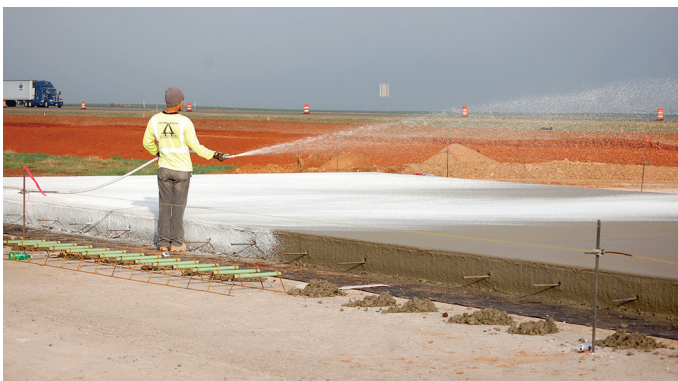
Figure 12. Curing compound application

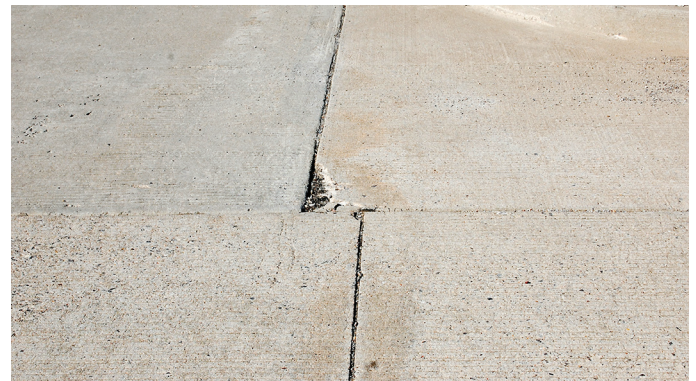
Upon inspection in February of 2024, only minor pavement distress was observed, including minor joint raveling and spalling, corner cracking, and one location with inconsistent surface texture. The distresses accounted for less than 0.5% of the project area (Figures 13 and 14). The only significant repair included a section at the exit of the inspection station caused by a washout from a water leak. Pavement markings are scheduled to be repainted in 2024.

Figure 13. Corner joint spalling

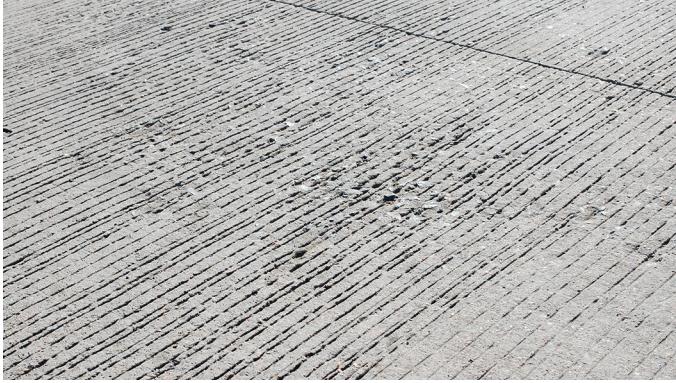
Figure 14. Surface texture inconsistency

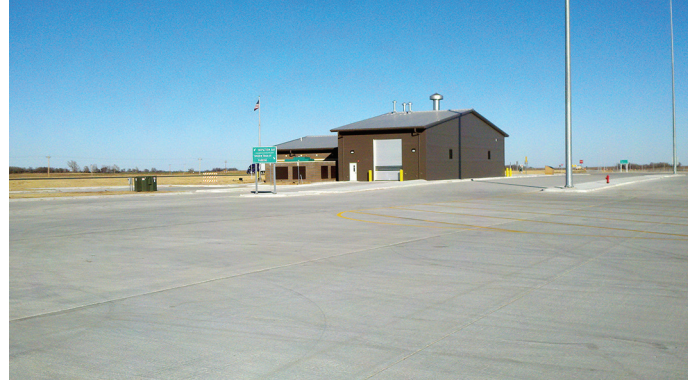
Figure 16. Completed project showing pavement markings (2012)

A port of entry facility was built adjacent to I-40 in Oklahoma in 2012 using Type IL cement. The contractor reported no significant differences in the batching, placement, or finishing of the concrete, and the pavement is performing well under heavy truck traffic (Figures 15 through 17).

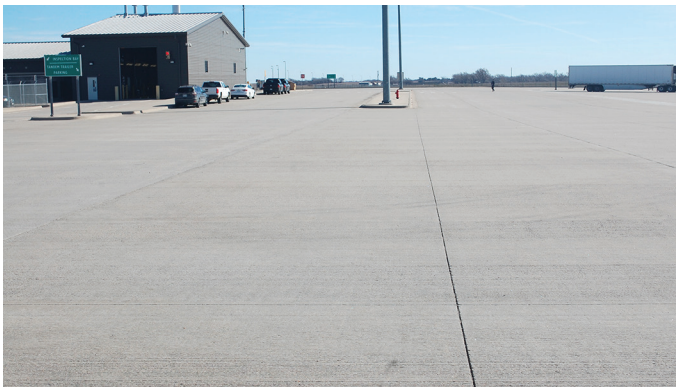
Figure 15. Finished pavement showing joint condition (2024)

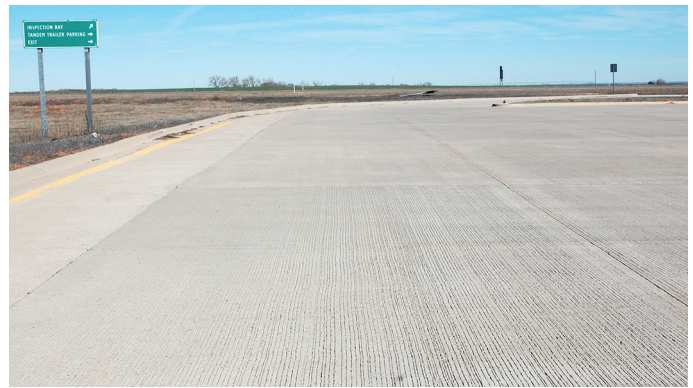
Figure 17. Finished pavement surface (2024)
