CONCRETE PAVING MIXTURE WITH SLAG CEMENT AND RECYCLED AGGREGATE IN THE CITY OF SEATTLE

Federal Highway Administration
Part of Cooperative Agreement 693JJ31950004, Advancing Concrete Pavement Technology Solution

National Concrete Pavement Technology Center
2711 South Loop Drive, Suite 4700
Ames, IA 50010-8664
cptechcenter.org

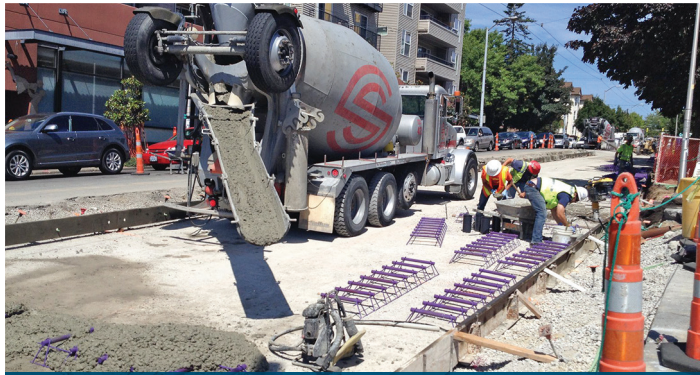
(a) Concrete placement using ready mix truck

Figure 3 illustrates the construction sequence:

1. Coated dowel bars were placed using dowel baskets (Figure 3a).
2. The concrete was placed using a ready mix truck in fixed forms, and a roller screed was used for strike-off (Figure 3b and 3c).
3. The surface was hand finished (Figure 3d).

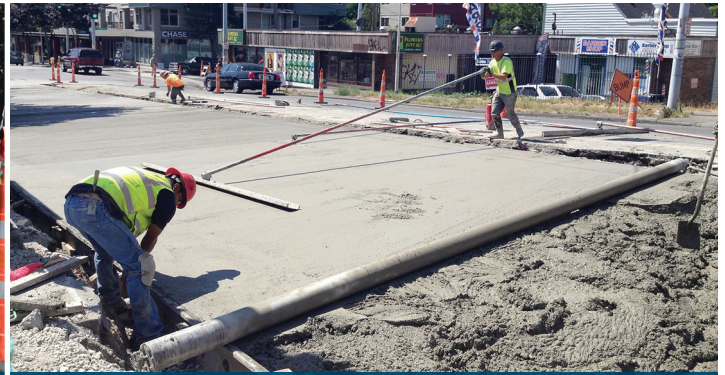
(b) Placement and finishing

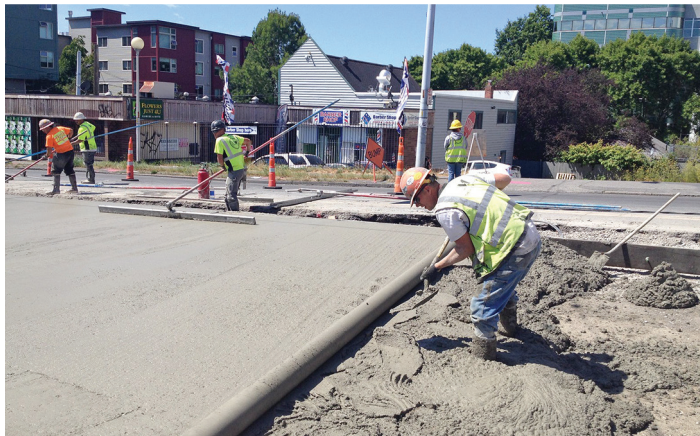
(c) Placement and finishing

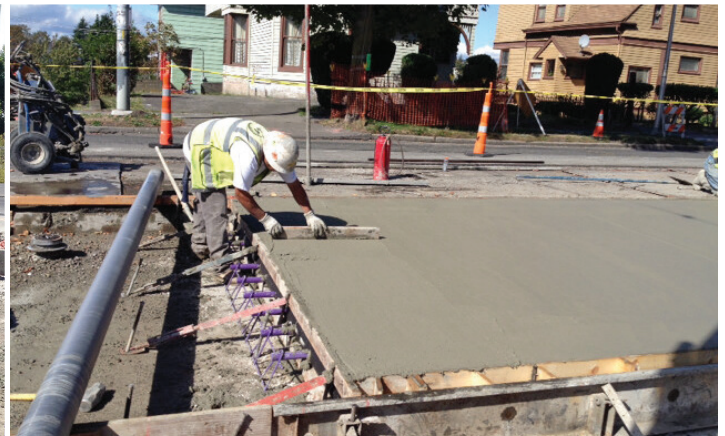
(d) Edge finishing
