Demonstrating the Use of Small Uncrewed Aircraft Systems (Drones) Capabilities and Data for Iowa Transportation and Infrastructure Work

Pilot Project No. 1 – Use of Small Uncrewed Aircraft Systems for Hairline Crack Detection on Bridge Deck

Task Report | May 2025

Sponsored by
Iowa Department of Transportation
Federal Highway Administration
SPR-RE24(010)-8H-00
(InTrans Project 24-904)

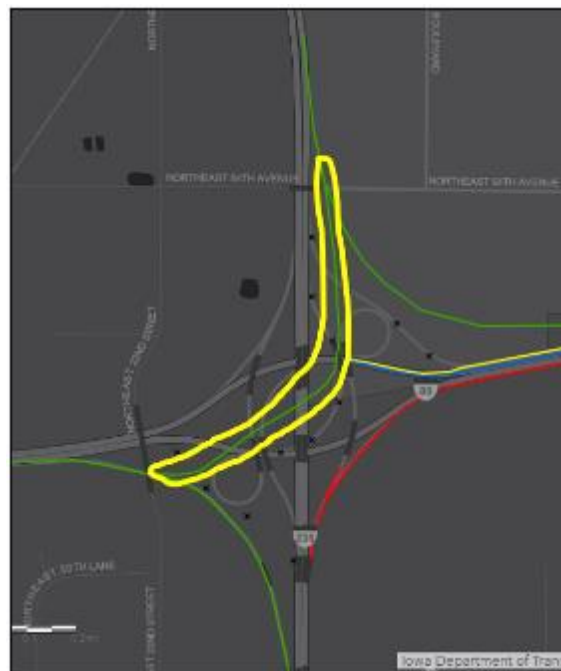
Figure 1. Location of the newly constructed NEMM bridge at the I-235 and I-80 intersection north of Des Moines, Iowa

The first pilot study decided upon in the meeting was to collect sUAS-based data to document and assess bridge deck cracks on a section of the newly constructed NEMM bridge located at the intersection of I-235 and I-80 north of Des Moines, Iowa, as shown in Figure 1. The area in the figure enclosed by the yellow line indicates the location where the new bridge was constructed. The bridge is divided primarily into three sections: Unit 1 (west section), Unit 2 (middle section), and Unit 3 (north section), with only Unit 1 open for data collection by the research team. Unit 1 of the bridge is about 1,140 ft (347.5 m) long and 48 ft (14.6 m) wide. Some longitudinal and transverse cracks began appearing on the bridge deck after construction, prompting the Iowa DOT to engage Niricson, a private consultant, and later Iowa State University (ISU) to document cracks in the bridge deck using sUAS. Niricson initially collected sUAS-based data from the Unit 2 and Unit 3 sections of the bridge deck. These sections had relatively large visible cracks and were subsequently overlaid to address immediate structural concerns. In contrast, Unit 1 was built with a different concrete mix, and the cracks in this section were finer than those in the other units. The Iowa DOT was particularly interested in the viability of using sUAS to document cracks on the Unit 1 bridge deck.

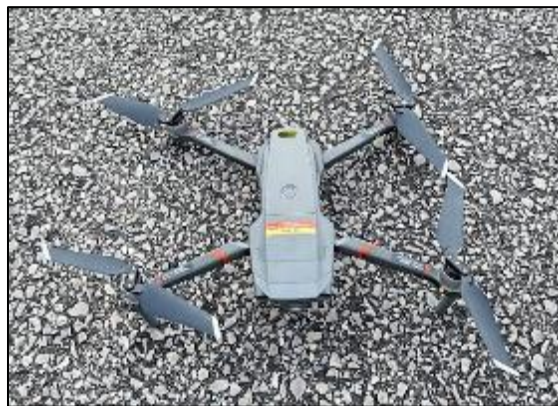
Figure 2. DJI Mavic 2 Enterprise Advance sUAS

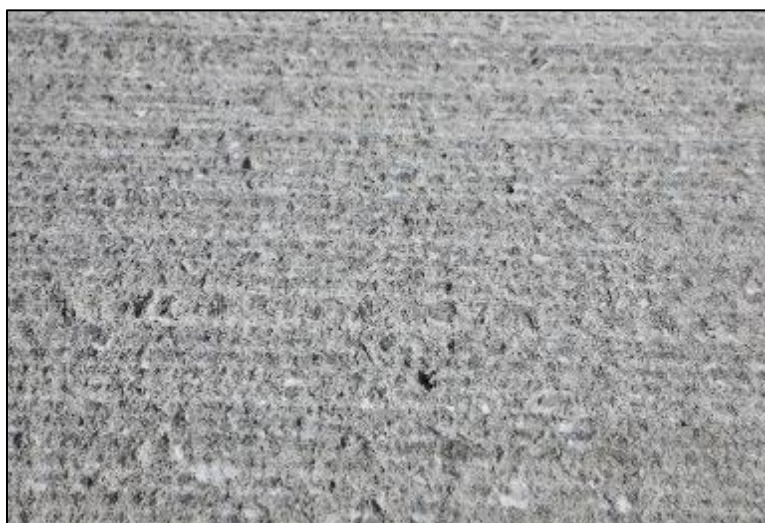
Figure 4. Milled surface of Unit 2

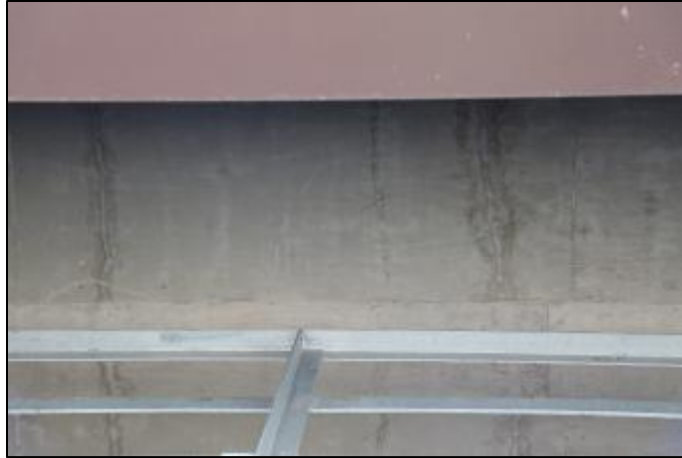
Figure 5. Cracks underneath the north side of the bridge

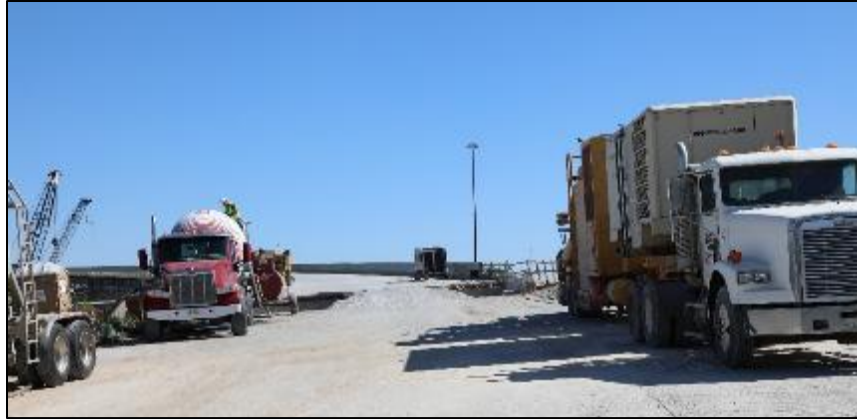
Figure 6. Presence of heavy construction equipment

- Due to the minimal transverse slope and the shorter width in Unit 1, a lateral flight plan seemed optimal.
- Some potential logistical challenges were the presence of heavy construction equipment and ongoing construction activities, shown in Figure 6, and high wind conditions.

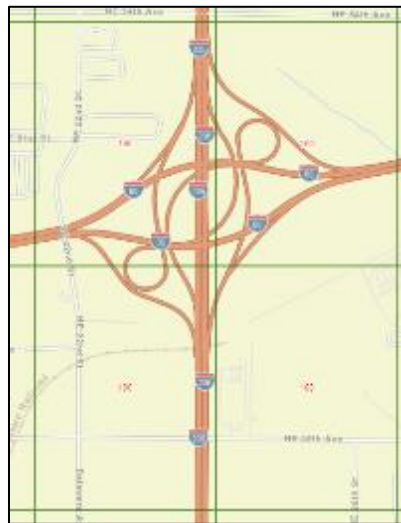
Figure 7. LAANC map with maximum approved flying heights shown in feet

- Since the area fell under Class E airspace, it had a maximum auto-authorized admissible flying limit of 100 ft (30.5 m), as shown in Figure 7. A Low Altitude Authorization and Notification Capability (LAANC) clearance from the Federal Aviation Administration (FAA) was required.

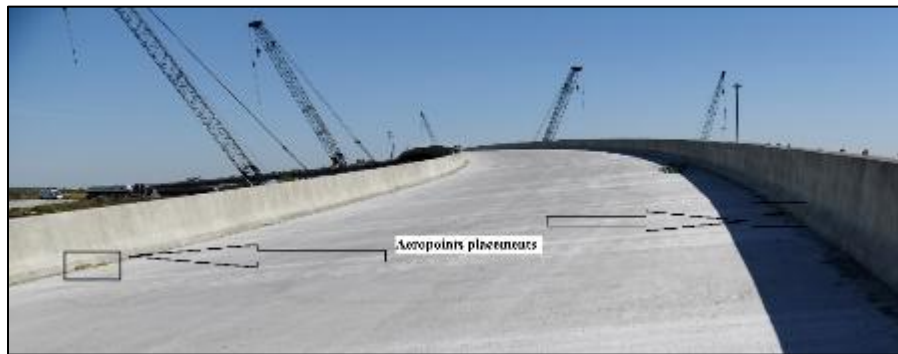
Figure 8. Placement of AeroPoints GCPs on the ground

With the preflight planning complete, the team ensured that the bridge section was free of obstacles and ready for operation. The research team placed 10 GPS-enabled Propeller AeroPoints GCPs at intervals along both sides of the bridge in the longitudinal direction, as shown in Figure 8. The AeroPoints automatically collected highly accurate GPS data that were uploaded to Propeller's cloud server and used for sUAS data processing to improve merged imagery outputs. For the initial few flight operations, an M2EA Real-Time Kinematics (RTK) module was used for better geo-positioning and stability using Networked Transport of RTCM via Internet Protocol (NTRIP). However, each time the sUAS and its remote controller were shut down and restarted for a battery change, the RTK module had issues connecting to the NTRIP server, so onboard GPS was used for position in the later flights.

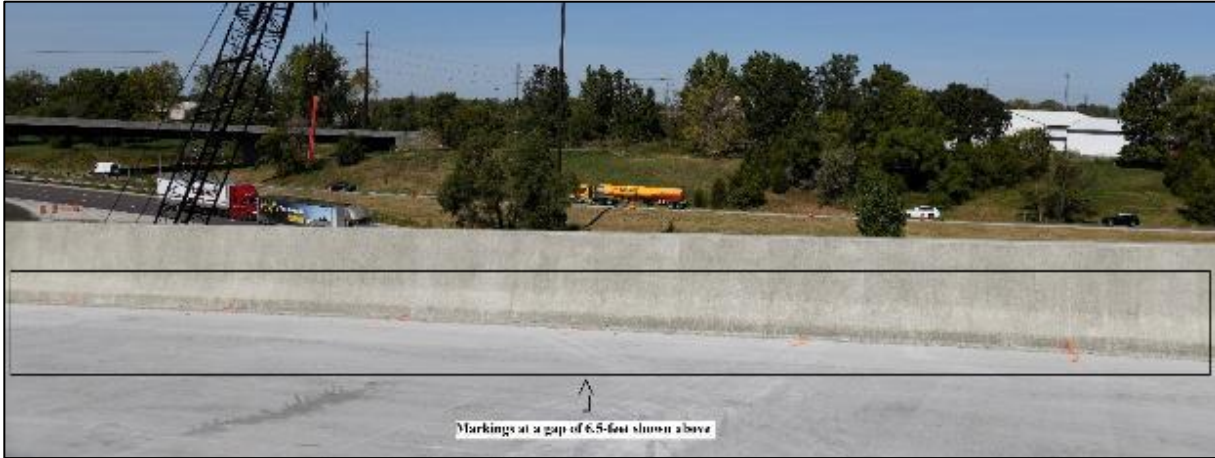
Figure 9. Markings at intervals of about 6.5 ft for an appropriate overlap

As previously decided, sUAS flights were to be conducted at altitudes of 15 ft (4.6 m) and 35 ft (10.7 m), targeting an approximate GSD of 0.04 to 0.06 in (1 to 1.5 mm) or lower. Since the M2EA cannot be flown on autopilot below 40 ft (12.2 m), the sUAS had to be manually flown. Due to such low flying altitudes and the desire to achieve higher stability during data collection, the “Tripod” flight mode was activated every time during the data collection phase, allowing the flight speed to be kept at less than 2 mph (0.9 m/s). The “Positioning” flight mode was used for moving the sUAS from one part of the bridge to another or taking a quick look at specific parts of the bridge. The data collection team initially tried to collect data by flying the M2EA along the bridge section but later decided to fly across the bridge deck to maintain a stable straight-line flight for adequate forward and side overlap for the entire 15 ft (4.6 m) altitude data collection. To achieve an appropriate overlap between passes, markings were made at an interval of approximately 6.5 ft (1.9 m), as shown in Figure 9.

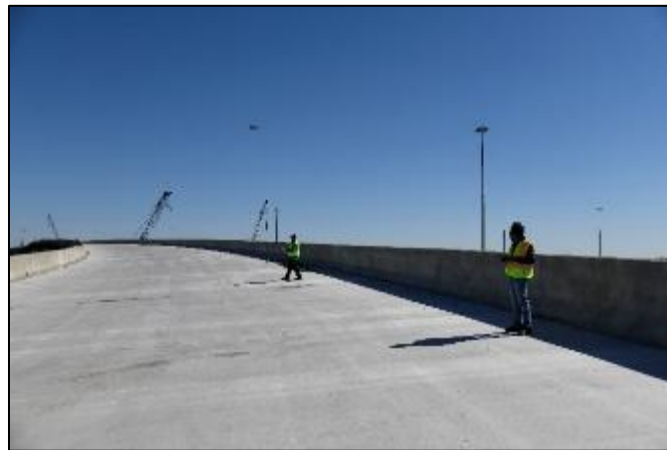
Figure 12. PIC controlling the sUAS while the VO keeps a close watch on the sUAS and the surrounding area

The team faced challenging environmental conditions, with strong winds of 14 to 18 mph (6.3 to 8.1 m/s) and high gusts, leading to difficulty in sUAS control. The flights were unstable, causing the sUAS to shake, complicating manual control and requiring constant adjustment to maintain stable flight paths. The slope variability and elevation changes in the surface of Unit 1 added to the complexity, necessitating a careful approach to sUAS navigation to ensure that all target areas were covered without missing critical details. Due to heavy traffic in the area and the strong wind conditions, flight operations in the afternoon were deemed unsafe, leading to the decision to suspend flights for the day. Figure 12 and Figure 13 show data collection activities.

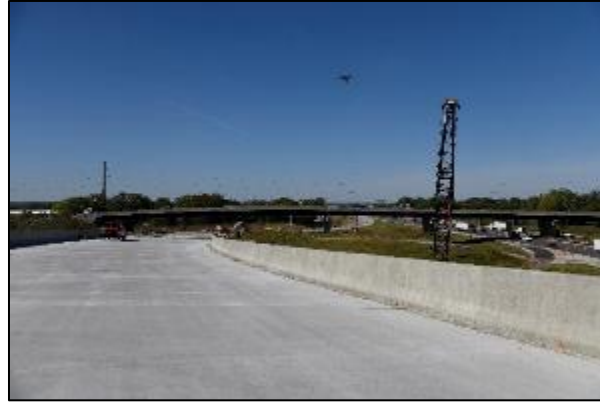
Figure 13. sUAS being navigated near the edge of the bridge to ensure that all target areas are covered precisely

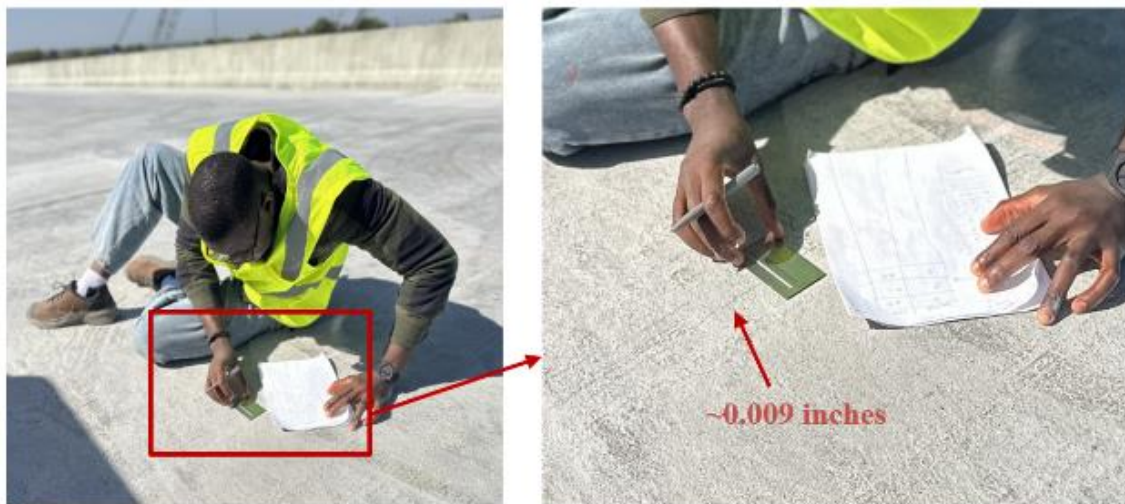
Figure 15. Ongoing measurement of observed hairline cracks

Before takeoff, the team performed a quick manual inspection of the bridge deck, identifying the locations of crack distresses to be marked and measured. Figure 15 shows a team member measuring a hairline crack using a crack gauge. Observing these cracks helped create ground truth data samples used for visibility analysis in later sections. The main data were collected at 15 ft (4.6 m) AGL, and additional data were collected at 35 ft (10.7 m) AGL. Data collection for the remaining Unit 1 sections at 15 ft (4.6 m) AGL was completed using seven separate manual flights. Figure 16 illustrates the combined paths of the seven missions.

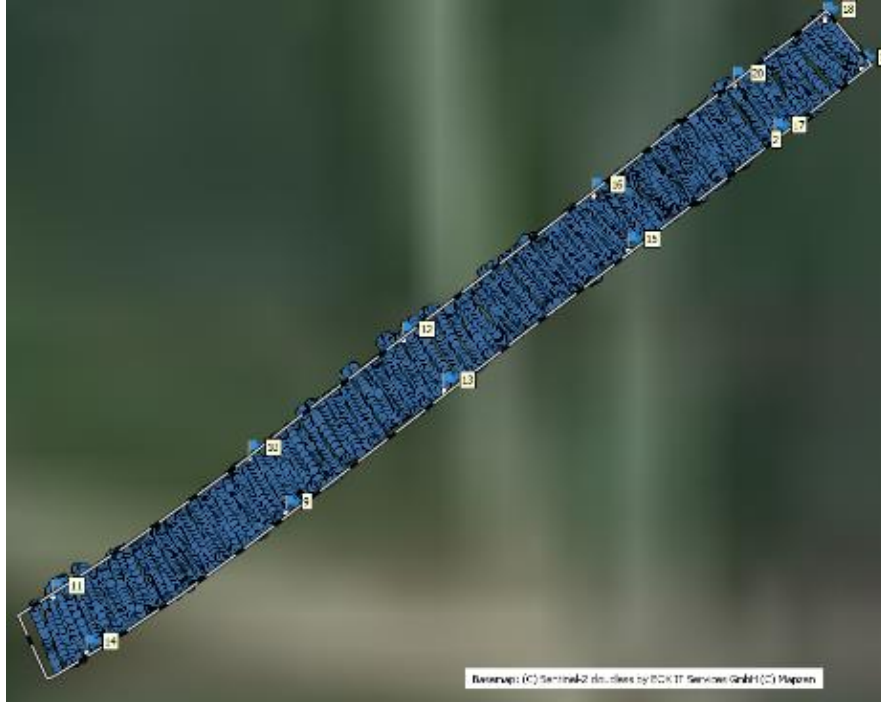
Figure 16. sUAS image points and GCPs represented using white boxes

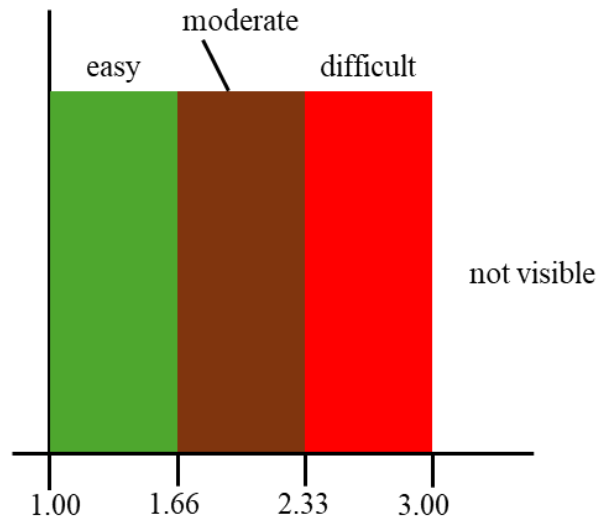
Figure 22. Final level of detection bounding range

The reviewers’ labels were aggregated, weighted, and compared for further analysis. Since the reviewers were knowledgeable about cracks but had no prior knowledge of the exact crack locations in the bounded marks, their deductions were assigned more weight. The final aggregate score was defuzzified using the numerical range illustrated in Figure 22. Table 2 shows the final weighted detection level for each crack sample and the combined similarity counts of the reviewers (4) and the sUAS team (1).

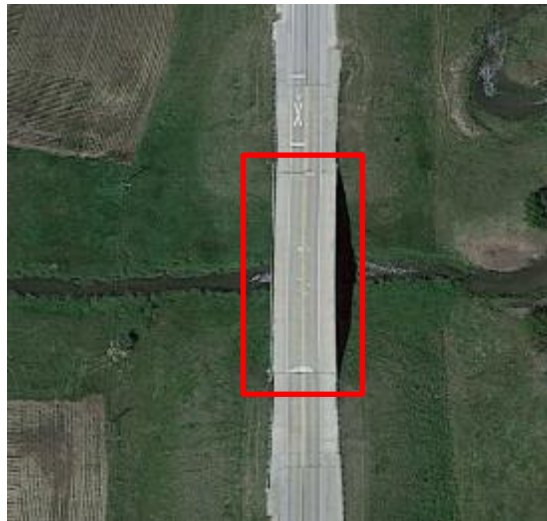
Figure 41. Satellite view image showing Humboldt County bridge bounded in red box

On October 6, 2024, Cedric Wilkinson, representing the Iowa DOT, contacted the research team to explore the potential use of sUAS technology for inspecting cracks on a grooved concrete bridge in Humboldt County, Iowa (shown in Figure 41). The one-year-old bridge is 150 ft by 44 ft (45.7 m x 13.4 m), with crack widths ranging from hairline to more than 0.025 in. (0.635 mm). Unlike the NEMM bridge, which has a relatively steeper transverse and longitudinal slope, the Humboldt County bridge is nearly flat in the longitudinal direction and features approximately 2% cross slopes on either side of the centerline.

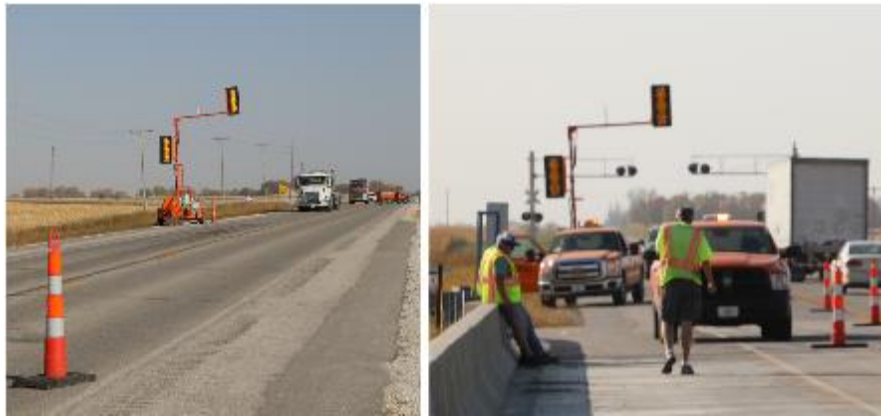
Figure 42. Traffic control signs at both ends of the lanes

The traffic management by Iowa DOT staff was critical for controlling traffic access during both automated and manual low-altitude flight operations.

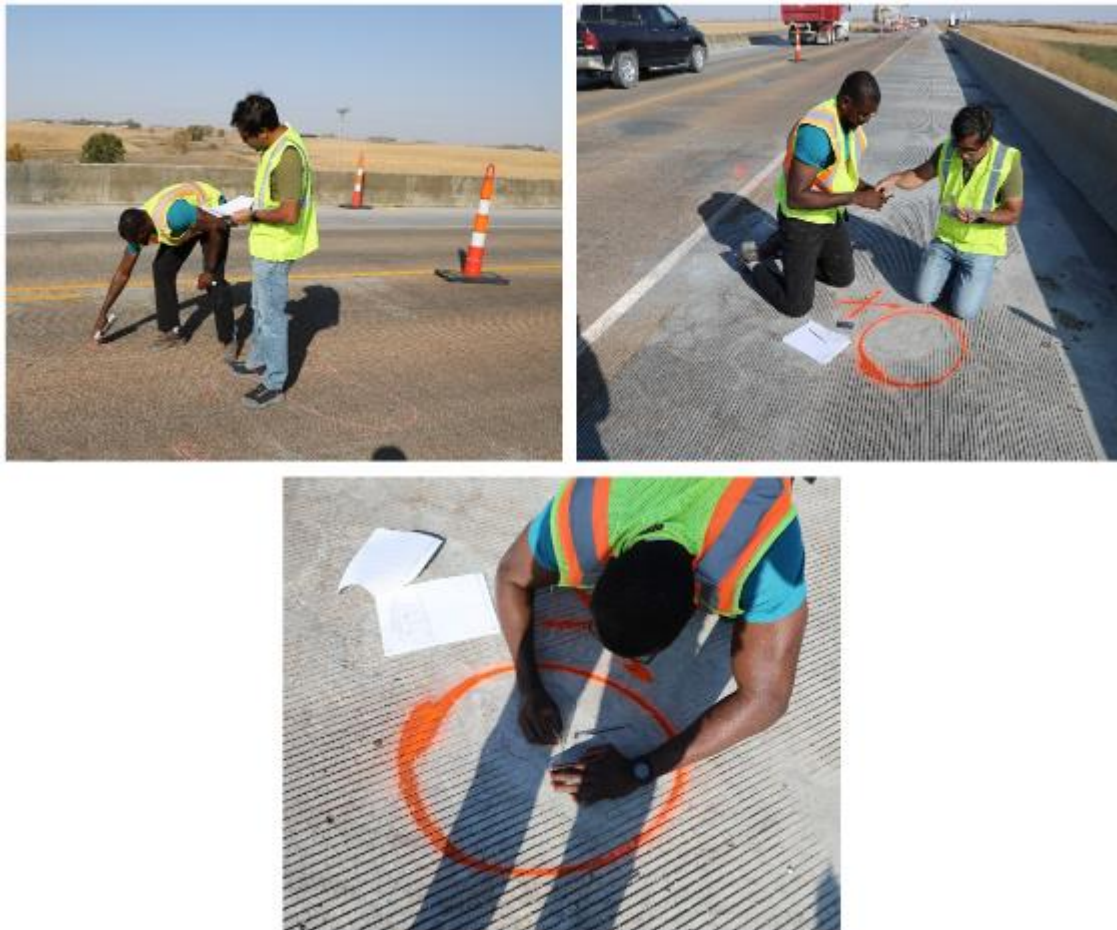
Figure 43. Research team manually inspecting the bridge and marking identified cracks

The research team developed a detailed data collection and safety plan a few days before going into the field. Availability was confirmed, and the necessary safety measures for an effective and safe data collection were discussed. On October 10, 2024, the research team, in collaboration with Iowa DOT personnel, conducted data collection at the Humboldt County bridge site. The research team followed safety guidelines to ensure efficient traffic flow and data collection. Before starting operations, the team conducted a safety briefing to ensure that all members were aware of potential hazards and emergency action plans. At first, traffic signs and cones were used to keep one lane open for vehicles (Figure 42). During this time, the team carried out a physical inspection of the bridge that focused on identifying and marking both hairline and significant cracks for measurement. Figure 43 shows the research team measuring and marking identified cracks on the bridge deck, while Figure 44 highlights examples of observed cracks.

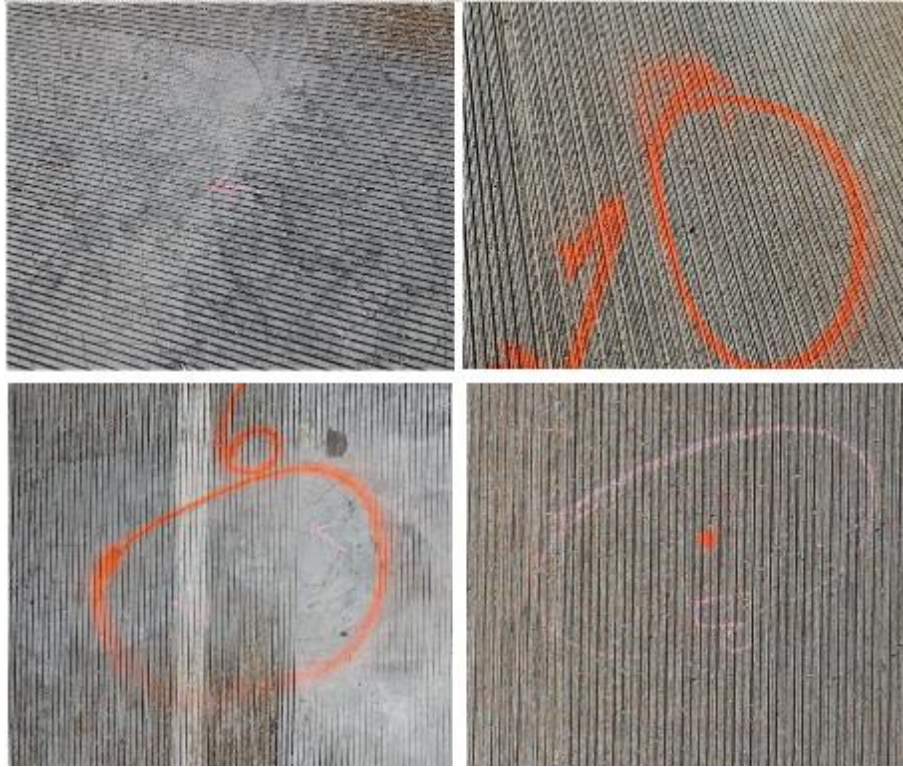
Figure 44. Identified and marked cracks on the bridge deck

While the longitudinally grooved bridge deck presented a challenge in distinguishing cracks from the grooved surface, particularly when cracks were aligned parallel to the grooves, transverse and angled cracks were easier to detect. After completing crack sampling and positioning six AeroPoints, full-lane closure was arranged and cones were removed from the median line to prepare for the first automatic mission flight at 40 ft AGL. Since the bridge is located outside controlled airspace, no flight approval was required. Figure 45 captures the flight in progress, which followed a longitudinal flight path with side and front overlaps ranging from 70% to 80%. Figure 45 illustrates the automatic flight path at a 40 ft altitude.

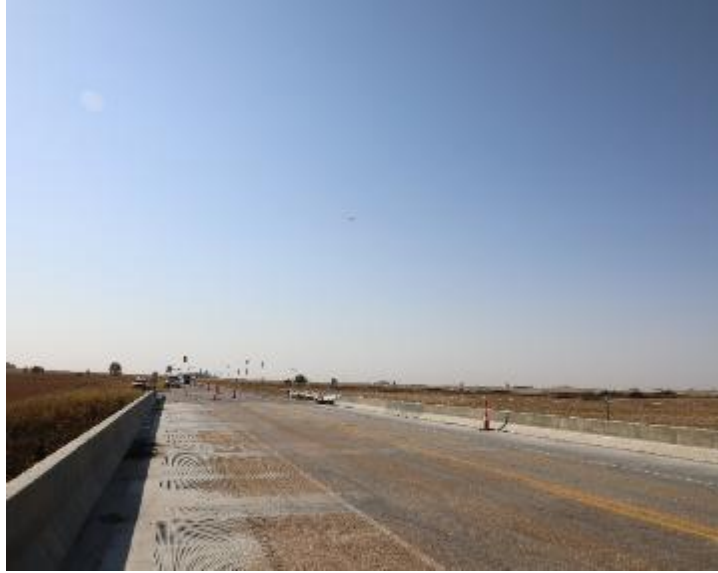
Figure 45. sUAS in automatic flight mode at 40 ft (12.2 m) AGL

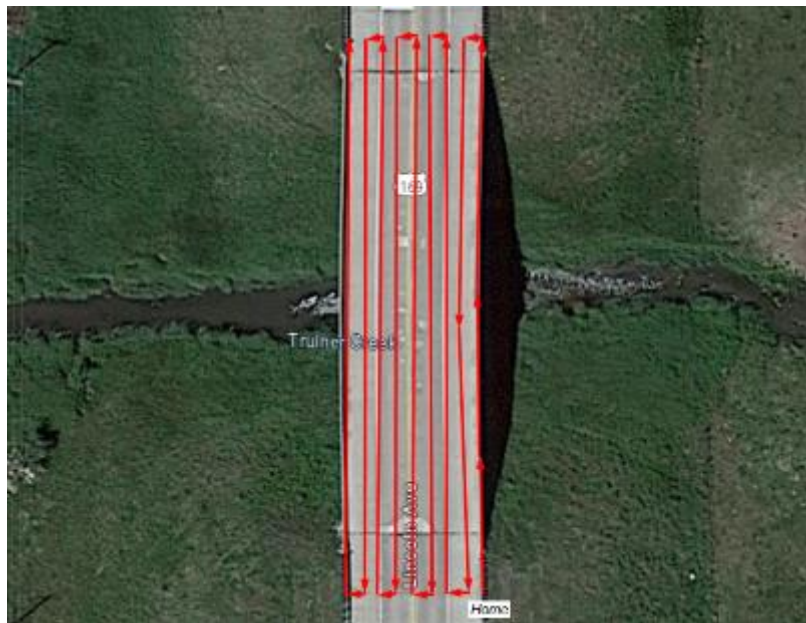
Figure 46. Manual mission flight at 15 ft (4.6 m) AGL

The research team completed the 40 ft AGL flight in four minutes, and traffic flow resumed in one of the two lanes. Over the closed lane, the research team manually flew the sUAS at an altitude of 15 ft AGL, ensuring necessary overlap while following a longitudinal flight path similar to that of the automatic mission. Figure 46 illustrates the 15 ft manual flight path, and Figure 47 shows the remote pilot, a zoomed-in image of the sUAS in the air, and a passing vehicle in the open lane.

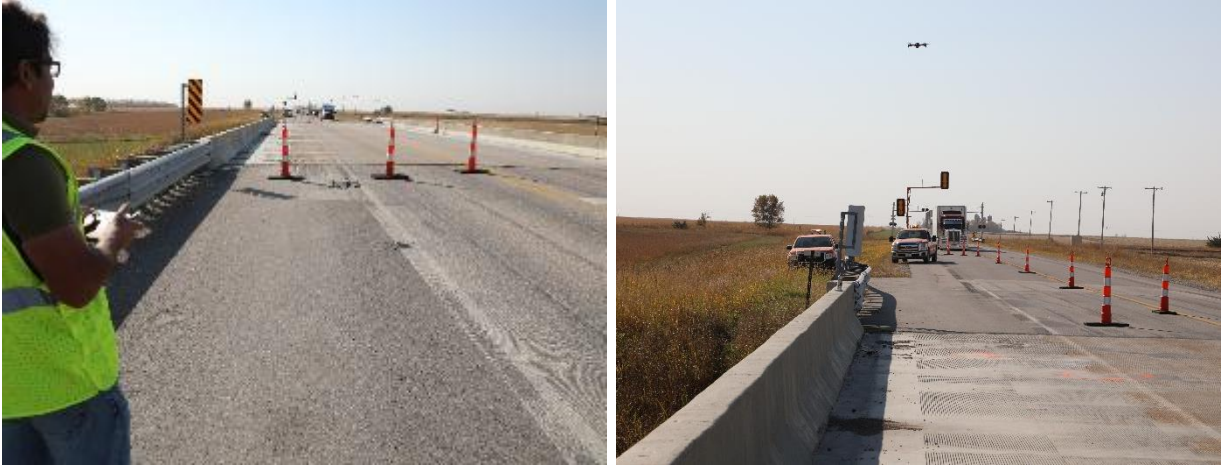
Figure 47. Manually controlled sUAS flight over a closed lane
