roads bridges transit technology news

Local Transportation Information Center
Iowa State University Engineering Extension Service

January, 1988

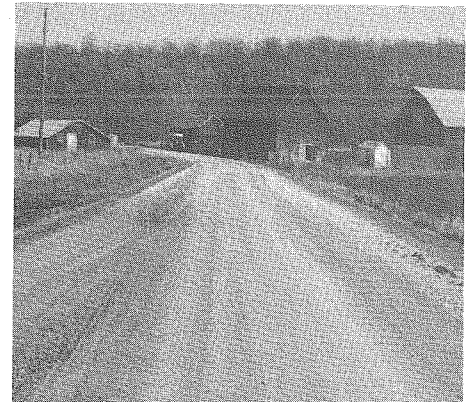
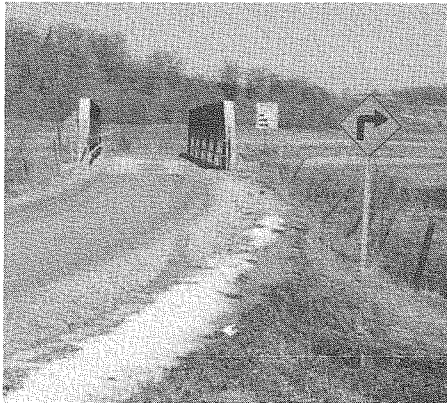
The accompanying photographs illustrate the problem that CAUSE can address. All of the photographs were taken in an area including about one-tenth of a county in central Iowa. There were 34 curves on granular-surfaced roads in this area. Shown in figure 1 is one of twelve curves that were preceded by warning signs. There were no warning signs on 22 curves such as the one shown in figure 2. All of the 13 turns in this area, such as the one shown in figure 3, had advance warning signs. However, shown in figure 4 is one of only three turns that also had speed advisory plates. This lack of consistency and

uniformity in signing would almost surely result in a lawsuit and a judgement against this county if there were an accident on a curve without a warning sign or a turn without a speed advisory plate.

not improve safety and would lead to an intolerable situation in terms of liability. The existing condition cannot be left as it is. Adding signs at the 22 curves without advance warning and speed advisory plates at the ten turns lacking these signs might improve safety and surely would reduce the potential for liability exposure. An engineer choosing among these alternatives will want to join the CAUSE.
