# Development of Two Test Level 2 Bridge Railings and Transitions for Use on Transverse Glue-Laminated Deck Bridges

Ronald K. Faller, Barry T. Rosson, Michael A. Ritter,  
Eric A. Keller, and Sheila R. Duwadi

The Midwest Roadside Safety Facility, in cooperation with the United States Department of Agriculture Forest Service Forest Products Laboratory and FHWA, designed two bridge railing and approach guardrail transition systems for use on transverse glue-laminated timber deck bridges. The bridge railing and transition systems were developed and crash tested for use on medium-service roadways and evaluated according to the Test Level 2 safety performance criteria provided in NCHRP Report 350. The first railing system was constructed by using steel hardware, whereas the second railing system was built by using glulam timber components. Four full-scale crash tests were performed, and the bridge railing and transition systems were determined to be acceptable according to the current safety standards in NCHRP Report 350.

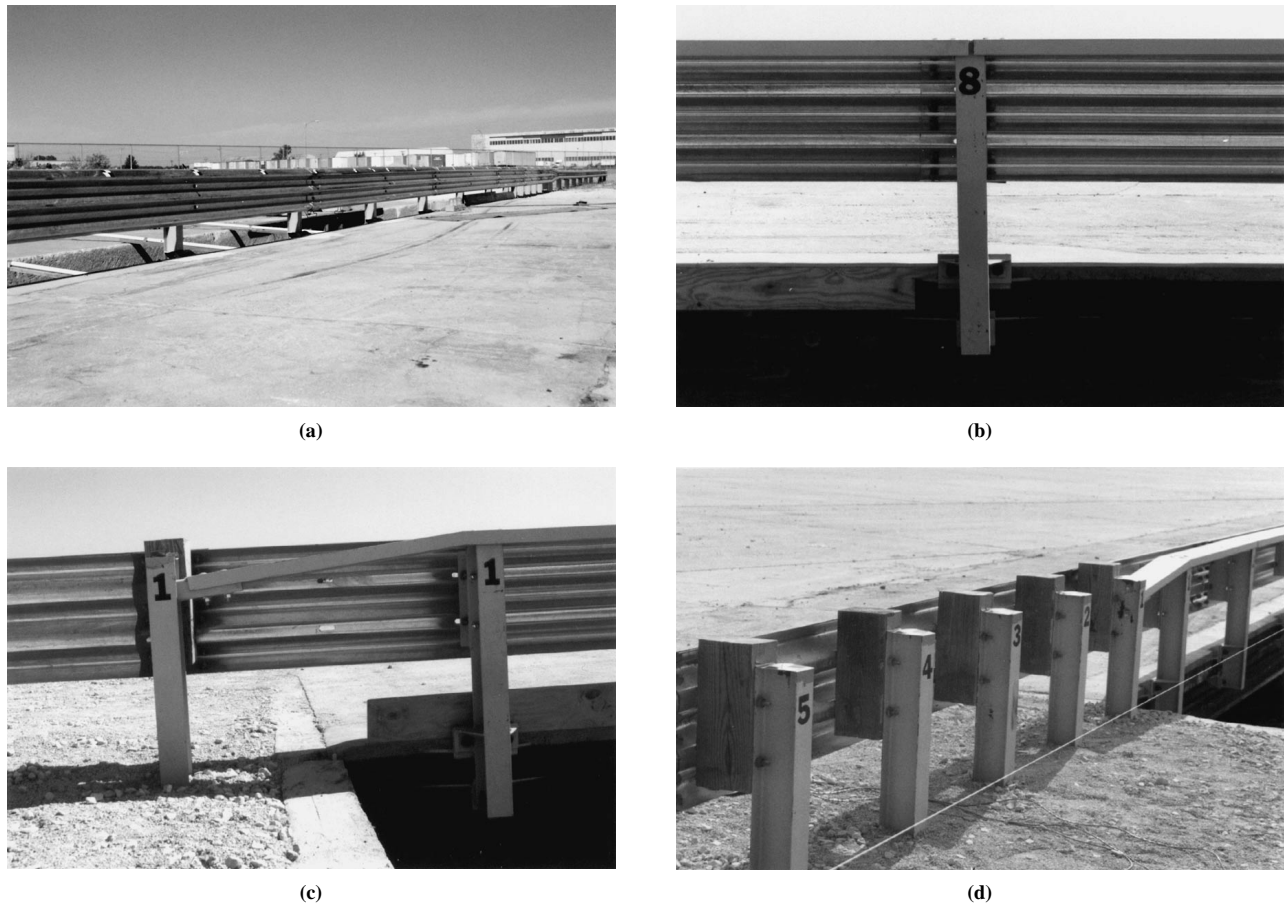
FIGURE 1 Steel thrie beam with channel bridge railing and thrie beam with channel transition, System 1.

The first bridge railing, referred to as System 1, was a steel system constructed with a thrie beam rail, an upper structural channel rail, and wide-flange posts and blockouts. Photographs of the steel bridge railing system and the attached thrie beam approach guardrail transition are provided in Figure 1. The second bridge railing, referred to as System 2, was a wood system constructed by using a rectangular rail, posts, and blockouts, all of which were manufactured from glulam timber. Photographs of the wood bridge railing system and the attached W-beam approach guardrail transition are provided in Figure 2.

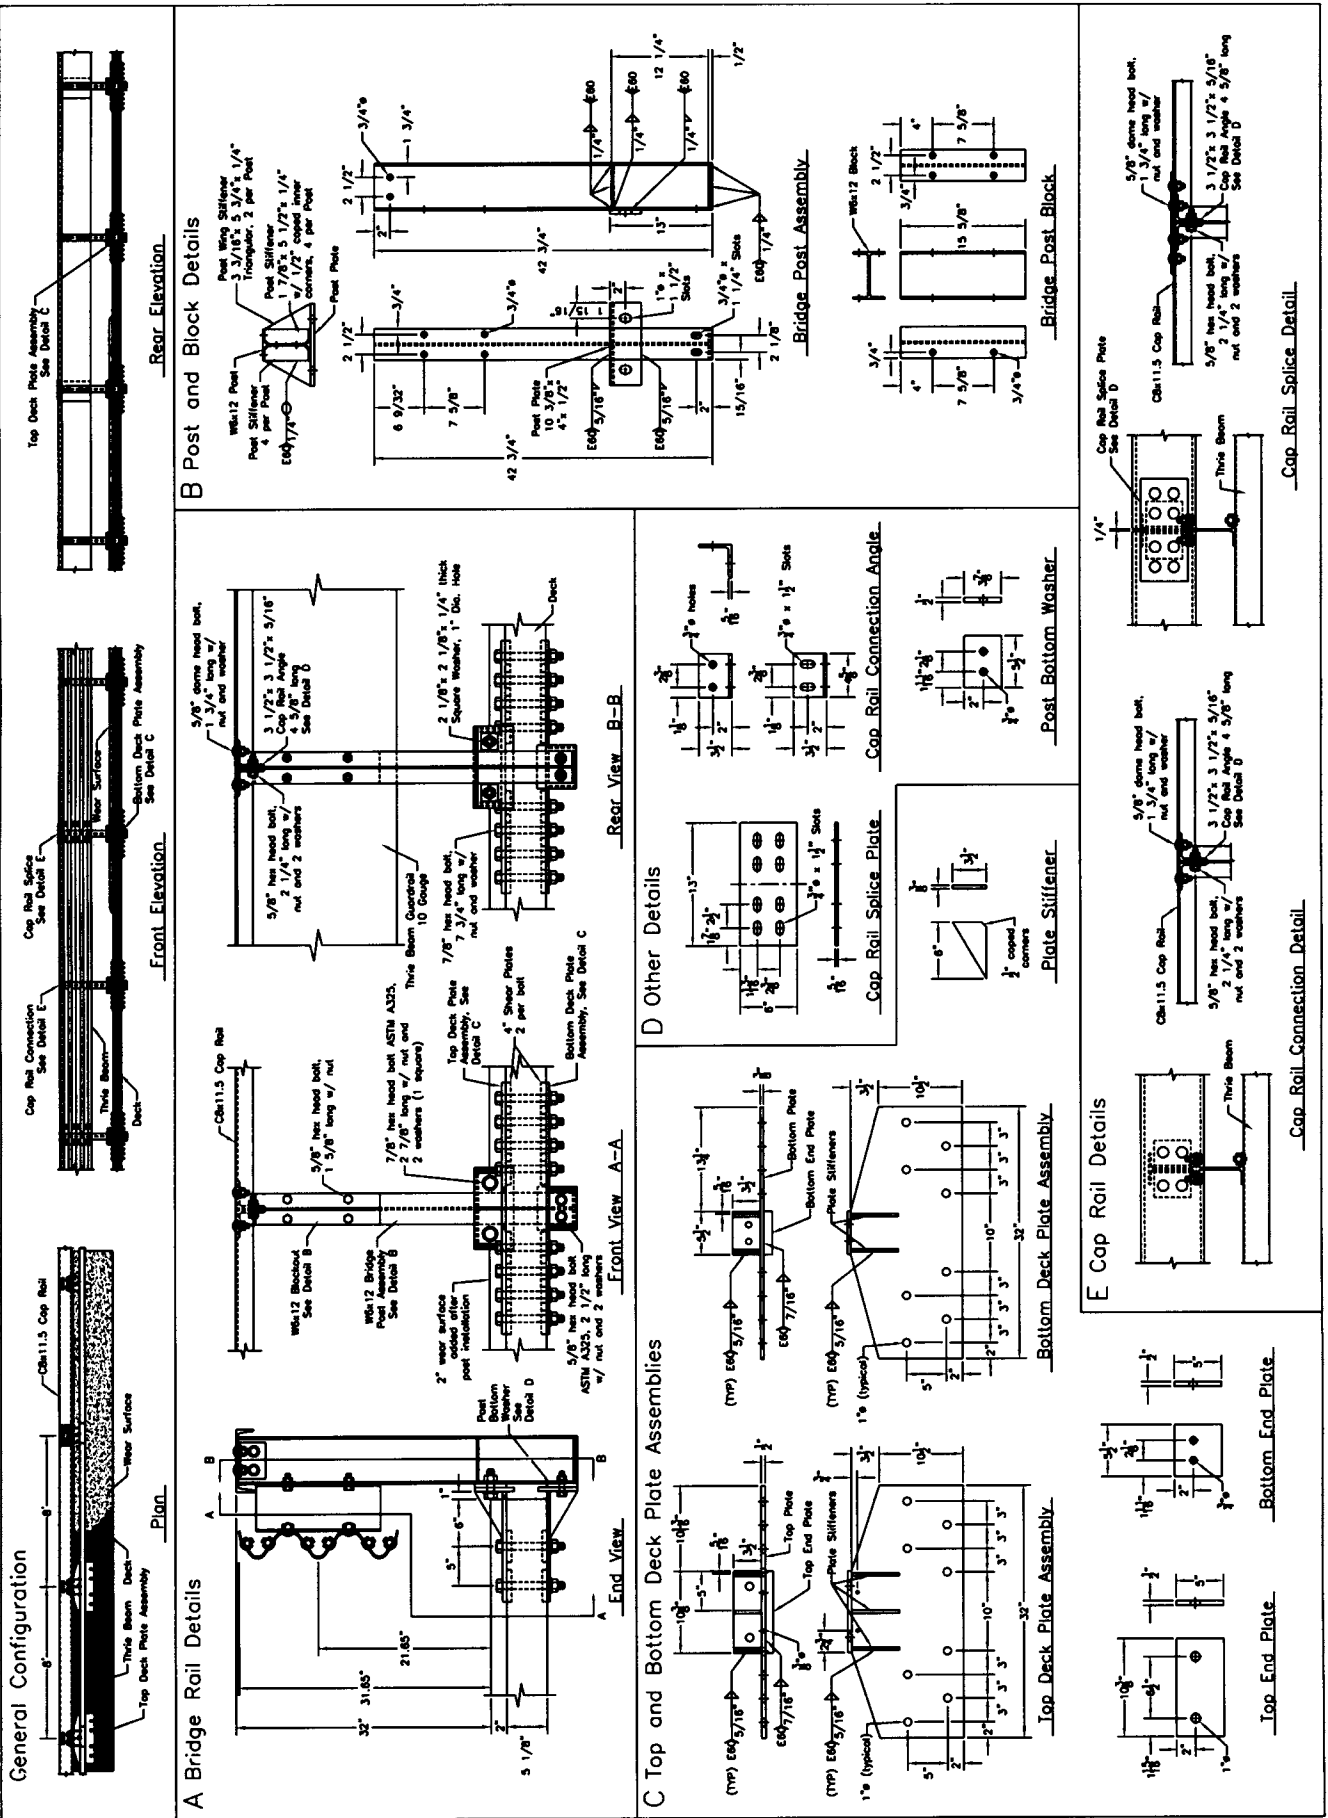
FIGURE 4 Steel bridge railing design details, System 1 (1 in. = 25.4 mm).

The first bridge railing system was designed as an all-steel system. This system was constructed with a thrie beam rail, an upper structural channel rail, wide-flange bridge posts and rail blockouts, and deck mounting plates. Specific details of this system are provided in Figure 4. For the steel system, a 10-gauge thrie beam rail was blocked away from wide-flange posts with wide-flange spacers. A structural channel rail was then attached to the top of the posts. The lower end of each post was bolted to two steel plates that were connected to the top and bottom surfaces of the bridge deck with vertical bolts.

System 1 was configured similarly to the TL-4 steel thrie beam and structural tube bridge railing system previously developed for transverse decks (1, 16). However, because the TL-2 impact condition provided a reduced impact severity from the TL-4 impact condition,

several design modifications were deemed necessary. As a result, the upper structural tube rail on the TL-4 system was replaced with a channel rail section. This modification not only provided reduced weight but improved constructability. Other design modifications included a reduction in the size of the deck mounting plates and a decrease in the number of vertical bolts used to attach the mounting plates to the timber deck panels. A 2438-mm post spacing, also used with the TL-4 railings for transverse decks, was selected instead of the usual 1905-mm post spacing. The increased post spacing was selected to optimize the design and to significantly improve the constructability of the railing system, which was based on 1219-mm-

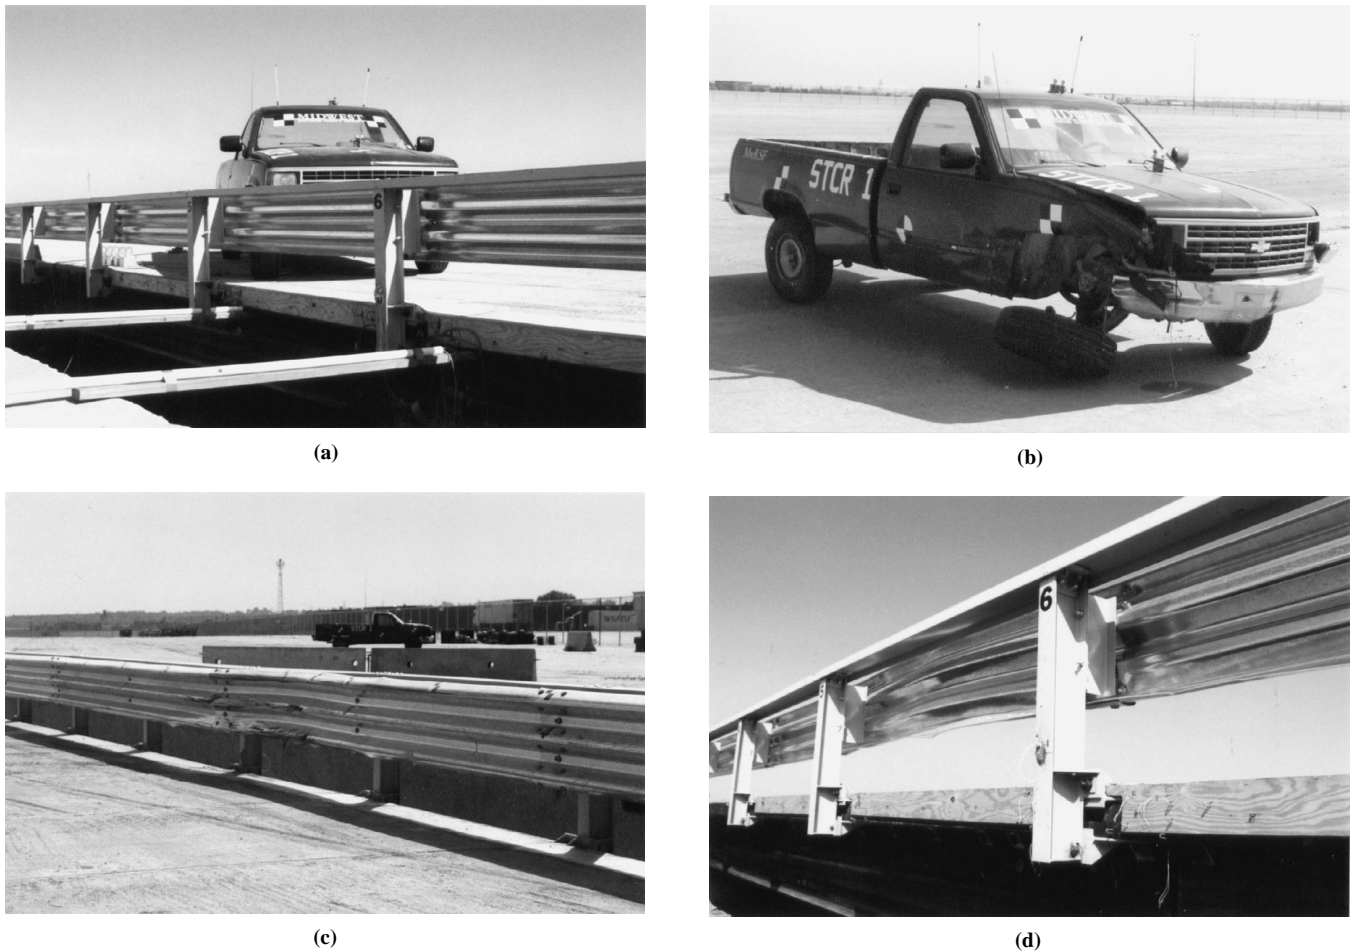
FIGURE 6 Test STCR-1: (a) impact location, (b) vehicle damage, and (c, d) bridge railing damage.

The first crash test, STCR-1, was successfully performed with a 1990 Chevrolet 2500 pickup truck with a test inertial mass of 1966 kg and at the impact conditions of 66.6 km/h and 25.6 degrees. During the impact event, the truck became parallel to the railing at 0.229 s and a speed of 46.1 km/h. At 0.519 s after impact, the vehicle exited the railing system at a speed of 45.2 km/h and an angle of 14.7 degrees. The maximum lateral permanent set and dynamic rail deflections were observed to be 102 and 157 mm, respectively. The location of the vehicle impact with the bridge railing, vehicle damage, and barrier damage are shown in Figure 6.

Following an analysis of the test results, it was determined that the steel bridge railing system met the TL-2 safety performance criteria provided in NCHRP Report 350. No significant damage to the test bridge was evident from the vehicle impact test. For the bridge railing system, damage consisted primarily of permanent deformation of the thrie beam rail, channel rail, wide-flange posts, and rail spacers. Although visual permanent set deformations of the steel components were found in the vicinity of the impact, all the steel members remained intact and serviceable after the test. Thus, replacement of bridge railing components would be based more on aesthetics than on structural integrity.

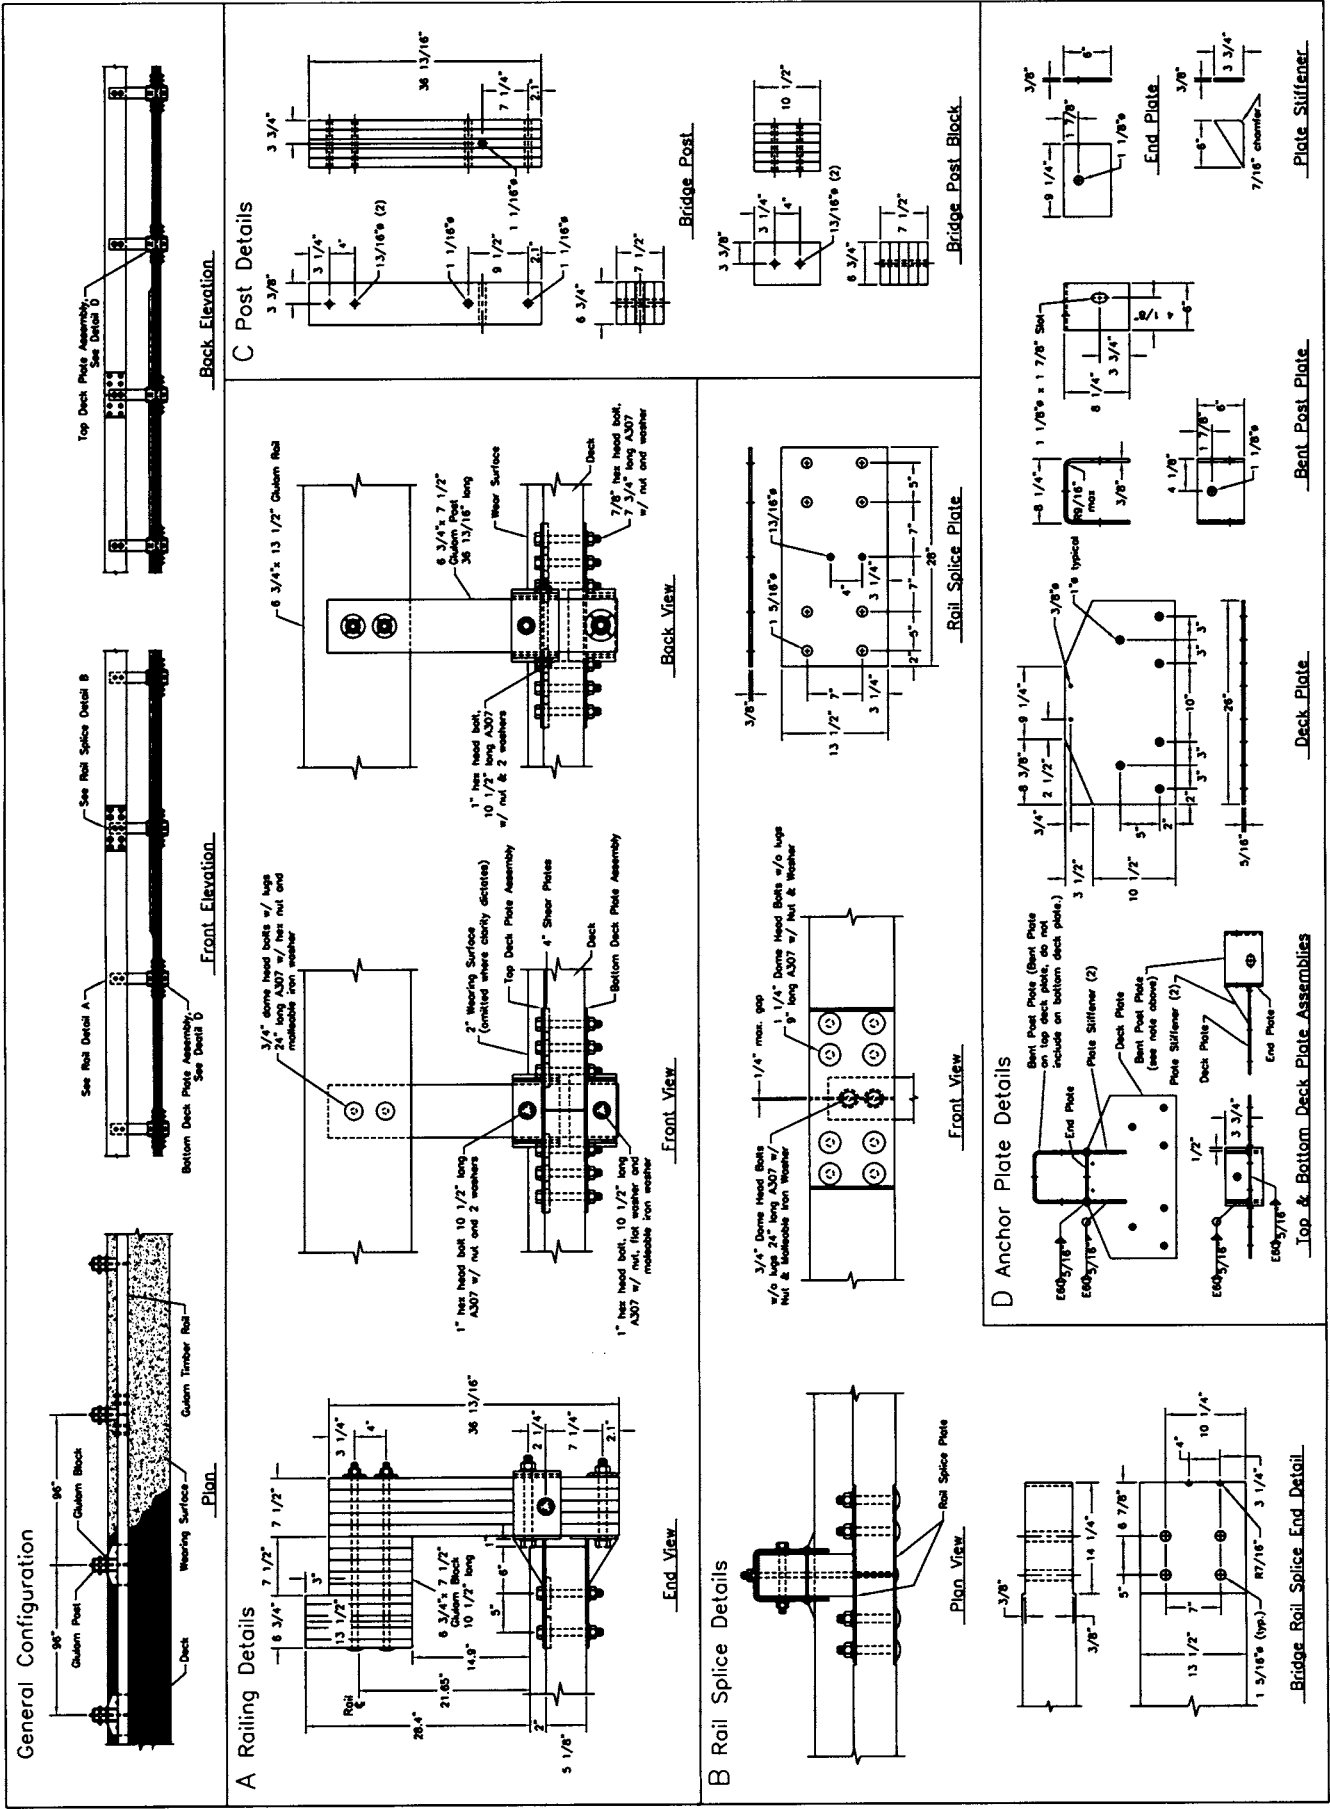
FIGURE 8 Wood bridge railing design details, System 2 (1 in. = 25.4 mm).

The second bridge railing system was designed to be an all-wood system, except for the structural steel connections. This system was constructed by using a rectangular rail, rectangular bridge posts, rail

blockouts, and deck mounting plates. Details of this system are provided in Figure 8. For the wood system, glulam timber for the rail and post members was Combination 48 southern yellow pine, as specified in AASHTO's *LRFD Bridge Design Specifications*, and it was treated with pentachlorophenol in heavy oil to AWP Standard C14 requirements (23). Glulam timber for the spacer blocks was fabricated with Combination 47 southern yellow pine, as specified by AASHTO, and was treated according to AWP Standard C14 (23).

System 2 was configured similarly to the PL-1 glulam timber rail without curb system previously developed for longitudinal decks (10, 13, 14, 16). However, for this system, all wood components were fabricated from glulam timber, whereas the previous system used glulam rail and sawn lumber posts and blocks. From the PL-1 railing system, the steel box that was used to support the posts was replaced with a more-economical steel U-shaped bracket, which attached to the deck surface. In addition, all structural members and the steel hardware were resized to account for the increased post spacing from 1905 to 2438 mm. Again, the new post spacing was selected to optimize the design and improve the constructability of the railing system, which was based on 1219-mm-wide deck panels.

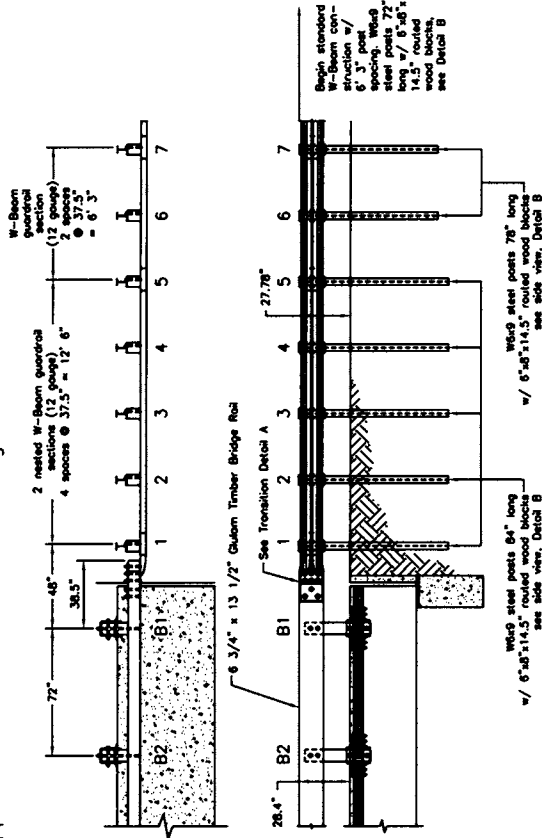
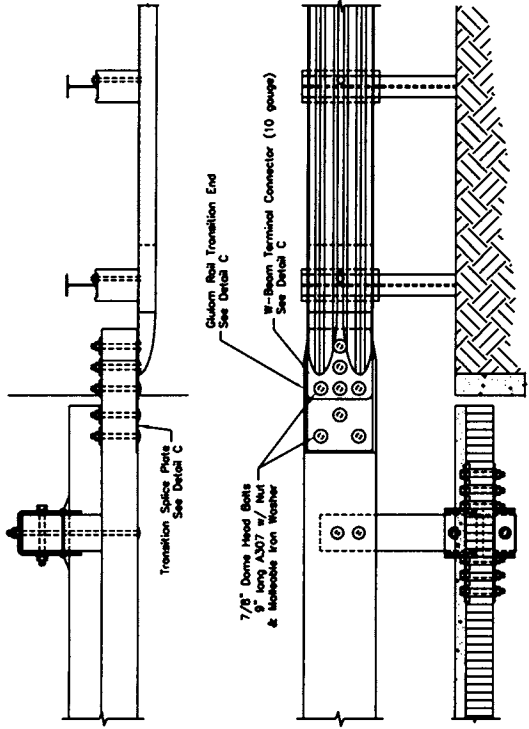
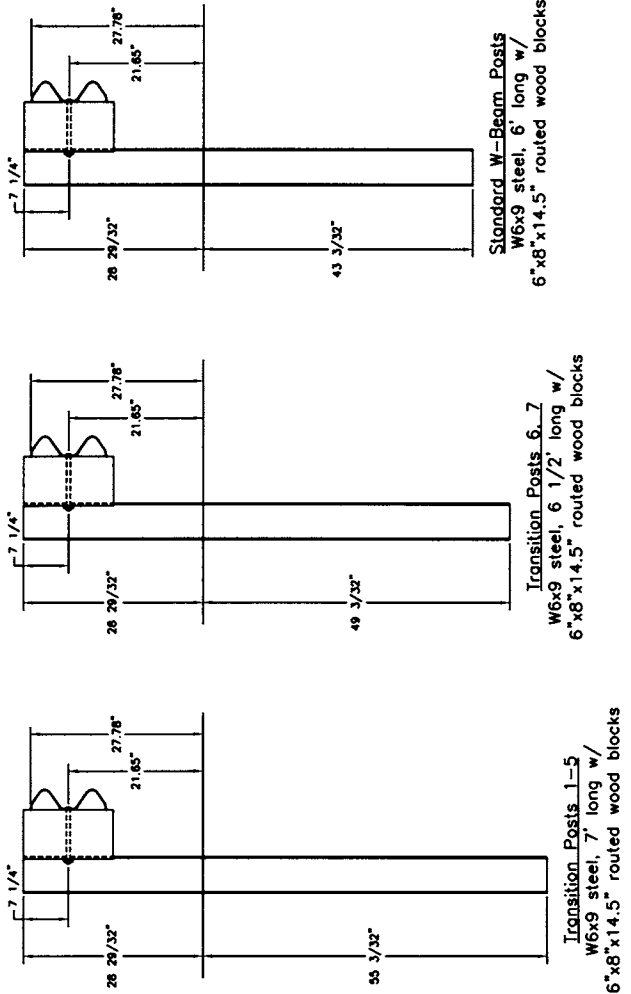
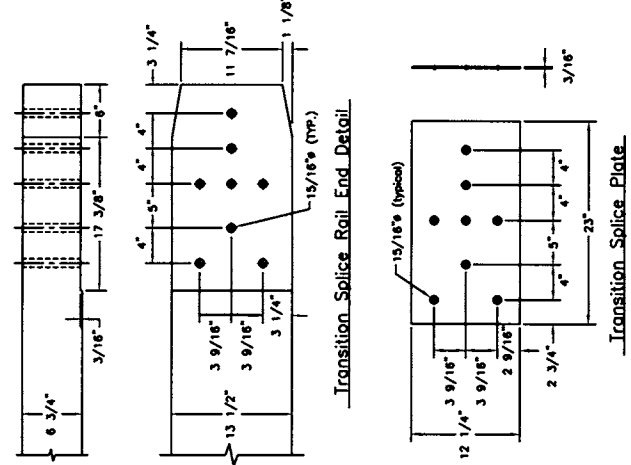
Approach Transition General Configuration

A Transition Splice Details

B Transition Posts Details

C Transition Splice Plate and Rail Details

FIGURE 9 Approach guardrail transition design details, System 2 (1 in. = 25.4 mm).

A TL-2 approach guardrail transition system was designed for attachment to each end of the bridge railing system. The system was constructed by using two nested steel W-beam rails, guardrail posts, and rail blockouts. Details of the approach guardrail transition used with System 2 are provided in Figure 9.
