Influence of concrete cracking on wood concrete composite bridges

Dr. Ing. Frank Schanack
Institute of Civil Engineering
Universidad Austral de Chile

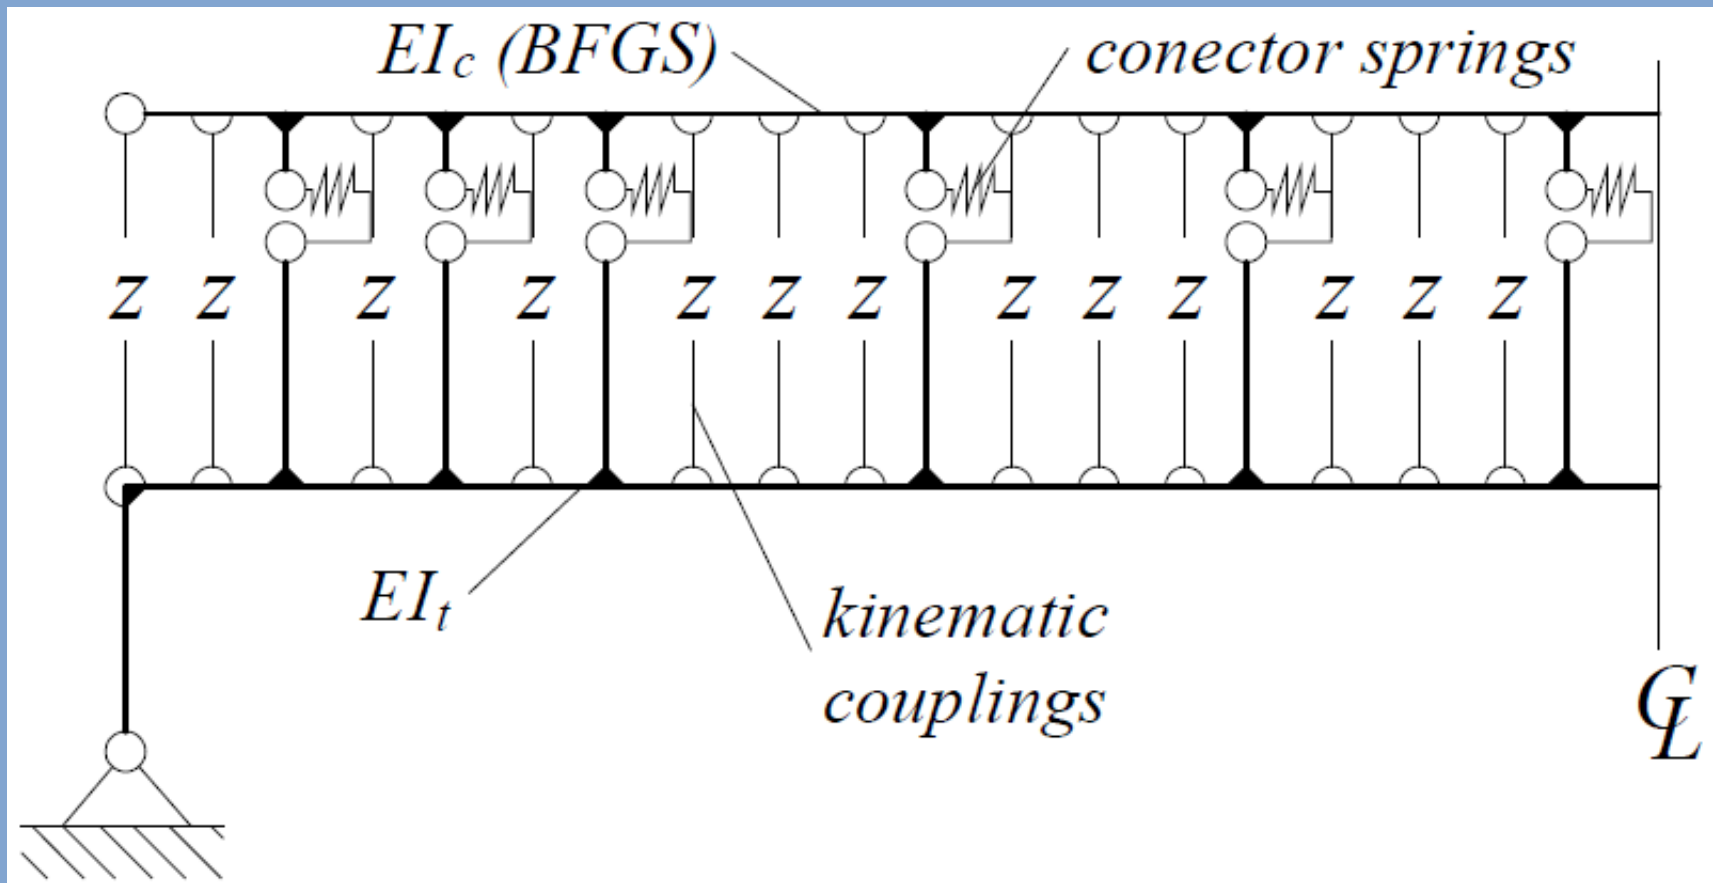
- **Parameterized FEM analysis model**

Concrete slab	Timber beam	General
Depth	Depth	No lineal load-displacement behaviour of the connection
Modulus of elasticity	Modulus of elasticity	Distribution of reinforcement
Tensile resistance	Creep	Type of loading and load history
Tension stiffening	Shrinkage	Length and width
	Swelling

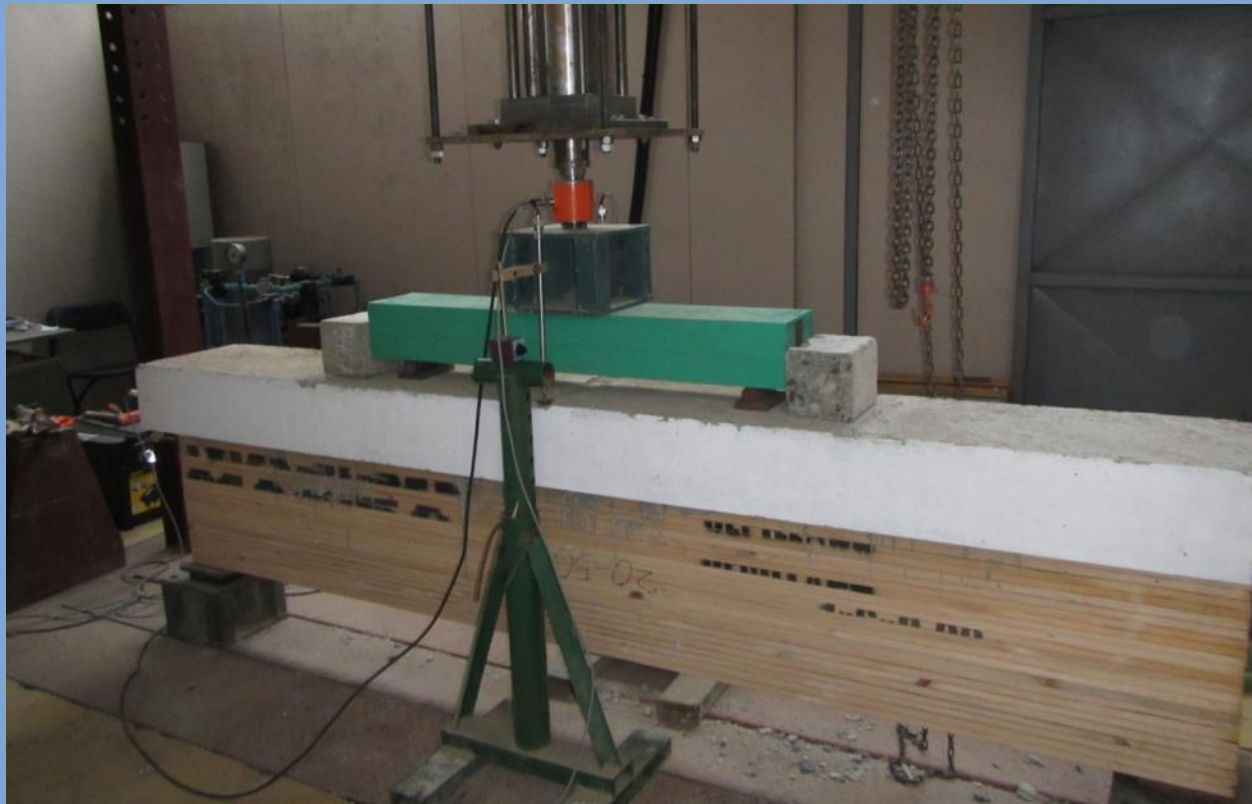
- **Own laboratory tests**
- **Bending tests, 3 m long, concrete 15 cm and 20 cm, timber 30 and 50 cm**

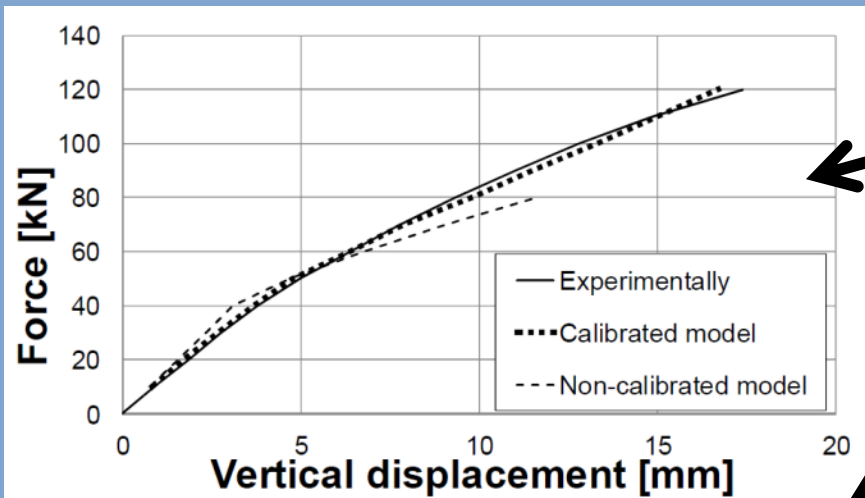
- **First calibration with test data from literature**

Klingenberg

Van der Linden

Yeoh

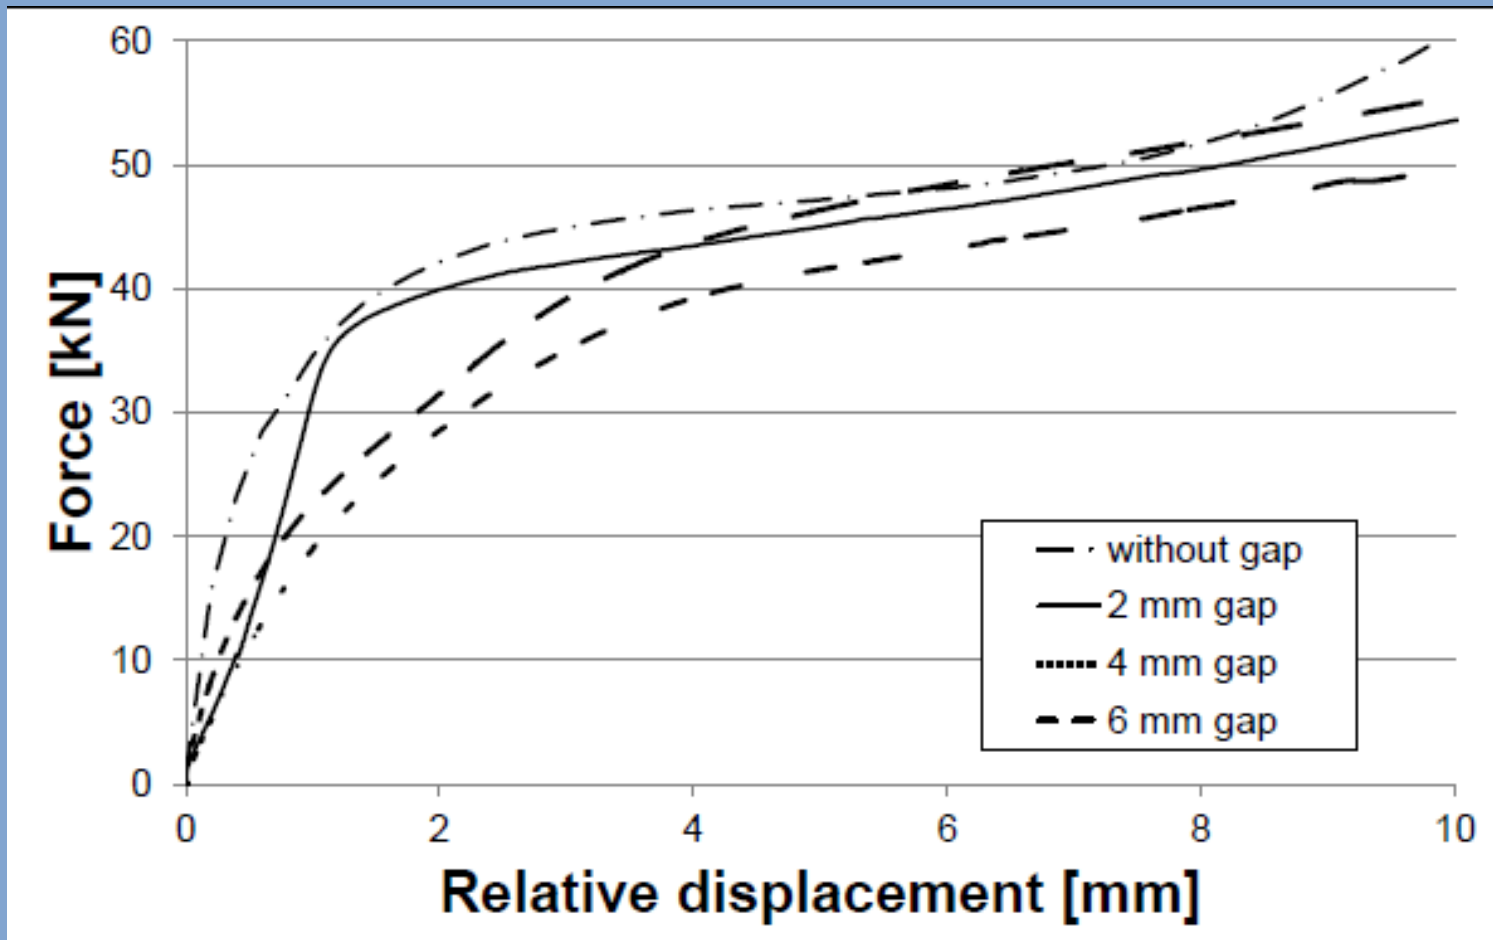
- **Shear tests**

Test specimen	F_u [kN]	F_{40} [kN]	F_{10} [kN]	u_{40} [mm]	u_{10} [mm]	k_{ser} [kN/mm]	$mean\ k_{ser}$ [kN/mm]	
0 mm-1	68	27.2	5.5	0.42	0.04	14.34		
0 mm-2	59	23.6	4.7	0.41	0.04	12.73	12.57	100%
0 mm-3	57	22.9	4.6	0.48	0.05	10.64		
2 mm-1	54	21.6	5.4	0.861	0.103	5.34		
2 mm-2	50	19.9	5.0	0.705	0.173	7.01	5.98	48%
2 mm-3	48	19.2	4.8	0.708	0.065	5.60		
4 mm-1	53	26.5	5.3	1.396	0.201	4.44		
4 mm-2	42	21	4.2	0.864	0.08	5.36	5.16	41%
4 mm-3	44	22	4.4	0.924	0.152	5.70		
6 mm-1	40	20	4	1.609	0.178	2.80		
6 mm-2	43	21.5	4.3	1.206	0.163	4.12	3.58	28%
6 mm-3	45	22.5	4.5	1.367	0.186	3.81

- **Chile has a big need for durable timber bridges**
- **Wood concrete-composite bridges can be the solution**
- **There is no satisfying design recommendation for concrete cracking in TCC beams**
- **FEM analysis show that concrete cracking alone does not explain the documented stiffness reduction**
- **Shear test show that concrete cracking reduces substantially the stiffness of bar-type shear connectors**

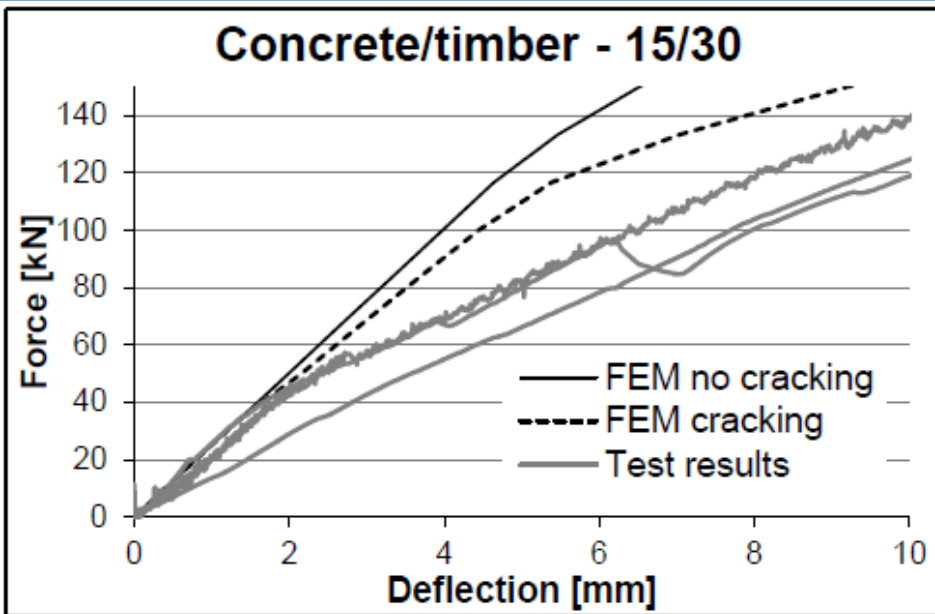
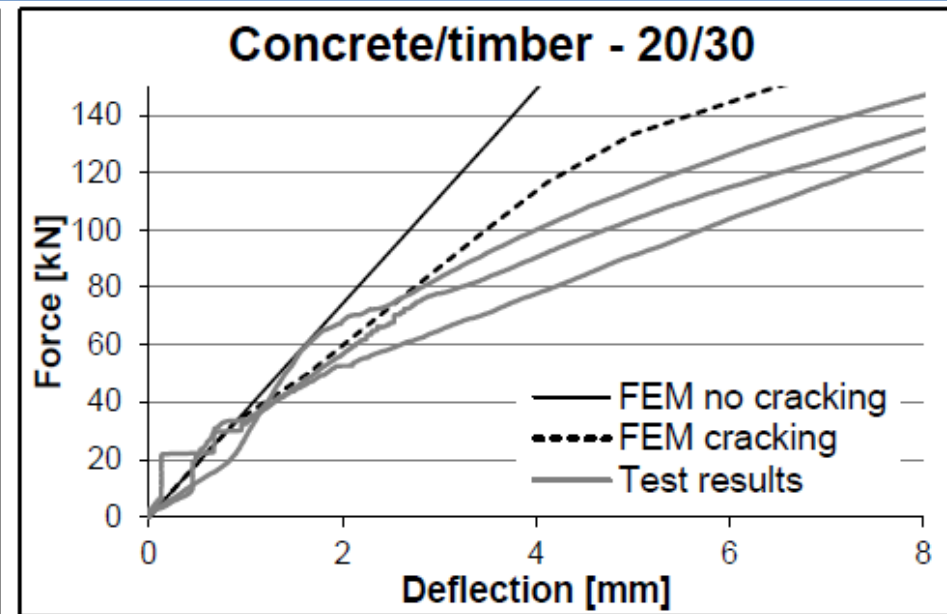
- **Bending tests**

- **The analysis model predicts correctly the initial elastic behavior and the crack initiation load**
- **When concrete cracking occurs, the slip modulus must be reduced**
- **Preliminary, a stiffness reduction by about 60% leads to a safe design**

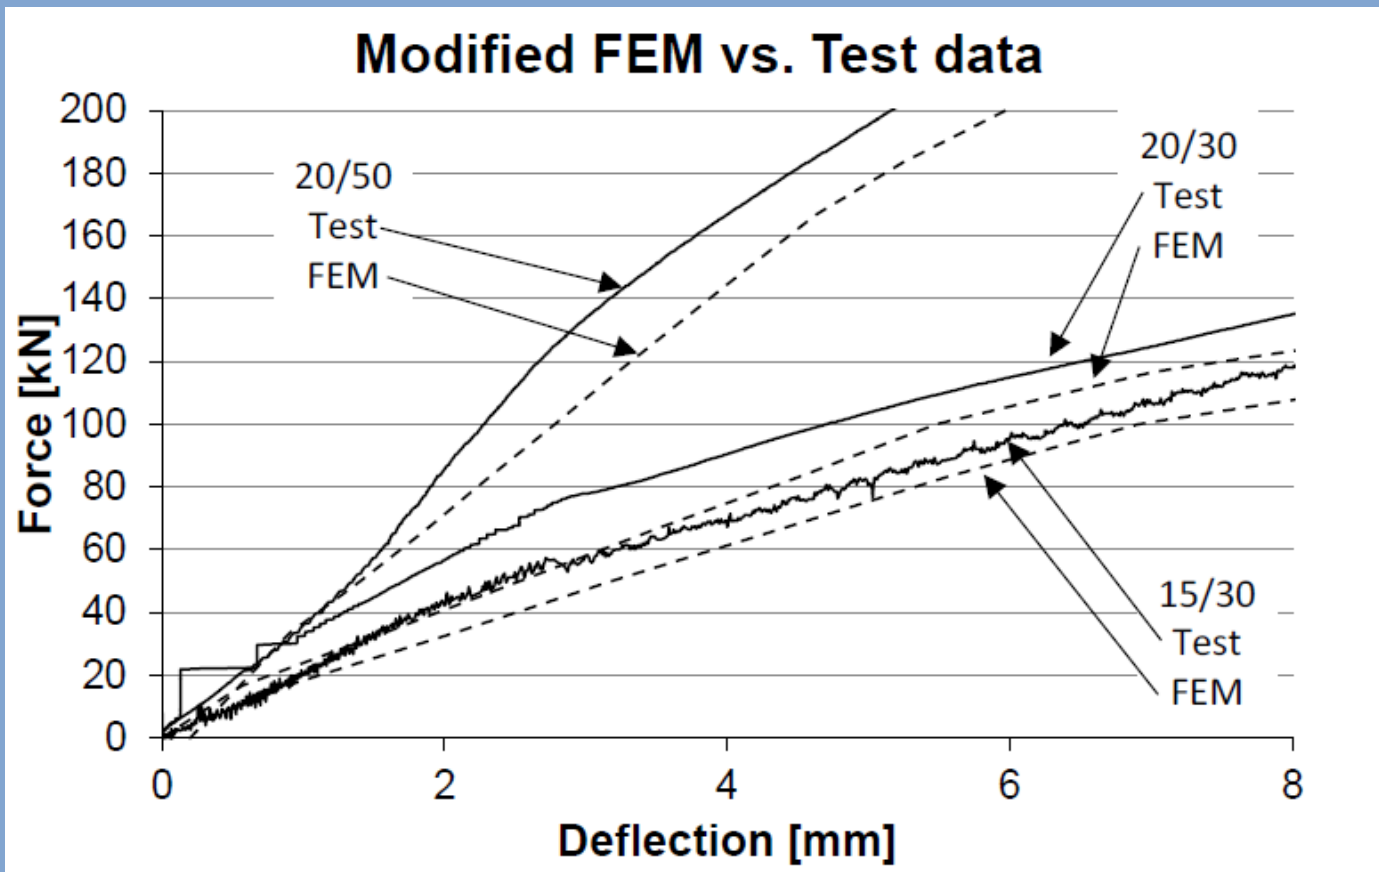
- **Final calibration of the FEM model**
- **Reduction of the connector stiffness by about 60%**
