# Investigation of Glulam Girder Bridges Constructed Prior to 1970

**US Forest Service**

*2<sup>nd</sup> International Conference on Timber Bridges (ICTB2013-Las Vegas)*

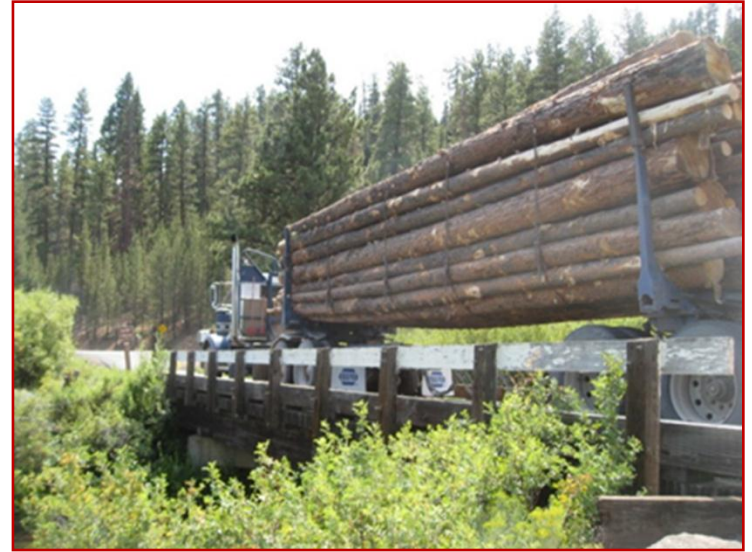
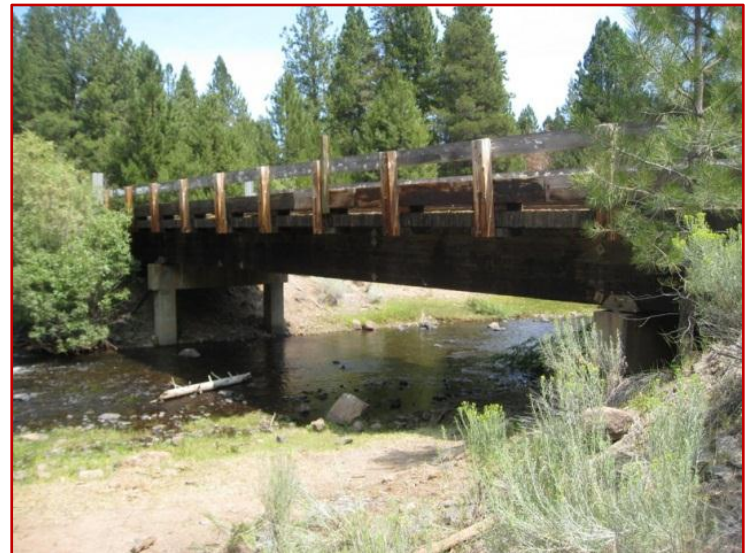
- Approximately 190 bridges located primarily in the Pacific-Northwestern states
- Scarf and butt joints used instead of finger-joints
- Many have balanced cantilevered end spans of 3m (10 ft.), 3-16-3
- Different decks (nailed, concrete, and glulam)
- Record of satisfactory bridge performance under heavy logging traffic for bridges built prior to 1970

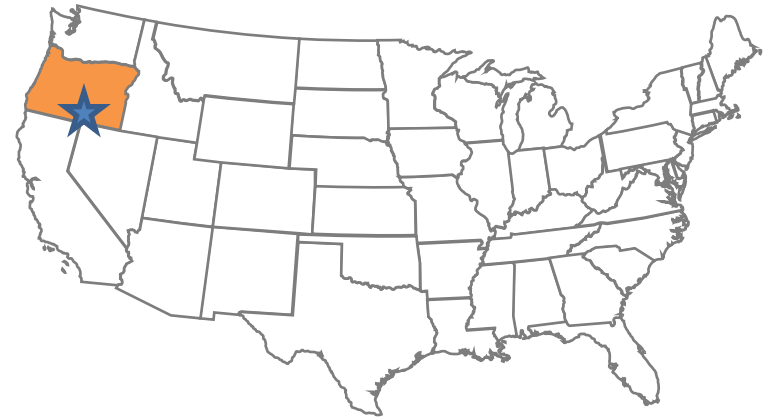
Upper Williamson bridge

- Evaluated 3 bridges in southern Oregon
- Overall bridge inspection
  - Live load testing
  - Investigate tension zone laminations using NDE tools

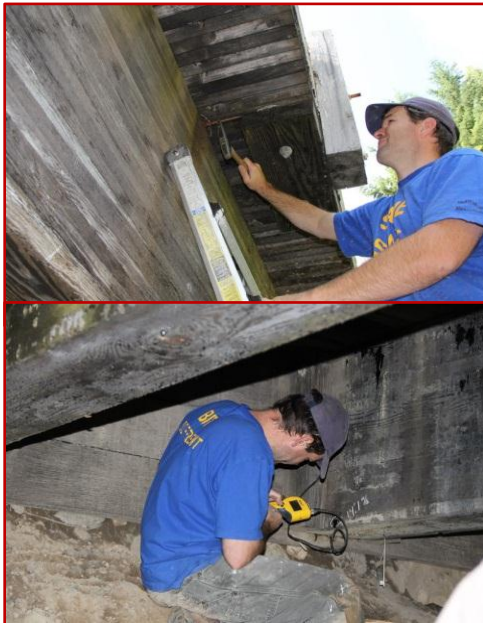
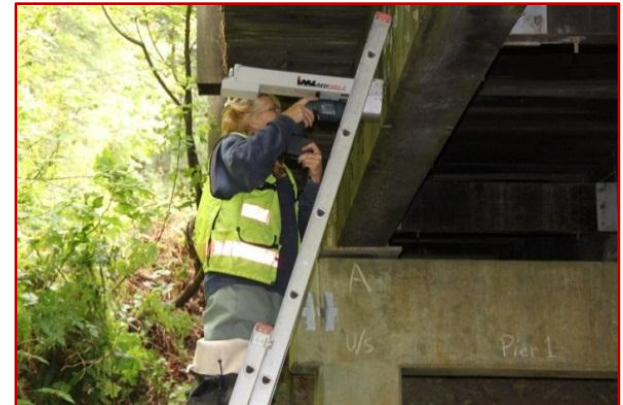
## Elder Creek Bridge

- Visual techniques, hammer sounding & moisture meter to identify areas to examine closely
- Stress wave timing and resistance micro-drilling NDE tools to characterize internal condition of bridge members

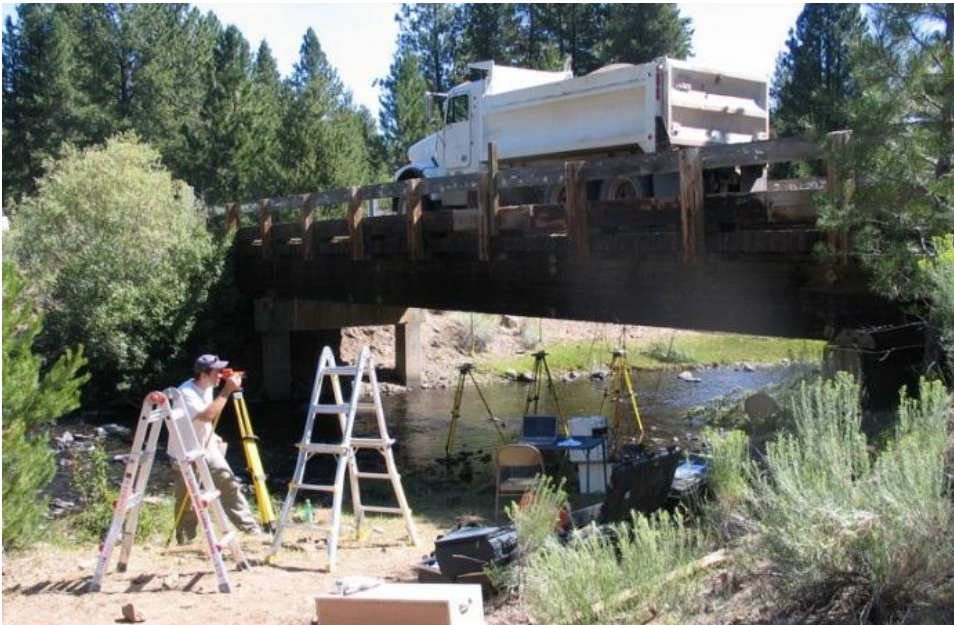
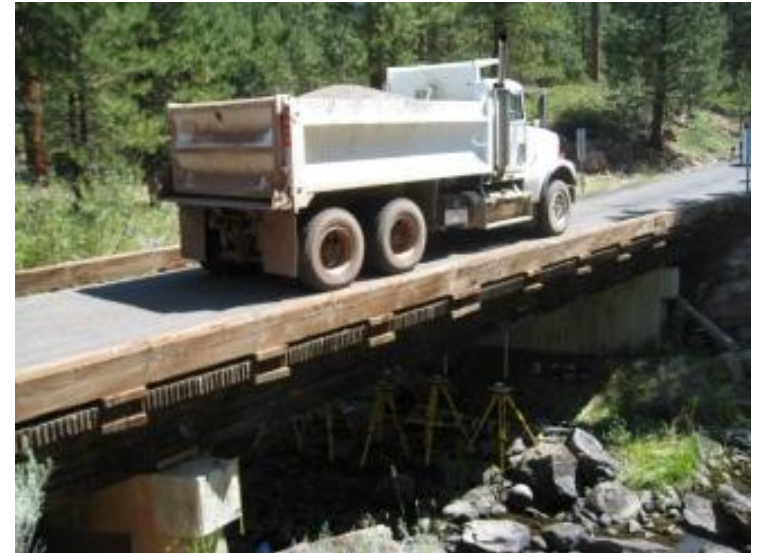
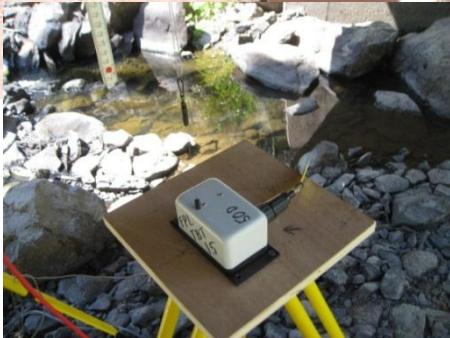
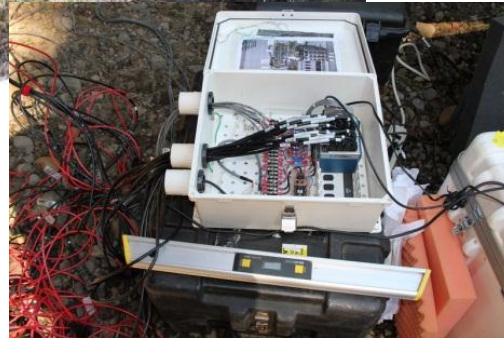
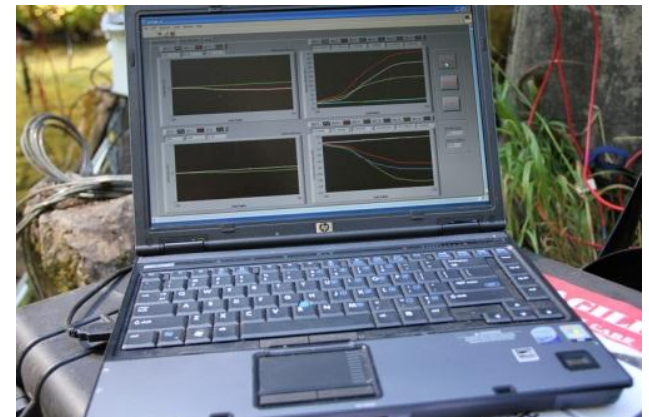
## Elder Creek Bridge

- Live Load Testing

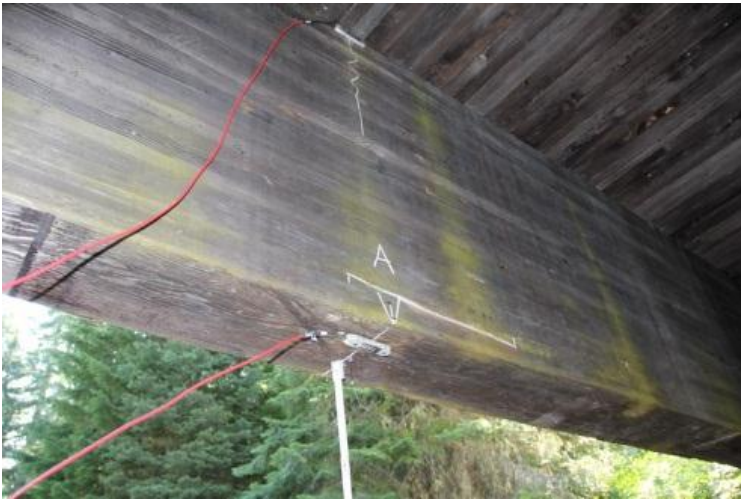
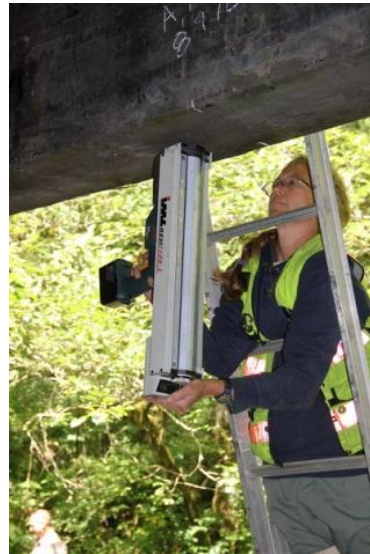
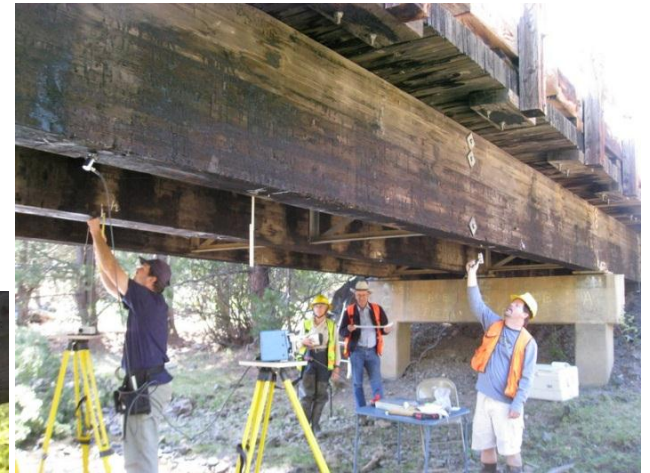
## Elder Creek Bridge

- Investigate tension zone laminations

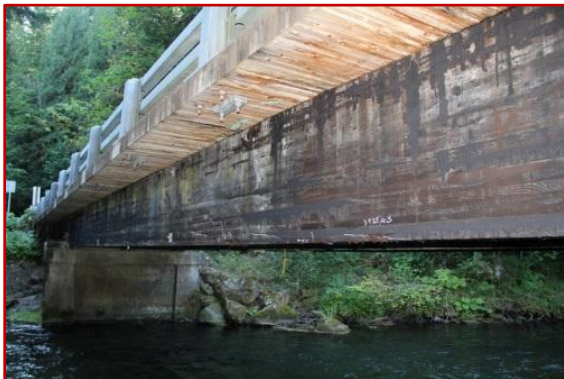
Panther Creek bridge

- Evaluated 3 bridges in southern Washington

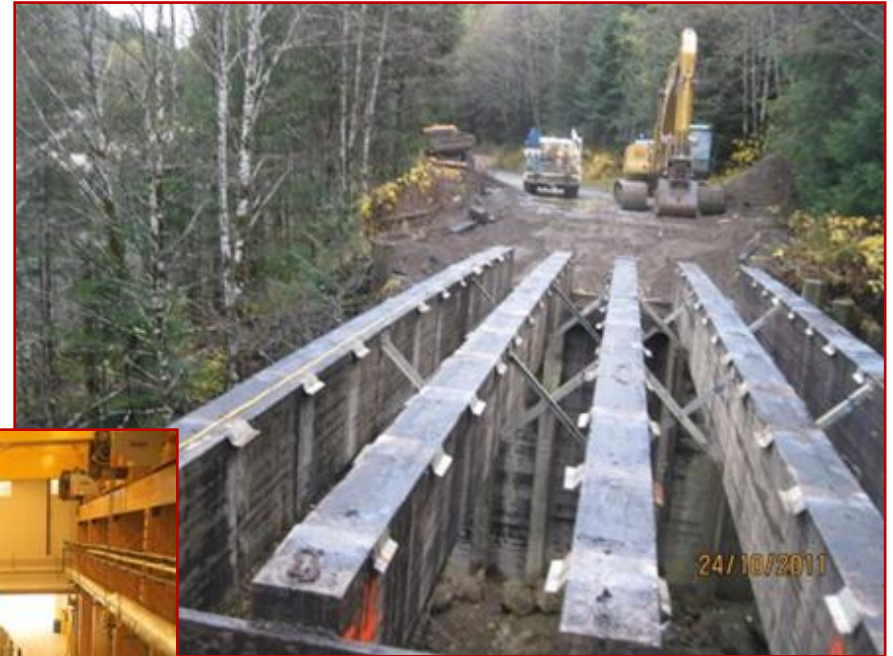
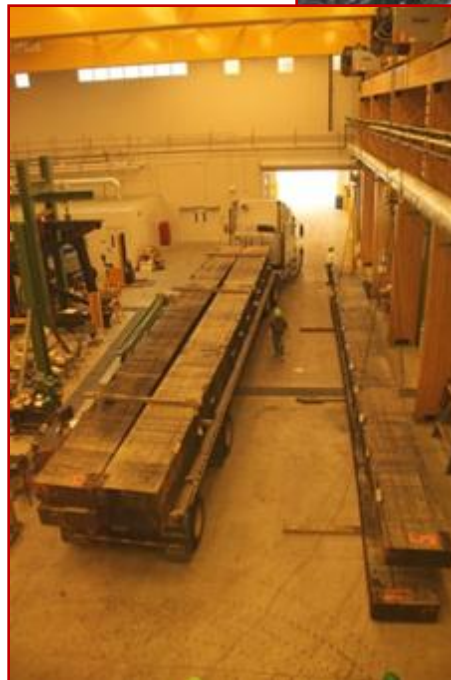
# Jenny Creek Bridge - Alaska

- Built in 1965 in temperate rainforests of the Southeast Alaskan coast
- 4 interior beams were salvaged & transported to FPL
- Opportunity to generate data on residual strength pre-1970's glulam
