Wind Loading on Historic Covered Bridges

F. Michael Bartlett

J. Peter C. King

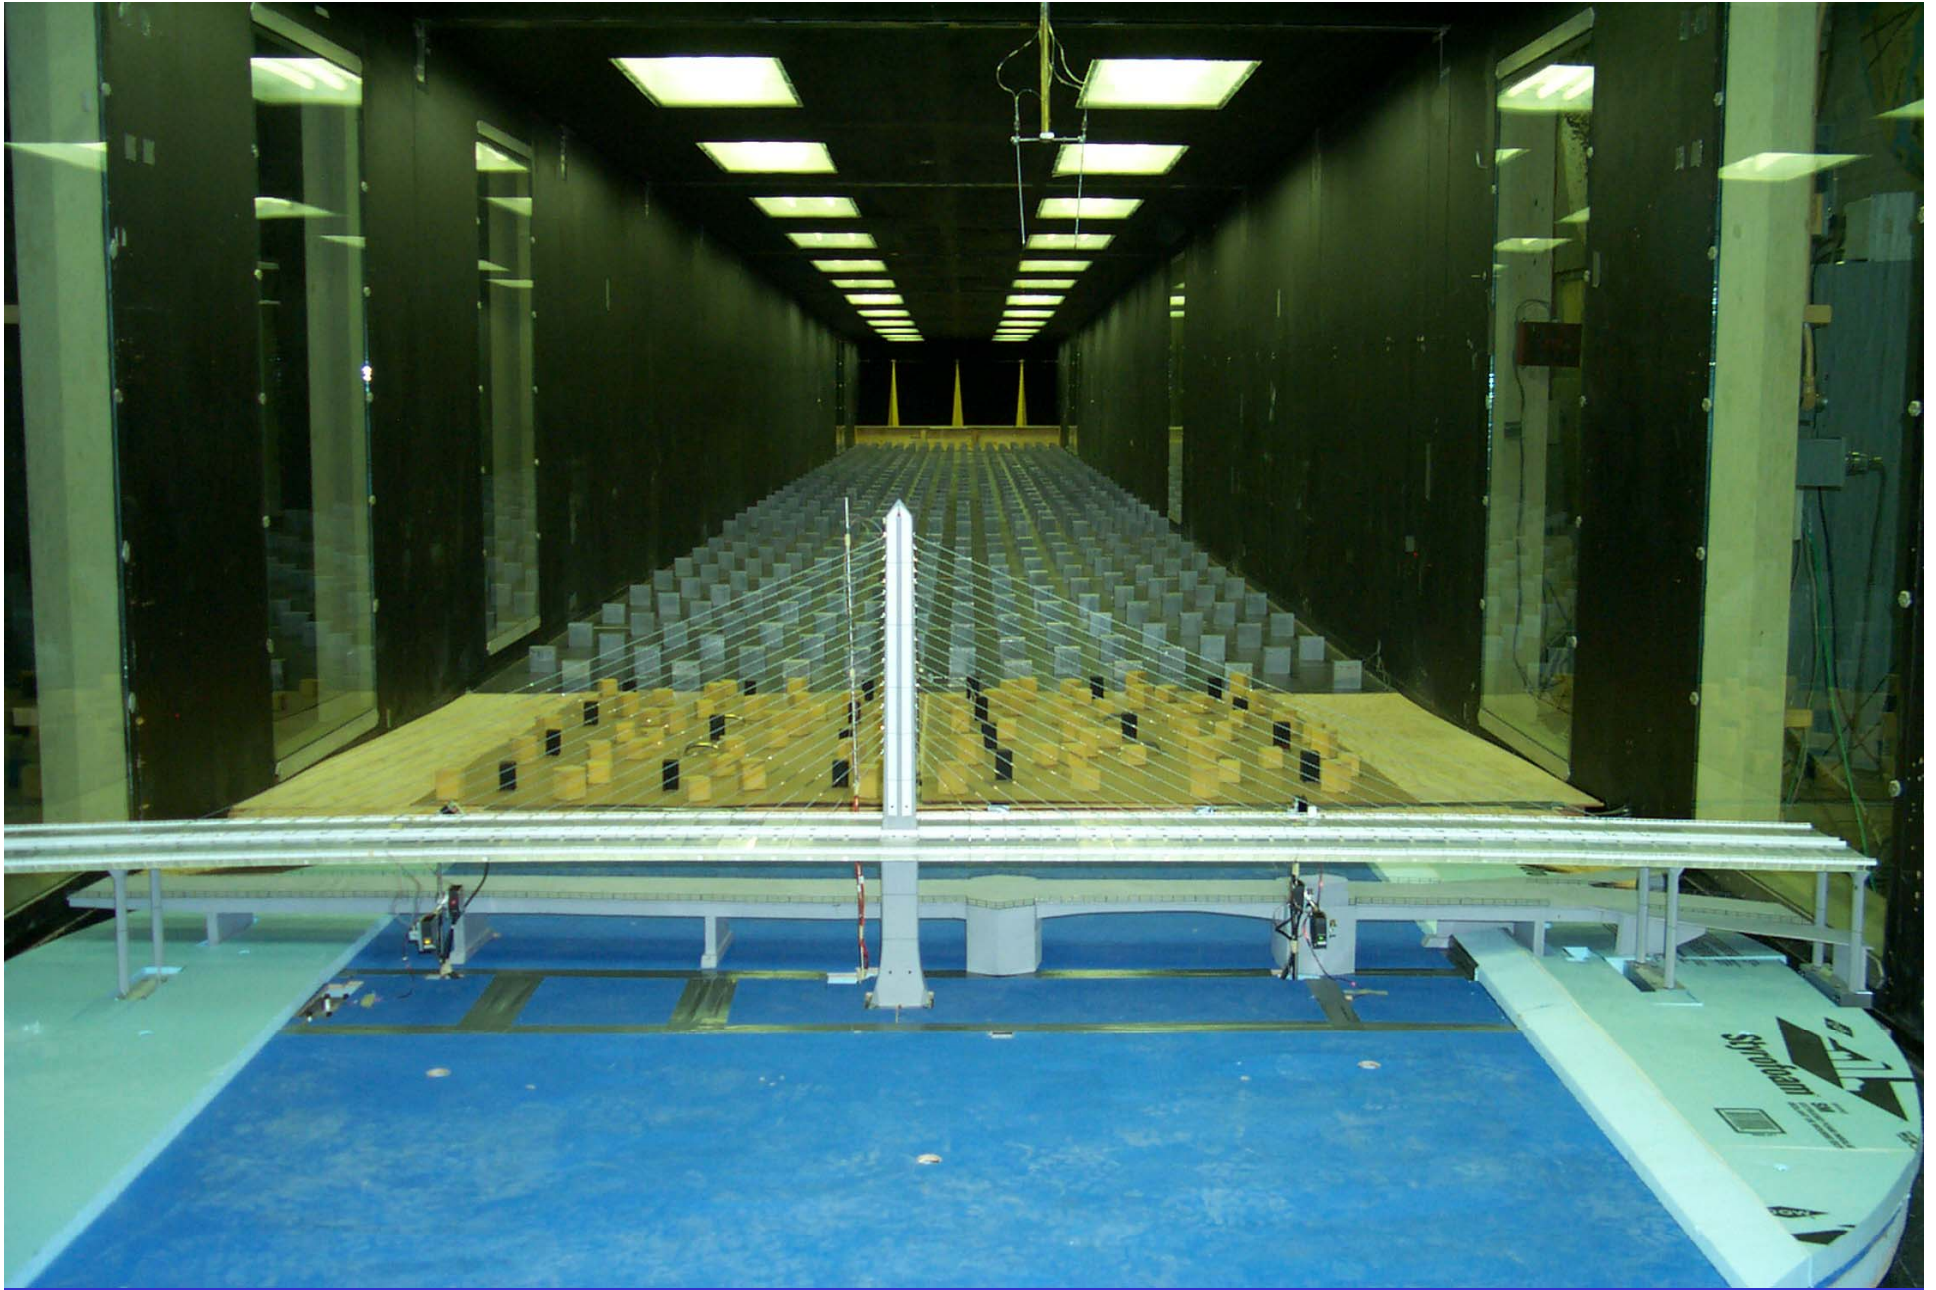
Maumee River Bridge in tunnel

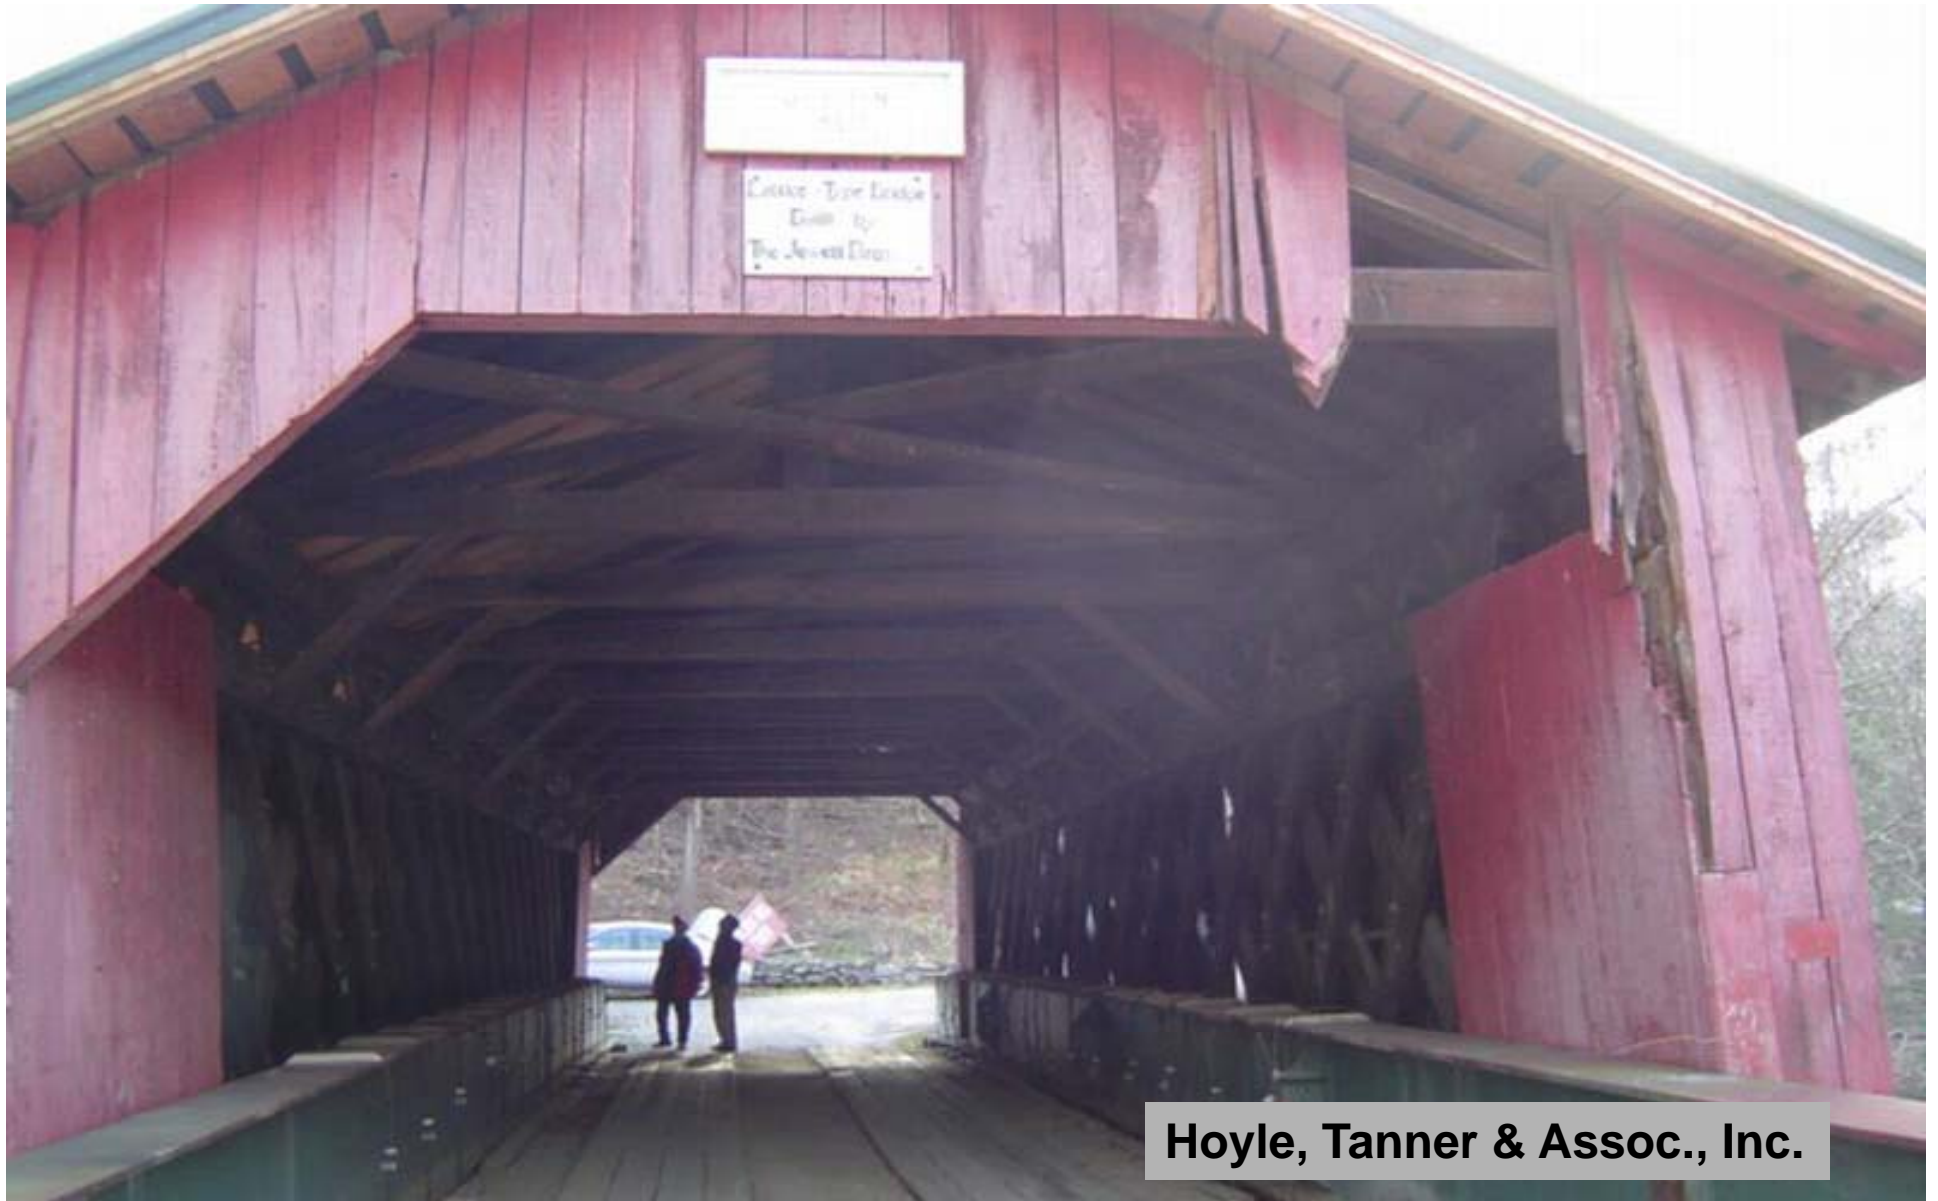
1874
Cottrell Type Bridge
Built by
The Seven Sons

Hutchins Covered Bridge – before rehabilitation

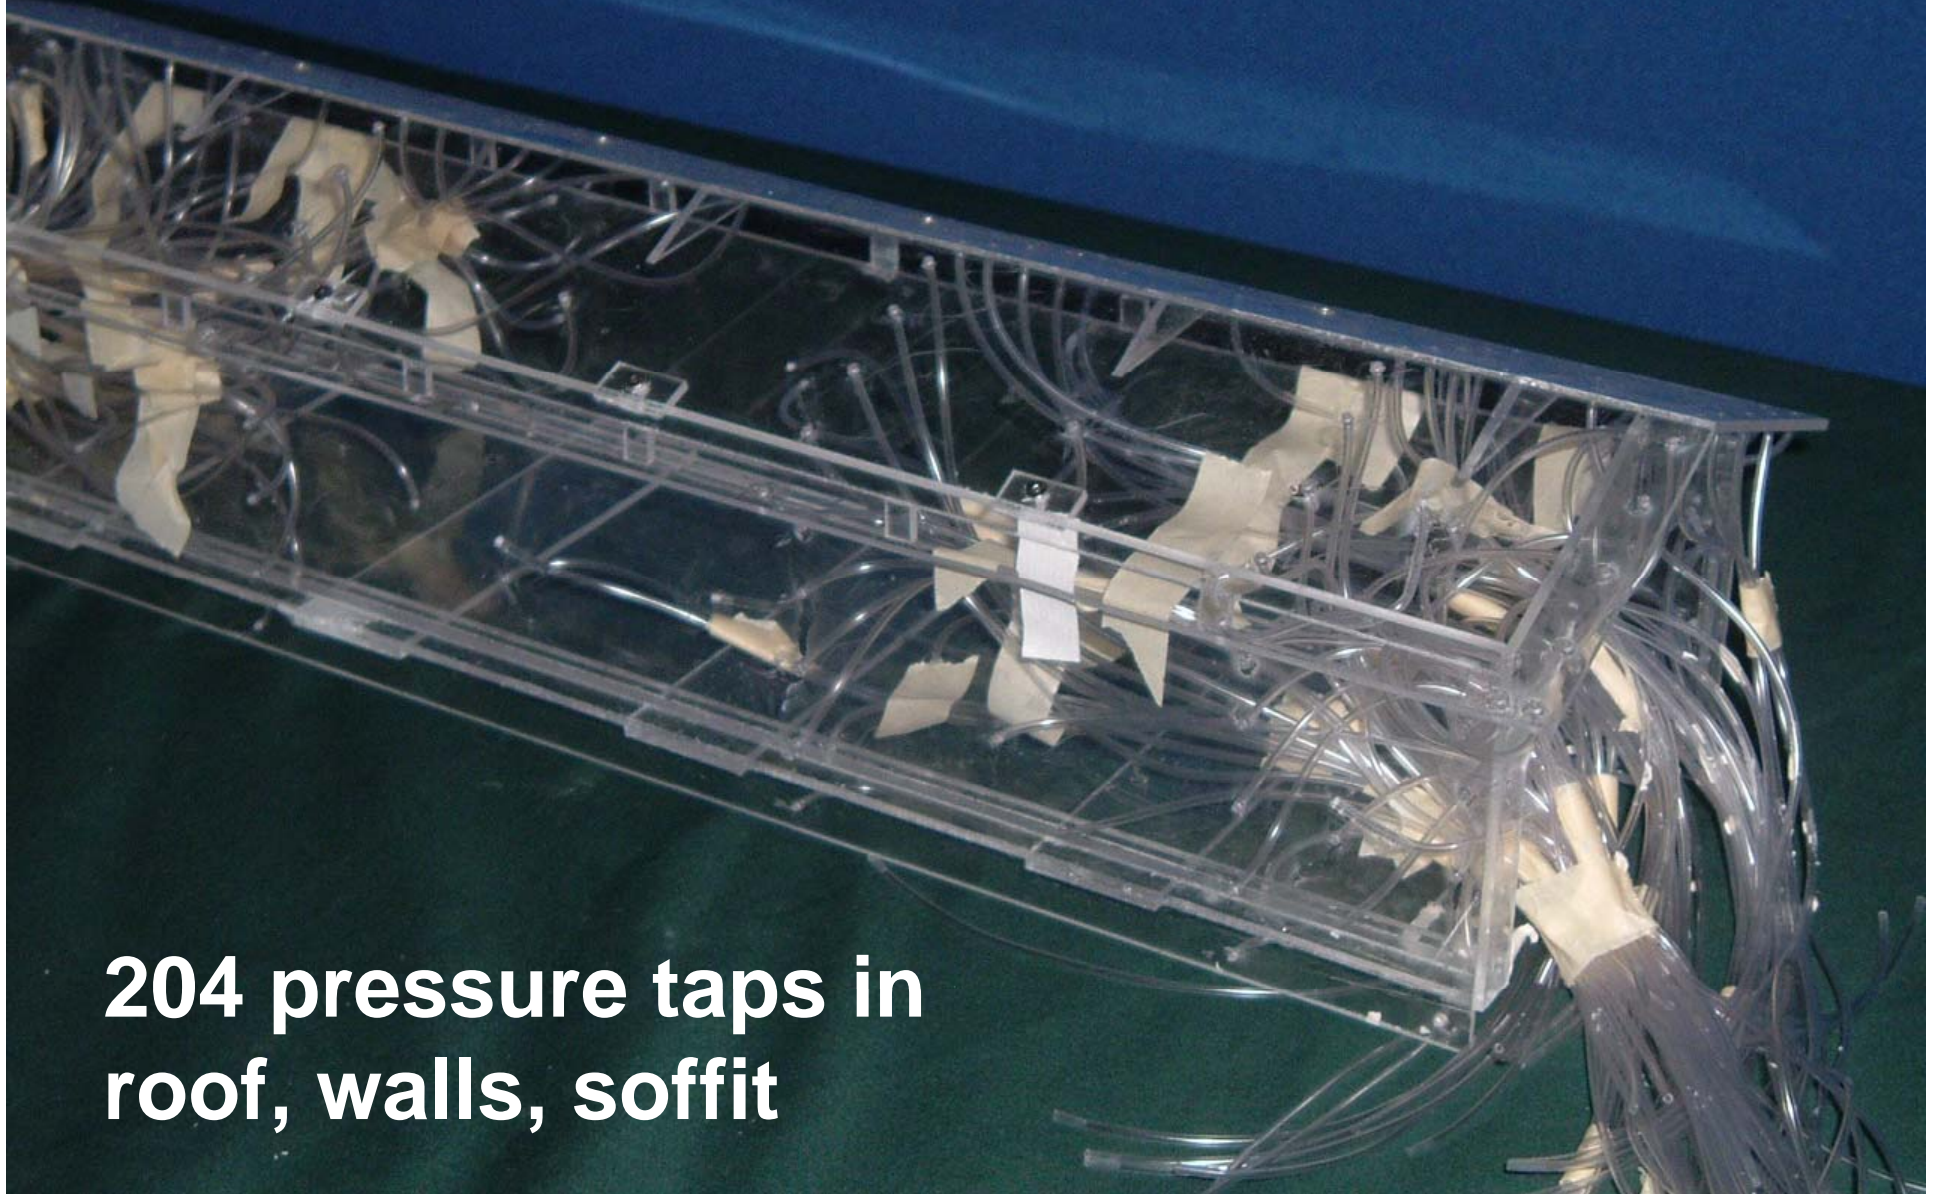
1:40 model by David Mizzen

204 pressure taps in
roof, walls, soffit

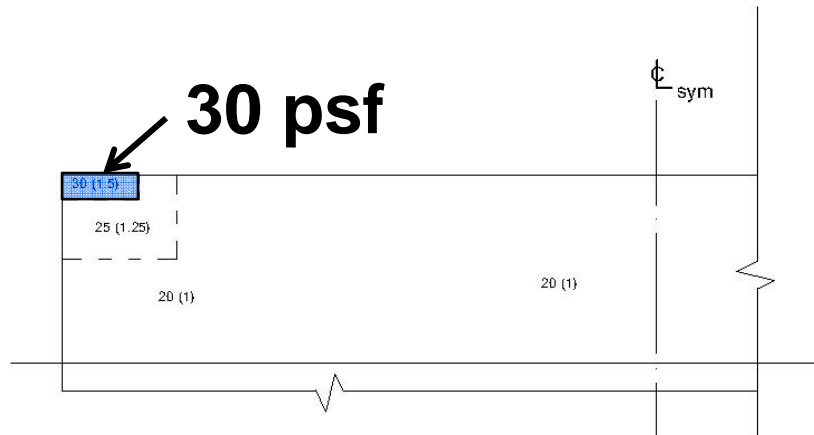
(a) **Roof**

Peak Positive Net Cladding Pressures

1. Check main wind-load resisting members using wind loads from ASCE 7 as those specified in AASHTO (1997) are excessive.
2. The 3.6 kPa (75 psf) pressure specified by AASHTO is accurate for cladding suctions at the ridge and eave at the end of the roof but is excessive elsewhere.

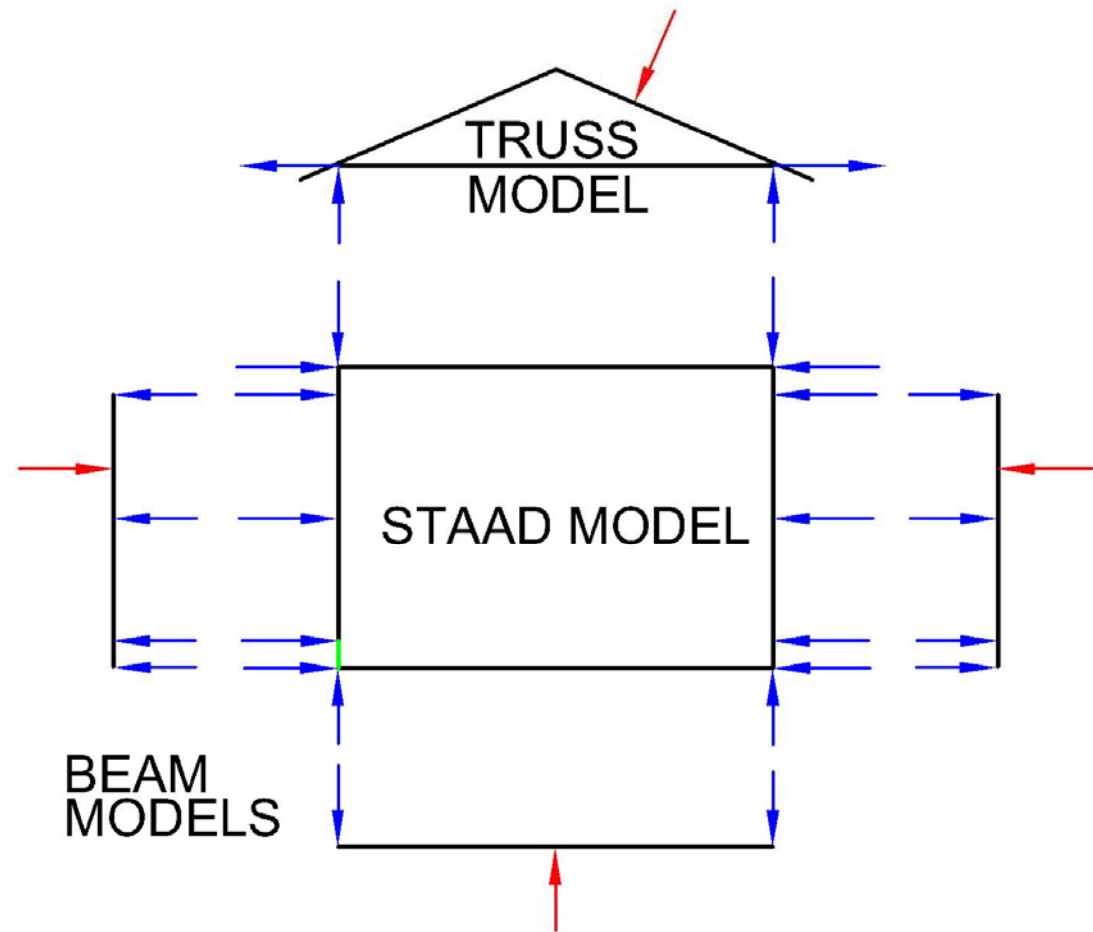
Member Forces Analysis

Time history
of member
forces
