# Two Bridges Built Using Black Locust Wood

## Summary

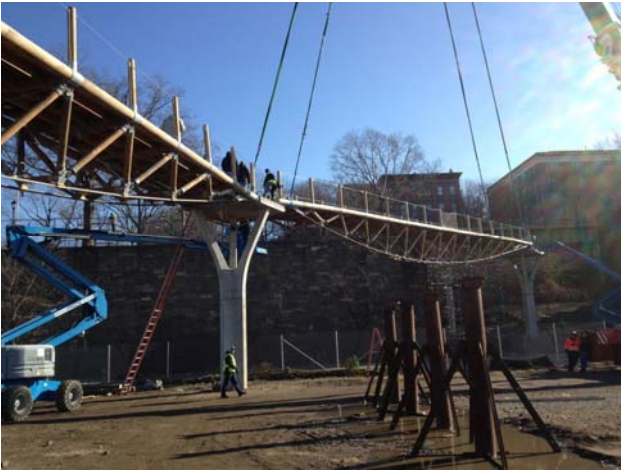
*Fig. 1 Squibb Bridge: a) main spans assembled off alignment and erected with a single crane. Fig. 2 Squibb Bridge: exploded view.*

The concept is an underslung suspension bridge composed of Black Locust timbers, and supported from below by a draped steel cable with props. The slender deck is just 25cm (10-inches) deep, with main spans up to 36.7m (120'-6"). To form continuous structural members the logs were turned on a lathe, and joined by steel pipe connections. The 150mm diameter (6"Ø) diagonal logs terminate in steel pipe fabrications, which are attached to the edge beams by bolted connections.

Bolted connections were designed to initially function as four bar linkages during fit-up, allowing the diagonal elements to be rotated into position and adjusted as required. Connection plates could be fabricated with a single bolt hole, the members could be assembled and adjusted as required, and the remaining bolt holes drilled to fit after completing the assembly.

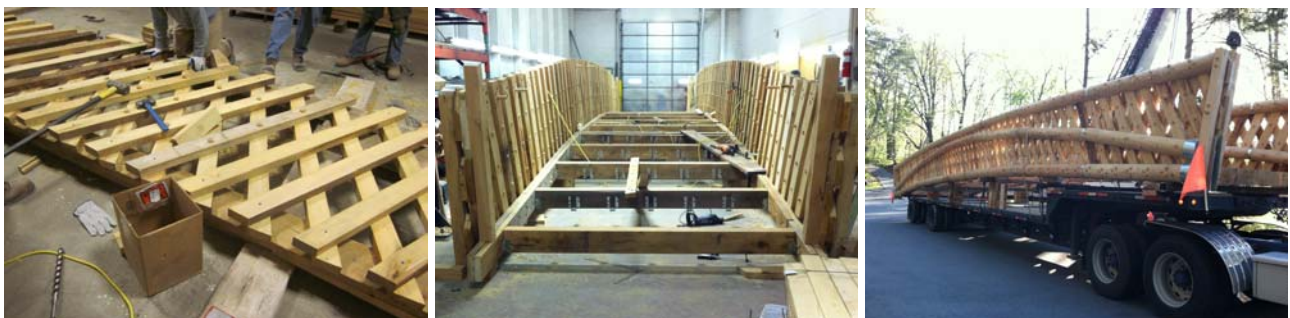
Fig. 7 TA Footbridge: truss layout, assembly, and delivery (photos by Tim Leiching).

A useful scheme for truss fabrication is outlined by Graton [11]. The trusses were assembled in the shop by laying out the timber members on a level area. Chords were laid out with their natural sweep oriented in the direction of the bridge camber. The chords, diagonals, and arch ribs were clamped together, but within days the timber had moved significantly as the wood began to dry. In lieu of clamps, a single decking screw was temporarily installed in a pre-drilled hole at each peg location along the top and bottom chords. Over-fastening was an effective means of controlling the movement of the green timber.

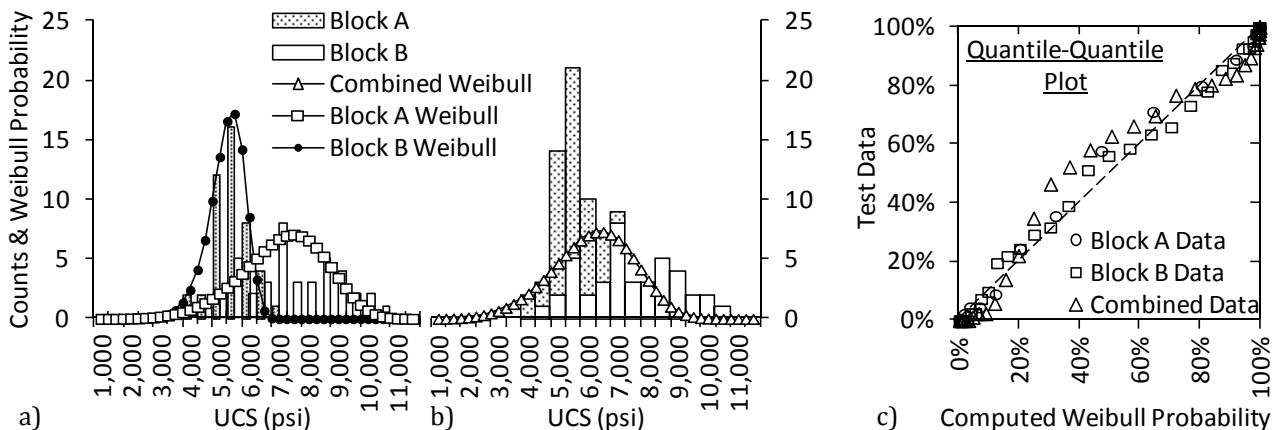
Fig. 9 Test data for small clears loaded in compression parallel to the grain: a) Block A and Block B data, with Weibull pdfs, b) combined data with Weibull pdf, c) Quantile-quantile plot illustrates a relatively poor fit for the combined data.

blocks of data. Compared to Block B, Block A exhibited a smaller mean strength and lower COV. Lower 5% one-sided confidence limits were computed at 75% confidence in accordance with ASTM D2915 [6], also referred to as the parametric tolerance limit (PTL). Despite having fewer samples and higher COV (broader spread of observed UCS), Block B has a higher PTL, and thus a higher design strength could have been used for TA Footbridge as compared to Squibb Bridge. Though the ASTM standard uses a normal distribution for computing the PTL, Weibull distribution is generally considered a better fit, and is used as the basis for calibrating Eurocode design values. A Weibull probability distribution function was fitted to each data set, shown in Fig. 9.

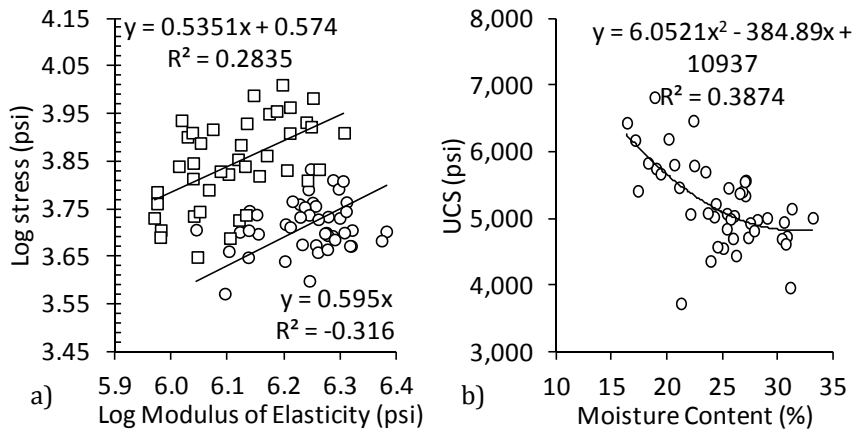
Fig. 10 UCS Relationships: a)  $\circ$  Block A and  $\square$  Block B MOE vs. UCS, b) Block A MC vs. UCS.

Concurrent with Block 0 mechanical testing, acoustic testing was performed on 207 logs at the mill, with the aim of capturing elastic modulus data representative of the population of logs used for Squibb Bridge. Test data are presented in Fig. 12, alongside the computed Weibull distribution. Voids were successfully detected by the software as having more than one strong frequency peak. UCS relationships from testing of small clears could be used to relate acoustic elastic modulus to the strength, and adjusted for moisture content (Fig. 10).

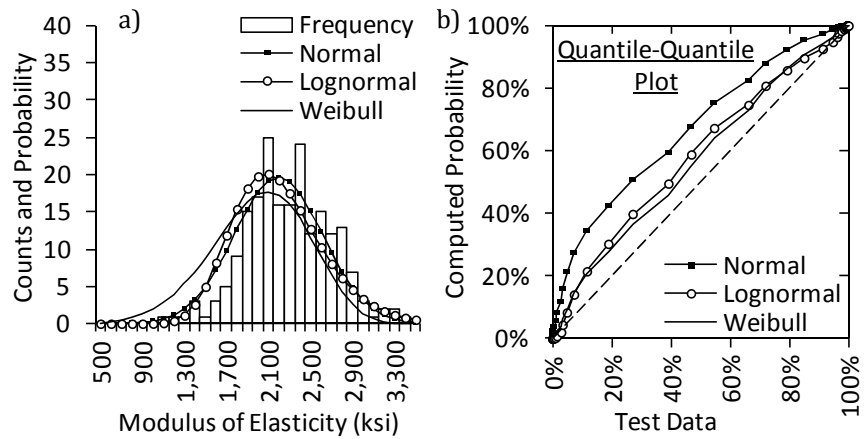
Fig. 12 Acoustic test data for logs: a) Block 0 data with Weibull pdfs, mean 2,264ksi, COV 20.3%, b) Quantile-quantile plot suggests Weibull distribution is suitable for the combined data.
