# **From Damage Maps to Condition Inventories:**

## **A proven concept for documentation of results of inspection of timber bridges and other timber structures**

**Frank Rinn**  
**President**  
**Rinntech Inc.**  
**Heidleberg, Germany**  
**frank.rinn@rinntech.com**

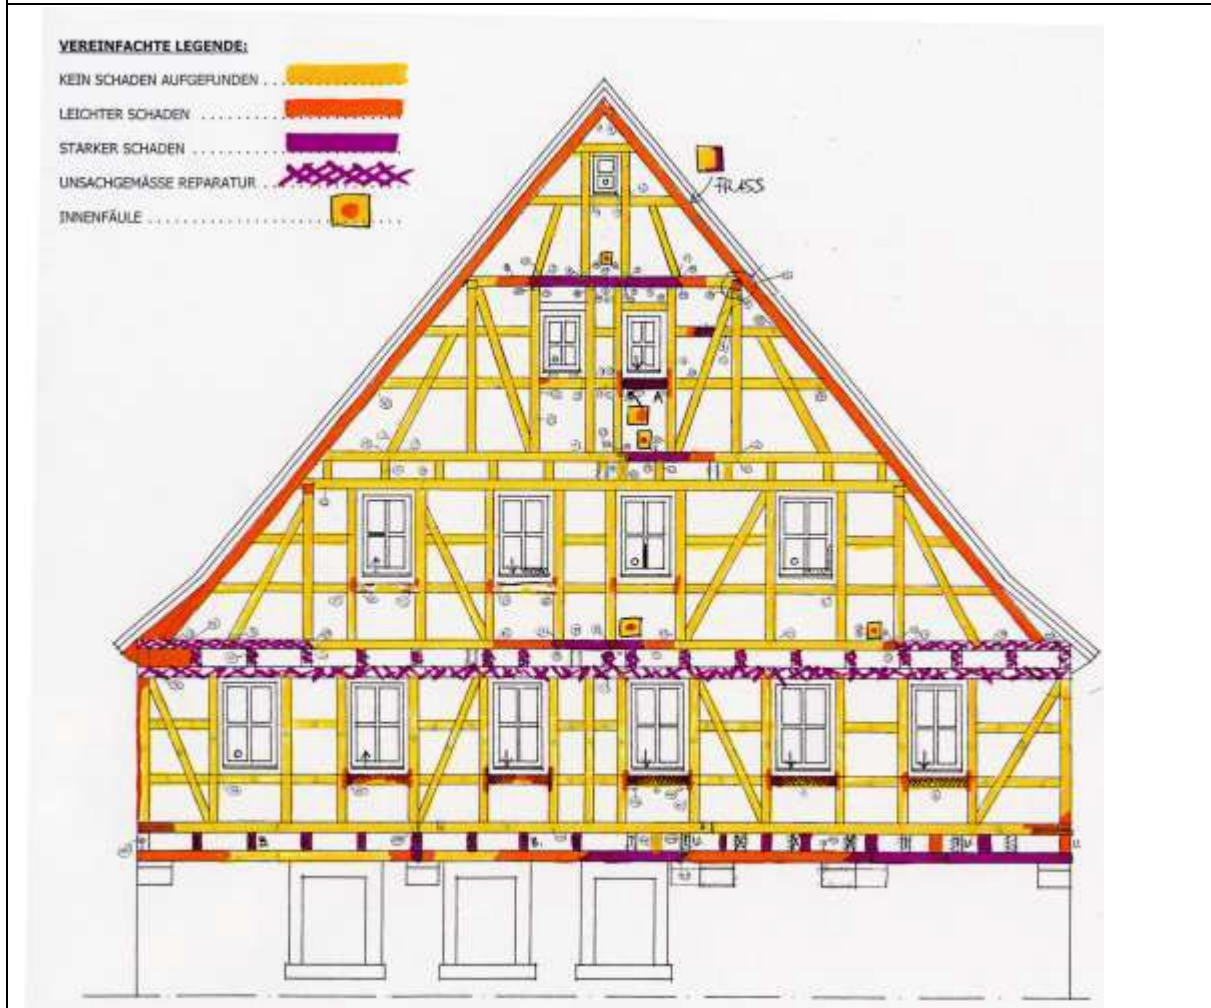
Fig. 5: Overview sketch with a simplified color coded condition inventory. This inspection was carried out by one person on one day including the drawing of the inventory what is usually done on site.
