# Inspection of Timber Bridges in the Southern US

**P. David Jones, Assoc.  
Prof. Department of  
Forest Products, MSU  
Starkville, MS, USA  
Joseph Dahlen, Asst.  
Prof. WSNR, UGA  
Athens, GA, USA  
Rubin Shmulsky, Dept.  
Head, Department of  
Forest Products, MSU  
Starkville, MS, USA**

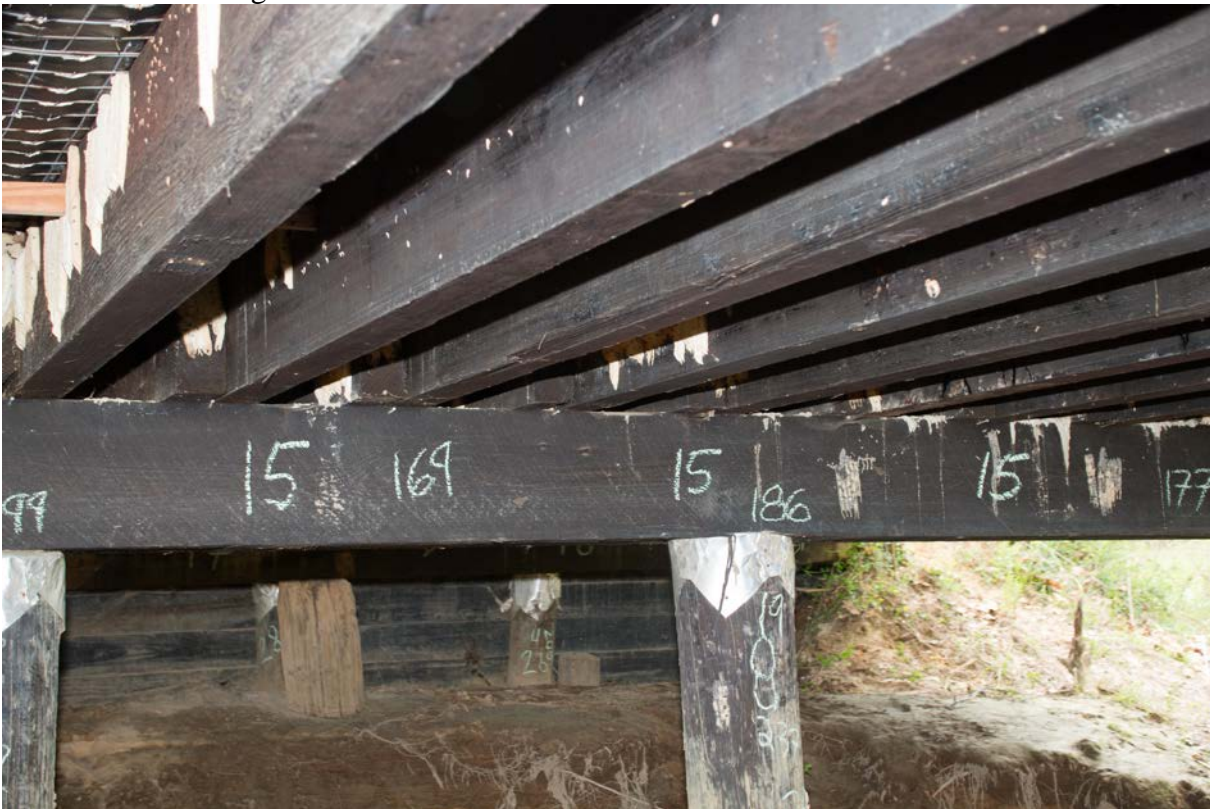
Figure 1. Alabama bridge 14268

All four of the bridges in Alabama were of similar construction, utilizing creosote treated stringers, caps, and pilings. Figure 1 shows an example of the bridge construction in Pickens county Alabama. The bridges were constructed between 1986 and 1997.

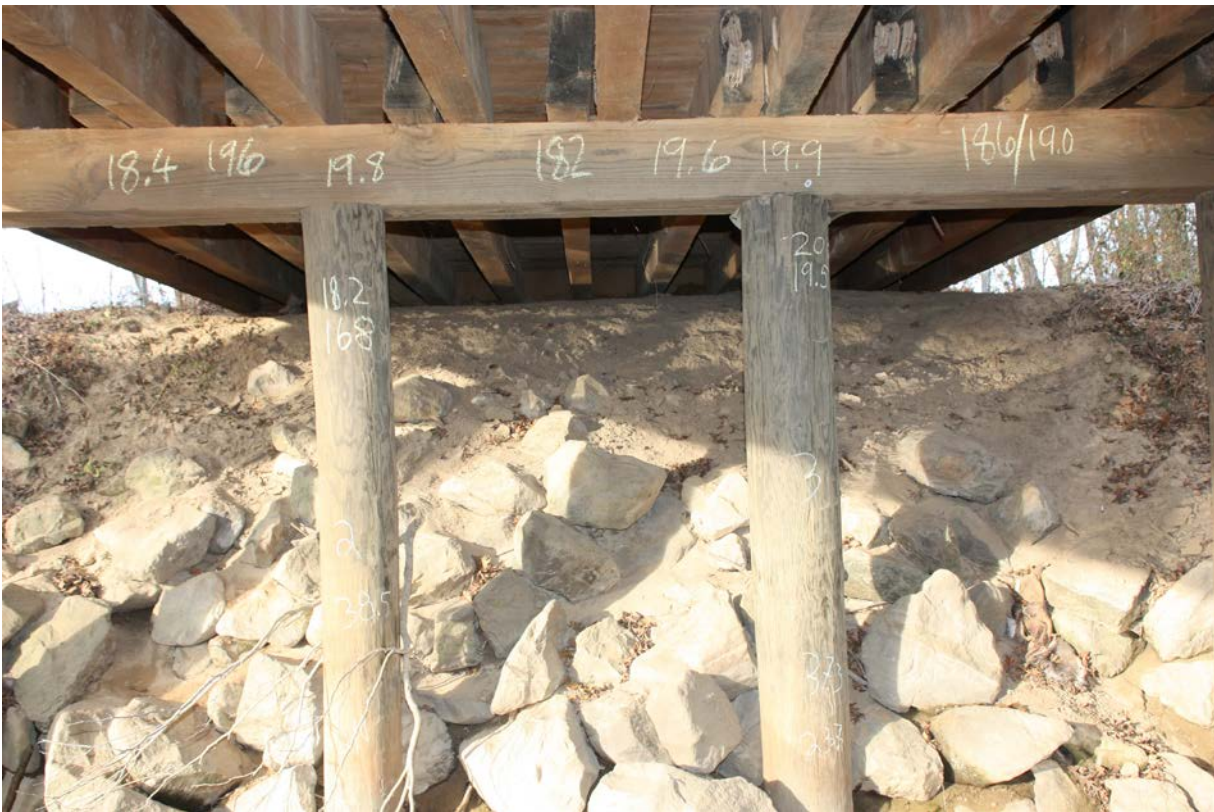
*Figure 2 Mississippi bridge 77*

All eight bridges inspected in Mississippi were treated with CCA and had similar construction. Figure 2 is an example of the timber bridges found in Lafayette county Mississippi. The bridges ranged in age from 22 years in service to only 16 years in service.
